SUBJECT: Notice of Intention to Demolish 39 Wilson Street, Hamilton, ON L8R 1C6 (Unoccupied Manse Adjacent to Trinity Lutheran Church)

HERITAGE IMPACT ASSESSMENT

Trini Lutheran Church 37-39 Wilson E, Hamilton

10 JAN 2025

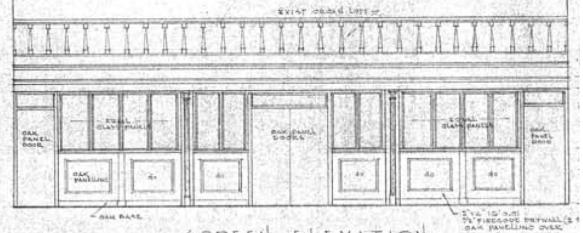
1991 partition wall at the south end of the Sanctuary designed by James Christie that is proposed for removal

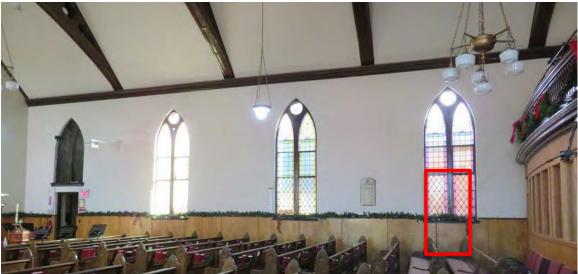
There will be direct impacts to one of the 1908 stained-glass windows in the east wall of the Sanctuary that is a heritage attribute. The lower portion must be removed so that a new doorway can be installed. Negative impacts can be mitigated by preserving the upper portion *in situ* and by salvaging and reusing any glass that is removed. The salvaged glass can be reused either as a feature in the new addition or for use as a repair material for any windows that require repairs. This work should be undertaken by a stained-glass expert.

East wall of the Church – the stained-glass window in Bay 2 must be modified for a doorway into the proposed addition.

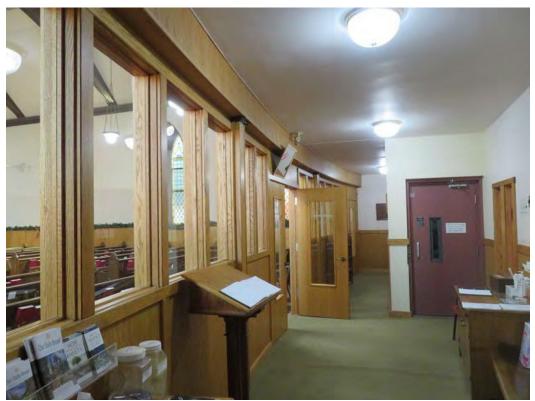
Church Interior – below the Gallery – oak partition wall & elevator installed in 1991 to be removed

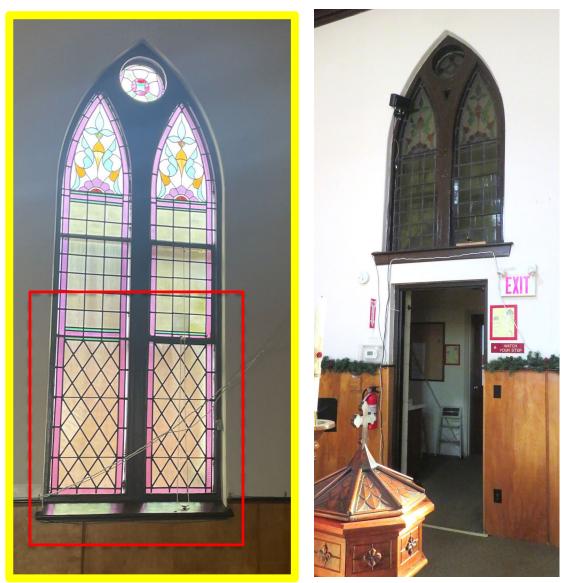
Church interior – Sanctuary east wall – stained-glass windows in Bays 1, 2, 3 & 4 (left) – there is a door in Bay 5 with stained glass above that matches the other windows

RECOMMENDED MITIGATION: salvage stained-glass from window to be modified for new doorway – work to be undertaken by stained-glass expert

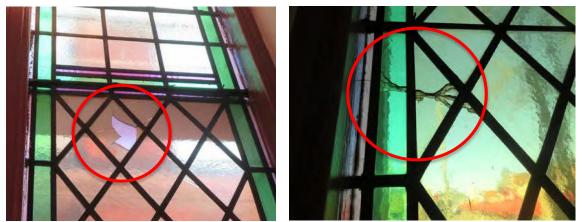
Church Interior - damaged 1908 stained-glass windows in the east (left) and west (right) side elevations

RECOMMENDED MITIGATION: stained glass expert to assess condition of stained-glass windows in East wall and provide protection measures

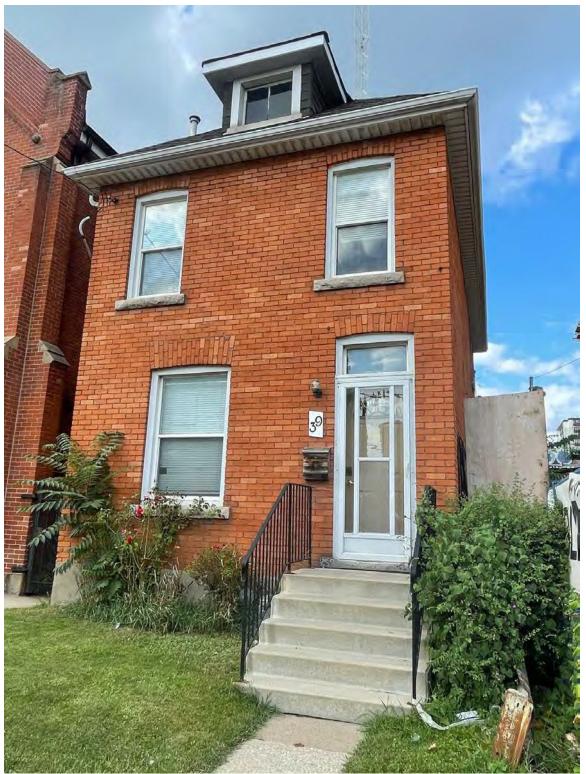
1902 Caretakers House, 39 Wilson Street – brick veneer – windows and doors have brick arches and cut stone sills – doors and windows have been replaced and concrete stairs have been installed at the front entrance on Wilson Street – foundation is parged

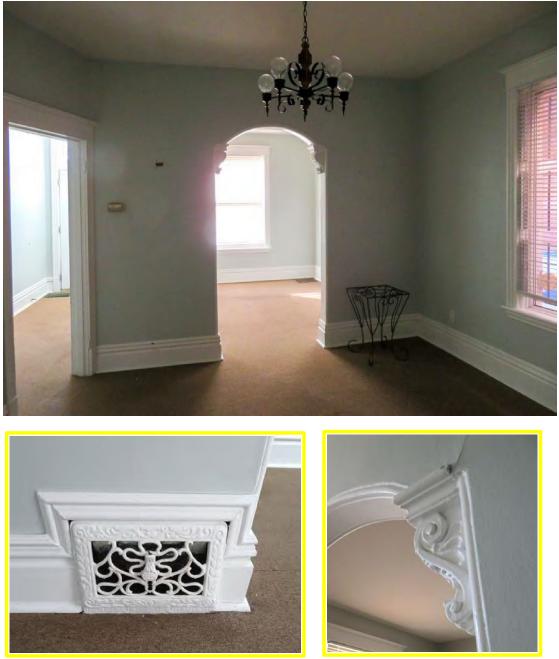
1902 Caretaker's House – interior – 1^{st} floor – the front room has two arched openings with ornate scrolls – the ornate heat vent covers are original

POTENTIAL SALVAGE ITEMS: metal vent covers & decorative wall brackets

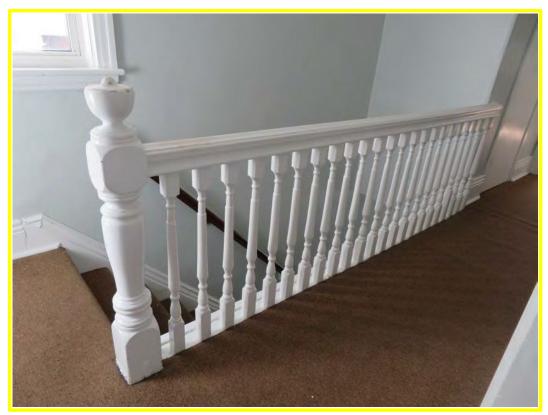
1902 Caretaker's House - original stair railing and newel post in the upstairs hallway

POTENTIAL SALVAGE ITEMS: stair newel, handrail & balusters

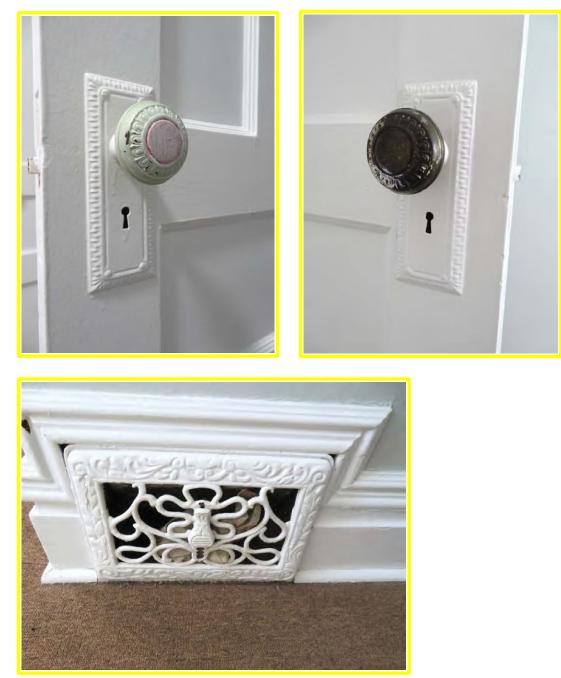
1902 Caretaker's House – interior – 2nd floor – original door hardware and vent covers

POTENTIAL SAVLAGE ITEMS: door hardware & decorative metal vent covers
