City of Hamilton - Heritage Permit Application Note Sheet

Address: 122 McNab Street South, Hamilton (MacNab-Charles Heritage Conservation District, Part V)

Permit Number: HP2025-023

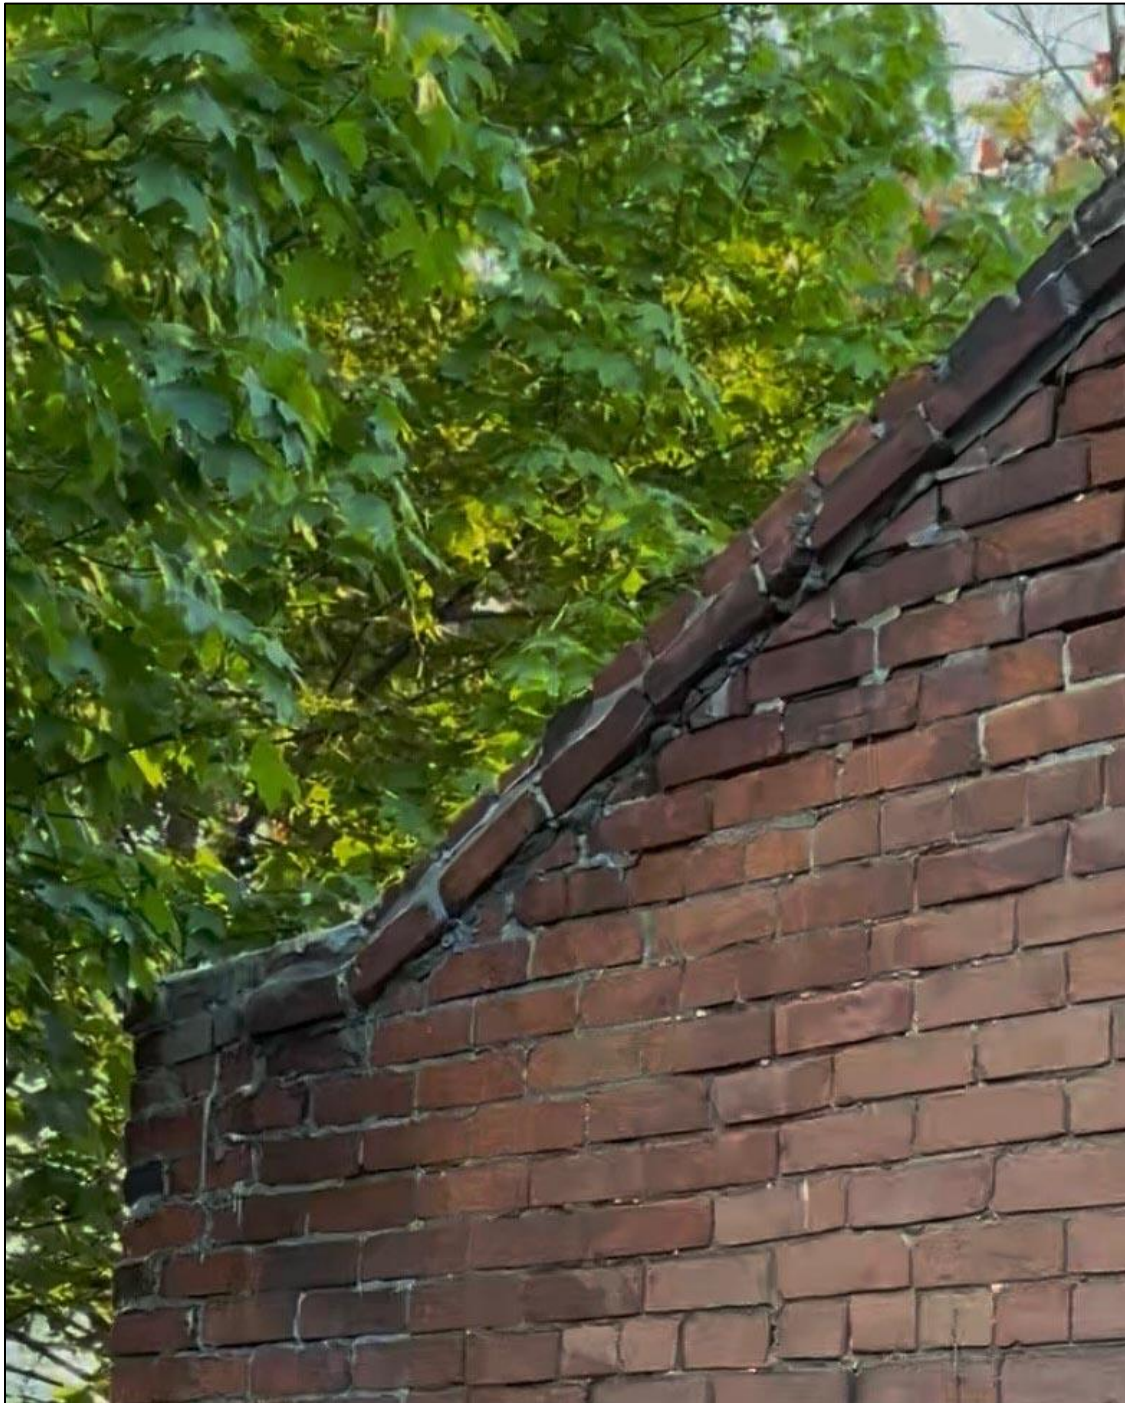
- Parapet is in poor condition, with brick that needs to be re-mortared or replaced.
 - Work is required for the property to comply with an order issued under the City's Property Standards By-law.
-

Figure 2: Photo of rear southwest parapet requiring repair

- Restoration of the brick parapet on the south-west corner of the rear wing of the building, including:
 - Repointing with a 1-1-6 course cream line mortar with pigment to match; and,
 - Installing true pressed clay bricks (lbstock) to replace missing or damaged bricks, to match the existing bricks.
-
