## City of Hamilton

# PUBLIC WORKS COMMITTEE REVISED COMMITTEE REVISED

**Meeting #:** 18-012  
**Date:** September 17, 2018  
**Time:** 9:30 a.m.  
**Location:** Council Chambers, Hamilton City Hall  
71 Main Street West

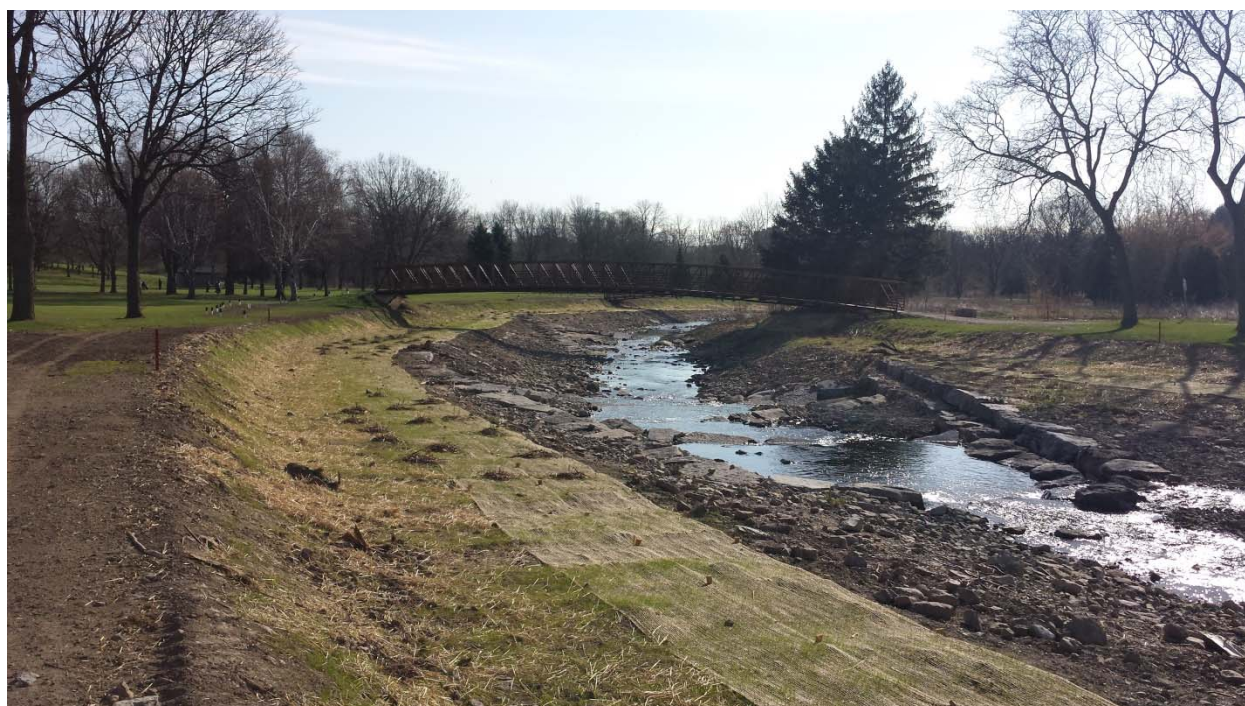
**Figure 2.4.3 2015 channel works through King's Forest Golf course which shows increased golf cart bridge spans, floodplain benches and modified in-stream structures.**

the steepest. The decreased number of monitoring cross sections observing erosion in excess of 0.3 m is a combined result of the lower magnitude event, relative to the July 2009 event, enhancements made to many of the in-stream structures further mitigating channel erosion (discussed further), and the increased density in riparian vegetation downstream of King's Forest Golf Course. Subsequent to observing the channel responses from the July 2012 storm and based upon continued monitoring and adaptive management, the initial design constraints of limited floodplain width and golf cart bridge spans, narrower than those recommended and constructed for the remainder of the rehabilitated reach, were re-addressed. In the spring of 2014, golf cart bridge spans were increased to 38 m and installed. In the winter and summer of 2015, increased floodplain connectivity by widening the existing creek floodplain corridor and the re-construction of the in-stream structures with further enhancements are currently underway (Figure 2.4.3).

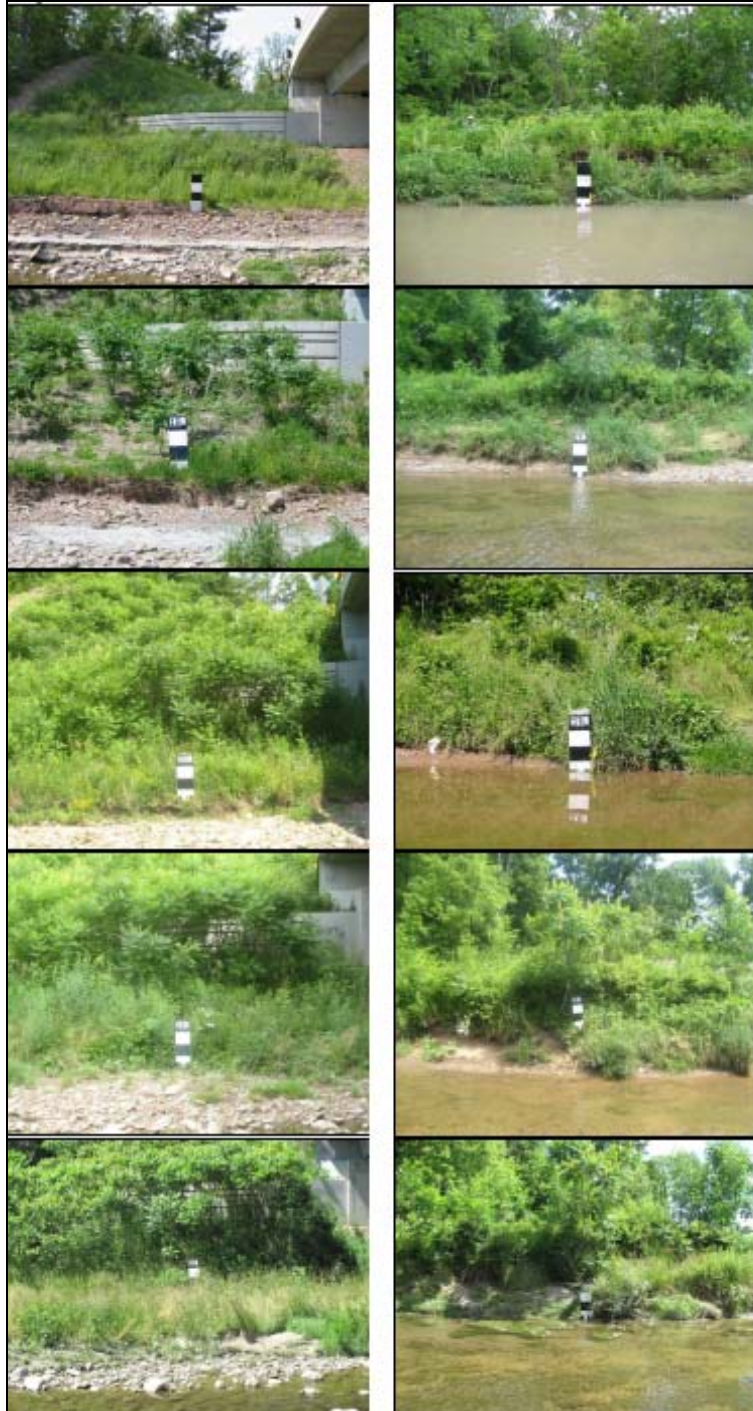
Figure 3. Photo monitoring images for transects 15 (left) and transect 19 (right) from 2008 – 2012.

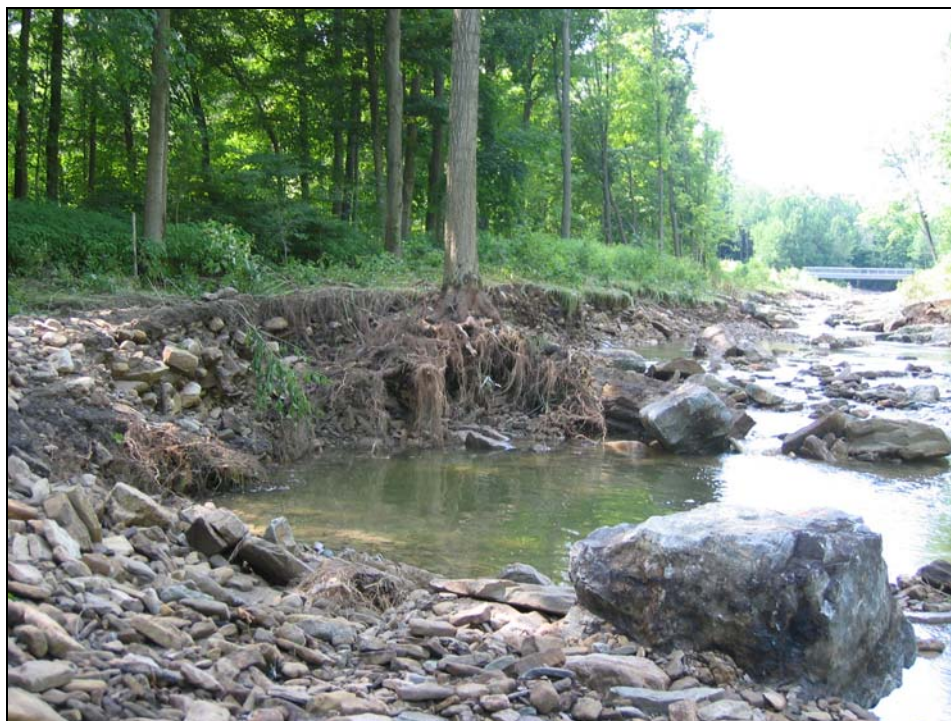
**Figure 4. Extensive erosion of the creek channel and embankment following the flood on July 29th, 2009. King's Forest between transects 2 and 3.**

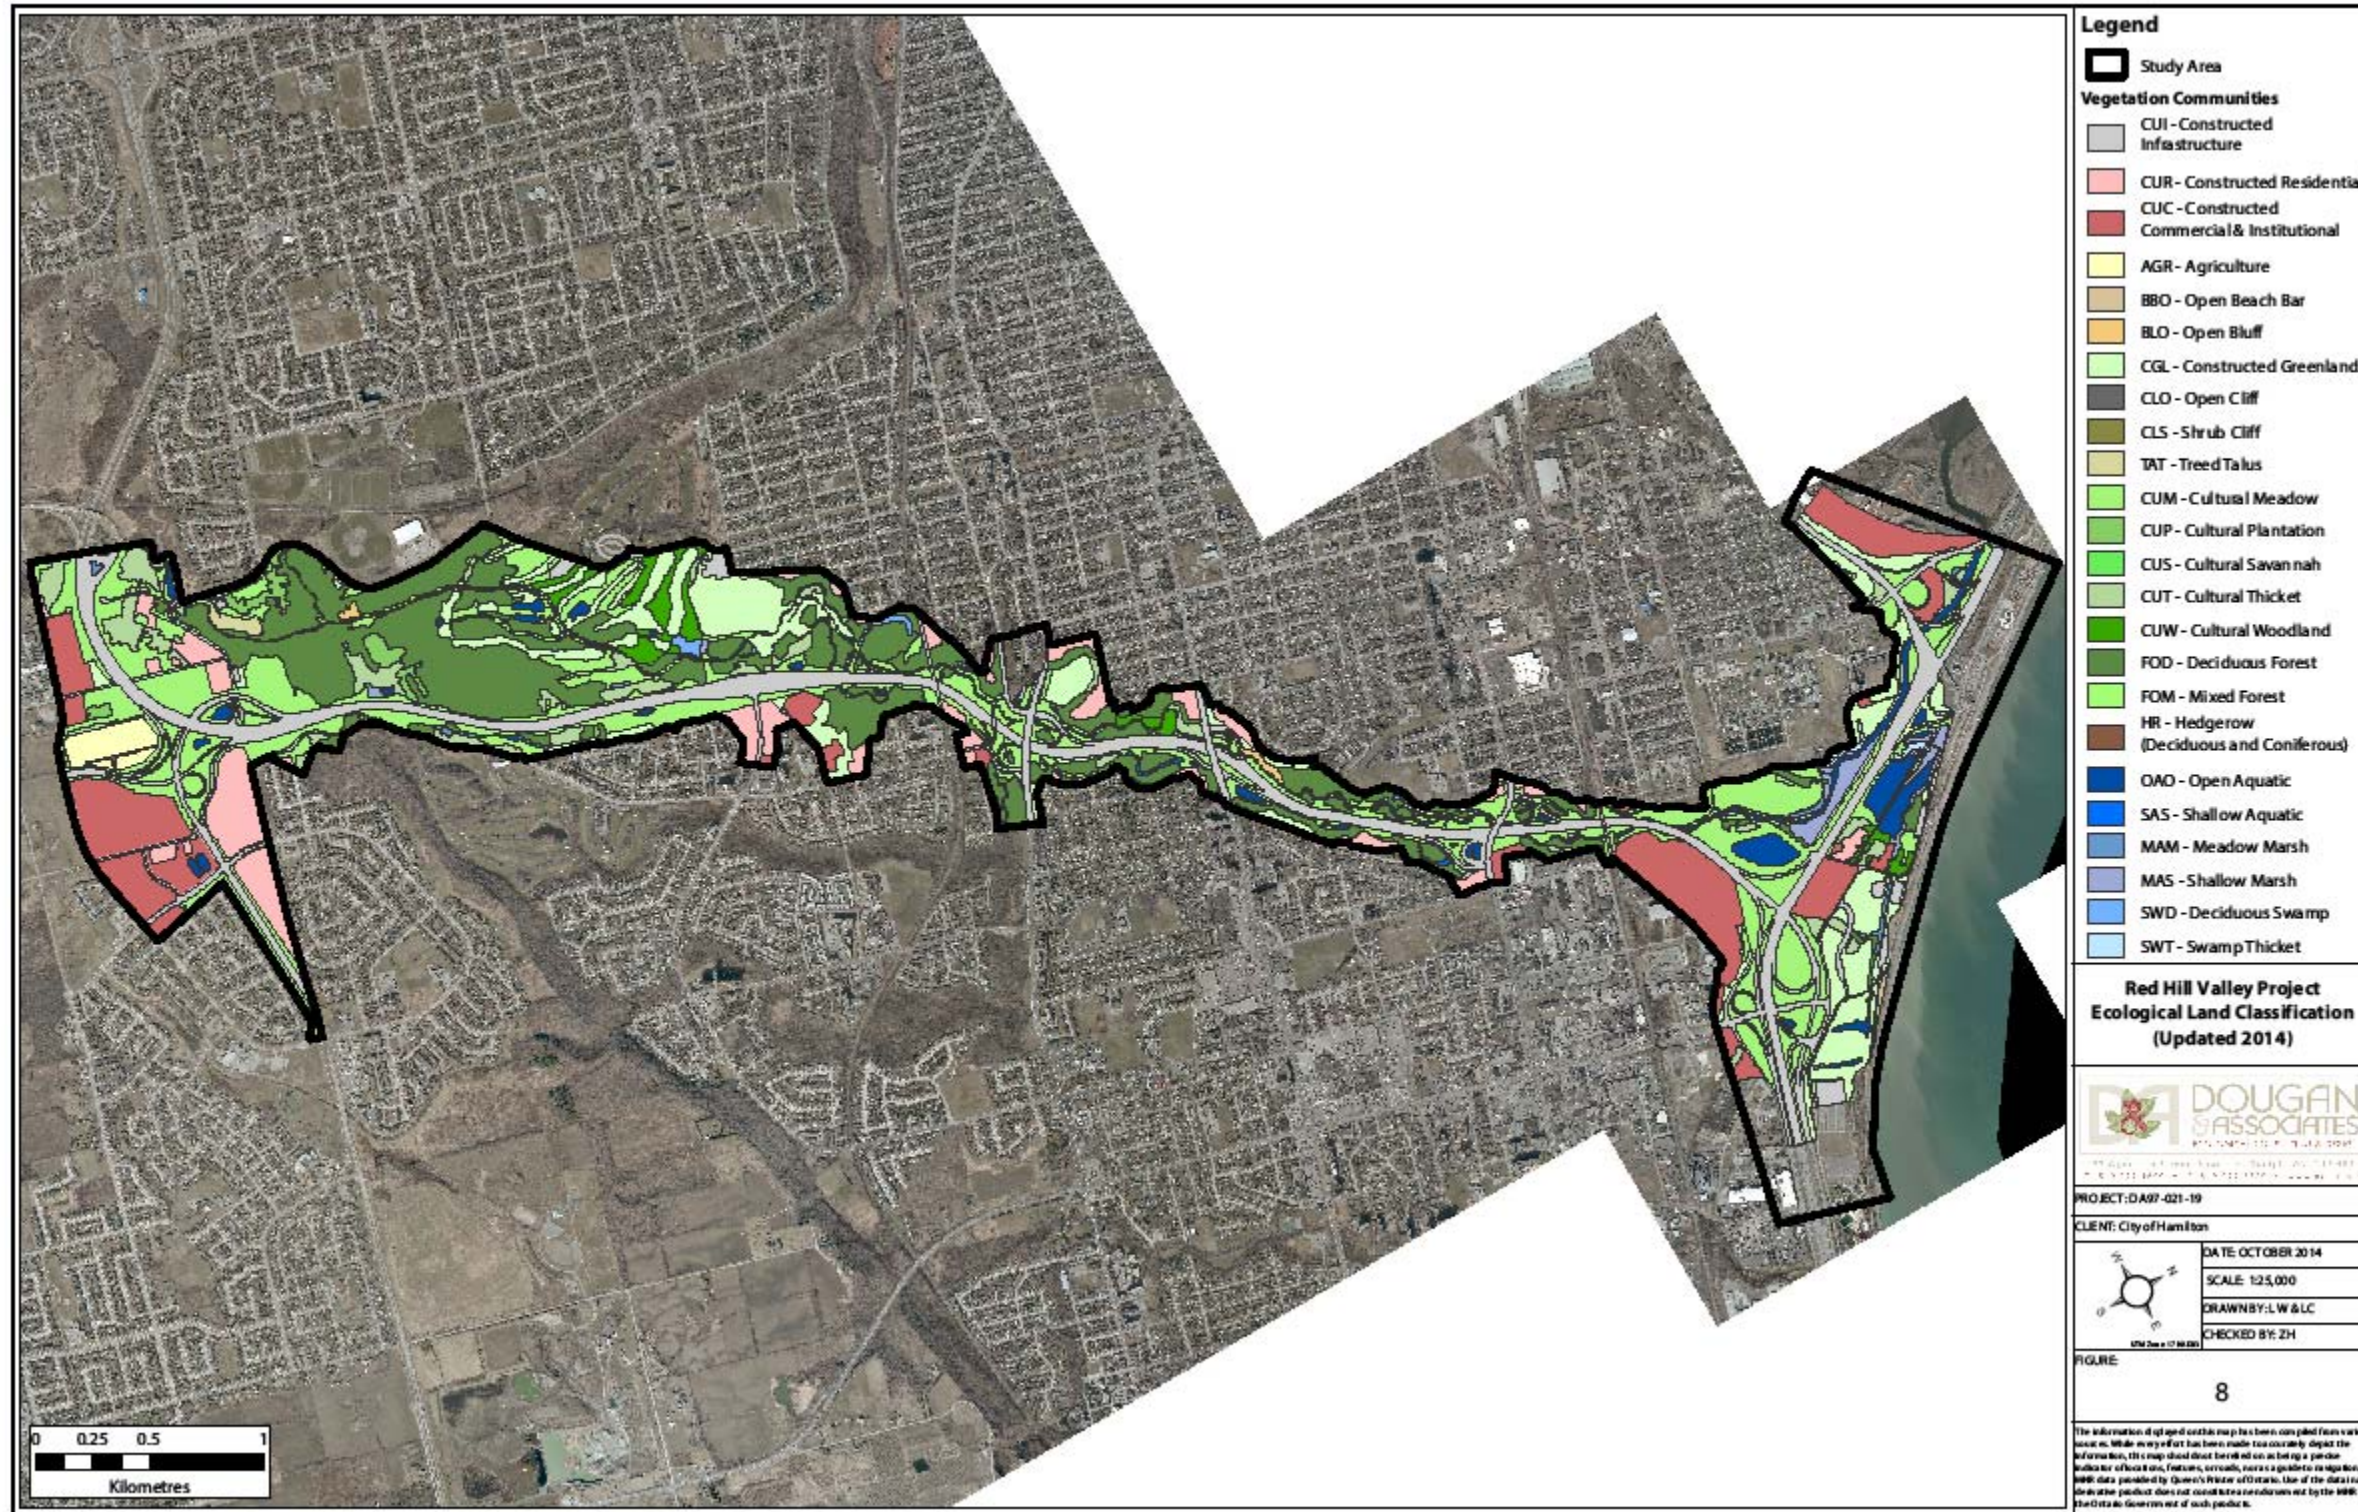
Figure 8. Ecological Land Classification for Red Hill Creek Project Study Area

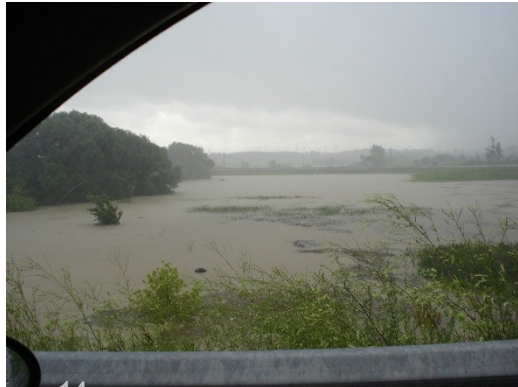
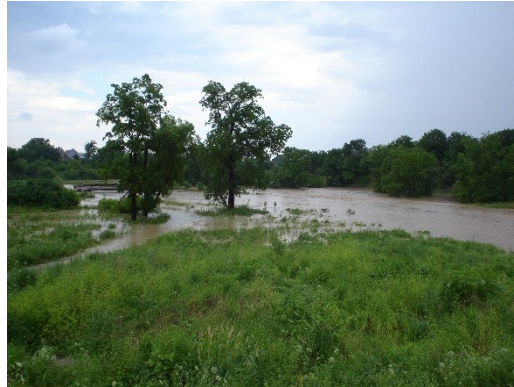
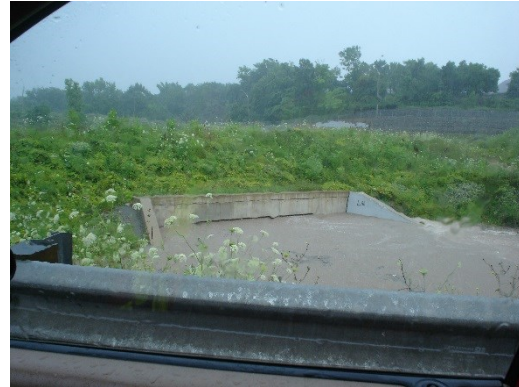
## Red Hill Valley Parkway Flood Management System

- 100 year performance standard established
- July 26, 2009 event greater than a 100 year storm (1.5x)
- Forensic study has determined all infrastructure to be operating per design objectives
- Some minor Operation and Maintenance improvements recommended

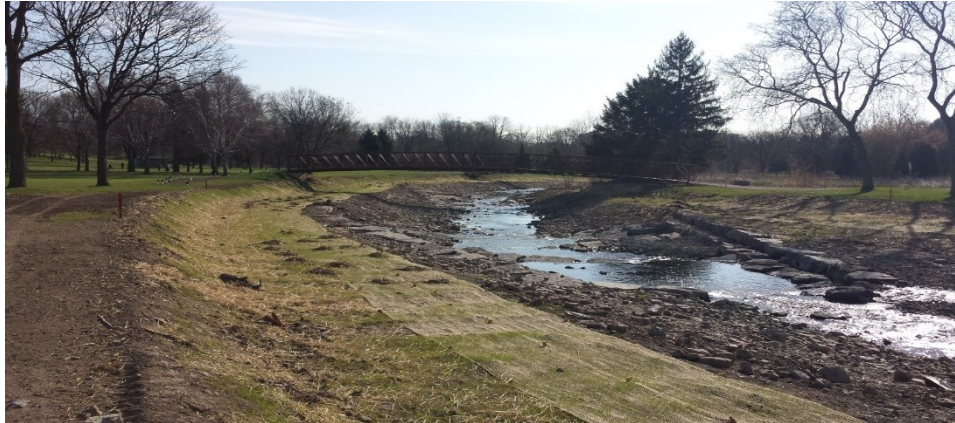
## Red Hill Creek System

- Subjected to numerous large storms shortly after construction
- Caused some initial instabilities and erosion
- Adjustments to channel form and structures required (2010 / 2015) particularly through Kings Forest Golf Club
- Riparian zone is well established with predominantly native species

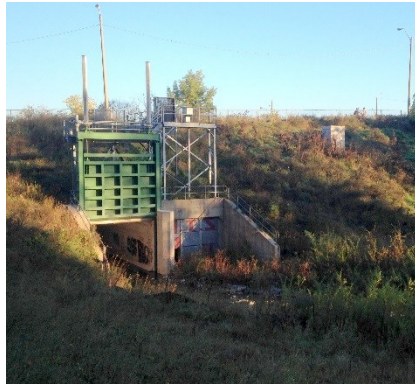
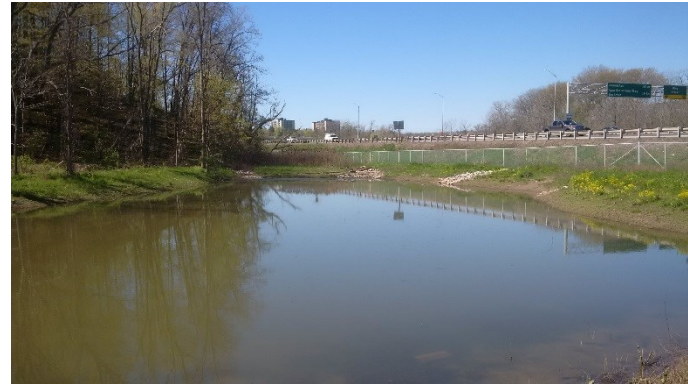
## Stormwater Management Facilities and Wetlands

- Flood Control Facilities
  - Dartnall, Greenhill, Davis (Ongoing)
  - Operating per design requirements
- Stormwater Quality Control Facilities
  - Eleven (11) City owned; three (3) Ministry of Transportation owned
  - Largely performing per design requirements; some ongoing improvements being conducted by City
