## City of Hamilton

# HAMILTON MUNICIPAL HERITAGE COMMITTEE REVISED

**Meeting #:** 21-001

**Date:** January 29, 2021

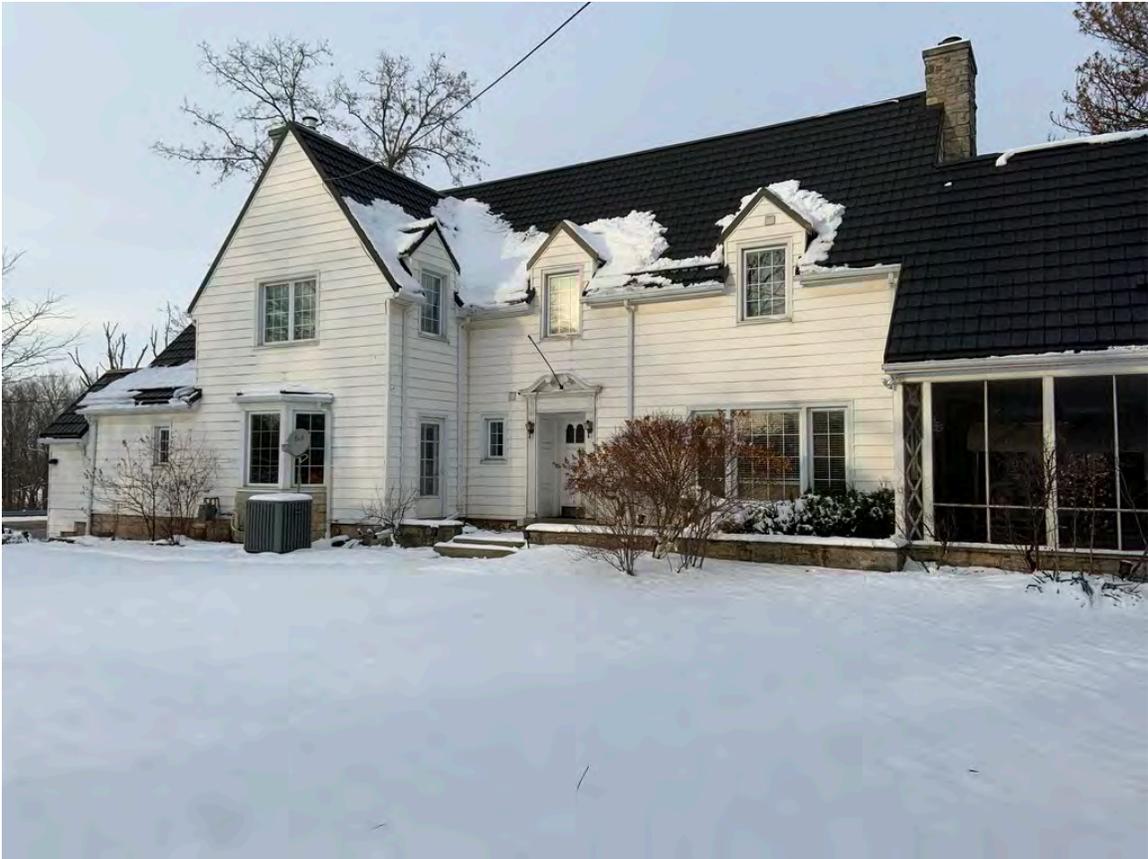
**West Elevation: 105 Filman Road, Ancaster**

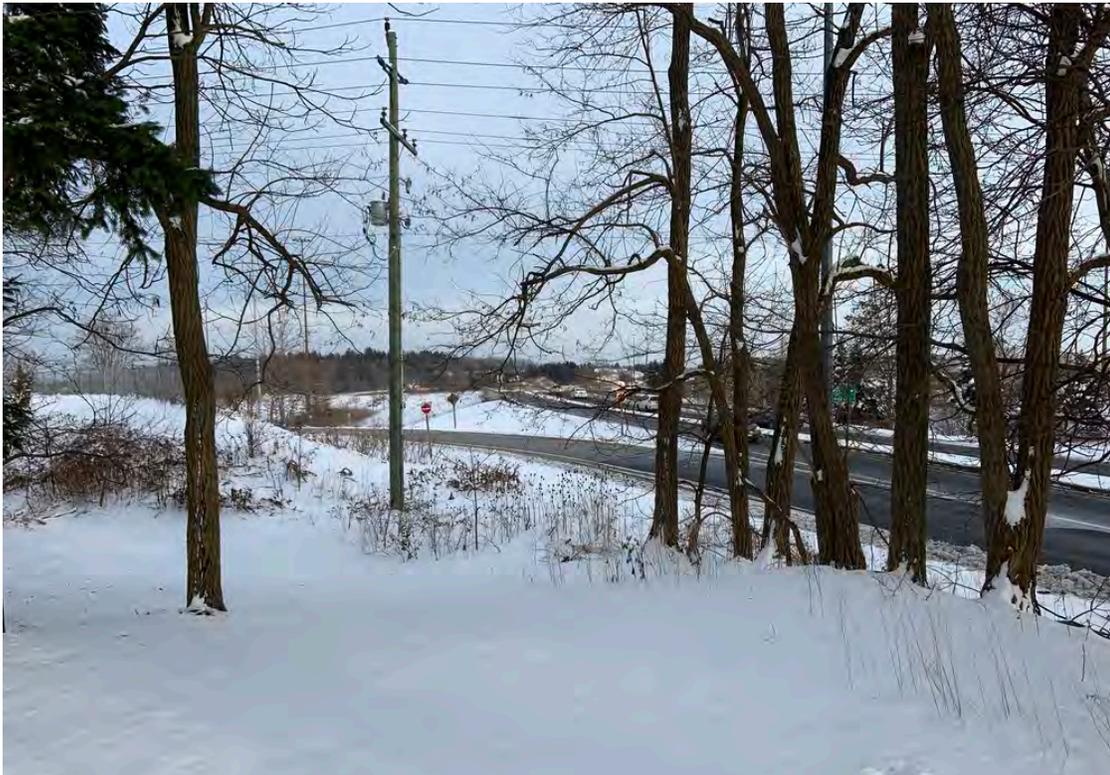
View to the east from the south eastern corner of the lot. Note the presence of many trees and elevation difference to the road below. Mohawk Road is an overpass here with Highway 403 below.

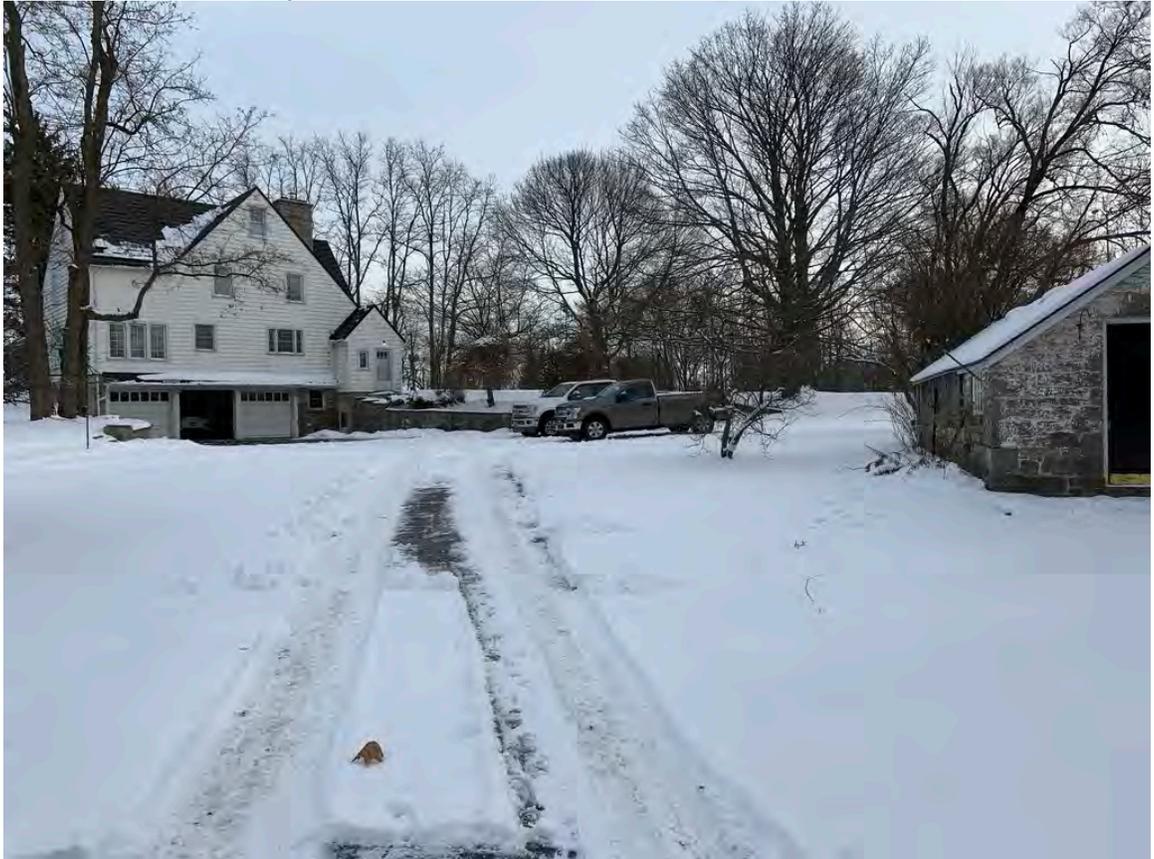
**01.02** A three-car garage (basement level) fronts the driveway. The 3 segmental overhead doors (original) are now operated remotely by electric motors.

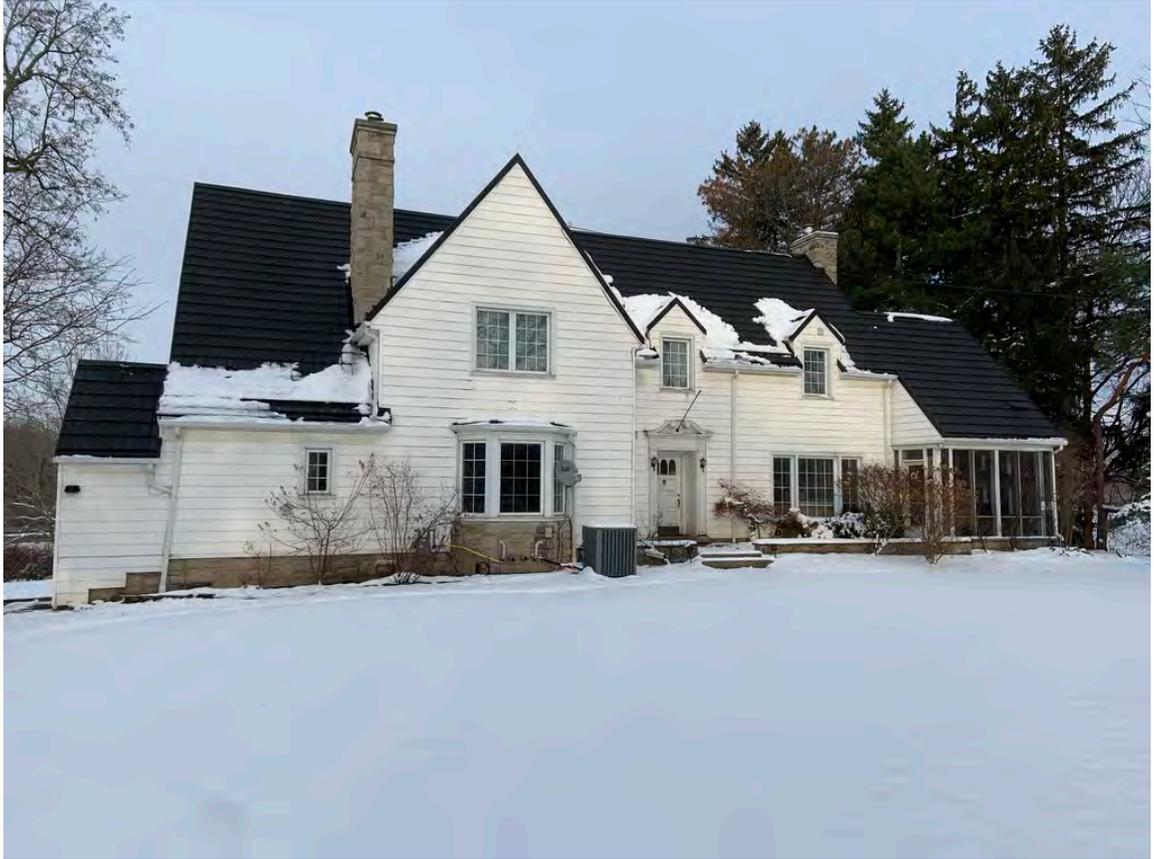
**01.12** South elevation (Rousseau Street) features asymmetrical elements including:

- a). a large gable with projecting triple unit bay window at first floor and double unit window at the second floor
- b). an entry door with a Colonial Revival broken pediment.
- c). a pair of faux coach lamps (electric) on the jambs of the door surround
- d). an entry door with six raised panels below a trio of Italianate arched window panes
- e). side panels to the deeply recessed doorway have three raised panels that do not match those of the door.
- f). a hardware store brass knocker and good quality lever and deadbolt set, and brass kick plate on the door.
- g). a short flagpole over the center of the door head. This feature is much more common on American homes than those in Canada.

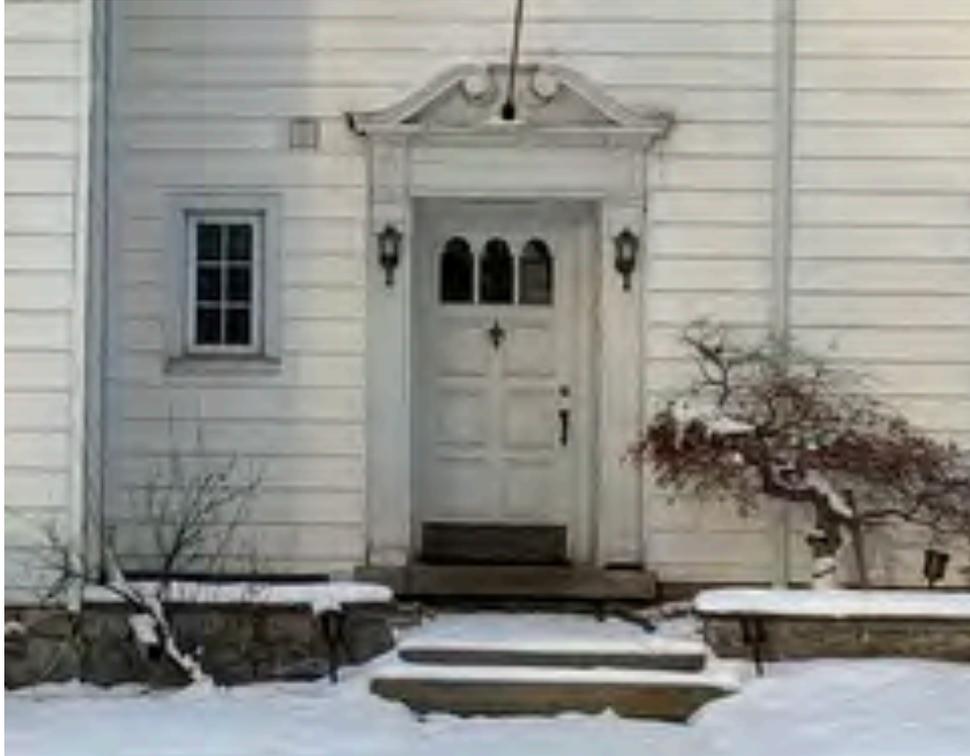
- 01.13** Detail of entry with “broken cornice” typified by American “Federal” designs, which are considerably more baroque in detail and ornament than Classical Revival, British designs.

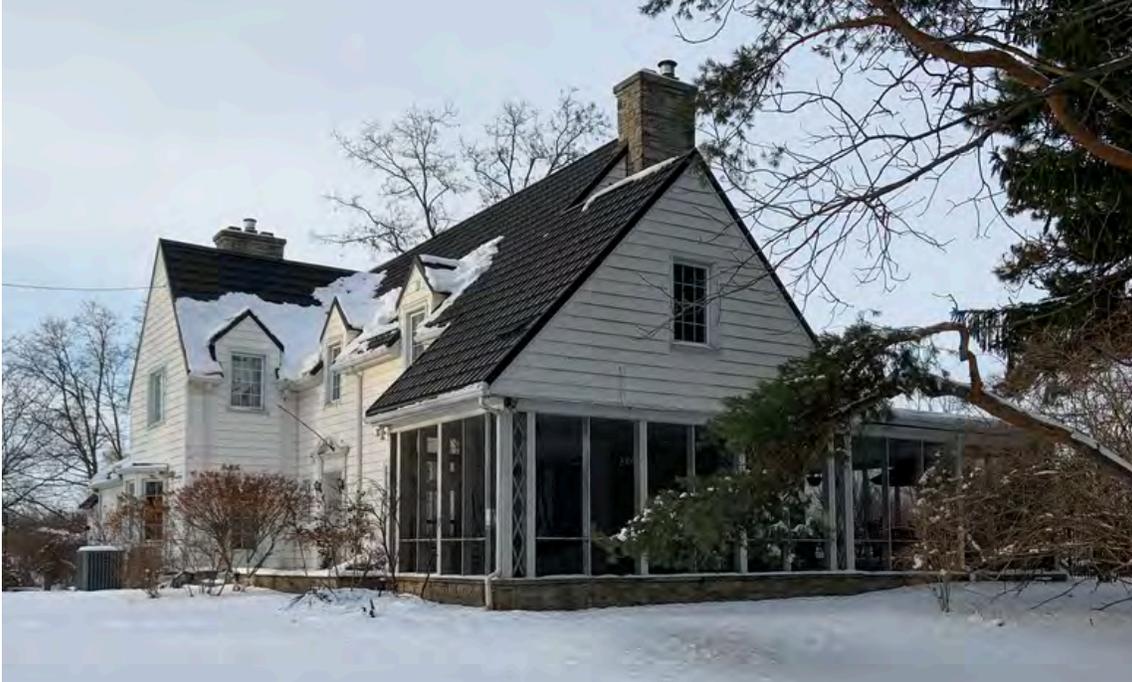
**01.22** The limestone cladding of the foundation continues around the base of the sunroom, providing the impression of a low plinth.

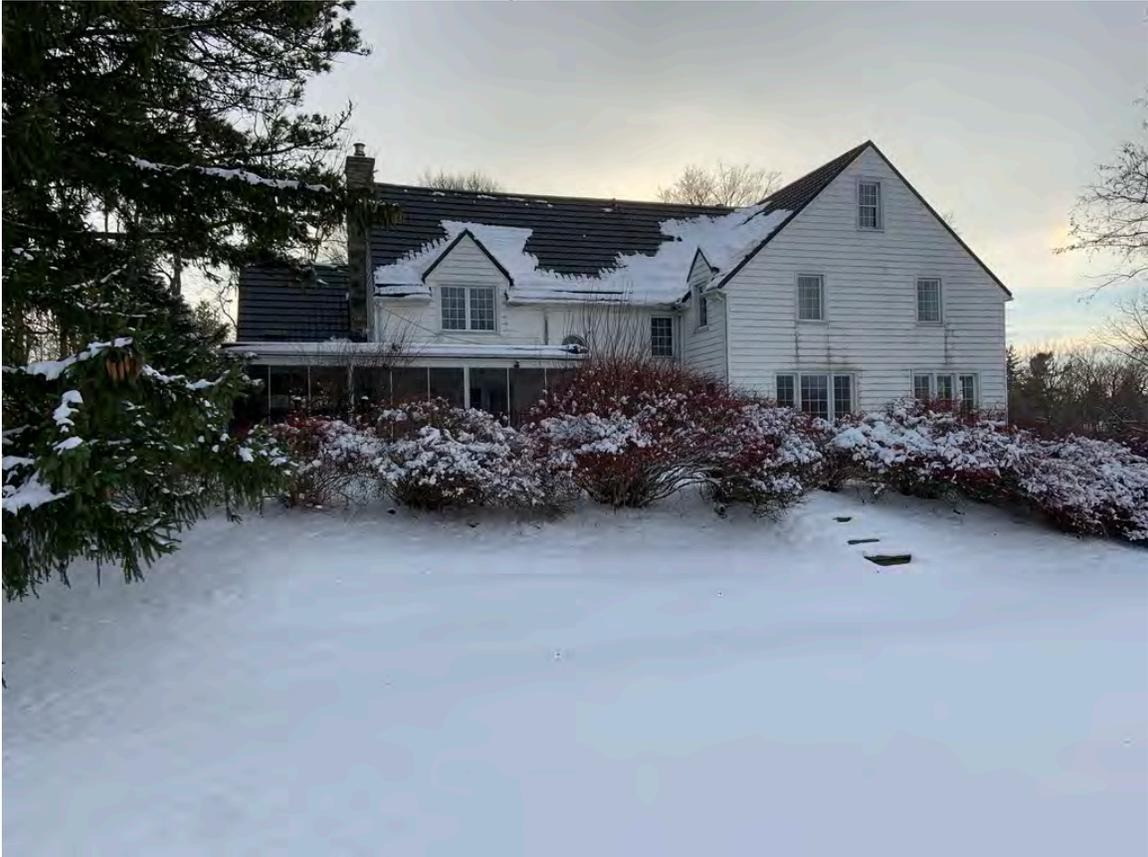
**01.31** a secondary entrance with arched door on the east side is situated opposite the main entrance on the west elevation. This doorway and door seem to be heavily weathered from being located close to an inside corner on the north side of the east elevation.

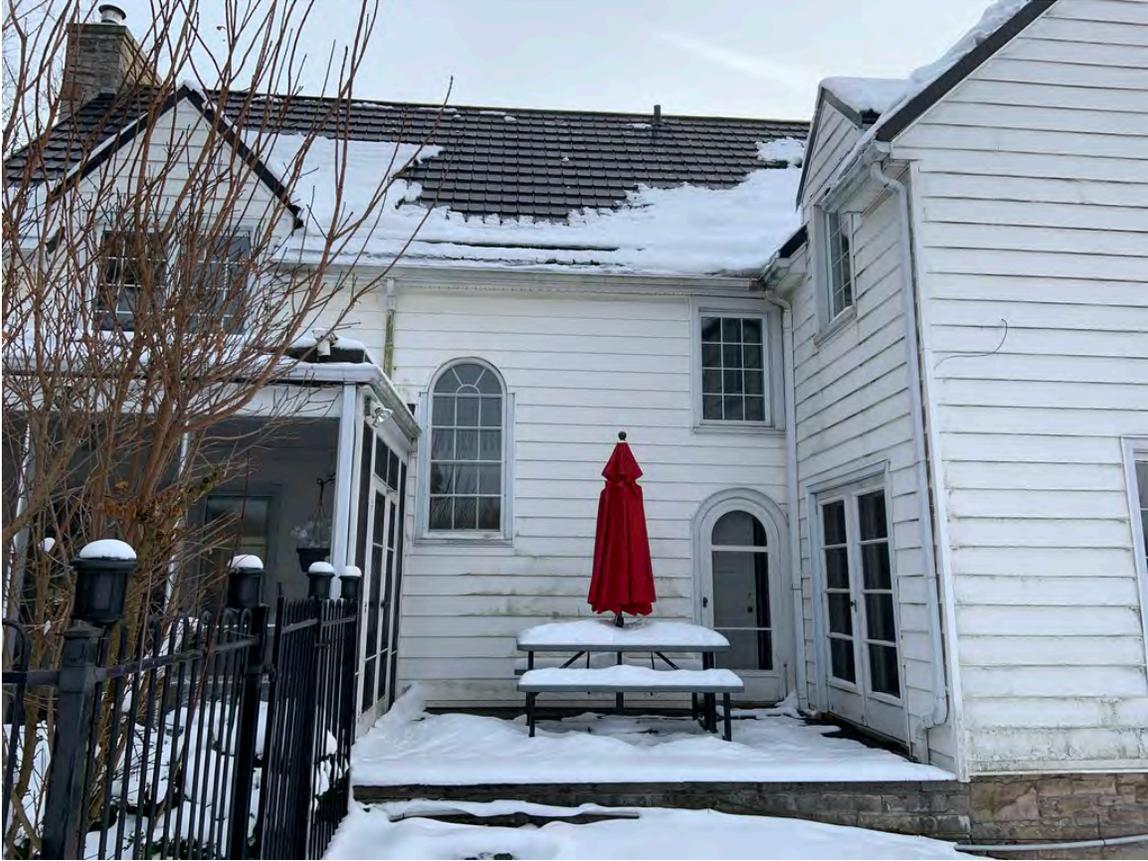
- 01.32** An arch topped window for the stair landing halfway between floors has been awkwardly flashed to accommodate the new aluminum siding. The segmented flashing demonstrates noticeably how it was made and secured by cutting and bending.

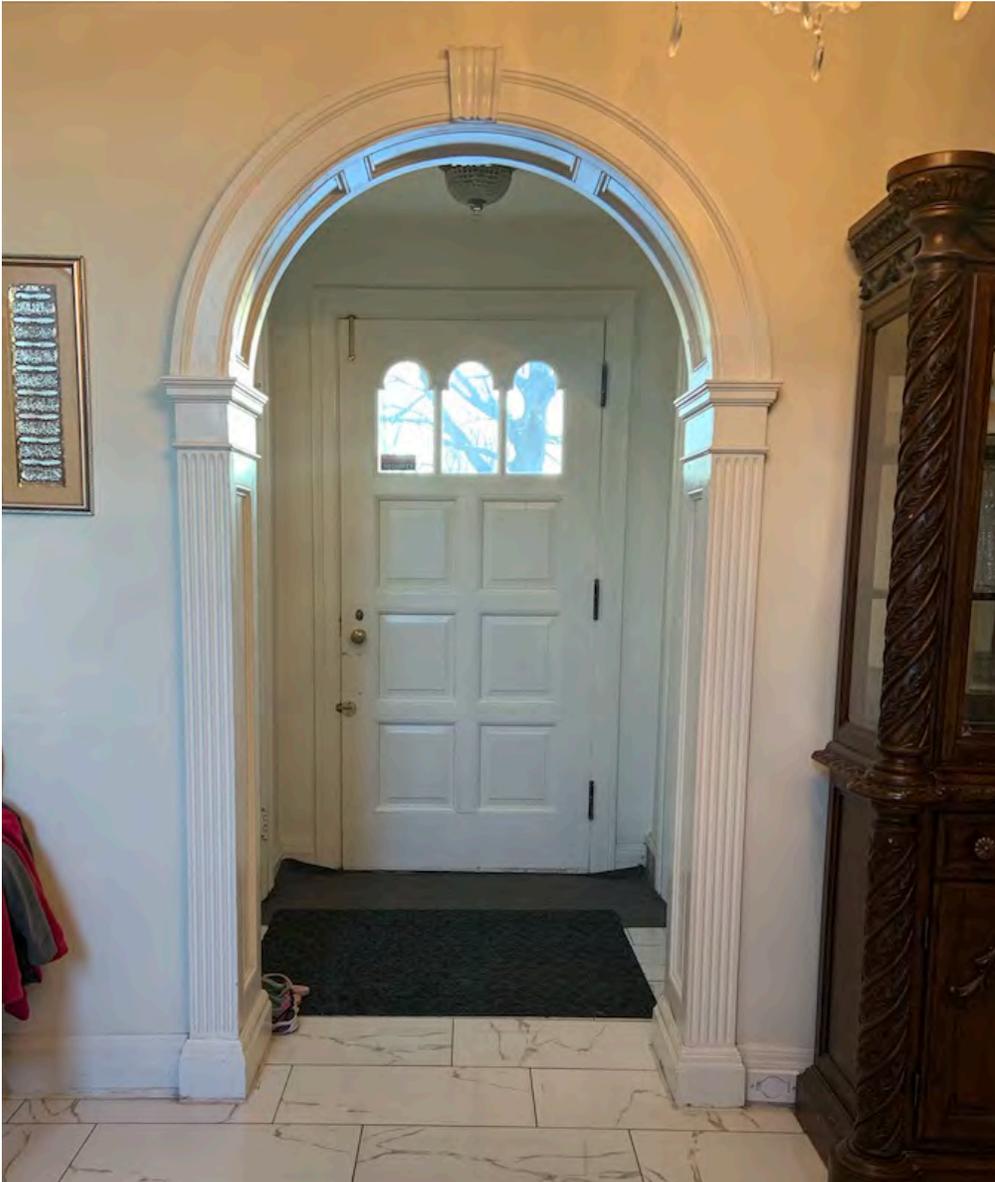
- 01.42** The built-up mouldings in the cornice around the hall emphasize horizontal layers of moulding but lack the “excitement” of deep shadow lines and reverse curvature that modulates the ceiling light. The effect is bland and difficult to define, but that may have been the intention of the builder.
- 01.43** The rather low ceiling height becomes obvious when one looks at the stairwell. The cornice mould is coped to terminate at the edge of the ceiling just above the foot of the stairs.

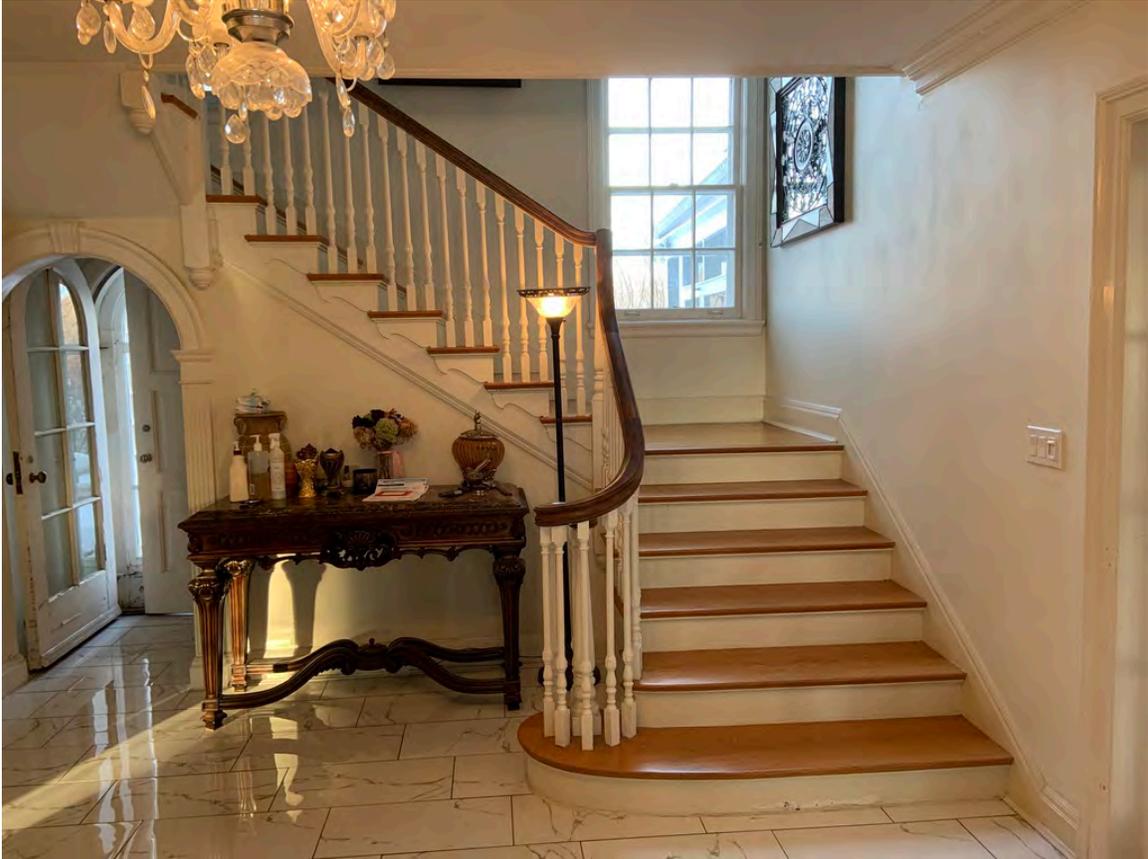
**01.45** Principle staircase to second floor, at entry hall.

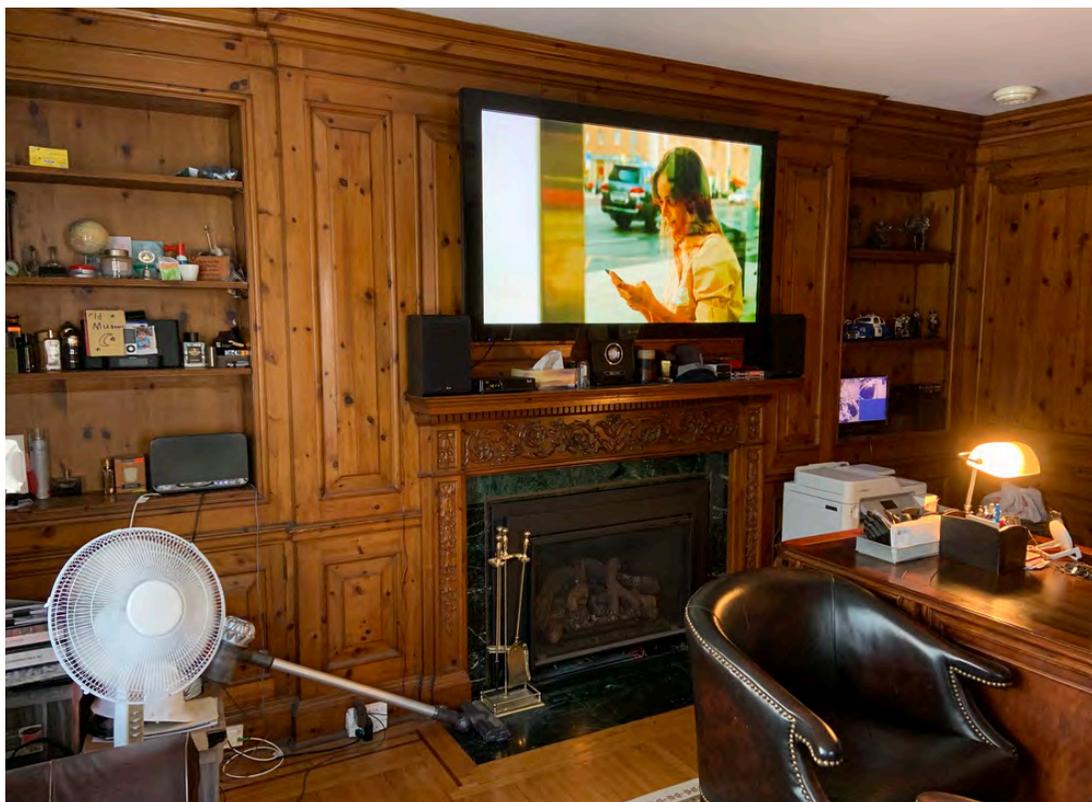
- 01.75** A study or home office is located across the hallway from the former dining room. The room is paneled with elaborate varnished pine cornices, raised panels and built in cabinetry. The working fireplace has an unusual pine mantle with dentils and elaborate botanical carvings of laurels, flowers and fruit. The hearth and fireplace surround were made with a deep green marble with white veins. The pine window and door trim suggests that this work is original to the house. This would indicate that the first owner used this room as his home office or study when the house was built. The absence of closets, change room or adjoining washroom, is good evidence that this comfortable room was not built for a physician. The windows have been replaced with modern vinyl casements, but the side door to the exterior is an original 8 pane fixture.

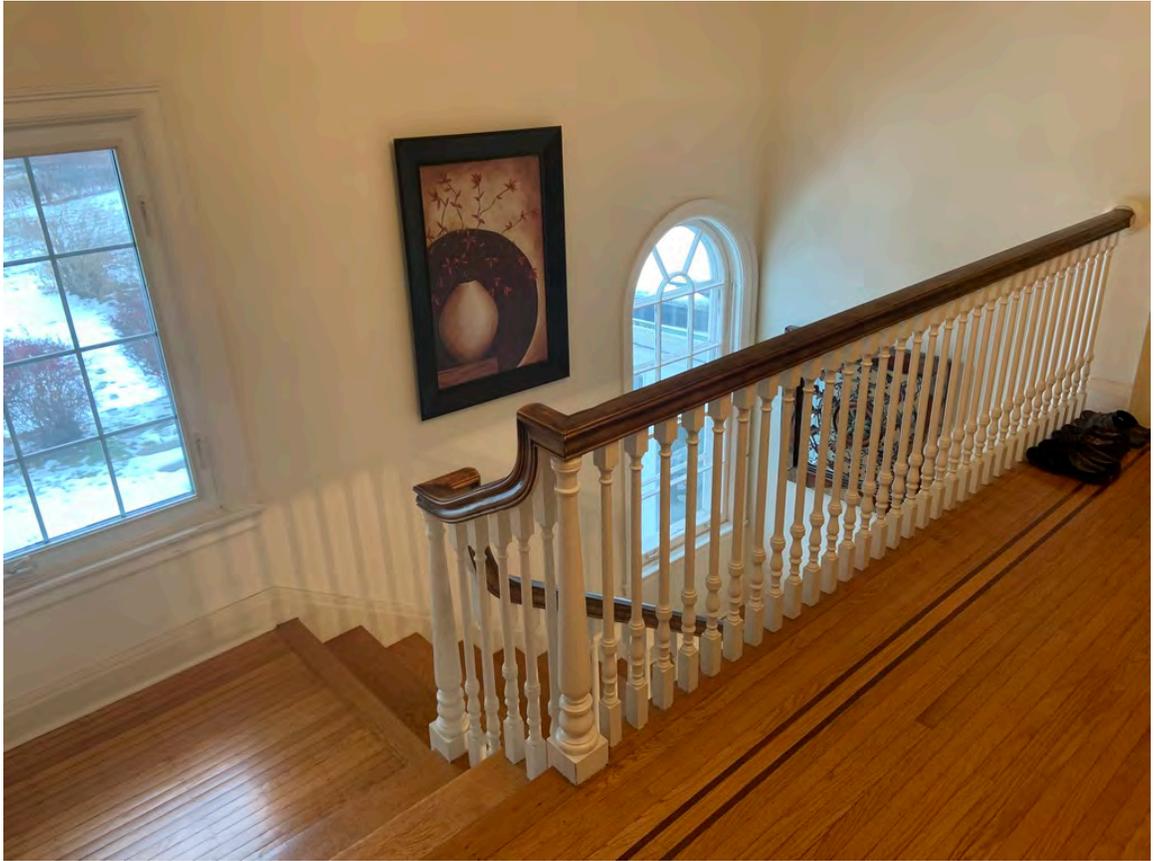
- 01.76** The second floor main hallway is open to the stairs below. The north slope of the roof is only visible above the ascending stairs. The roof is high enough at the landing to be 100" clear of the landing.

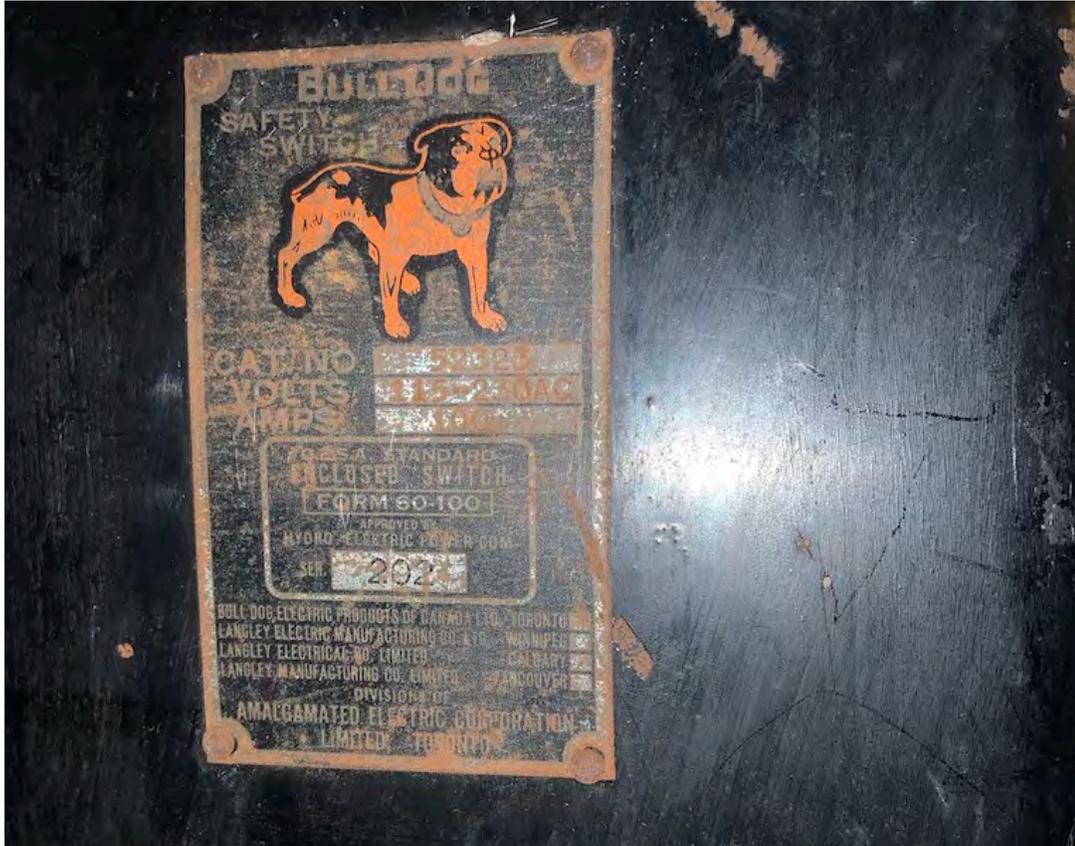
- 01.94** Another breaker box is labeled Taylor Electric Mfg. Co. Ltd. London - Canada. The logo and graphics on this name plate are very typical of inter-War equipment, so was probably installed at the same time as the Bull Dog Safety Switch. A note on this breaker indicates that it is still used for a dual power bar outlet on the work bench. All other electrical equipment is modern, except the heavy cast steel block (brass bolts) for original telephone wiring.

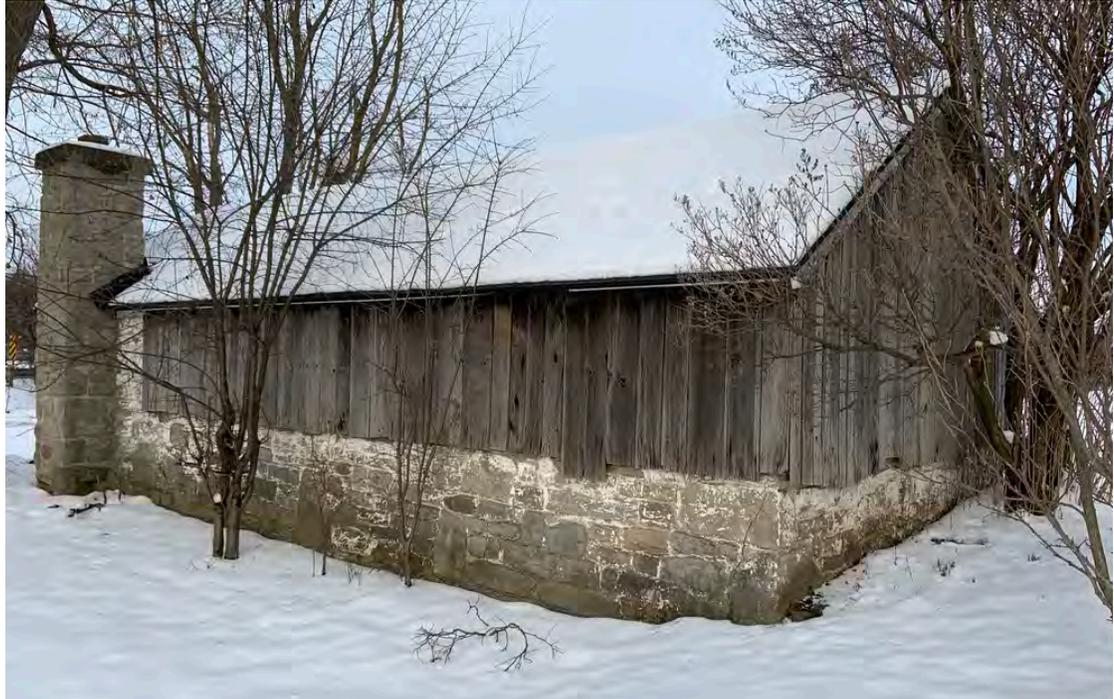
**02.04** The random rubble masonry is of utilitarian quality except for a dressed lintel over the doorway. This lintel has drafted margins and a pecked face. This is the only stone with substantial workmanship, so may be reclaimed from another older building. Larger squared blocks were used as quoins at the lower corners of the structure to tie the walls together. This was good practice, particularly where the backs of the stone blocks are very irregular and undressed. In common work like this, the outer face received the best blocks, the inner face smaller and less perfect pieces and the core of the wall was filled with rubble, chips and mortar. The thickness of blocks may vary from six or eight inches as they appear at corners to less than three inches, as most of the load bearing capacity is on the face of the stones when properly squared and pointed.

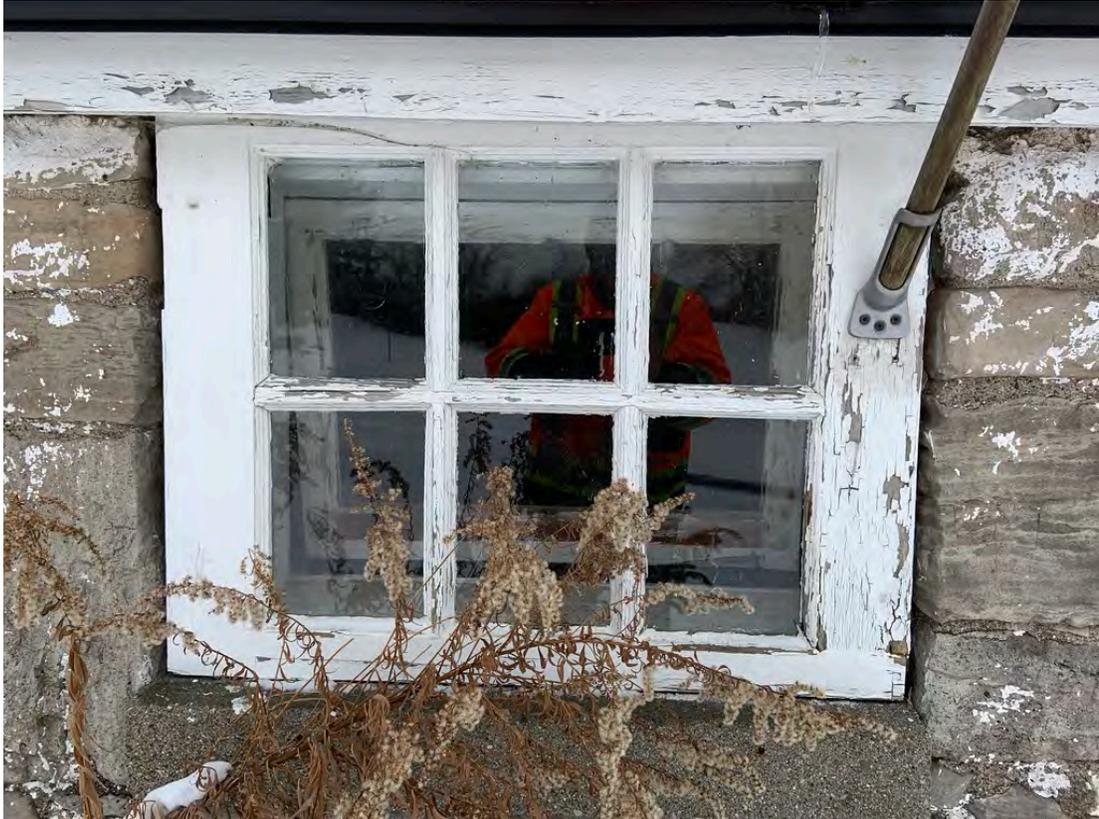
**02.06** The sash window on the north elevation appears at first to be historic, but has none of the characteristics of a window built between 1790 & 1875. The masonry was not built around a framed box. The sash was cut to fit the masonry opening. The sill is poured concrete not dressed stone, pine nor white oak, as would be expected before WW1. The aggregate in the concrete is fine sharp sand with small pebbles. This is typical of hand mixed concrete before WW2. The binder in 19<sup>th</sup>. century mortars was lime. Here it is Portland Cement. Most workmen did not understand how concrete required a balance between just enough water and thorough mixing. When they opted for an easier to shovel "sloppy" mix, it would result in low strength concrete. The over hydrated Portland reduced the growth of crystals in the matrix which produce the ultimate strength of the concrete. The surface has weathered away here.

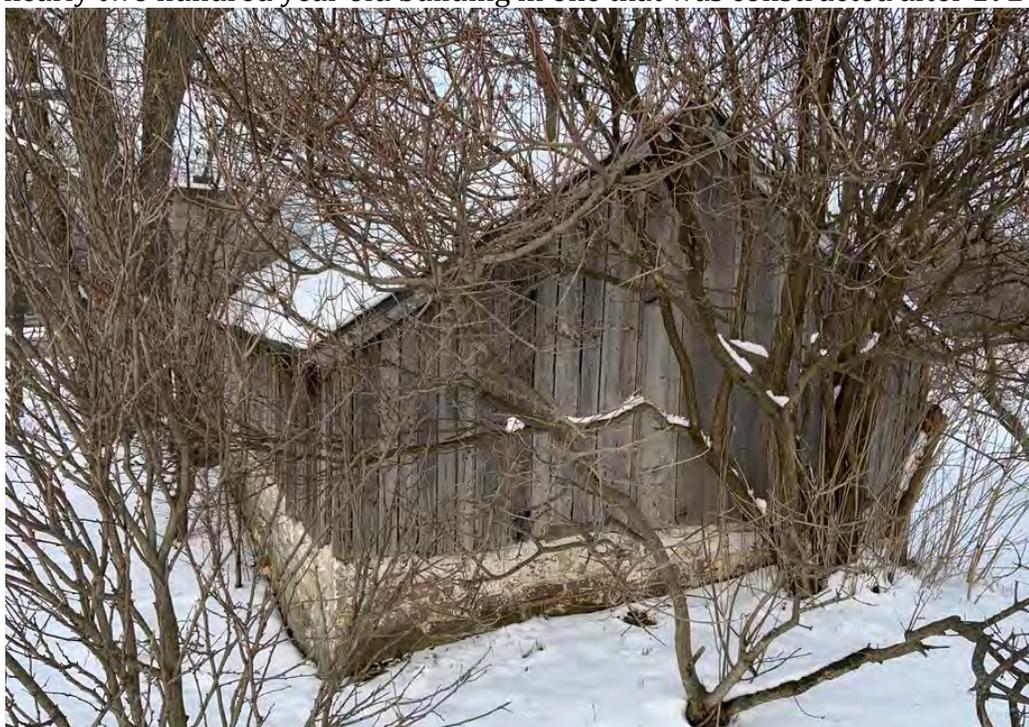
- 02.11** If the building were used as a storage shed or other utility building, it would likely have had another single or double door in the eastern end of the structure. The only access is via the narrow west door.
- 02.12** One might consider whether the building was a chicken coop or poultry house. In this case it would likely have had small access doors to allow the birds to come and go to access food and water during the day, and also be shut in at night to isolate them from foxes and raccoons. There are no signs that the wall boards were ever different than we now see them.

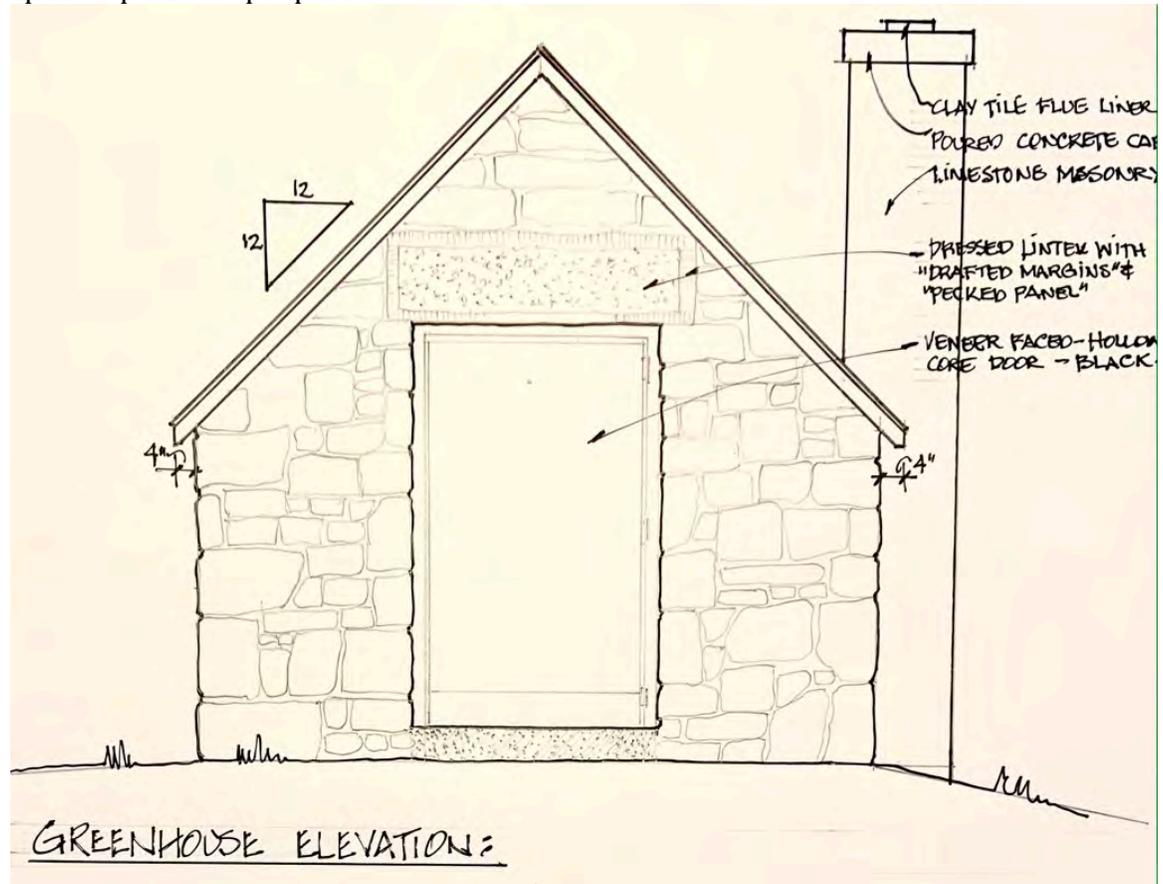
**02.19** Sketch of the west elevation with single entry door. The chimney was added later. The only dressed stone, the lintel is reclaimed from another structure.

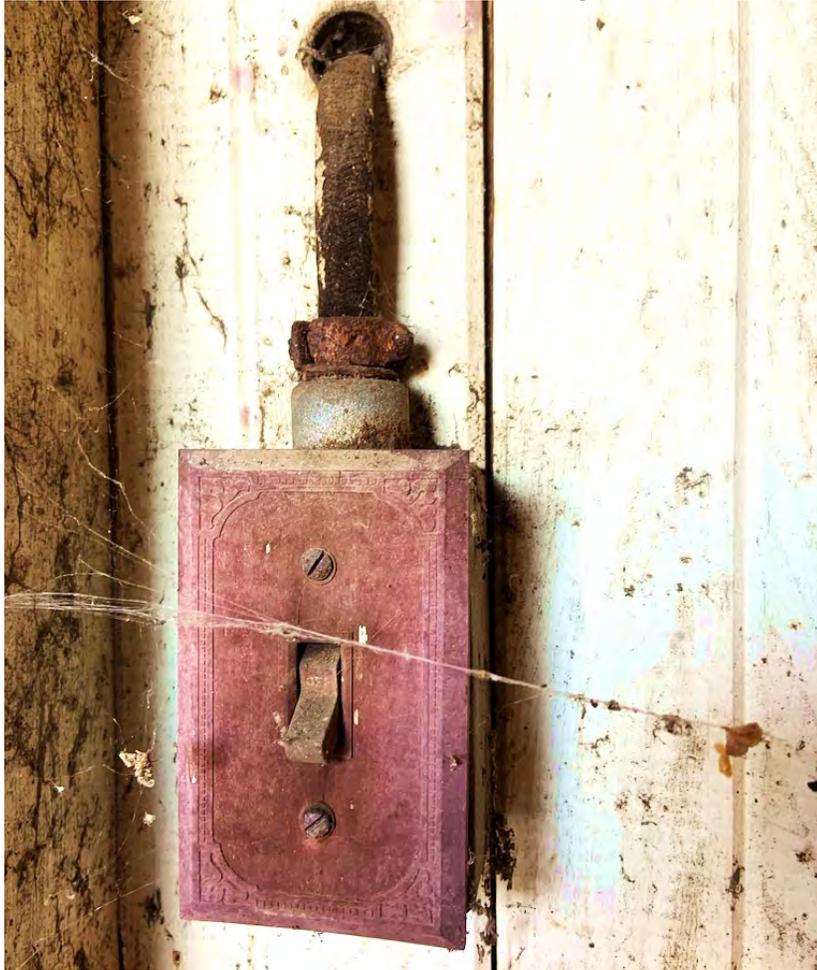
- 02.23** The electrical panel, switch plate & black asphaltic paper wrapped wiring are typical of the 1920's and 1930's and appear to have been installed when the building was constructed. Ceramic blocks for the lightbulbs were fastened to the collar ties and wiring fed from above.
- 02.24** It is possible that the first door to the shed was a batten door, since that would match the interior door and explain the necessity for replacement roughly forty years ago. The second door is a "batten and rail" door which

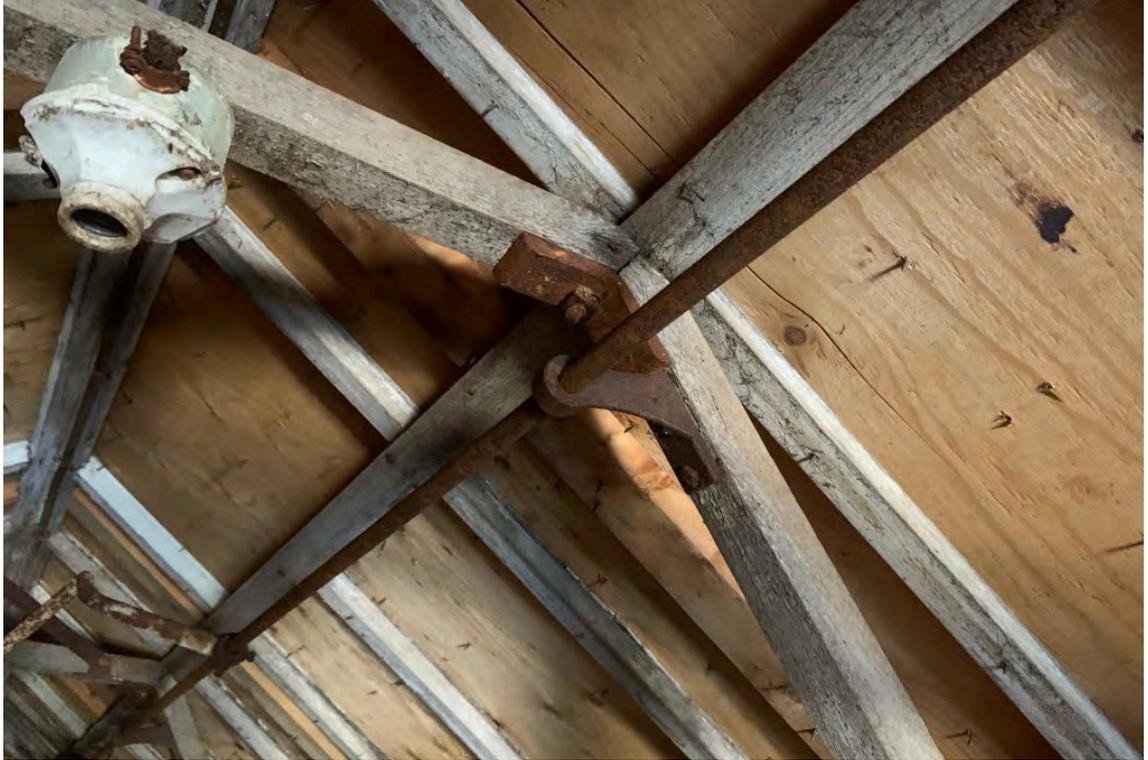
**02.30** Truss connection with iron bracket / reinforcing plate. Note rod with crank arm at ridge is retained by the bracket without a bearing or bushing. The original octagon box with ceramic light fixture was fastened to the tie beam directly below the ridge. All connections are nailed and utilitarian, except for the bolted brackets at the underside of the collar tie / compression brace joint. The trusses supported the purlin before the glass bars were installed. These heavy pieces of hardware ensure a strong joint and support a longitudinal steel rod) 7/8" that has a pair of articulated cranks at the approximate center of the roof. The cranks have a hinged "knee" and a hinged "foot" at the end of the second segment. A square headed machine bolt is used to secure the large "knuckle" of the arm to the rotating rod. Looking more carefully at the rafters in this area we see that the rafters are missing above the "purlin" in the vicinity of these two cranks. This indicates that a pair of hinged vents were located on either side of the ridge, and that these vents were made to open via the cranks and rods.

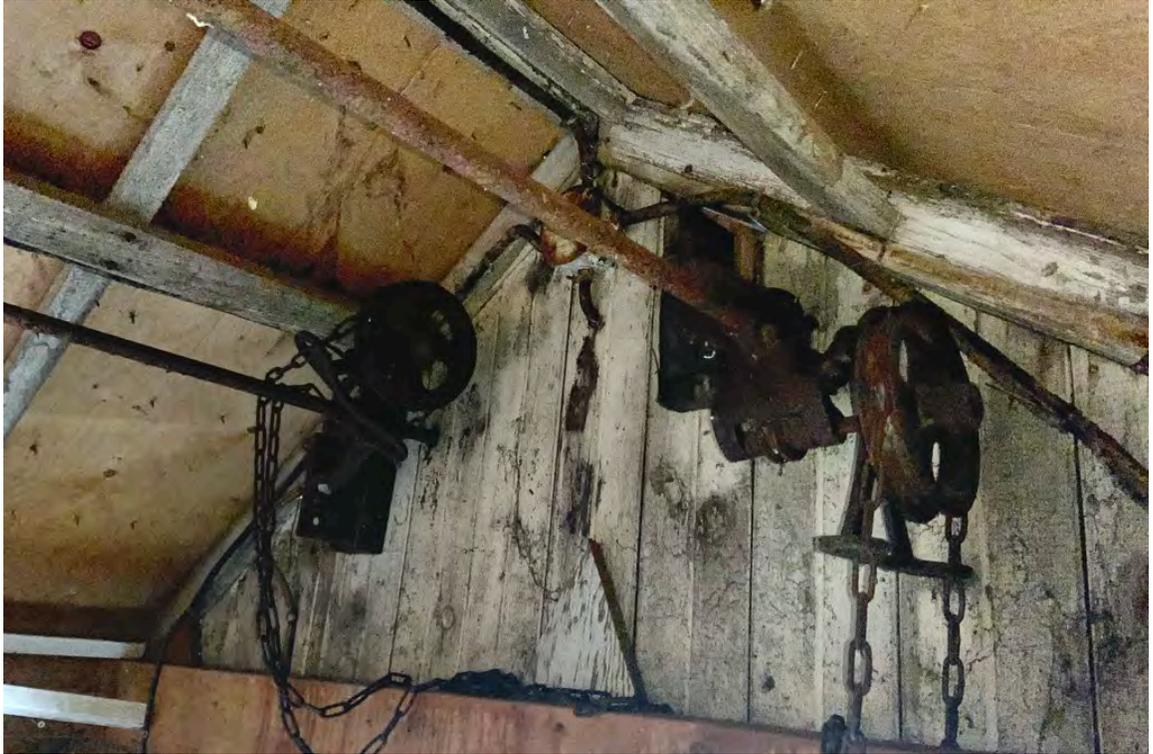
**02.31** When looking back towards the partition, we see that the rods are supported by a complex iron mechanism that acts as a support for each rod and mechanical linkage to the large iron pulley wheel adjacent. A chain over the flanged wheel was used to rotate the wheel, and cause the horizontal rod to drive a differential gear in the bearing to rotate the crank shaft. This manual mechanism can still be seen today in some commercial overhead doors. It is an elaborate method to open two roof vents that could be reached more simply with a broomstick. This mechanism was likely intended for commercial greenhouses instead of small garden glass houses. It would appear that builder of this little garden building had serious intentions of starting lots of flowers and plants in a greenhouse before setting them out in beds.

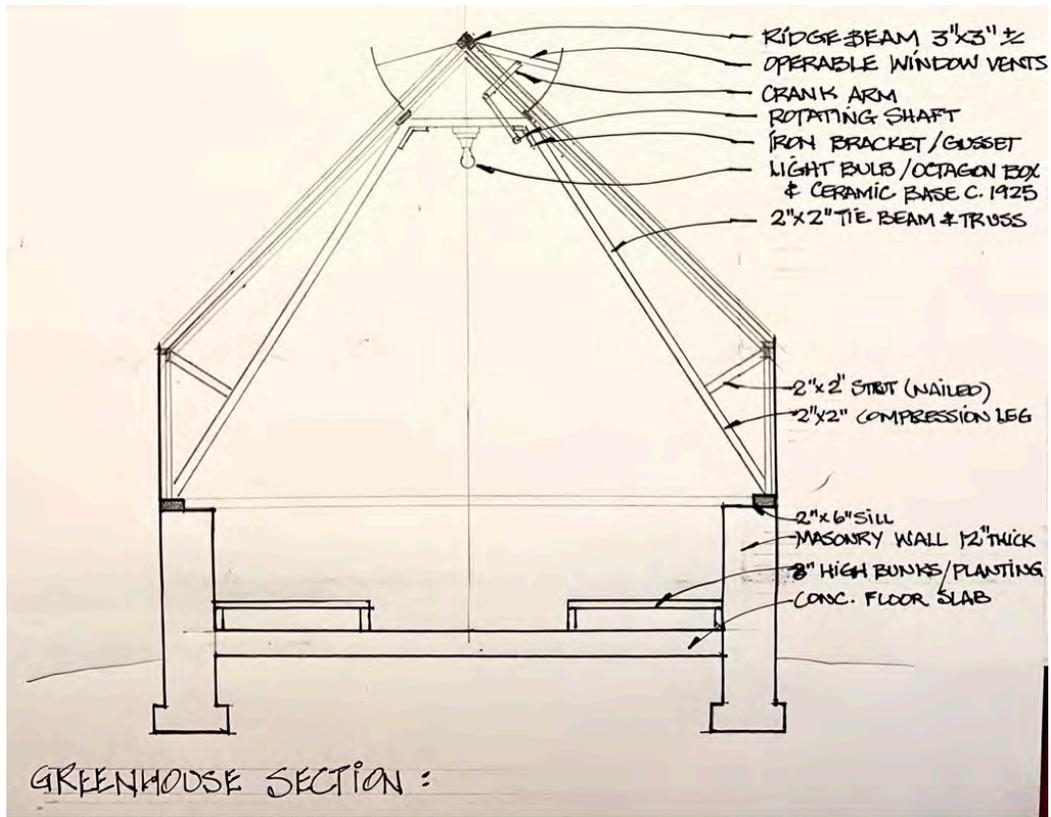
- 02.32** A Breaker box mounted on the partition beside the window has a Builder's Plate: Canadian Westinghouse Co. Ltd. Hamilton, Canada Max. 50 amps. 125 A.C. 250 Volts. Type WK 50 "NOFUZ BREAKER" Pat. 1926-29-32-33 This equipment is connected to the ceramic screw type light fixtures in the ceiling, indicating that the light system was installed in or after 1933 in the greenhouse.
- 02.33** A pair of wooden "bunks" were built on either side of the center walkway. These ventilated platforms supported potted plants and provided nearly 8" of airspace above the concrete floor. This allowed drainage of water from the pots to prevent root rot, an important consideration when there are many seedlings that need constant watering.

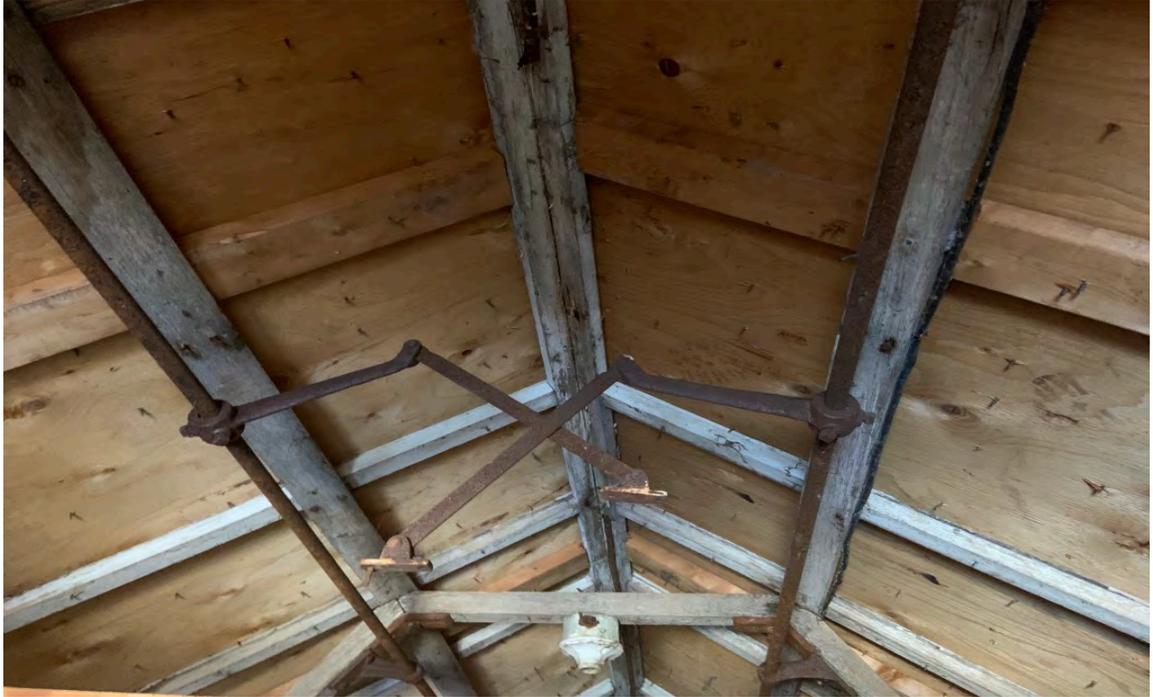
**02.34** A block with a ceramic lightbulb socket is screwed to the center of each collar tie to provide electric light to the space below. The fixtures appear to be contemporary to the early knob and tube type wiring. Note new plywood sheathing on roof to support shingles.
