## City of Hamilton

# HAMILTON MUNICIPAL HERITAGE COMMITTEE REVISED

**Meeting #:** 21-001

**Date:** January 29, 2021

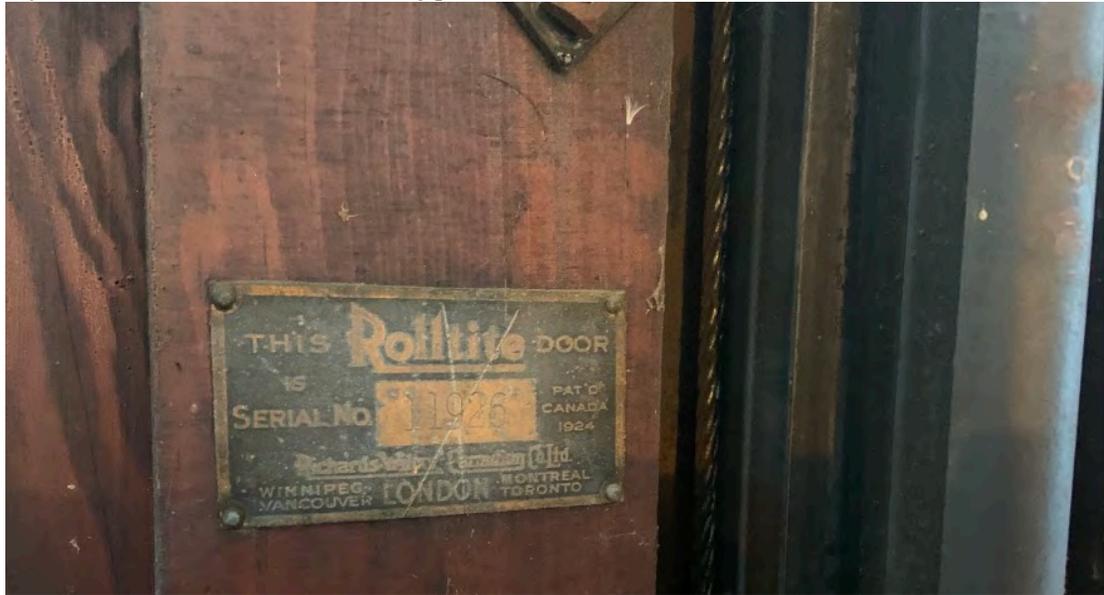
**03.12 Builders Plate: "This Rolltite Door"**  
 Serial No. 11926 Pat. "D" Canada 1924  
 Richards Wilcox Canadian Co. Ltd. Winnipeg Vancouver London Montreal Toronto  
 Two doors have sequential number plates.  
 They were likely installed in 1924, 1925 or 1926.

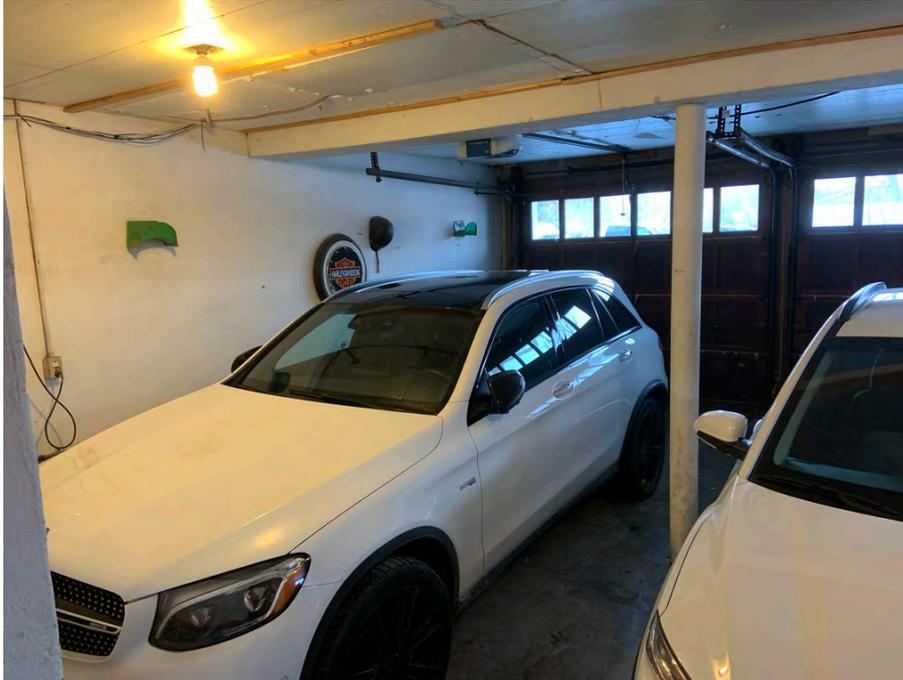
View of three car garage with steel pipe column and steel beam supporting joists in the floor above. The roll up doors are only 8' wide, with narrow posts supporting the lintel above. The concrete floor is original, and buried the footings for the posts in the manner of contemporary houses. Steel beams were rarely used in residential houses before WW1 and were still uncommon until after WW2. The ceiling is insulated above the unheated garage. The concrete foundation wall has a stucco finish inside the garage.

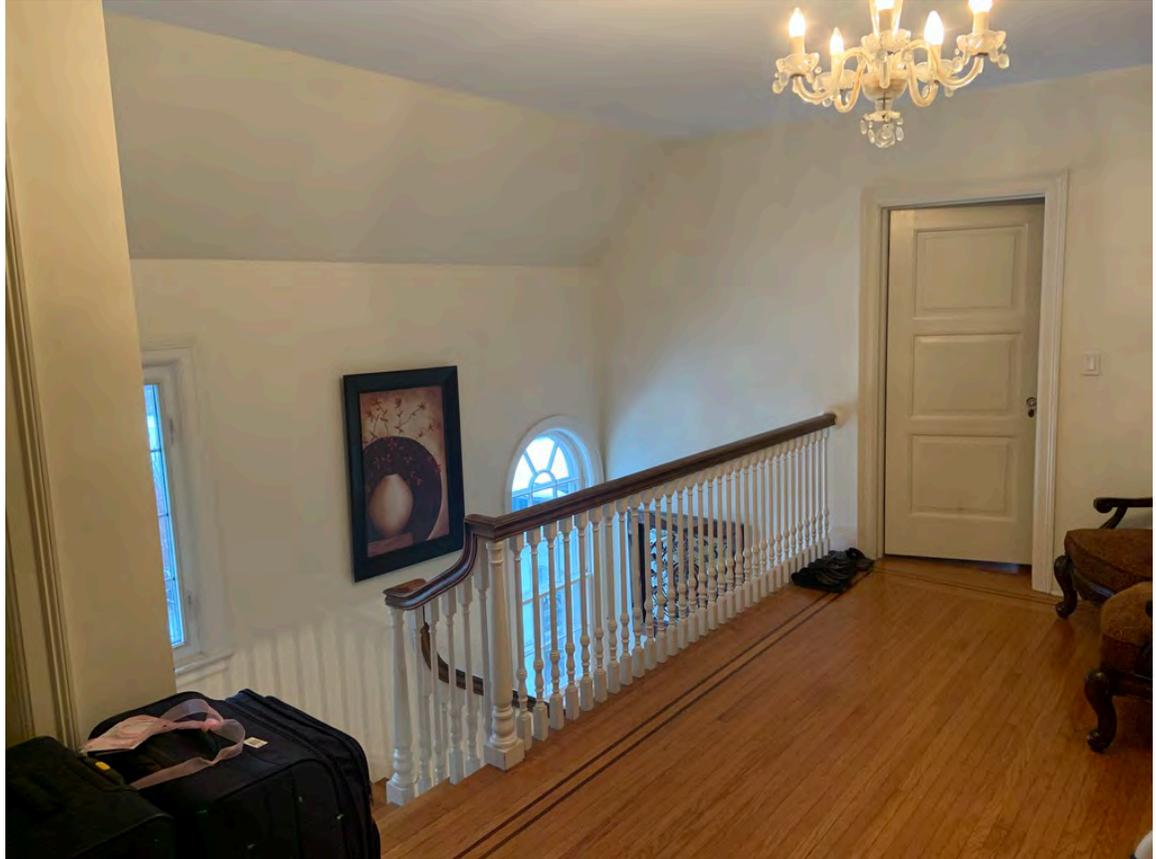
Second floor hall and sloping roof above the stairwell. The window heads are uncomfortably different and below eye level when standing on the second floor.
