City of Hamilton PUBLIC WORKS COMMITTEE ADDENDUM

*8.1 Burlington Street Sewage Spill Update (PW22088) (City Wide)

ТО:	Mayor and Members City Council			
COMMITTEE DATE:	November 28, 2022			
SUBJECT/REPORT NO:	Burlington Street Sewage Spill Update (PW22088) (City Wide)			
WARD(S) AFFECTED:	City Wide			
PREPARED BY:	Shane McCauley (905) 546-2424 Ext. 1020 Susan Girt (905) 546-2424 Ext. 2671			
SUBMITTED BY: SIGNATURE:	Nick Winters Director, Hamilton Water Public Works Department			
O.G.W. G.C.	NLA

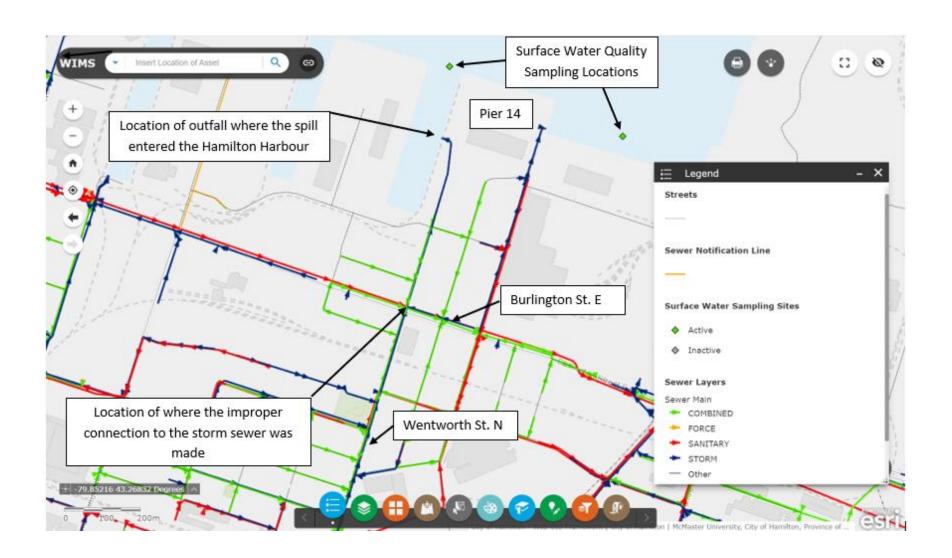
Appendix "A" to Report PW22088 Page 1 of 1

Appendix "A" to Report PW22088 – Map of the Spill Location and Storm Sewer Outfall

On Tuesday, November 22, 2022 Hamilton Water staff identified an improper connection between a combined sewer and a storm sewer in the vicinity of Wentworth Street North and Burlington Street East, Hamilton. Appendix "A" to Report PW22088 shows the location of the improper connection and the outfall that discharges to the Hamilton Harbour. This improper connection allowed combined sewage (made up of sanitary discharges in the sewer shed and storm water connections) to enter the storm sewer that outlets directly into the Hamilton Harbour at the Hamilton Oshawa Port Authority (HOPA) Pier 14. The combined sewage that entered the storm sewer is considered a spill under the Provincial Environmental Protection Act. Historical records indicate that the connection causing the spill likely occurred sometime in the later half of 1996 during a City of Hamilton capital construction project on Burlington Street East.

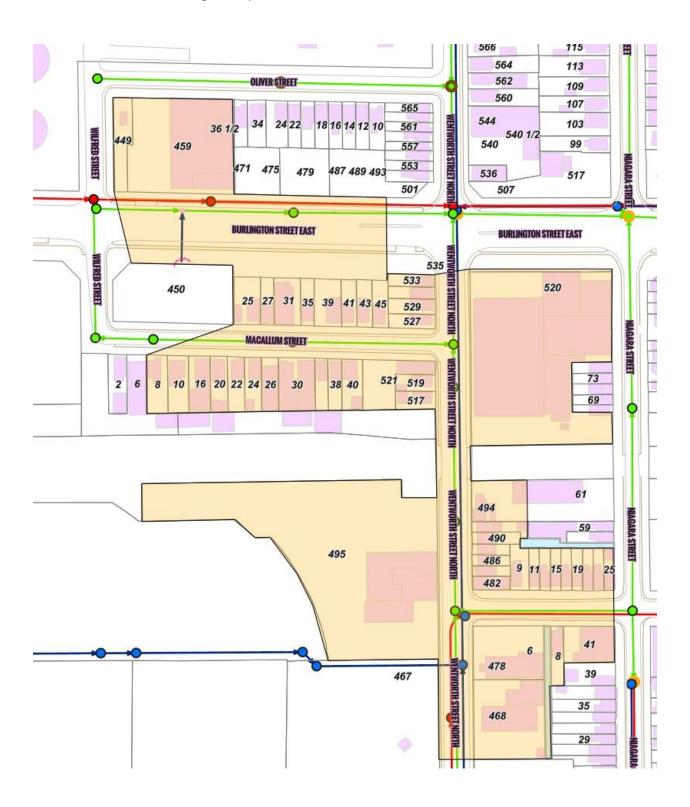
Appendix "C" to Report PW22088 – Map Showing Affected Properties

Properties within the shaded area below were identified as being connected to the combined sewer causing the spill.

By examining Hamilton Water's Geographical Informational Systems (GIS) staff identified 50 properties with service connections that would have contributed to the sewage spill. A map that identifies these properties has been attached as Appendix "C" to Report PW22088.

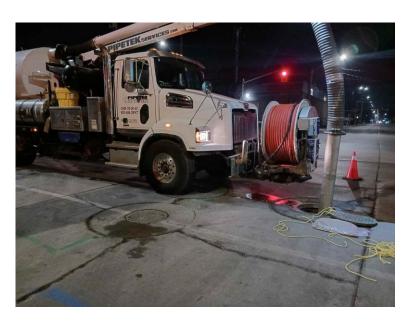
Spill Notification

Initial notification to MECP Spills Action Centre:

Tuesday November 22, 2022 at 12:12 pm Spills # 1-29OZAO

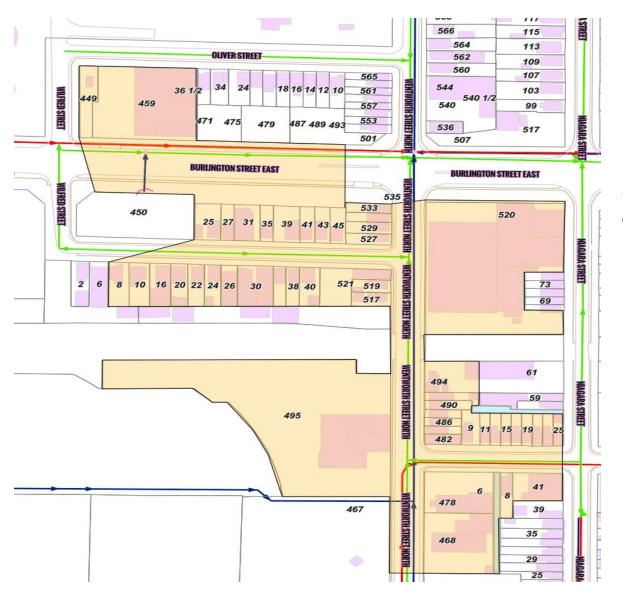
Catchment Area

50 properties within the catchment area of the spill:

- Burlington Street East
- Wentworth Street North
- Brant Street
- Macallum Street

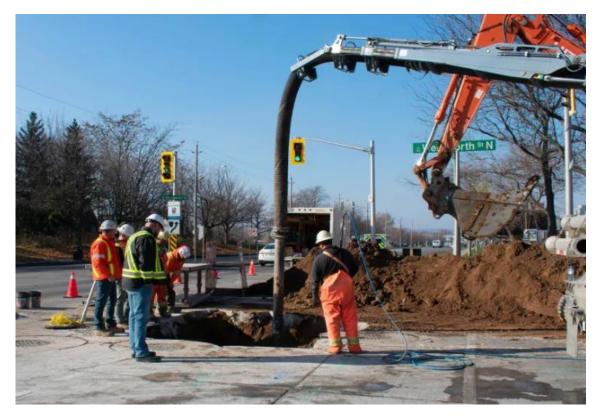
Completed Repair & Sewer Realignment

- The repair and sewer realignment started at 8:00 a.m. on November 23, 2022
- The leak was stopped at 9:32p.m. on November 23, 2022
- The crew completed all works and was offsite at 12:30 a.m. on November 24, 2022

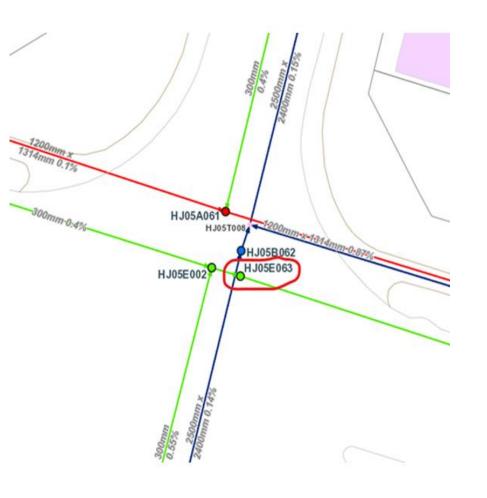
Completed Repair & Sewer Realignment

536 Wentwor HJ05S014

Pre Repair and Realignment

Post Repair and Realignment

On November 22 and 23, 2022, Hamilton Water and Engineering Services worked together to determine an appropriate method to repair/reconfigure the improper combined sewer connection to the receiving storm sewer to eliminate this flow. Staff determined that it was possible to connect the combined sewer (that was spilling into the storm sewer) to the large Western Sanitary Interceptor sewer that flows directly to the Woodward Wastewater Treatment Plant. The reconfiguration included installing a new section of sewage pipe approximately 4.5 metres in length. Once this connection was made, the connection between the combined sewer and the storm sewer was eliminated by capping the ends of the abandoned pipe with concrete.

The new connection was completed on Wednesday, November 22, 2022 at 9:32 p.m. Temporary road surface restoration was completed, and construction crews left the site at 12:30 a.m. on Thursday November 23, 2022. Hamilton Water staff completed repairs as urgently as possible, repairing the sewer within 31 hours of discovery. Hamilton Water returned to the site first thing in the morning on Thursday, November 23, 2022 and completed a camera inspection of the reconfiguration and verified that the new connection was functioning properly, and the abandoned pipe was properly capped. City records were updated to reflect the new sewer configuration. Final restoration of the road surface will be completed by Engineering Services once Hamilton Water have completed their analysis verifying that the repairs are the most appropriate long-term solution.

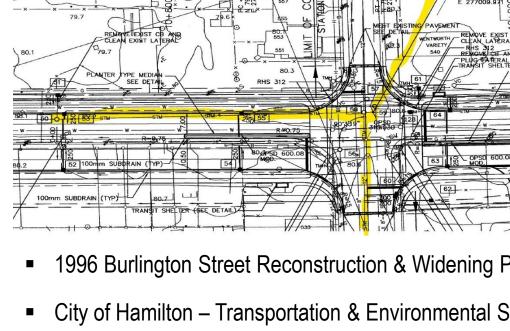
What Happened and How?

- 1996 Burlington Street Reconstruction & Widening Project
- City of Hamilton Transportation & Environmental Services Group
- Design drawing 96-H-11_3 has mislabeled sewers shows a deliberate connection to the storm sewer

understanding was completed by the City's former Transportation, Operations and Environment Division in 1996. In the engineering drawings associated with this contract, staff identified drawing 96-H-11 which includes a note stating, "Break into top of existing box culvert with 15" storm sewer". Staff also noted that on this drawing, a number of lengths of combined sewer pipe are incorrectly labeled as storm sewer pipes. Drawing 96-H-11 has been included as Appendix "B" to Report PW22088 illustrating this fact. It is City staff's current understanding that the 1996 Burlington Street reconstruction work included sub-surface infrastructure upgrades to watermains and a modification to the incorrectly labelled combined sewer that created an improper connection to the storm sewer.

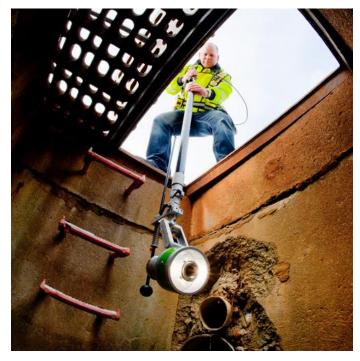
Why Was the Spill Not Discovered Sooner?

- Zoom Camera Sewer Inspection Contracts
 - C11-29-04
 - C11-86-10
 - C11-39-15
- Approximately 9,600 videos per year
- PDF Deficiency Reports Provided to City Staff
- Bulk Uploads of Videos
- Contractors not Experienced with City Sewers
- Contractors not Looking for Cross Connected Sewers

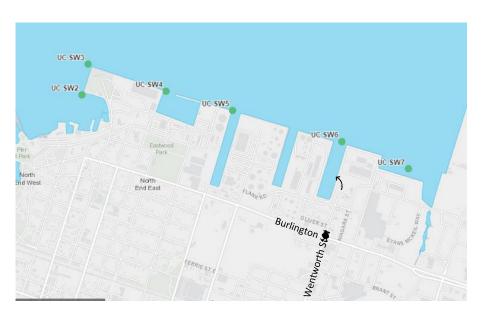
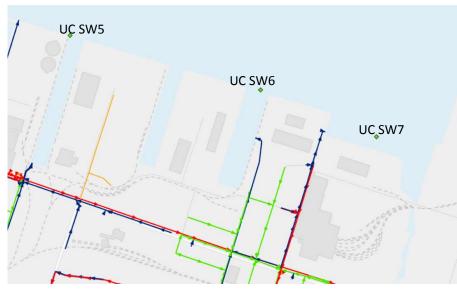
SURFACE WATER QUALITY PROGRAM: HAMILTON HARBOUR SAMPLE LOCATIONS AT AND UP- / DOWN-STREAM TO WENTWORTH CSO

7 - Wentworth CSO Outfall

🌢 - Burlington / Wentworth Spill Location

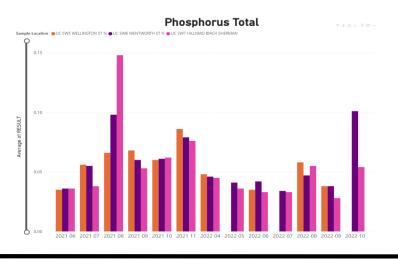
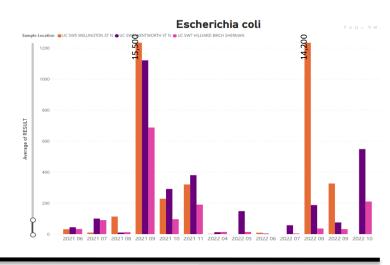
SURFACE WATER QUALITY PROGRAM: SW6 Data

Note: During the Oct 2022 sample event, two (2) tugboats were docking a ship, working up sediment at UC SW6 location.
