City of Hamilton
HAMILTON MUNICIPAL HERITAGE COMMITTEE
AGENDA

Meeting #: 25-005
Date: April 25, 2025
Time: 12:00 p.m.
Location: Room 264, 2nd Floor, City Hall (hybrid) (RM)
71 Main Street West

Recommendation to Designate 2 Hatt Street, Dundas under Part IV of the *Ontario Heritage Act* (Ward 13)

Recommendation to Designate 252 Caroline Street South, Hamilton (Central Presbyterian Church), under Part IV of the *Ontario Heritage Act* (Ward 2)

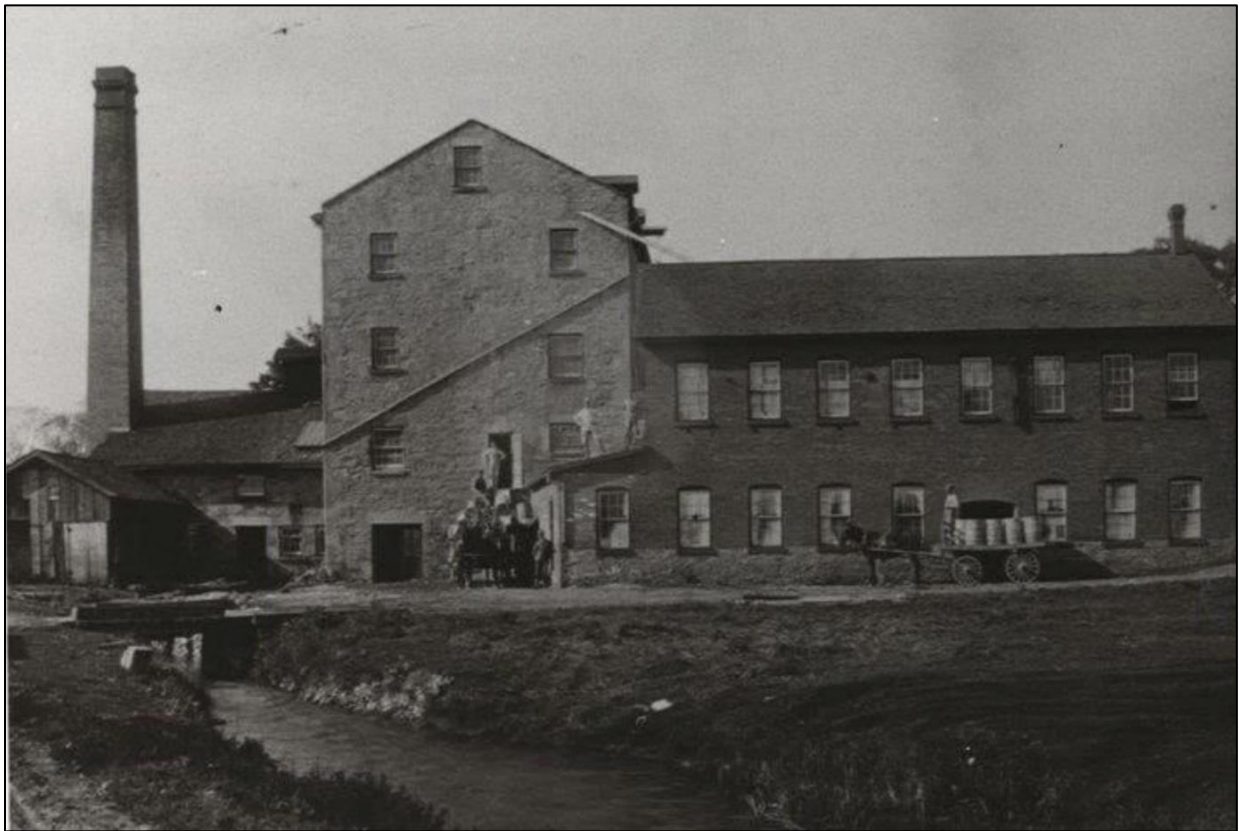
Figure 7: The New Dundas Mills circa 1900. (Source: Dundas Mill, P-2223, Photograph Collection, Dundas Museum and Archives)

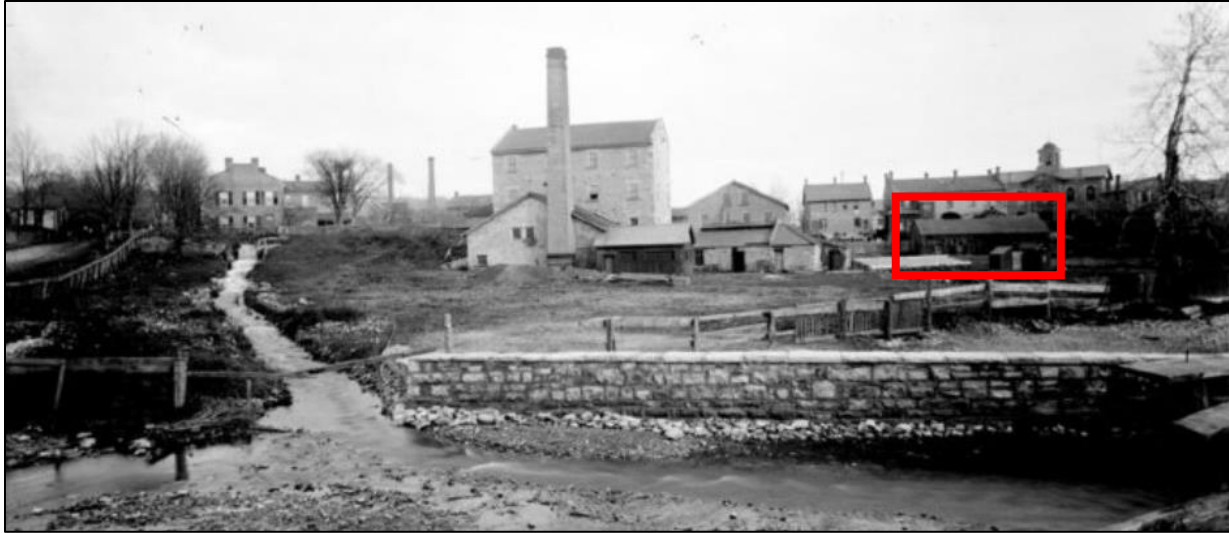
Figure 9: The New Dundas Mills circa 1890, 2 Hatt Street is highlighted. (Source: Kerr Milling Company, GN-0148, Glass Negative Collection, Dundas Museum and Archives)

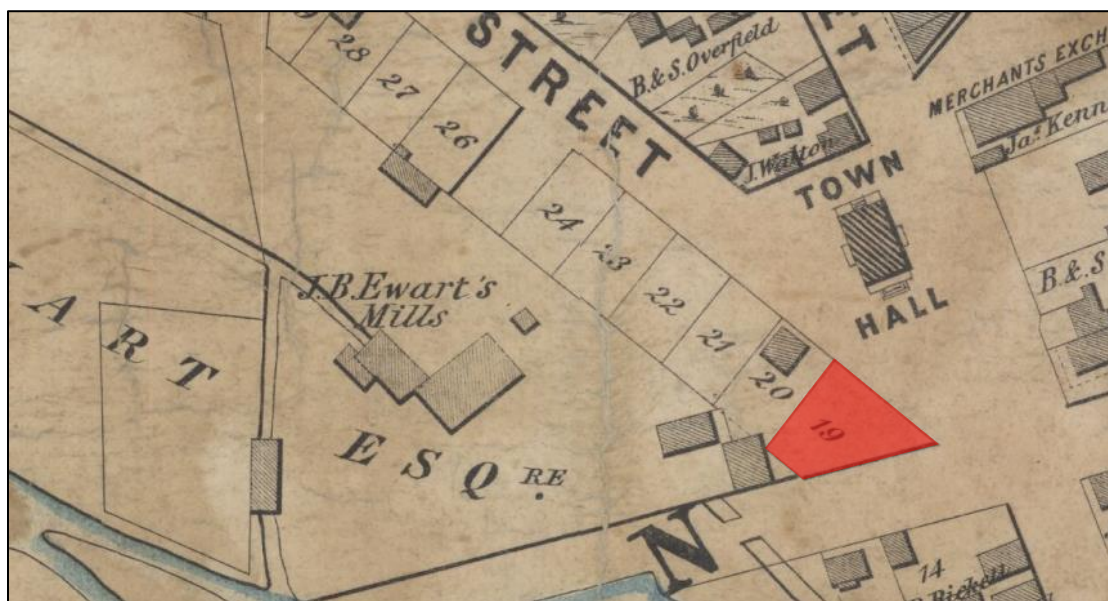
Figure 11: Map of the Town of Dundas, Marcus Smith, 1851. Closeup of 2 Hatt Street. Location of subject property highlighted in red. (Source: McMaster University, <http://digitalarchive.mcmaster.ca/islandora/object/macrepo%3A61445>)

the 1827 map of Dundas (Figure 10) shows a structure located on the property of 2 Hatt Street, a more detailed 1851 map by Marcus Smith (Figure 11) does not show a structure being located on the property. This is likely an error on Smith's part, as an engraving from 1853 shows a roofline similar to that of the property located at 2 Hatt Street in the same approximate location, and there is no record of the building being moved to or from a different location.

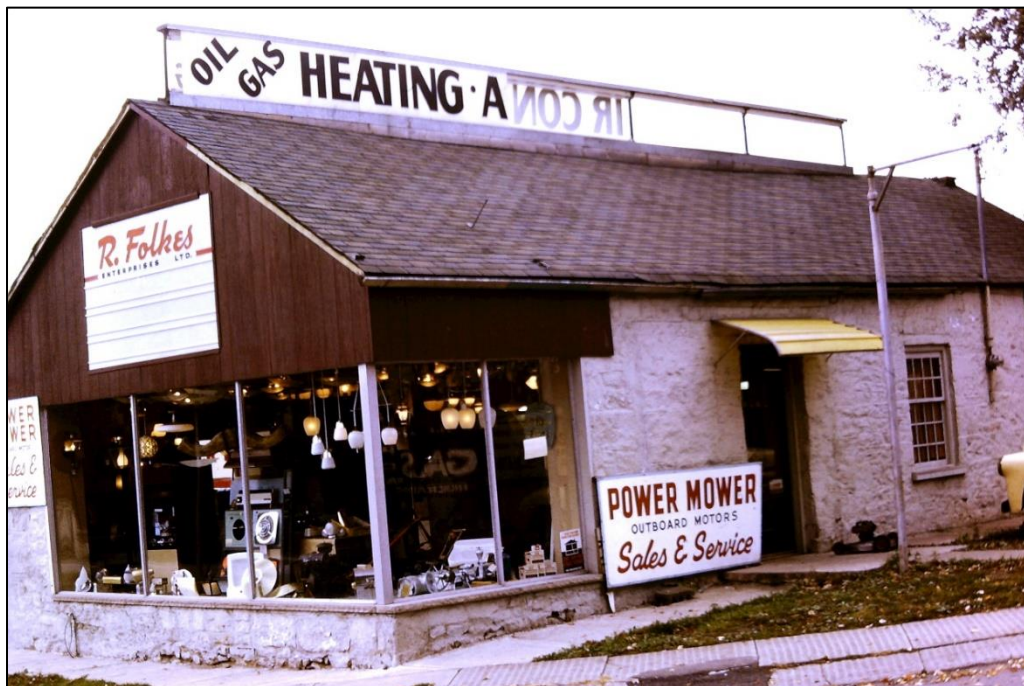
Figure 13: 2 Hatt Street, 1964, following renovations (Source: Dundas Museum & Archives, "The Way We Were in the Nineteen Sixties" Slide Collection)

In 1961, the property was sold to Robert Folkes of R. Folkes Ent. Ltd., who opened R. Folkes House of Lights and Shades.⁸⁴ It was during this time that a large portion of the east wall and approximately 9 feet of the north wall were demolished and converted into a display window (*Figure 13*). In the early 2000s, access to Main Street from Hatt Street was cut off and the terminus of Hatt Street was converted into a parking lot for Town Hall. In 2004, the property was sold again and converted into a private art gallery called Cairn Gorm Studio Artworks, which operated until 2013.⁸⁵ The building is currently vacant.

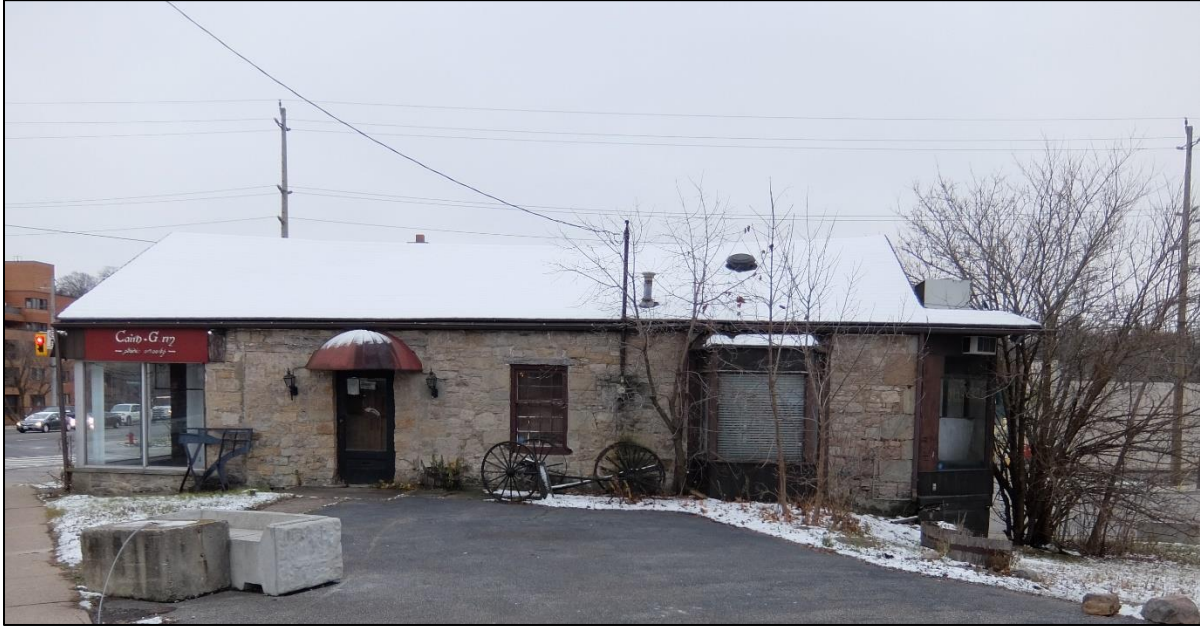
Image 3: Northern Elevation (December 2022)

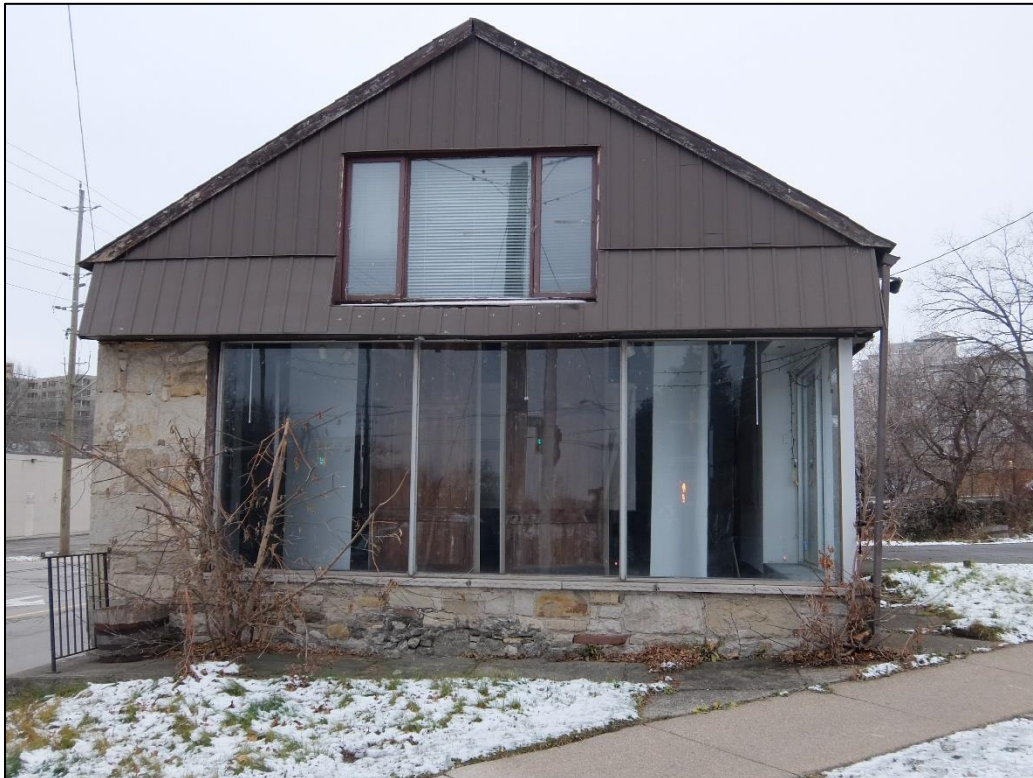
Image 4: Eastern Elevation (December 2022)

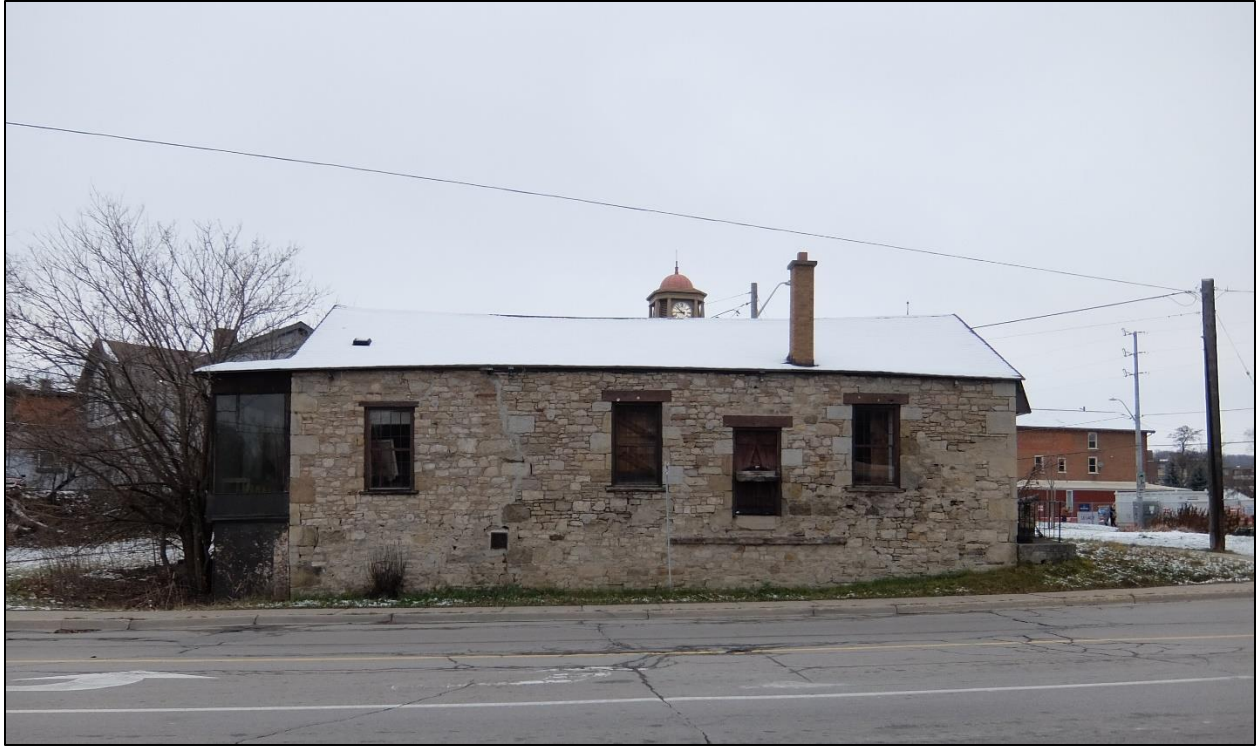
Image 5: Southern Elevation (December 2022)

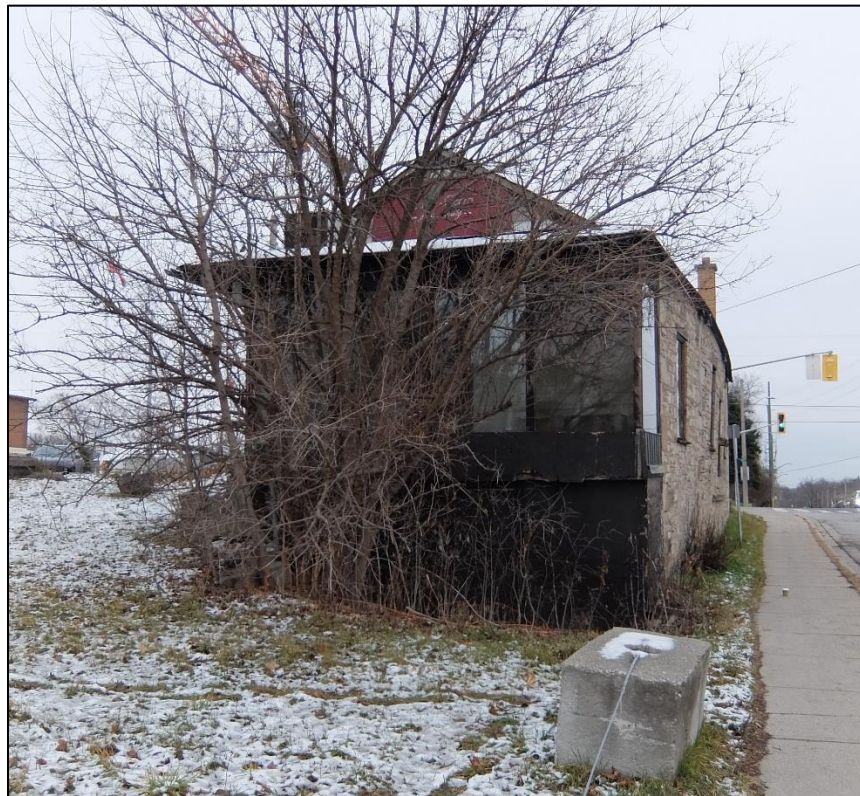
Image 6: Western Elevation (December 2022)

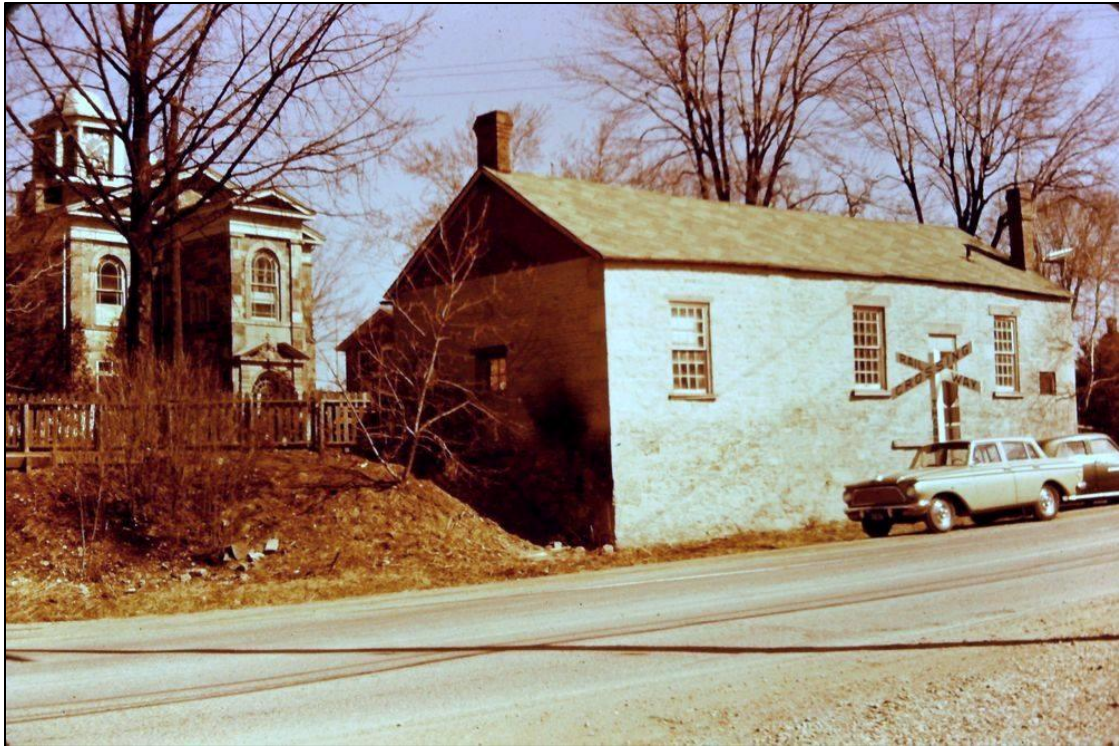
Image 12: 2 Hatt Street, c. 1950s, prior to renovations (Source: Dundas Museum & Archives, "The Way We Were in the Nineteen Sixties" Slide Collection)

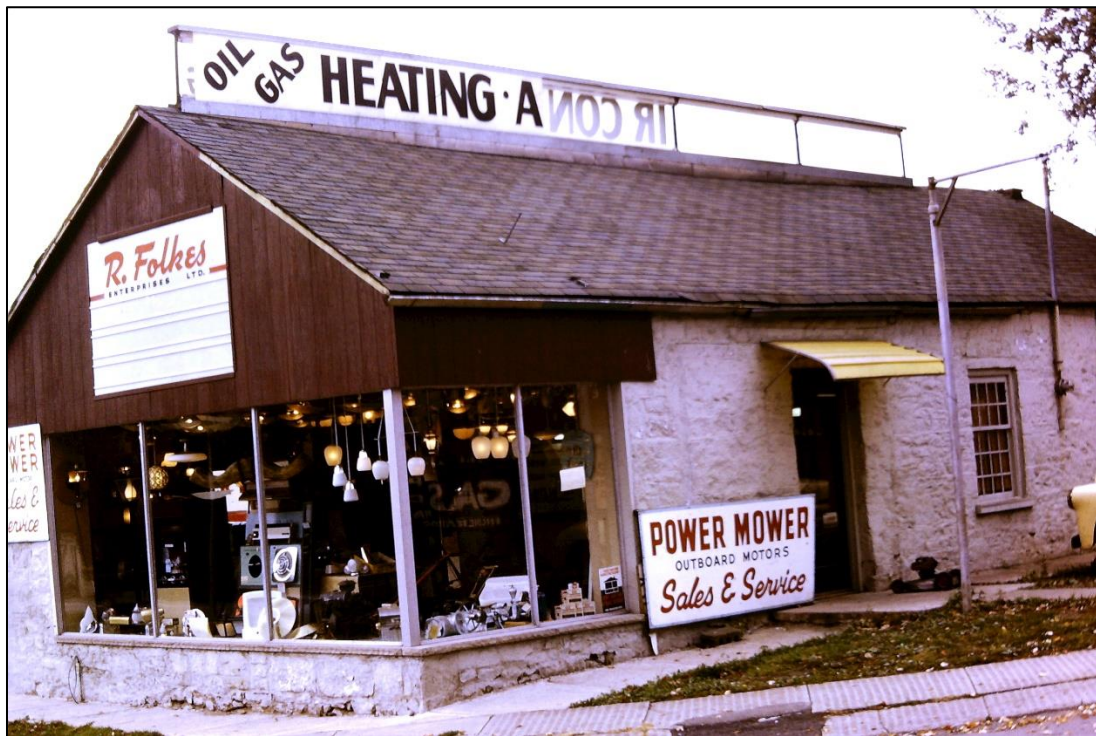
Image 13: 2 Hatt Street after renovations were complete, 1964 (Source: Dundas Museum & Archives, "The Way We Were in the Nineteen Sixties" Slide Collection)

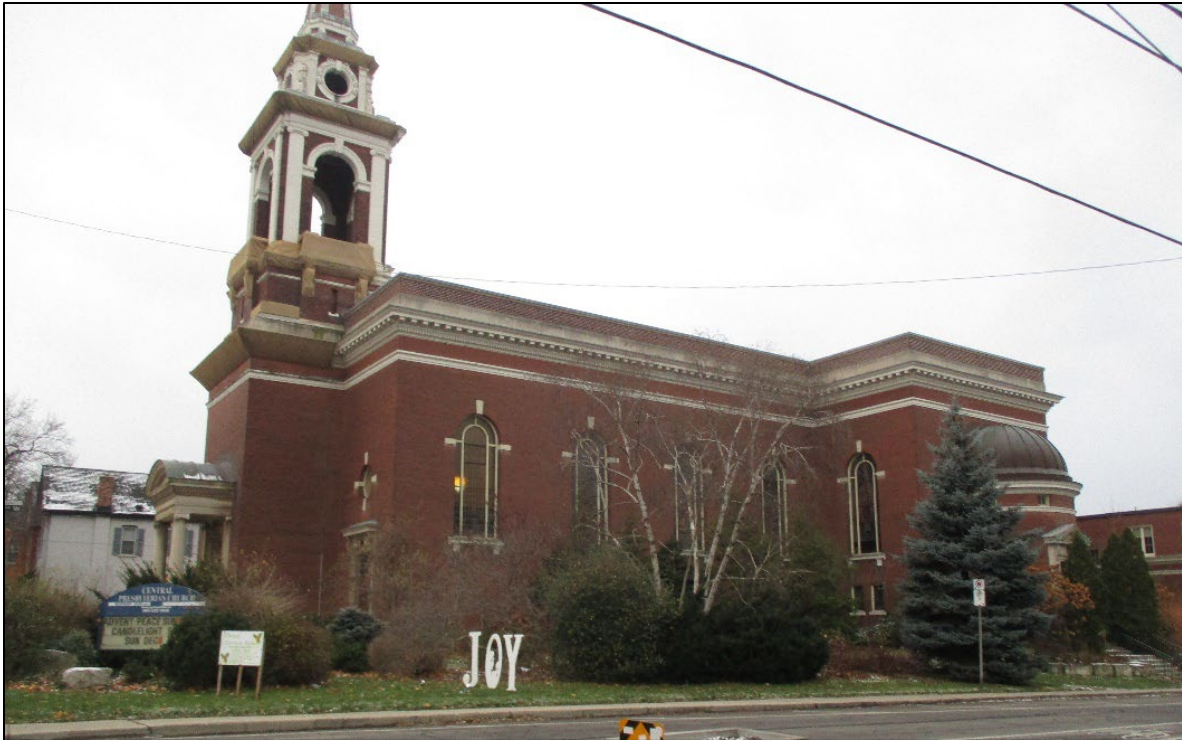
Figure 2: View of north elevation.

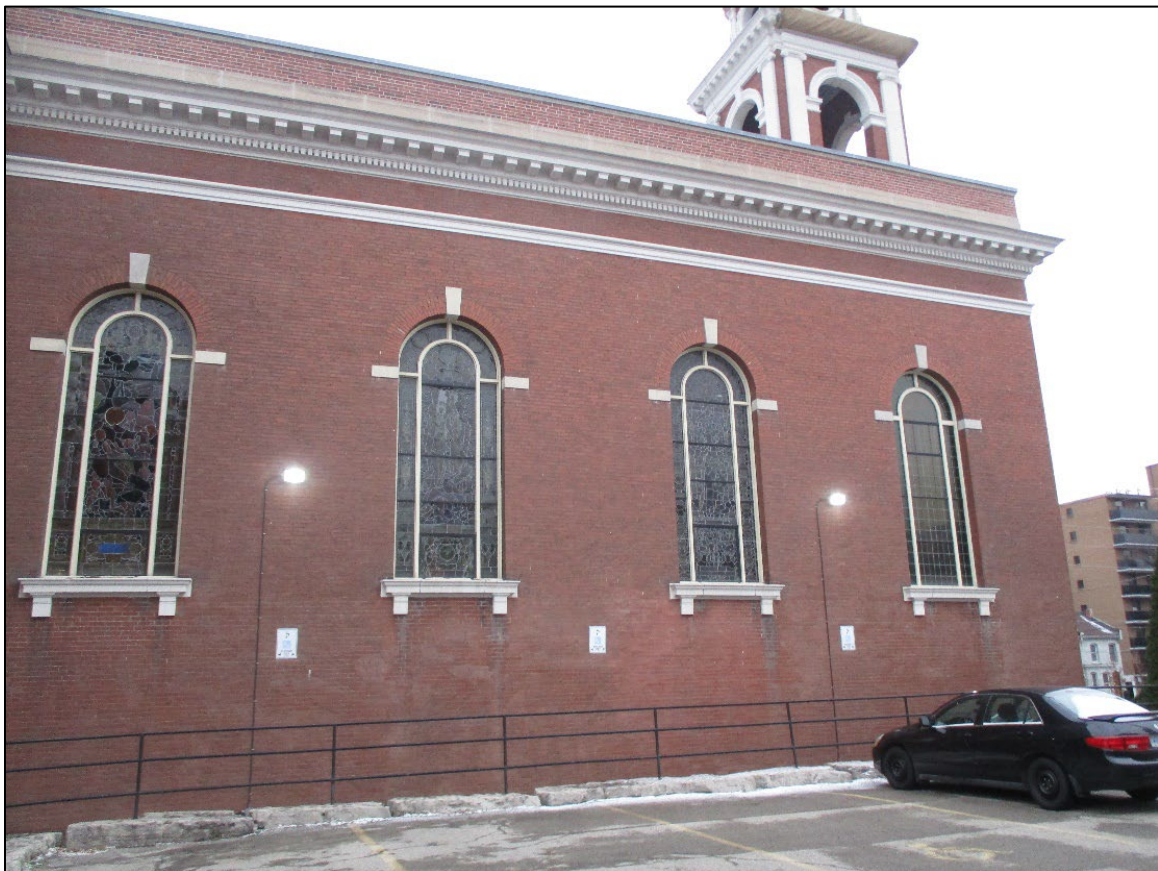
Figure 3: View of south elevation.

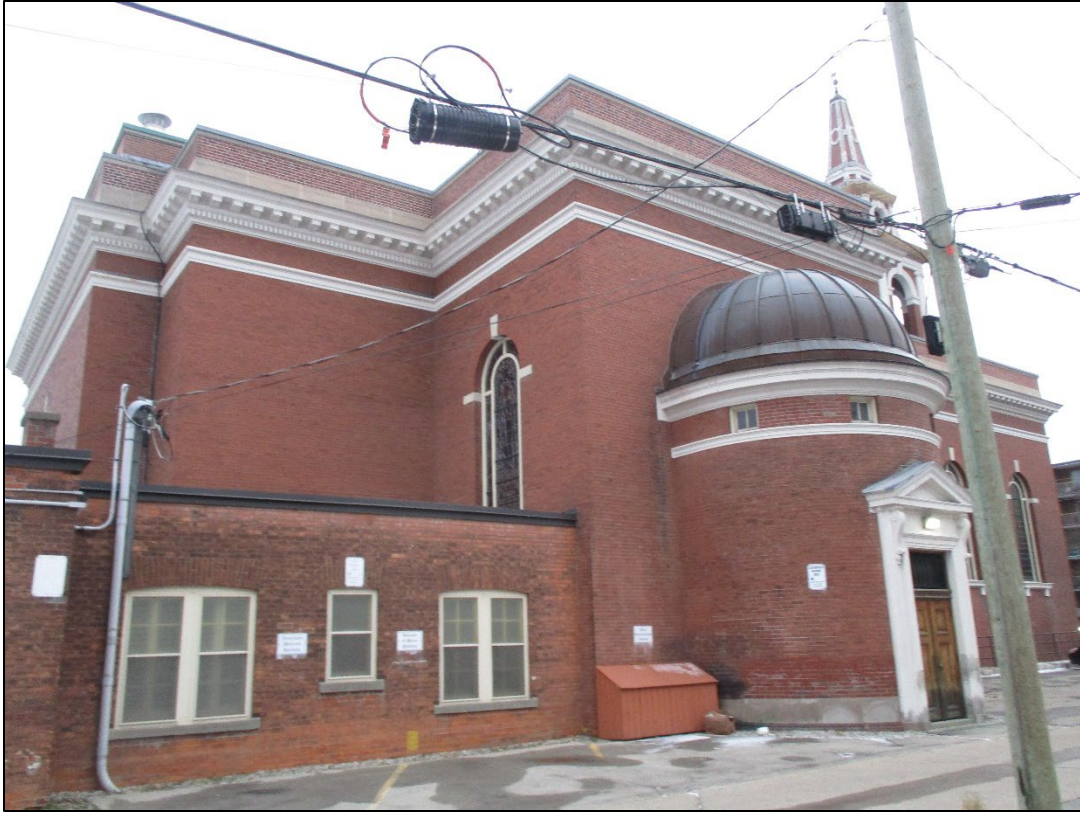
Figure 4: View of southwestern corner.

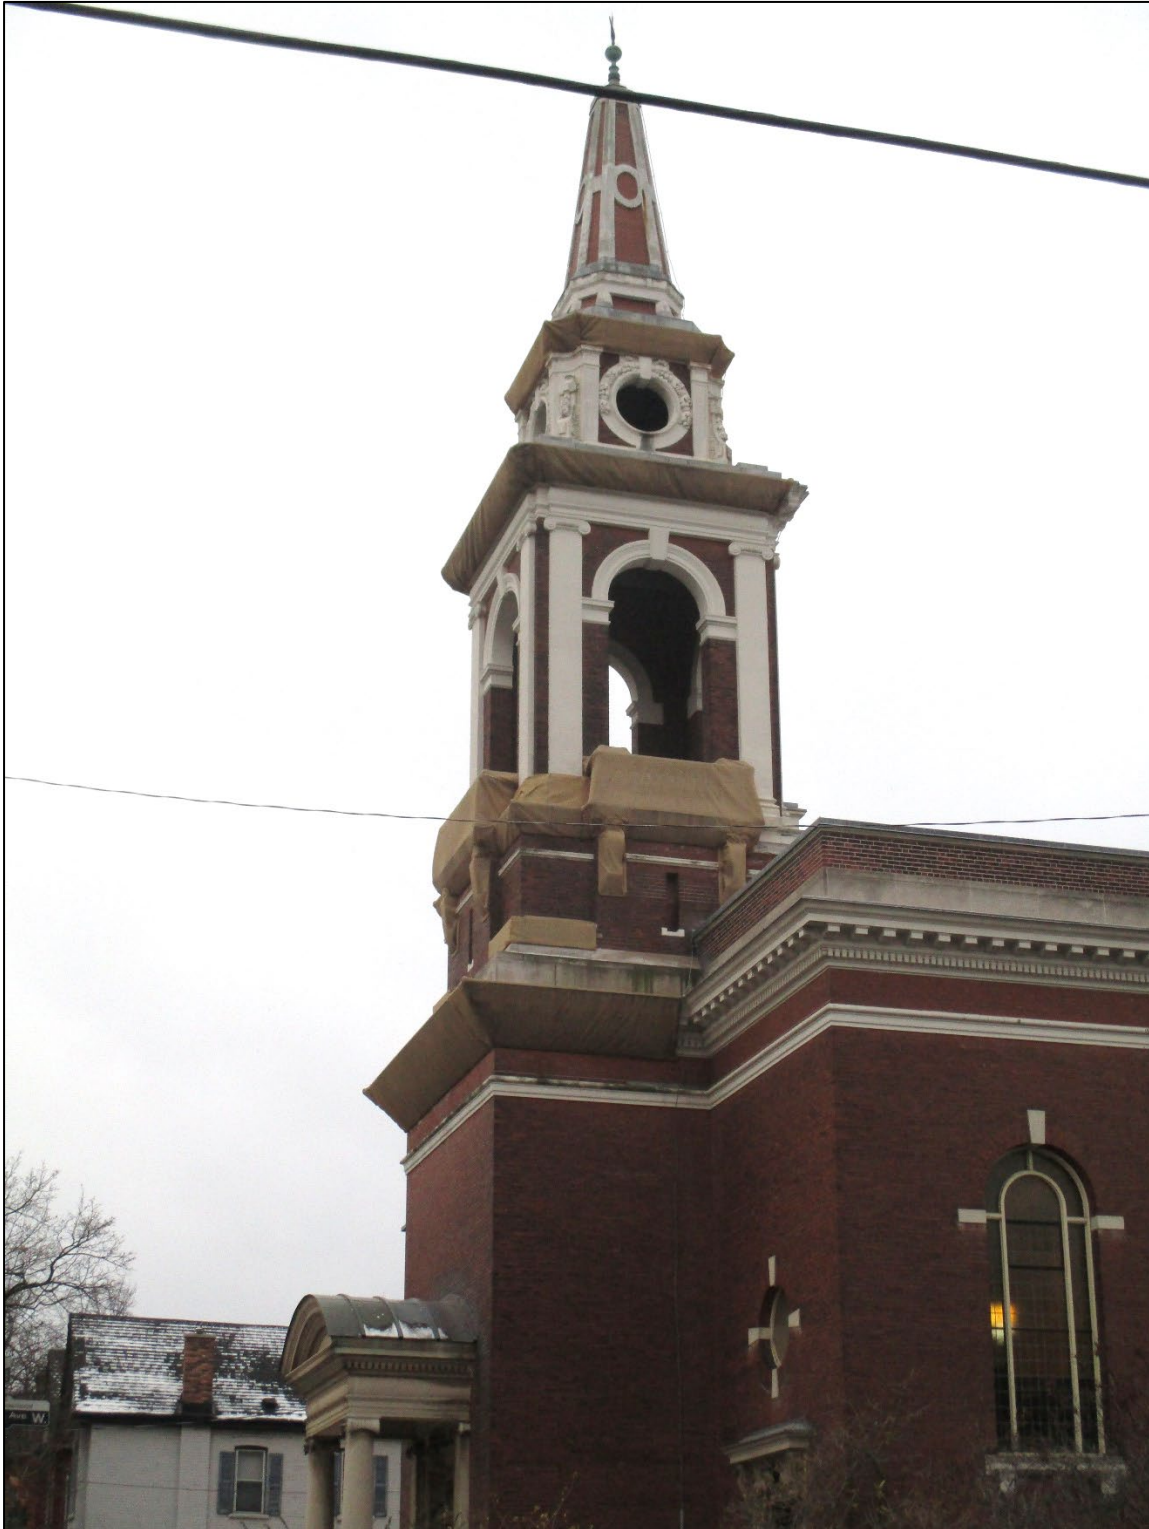
Figure 7: Detail view of spire.

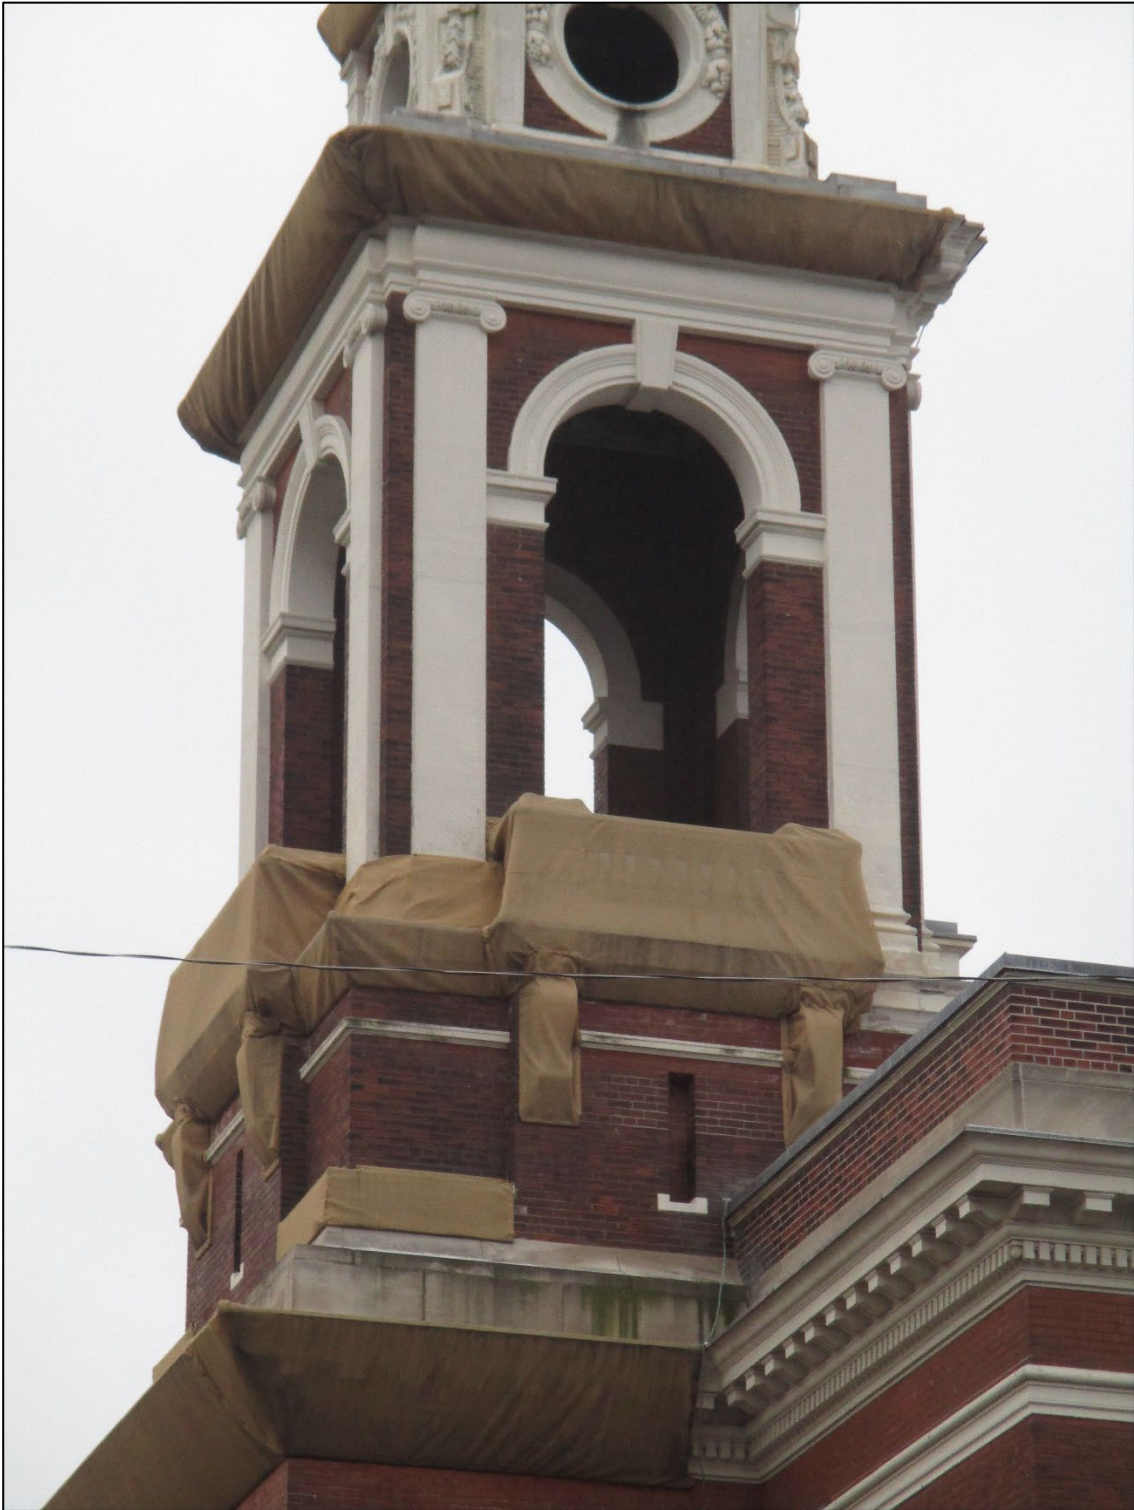
Figure 8: Detail view of spire base.

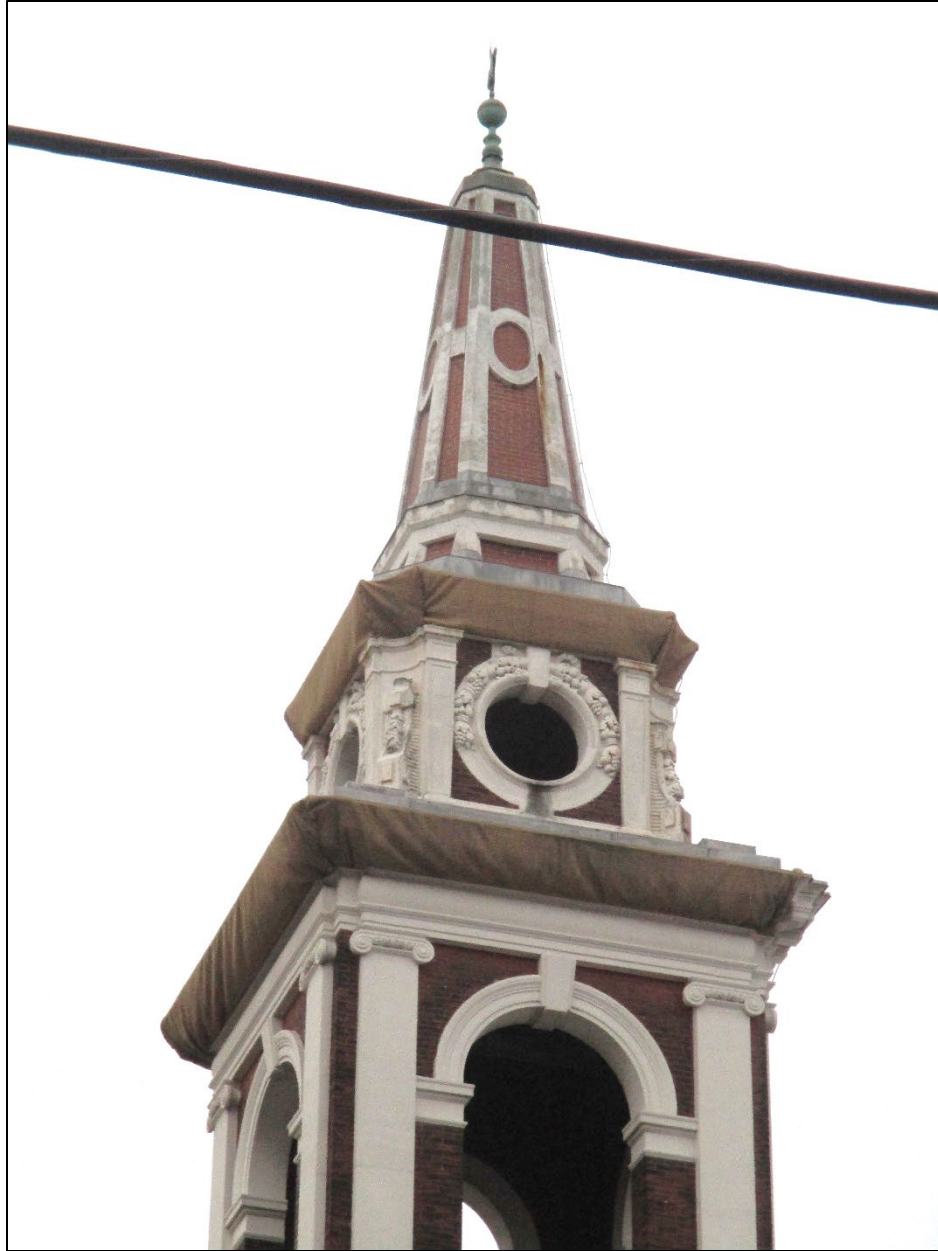
Figure 9: Detail view of spire top.

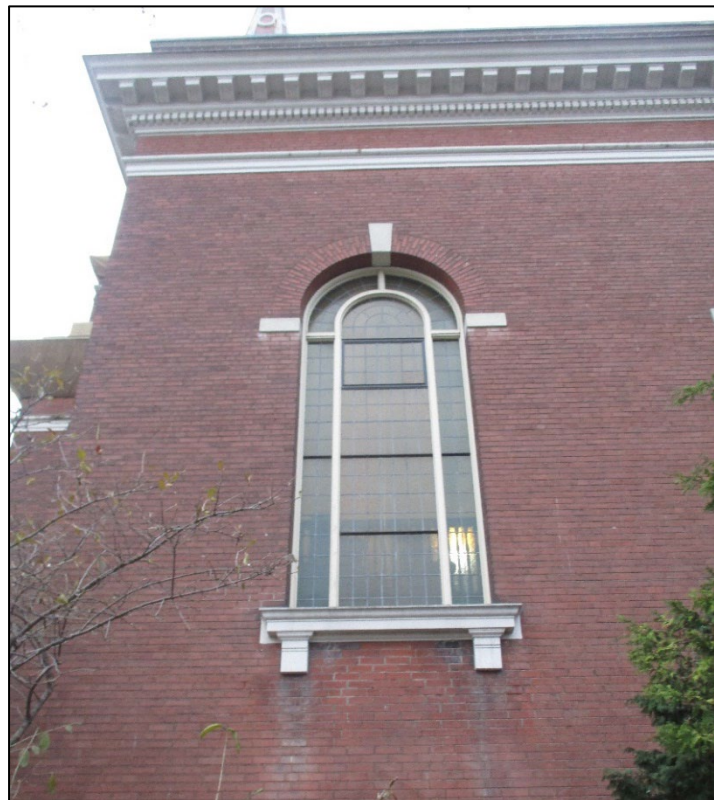
Figure 15: Detail view of window surround.

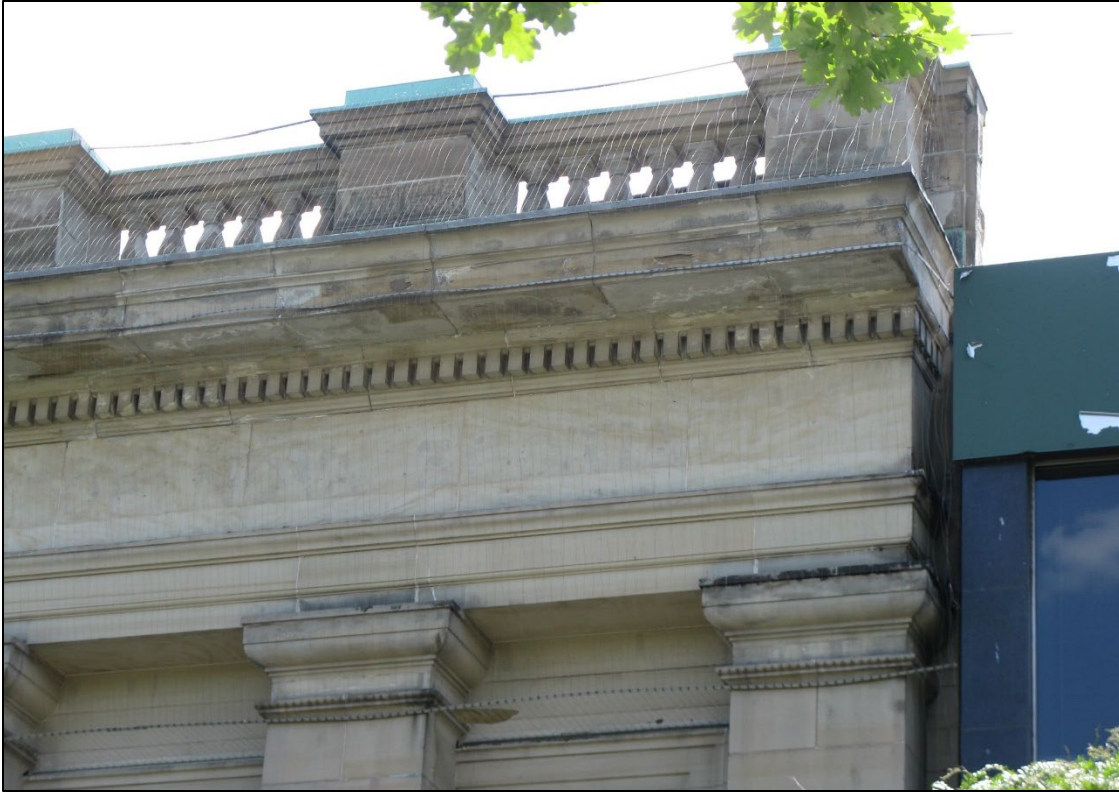
Image 4: Close-up of the stone balustrade, entablature, and doric capitals (July 10, 2012)

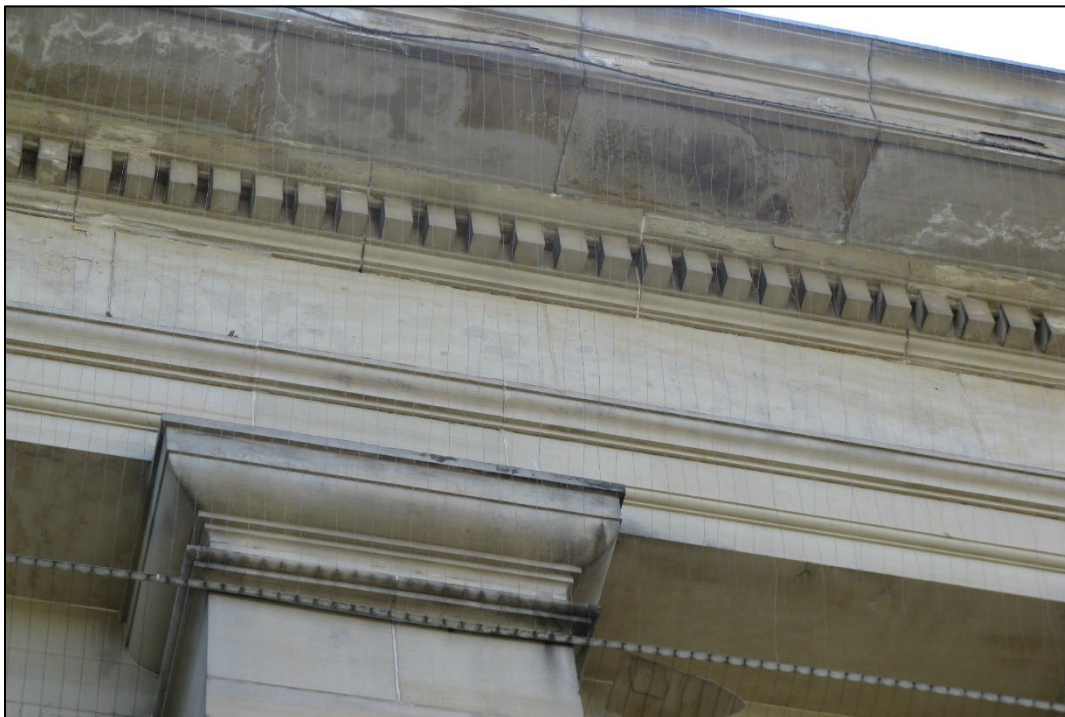
Image 5: Close-up of the dentilated cornice (July 10, 2012)

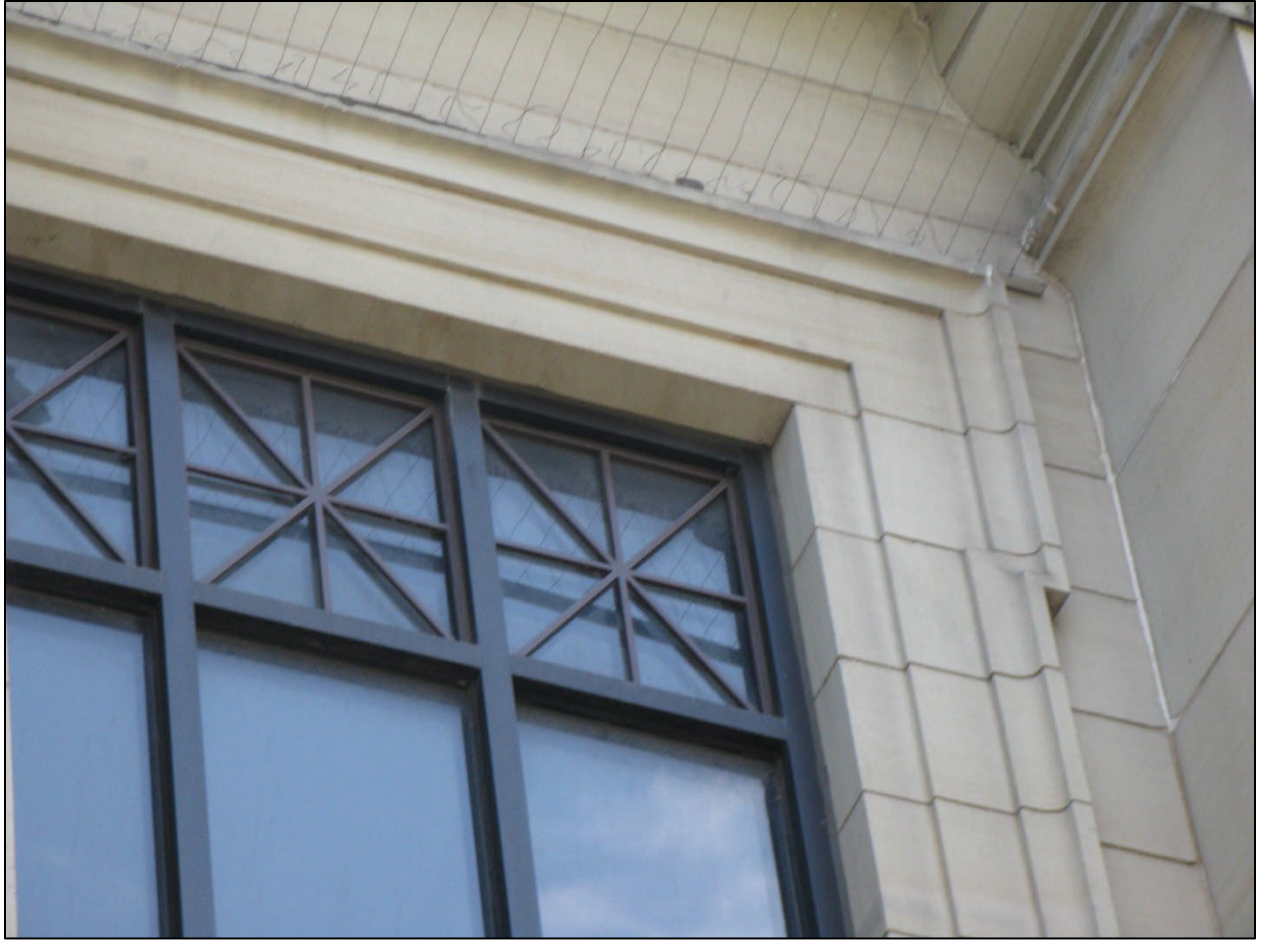
Image 6: Close up of multi-pane metal windows with decorative metal Roman lattice window grillwork (July 10, 2012)

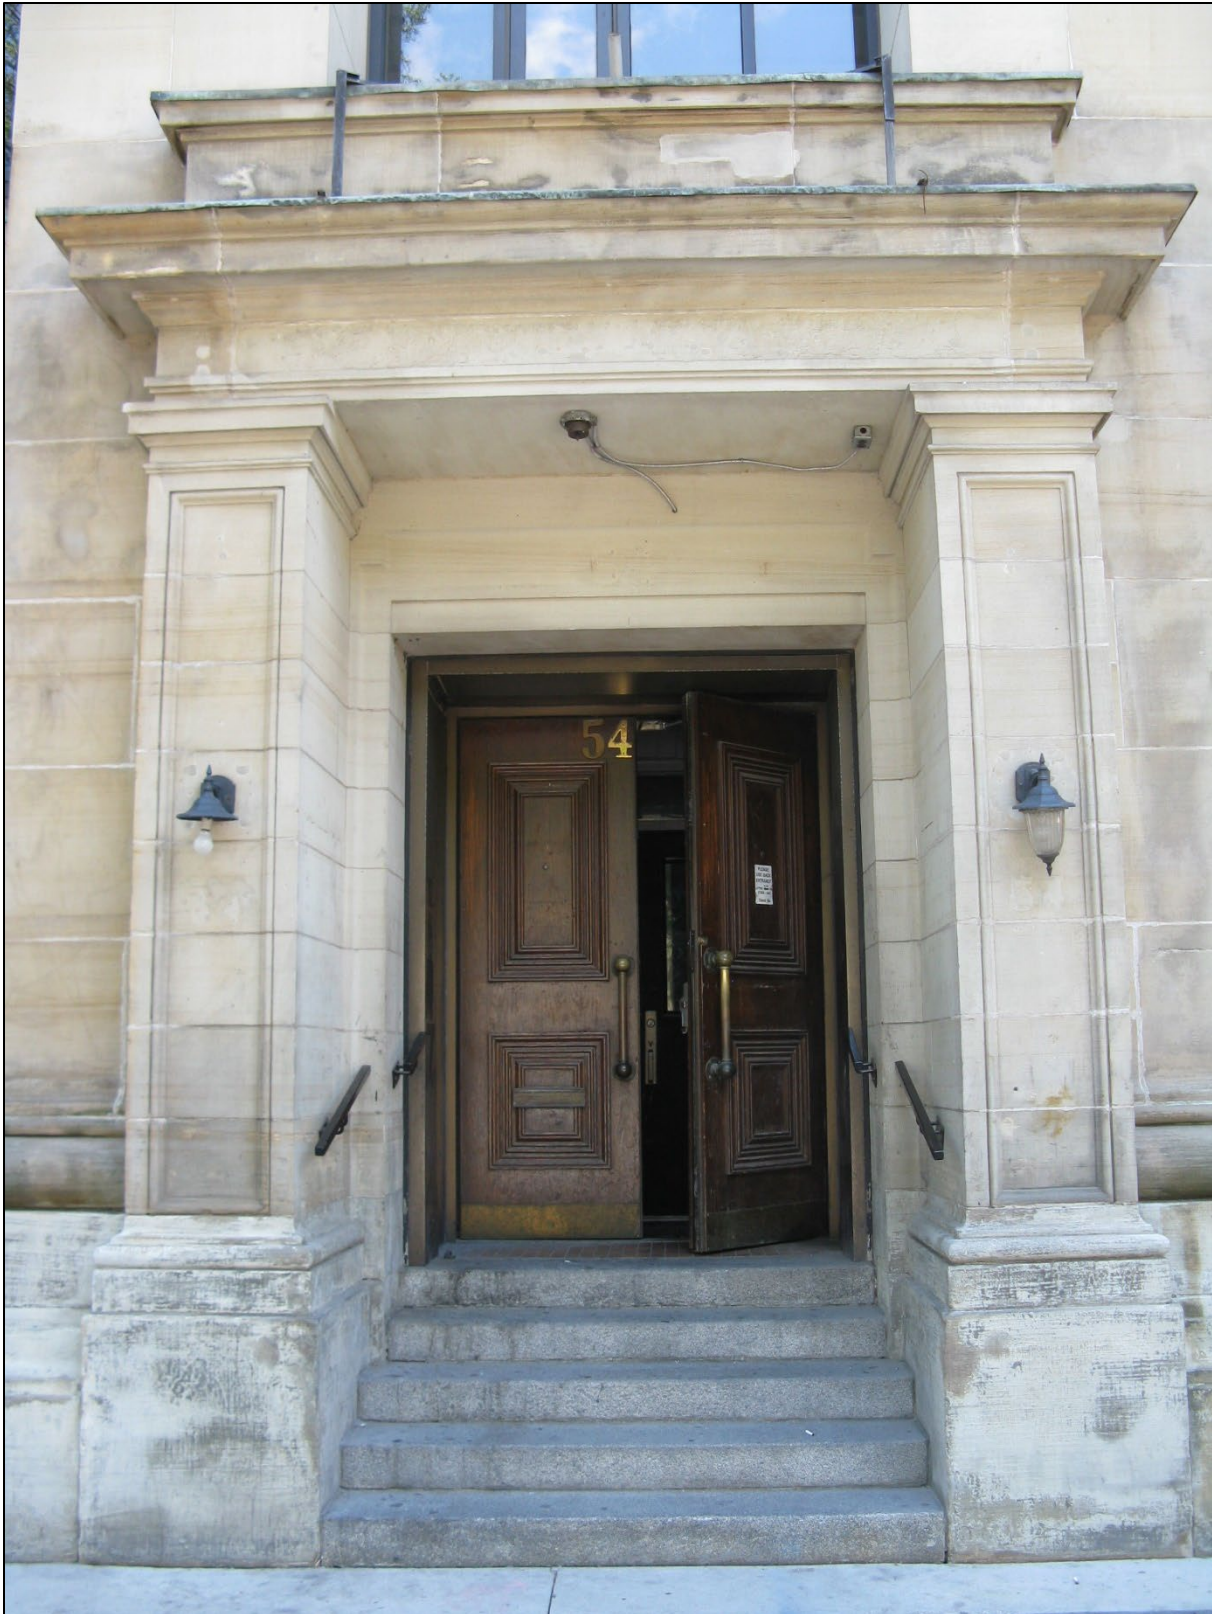
Image 7: Close-up of the recessed central entrance with stone surround, flanking columns with moulded panels and Doric capitals and entablature (July 10, 2012)

Sometime after the 1980s, two stone lions were added as decoration in front of the first storey window bays flanking either side of the front entrance, which have become notable of features the building. While much of the building's exterior features are intact, over time some small modifications and upgrades were completed, including the replacement of the tall second and third storey metal-framed windows with new windows and window casings which replicate the style of the original windows. The first storey windows were also modified and replaced, possibly more than once, elongating them and removing the original carved stone sill. This means that the current windows which are sympathetic to the original design of the façade, mirroring the original tripartite design of the second and third storey windows, are not original to the façade. The current recessed, double leaf door is similarly a replacement, but it is significant that the original recessed double leaf design has been preserved.

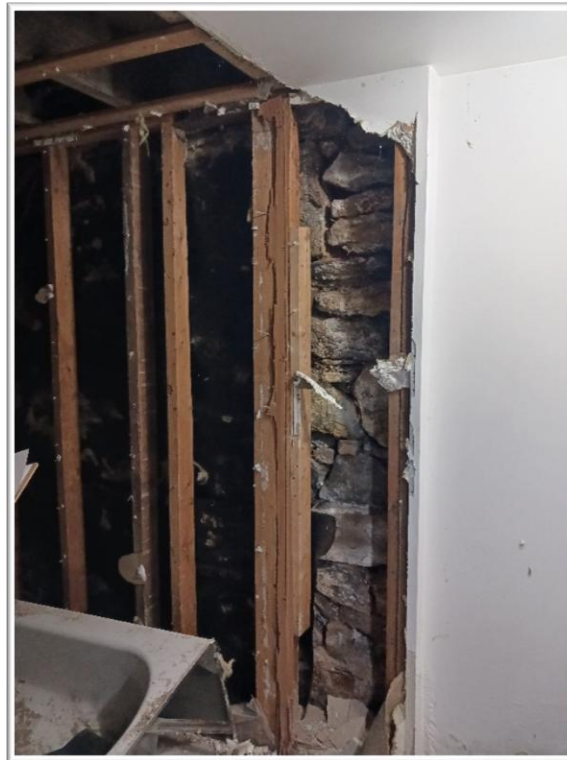
Figure 3: Damaged Foundation wall

The existing rubble foundation wall is not waterproofed from the exterior, resulting in significant water infiltration. Over time, this has led to deterioration of the foundation material, weakening the structural integrity of the building. Addressing these issues would require exterior excavation, installation of a proper waterproofing membrane, a weeping tile system to manage water drainage, and repointing of the stone wall to restore its stability. Without these measures, continued water penetration will accelerate deterioration and further compromise the foundation's load-bearing capacity.
