City of Hamilton
HAMILTON MUNICIPAL HERITAGE COMMITTEE
AGENDA

Meeting #: 25-005
Date: April 25, 2025
Time: 12:00 p.m.
Location: Room 264, 2nd Floor, City Hall (hybrid) (RM)
71 Main Street West

Recommendation to Designate 2 Hatt Street, Dundas under Part IV of the *Ontario Heritage Act* (Ward 13)

Recommendation to Designate 252 Caroline Street South, Hamilton (Central Presbyterian Church), under Part IV of the *Ontario Heritage Act* (Ward 2)

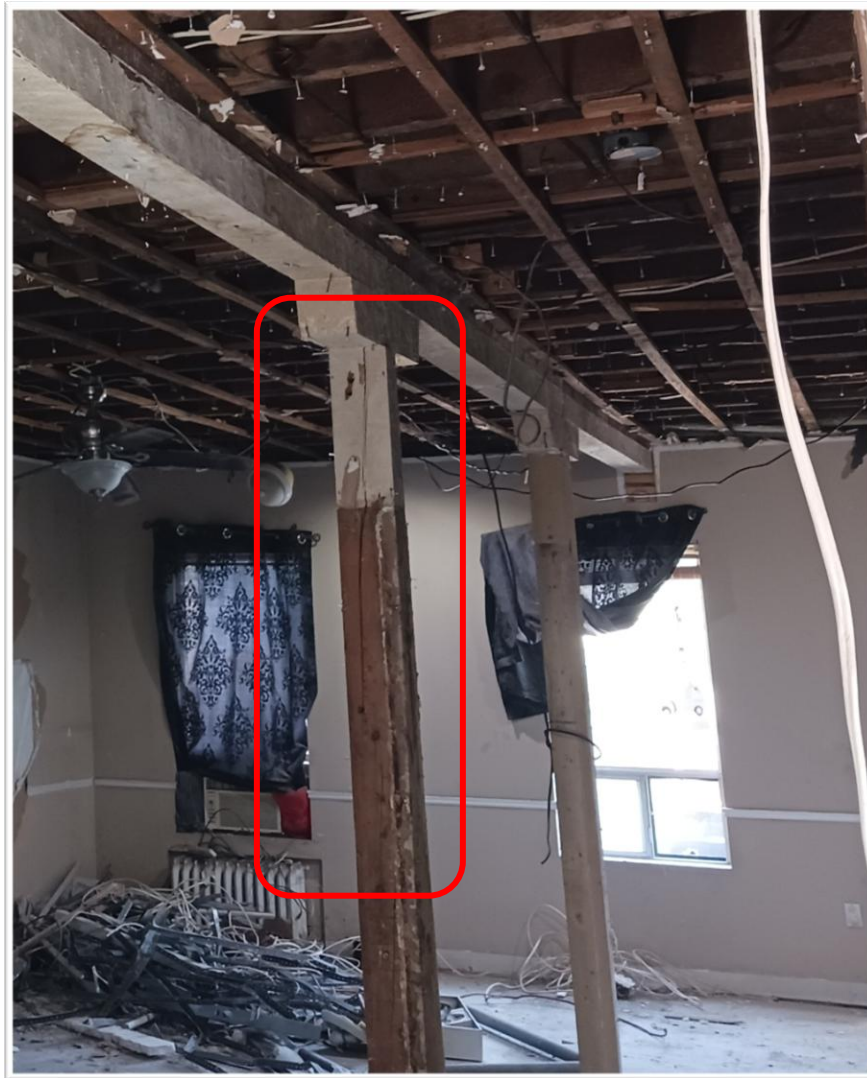
Figure 11: Cracked Structural Column

To prevent future failure, reinforcement or replacement of the column should be considered. If reinforcement is pursued, methods such as steel plate wrapping or bolted splints could be used to improve the column's load-bearing capacity and prevent further cracking. However, if the crack continues to grow and significantly compromises the column's strength, complete replacement will be necessary to ensure the structural integrity of the building.

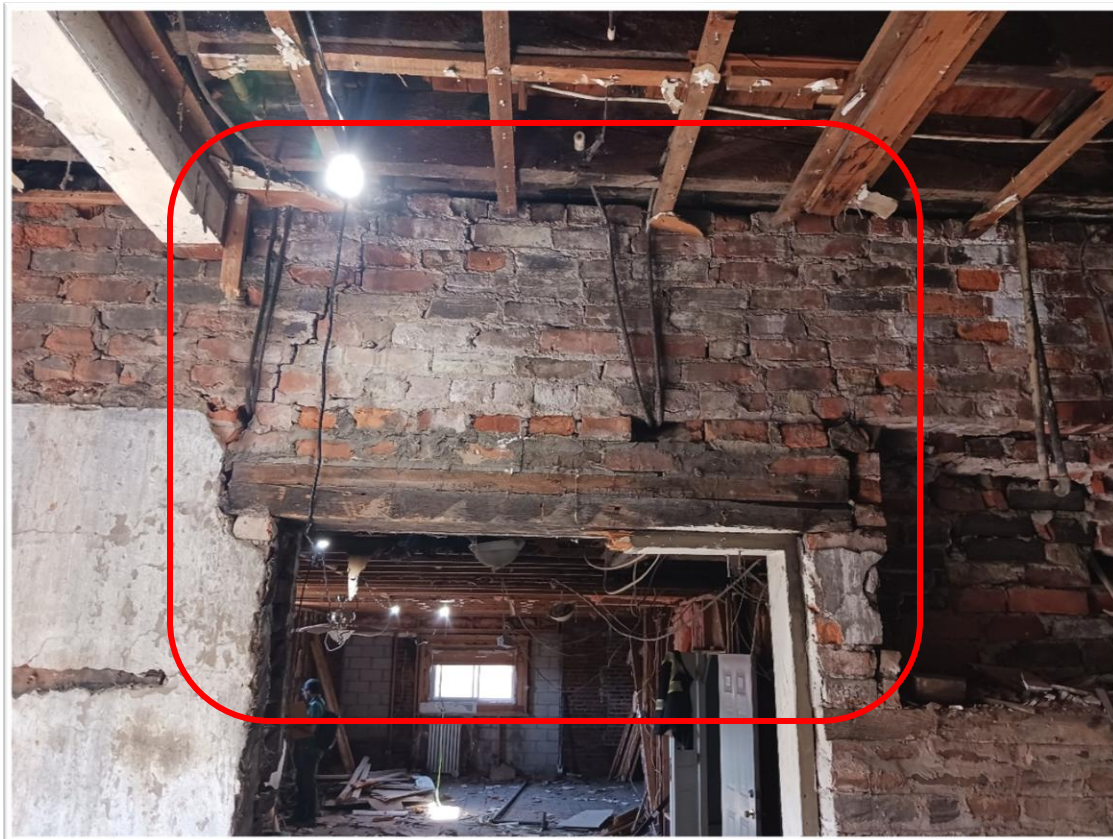
Figure 12: Deflected Lintel with Compromised Supports and Cracked Masonry Wall

Although this is a non-load-bearing wall, its current condition poses a significant risk of localized collapse. The extensive damage to both the lintel and its supports means that the entire section needs to be demolished and rebuilt to restore structural integrity. Proper reconstruction with a reinforced lintel and stable bearing conditions will ensure long-term durability and prevent further structural instability.

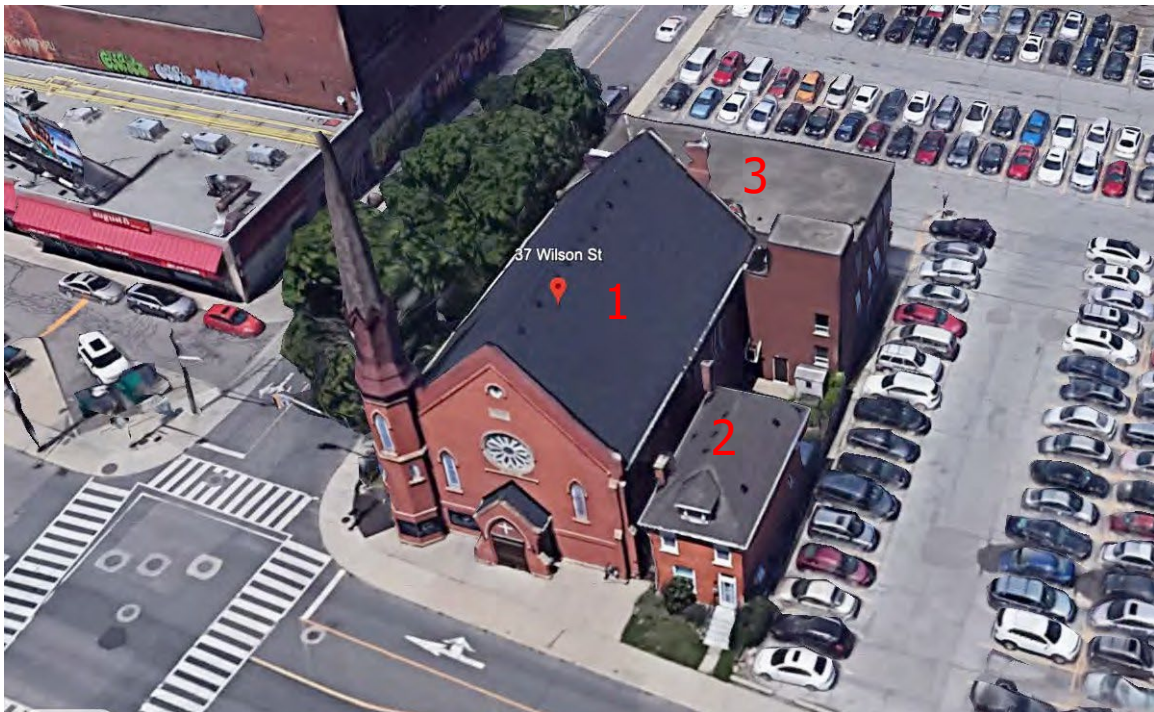
AERIAL VIEW – Google earth photo taken before condo construction to the east and north of the church

1 1867 Church 2 1902 Caretaker's House 3 1969 Rear Addition

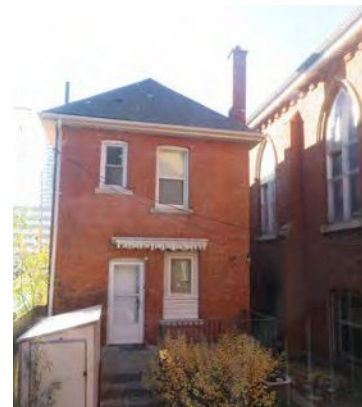
Caretaker's House (1902) – proposed for demolition to accommodate the proposed addition

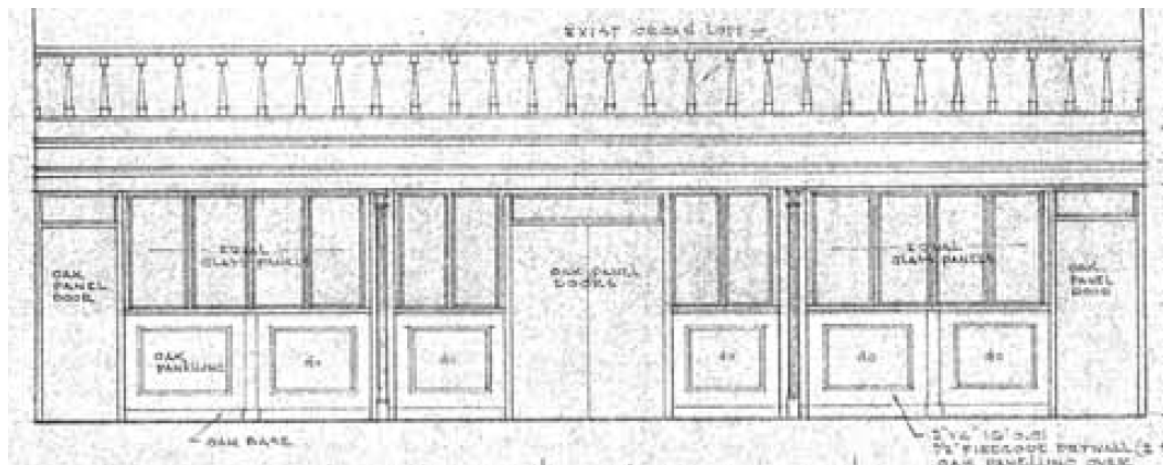
1991 partition wall at the south end of the Sanctuary designed by James Christie that is proposed for removal

Minor changes will be made to the interior of the Sanctuary. The oak and glass partition wall at the south end of the Sanctuary that was installed in 1991 will be removed to enlarge the Sanctuary space. The existing passenger lift in this area will be removed since it will be replaced by a new elevator in the addition.

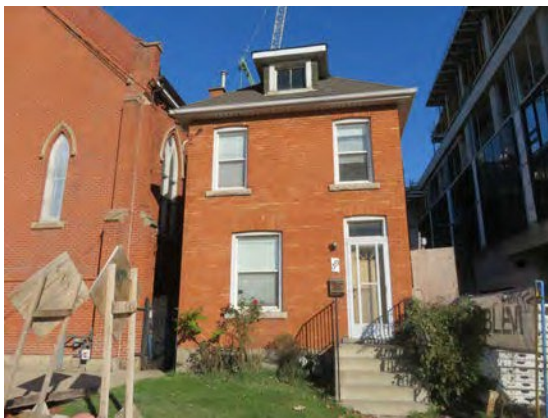
The brick dwelling located in the east side yard of the church must be demolished to accommodate the proposed addition. It was originally constructed by the congregation in 1902 as the Caretaker's Residence and is a modest brick structure with a square plan and a hipped roof.

The Caretaker's House (1902) in the east side yard must be demolished to accommodate the proposed addition

Negative impacts associated with the proposed demolition of the Caretakers' House at 39 Wilson Street are minor and can be mitigated through documentation and salvage. This building has been documented and potential salvage items have been identified in the photo-documentation provided in Appendix B: Photo Documentation. No further mitigation is required. The applicant is encouraged to remove the recommended salvage items prior to demolition, if feasible.

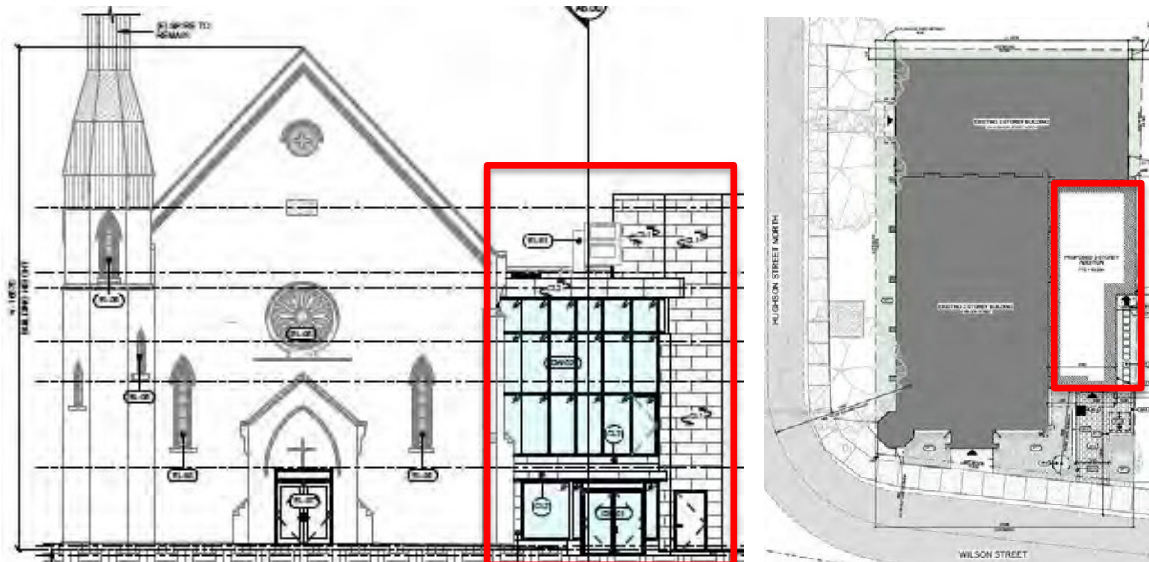
Proposed Addition on the east side of the Church – glazed front wall and new landscaping on Wilson Street – interior space in the addition is organized around an atrium to minimize impacts on the east wall of the Church – skylights in the roof will provide natural light to illuminate the stained glass windows in the atrium

and the entrance will be fully accessible. The addition will contain a new elevator that will service the two levels of the Church and the three levels of the new addition.

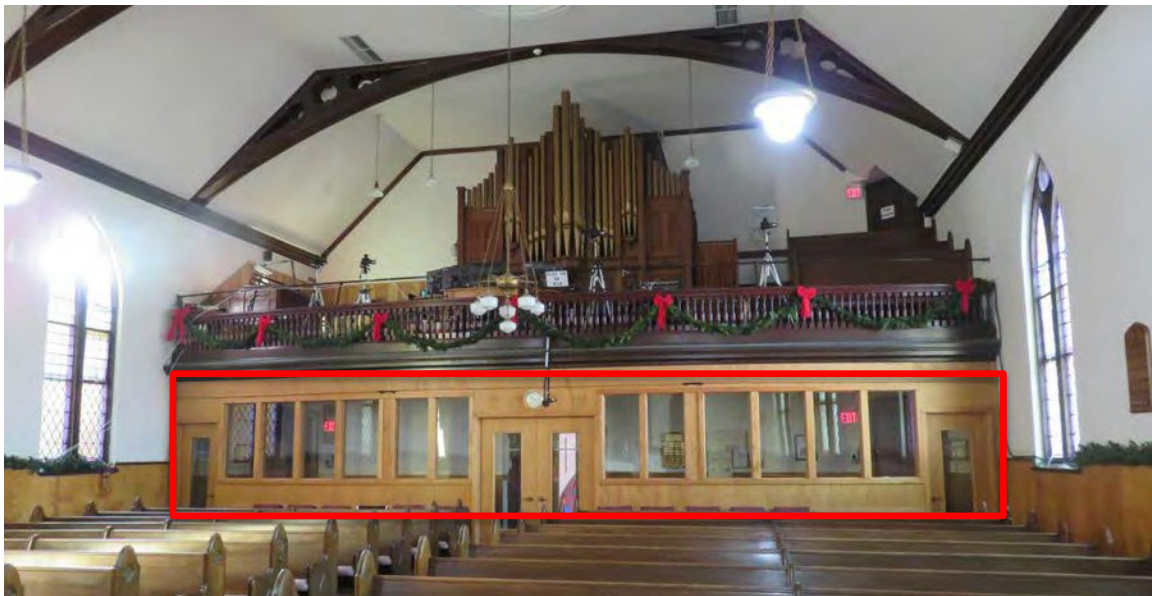
Proposed Interior Alterations to the Sanctuary - partition wall installed in 1991 to be removed – Gallery to remain

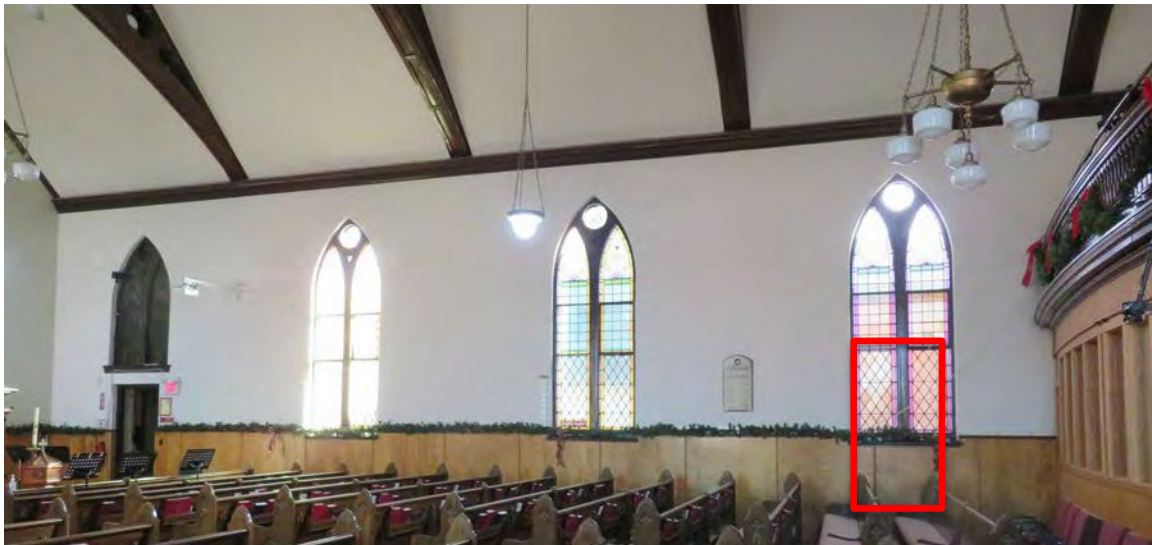
East wall of the Church – the stained-glass window in Bay 2 must be modified for a doorway into the proposed addition.

There will be direct impacts to one of the 1908 stained-glass windows in the east wall of the Sanctuary that is a heritage attribute. The lower portion must be removed so that a new doorway can be installed. Negative impacts can be mitigated by preserving the upper portion *in situ* and by salvaging and reusing any glass that is removed. The salvaged glass can be reused either as a feature in the new addition or for use as a repair material for any windows that require repairs. This work should be undertaken by a stained-glass expert.

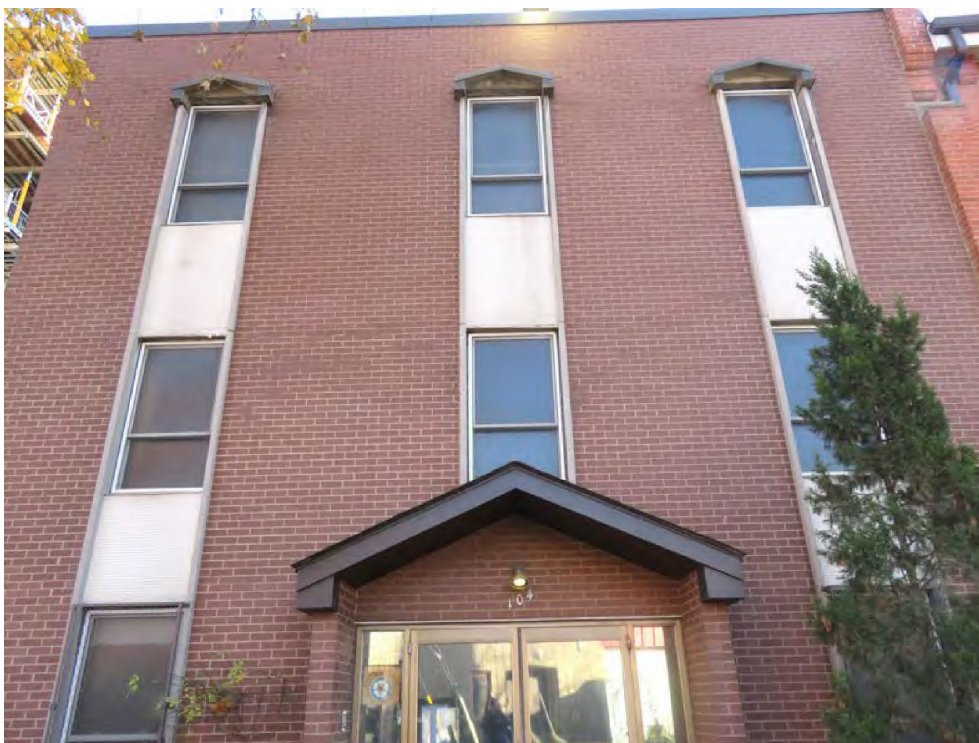
1969 Sunday School Addition that replaced the attached 1867 Parsonage – the original windows have been replaced – cladding has been installed on top of the concrete window caps and above the door – the trim framing the window bays is Queenston limestone

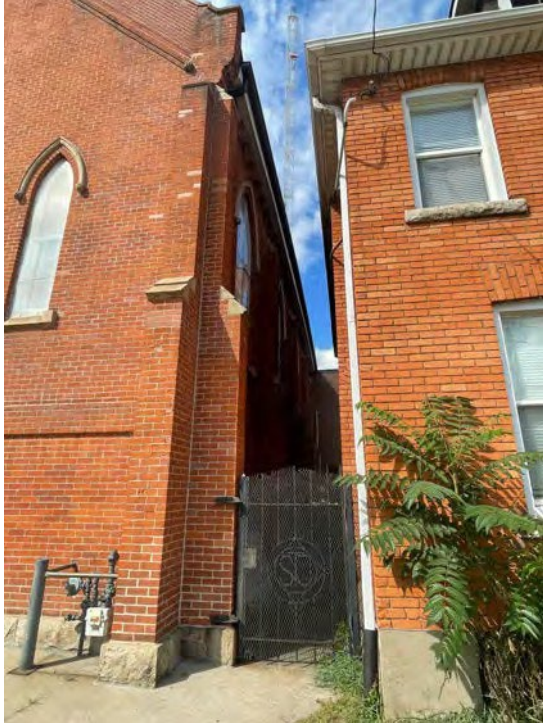
Narrow gap between the Church & Caretaker's House

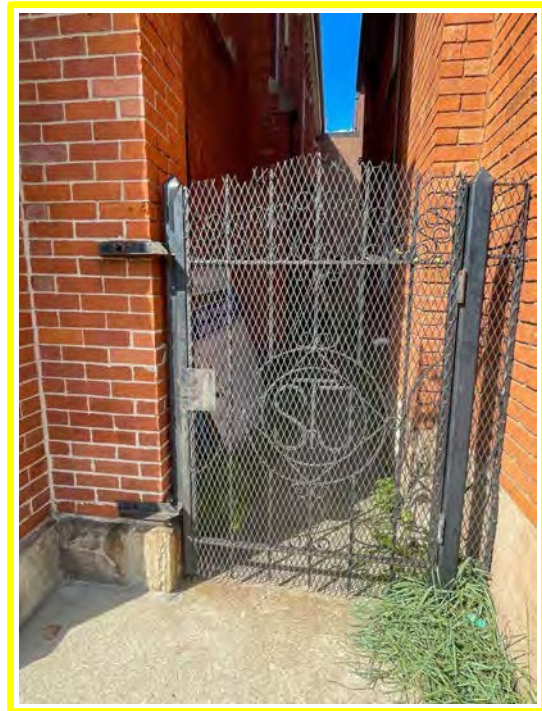
Iron gate with "STJ" (St. John's)
POTENTIAL SALVAGE ITEM

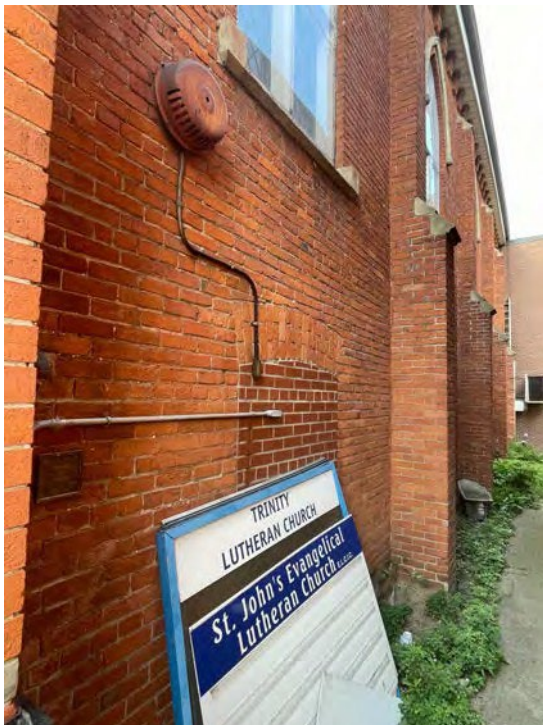
East wall of the Church – basement window infilled

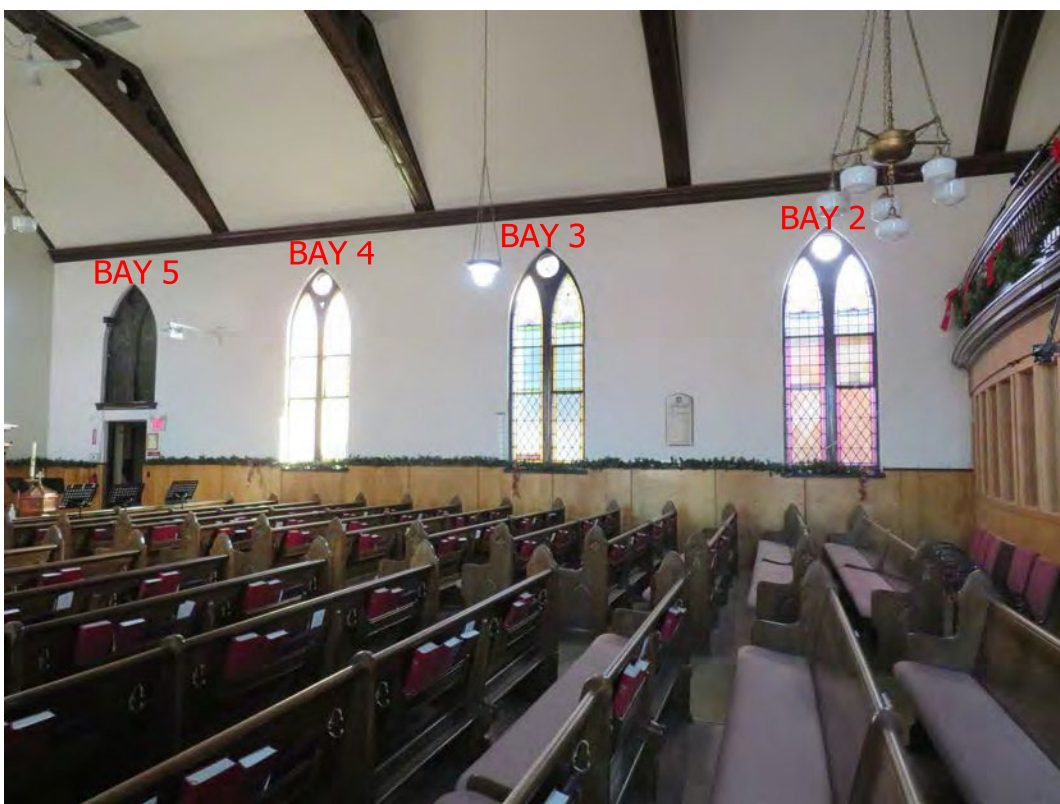
Church Interior – Sanctuary east wall – existing doorway into the rear addition in Bay 5 – a similar modification will be made to the window in Bay 1

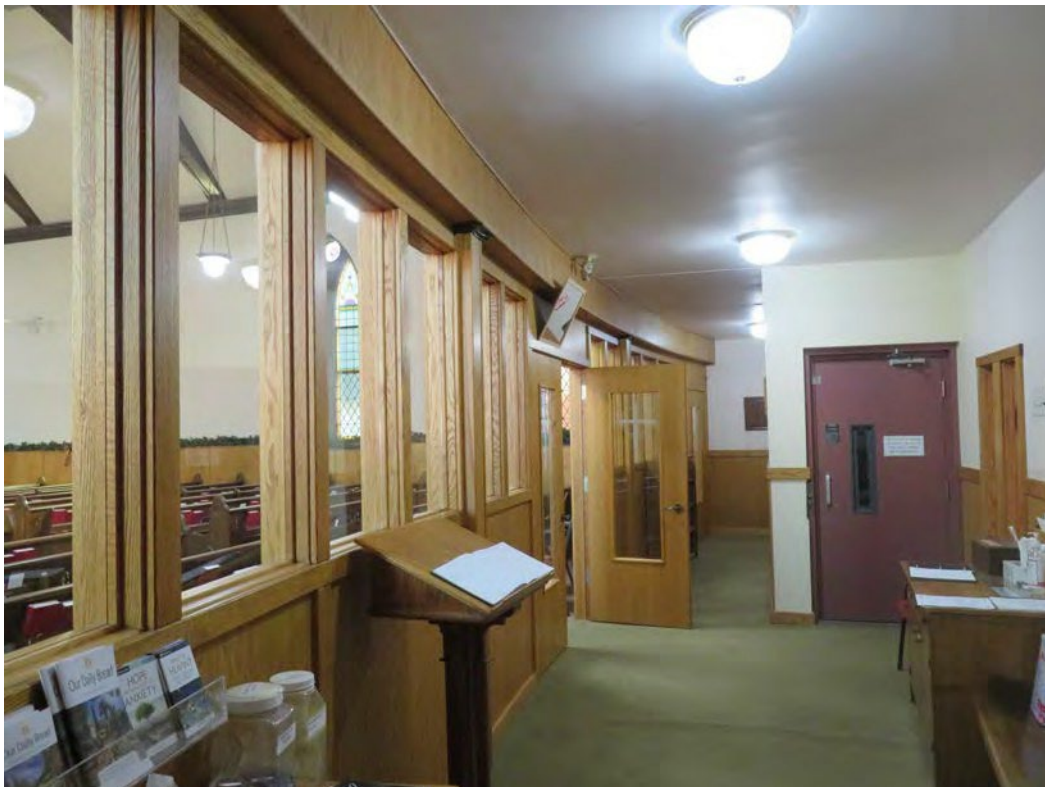
Church Interior – below the Gallery – oak partition wall & elevator installed in 1991 to be removed

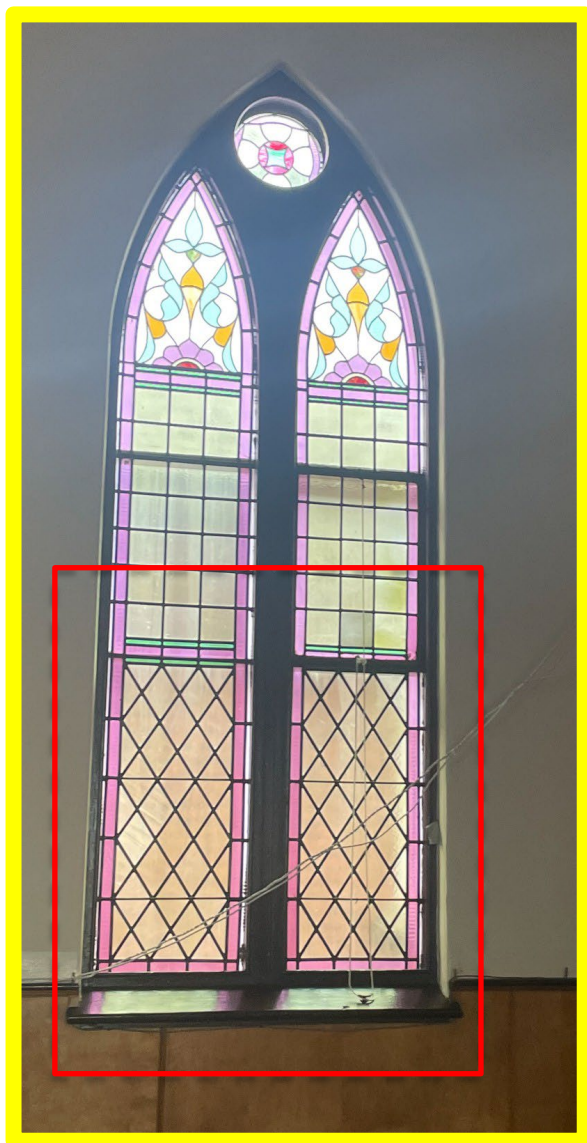
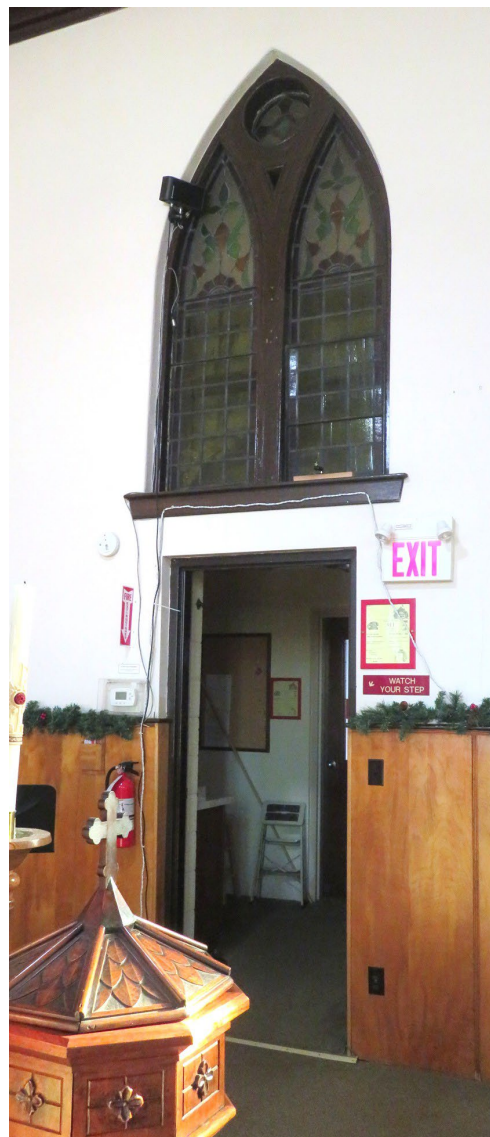
Church interior – Sanctuary east wall – stained-glass windows in Bays 1, 2, 3 & 4 (left) – there is a door in Bay 5 with stained glass above that matches the other windows

RECOMMENDED MITIGATION: salvage stained-glass from window to be modified for new doorway – work to be undertaken by stained-glass expert

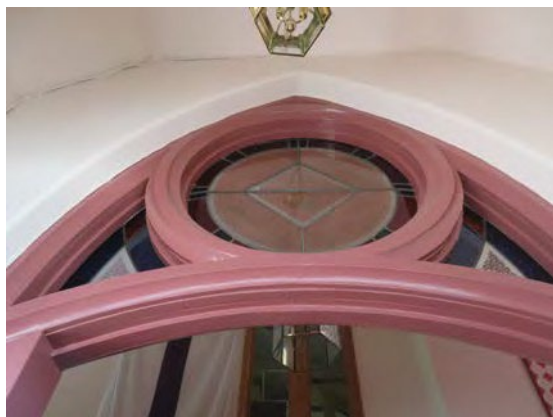
Church interior – small Vestibule inside the Front Entrance on Wilson Street – doorway and arched transom with stained glass – *arch and stained-glass transom are heritage attributes to be preserved *in situ*

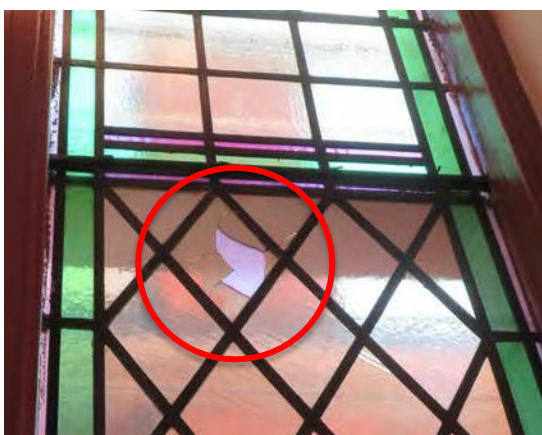
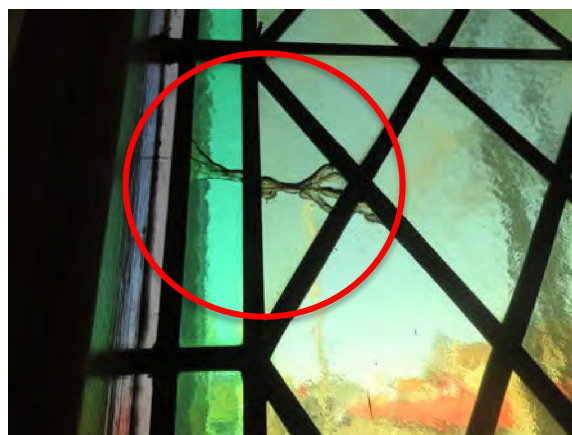
Church Interior – damaged 1908 stained-glass windows in the east (left) and west (right) side elevations

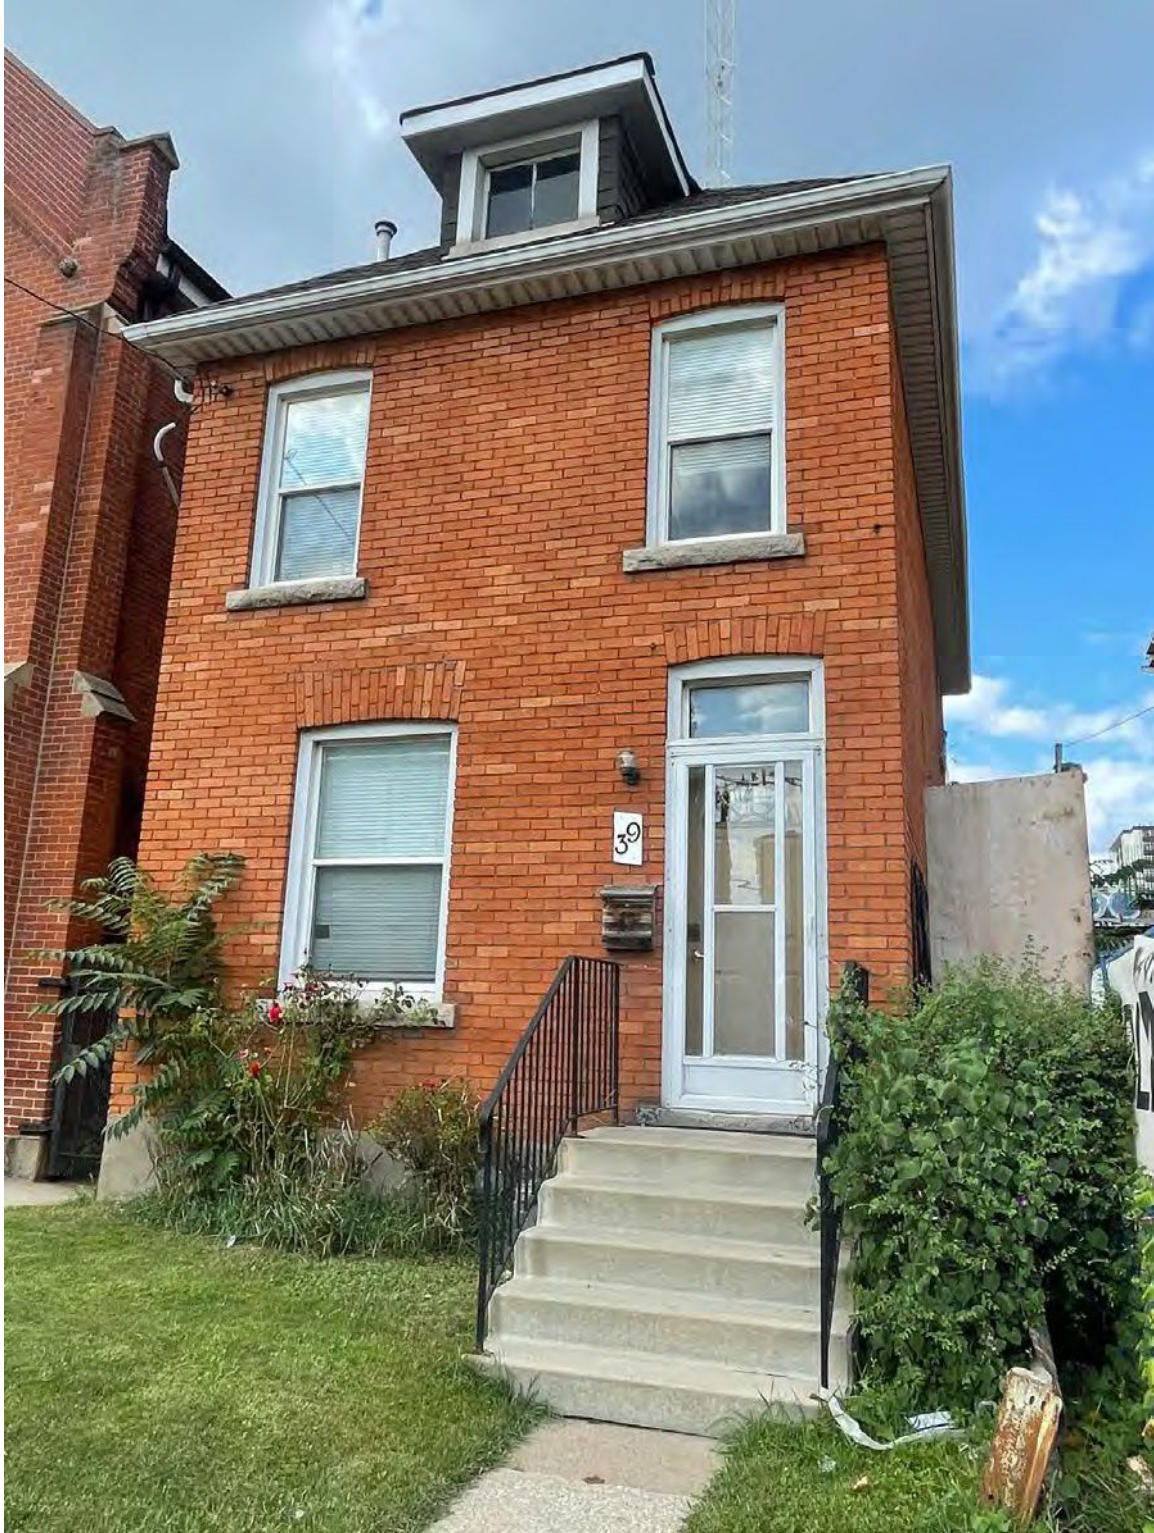
1902 Caretakers House, 39 Wilson Street – brick veneer – windows and doors have brick arches and cut stone sills – doors and windows have been replaced and concrete stairs have been installed at the front entrance on Wilson Street – foundation is parged

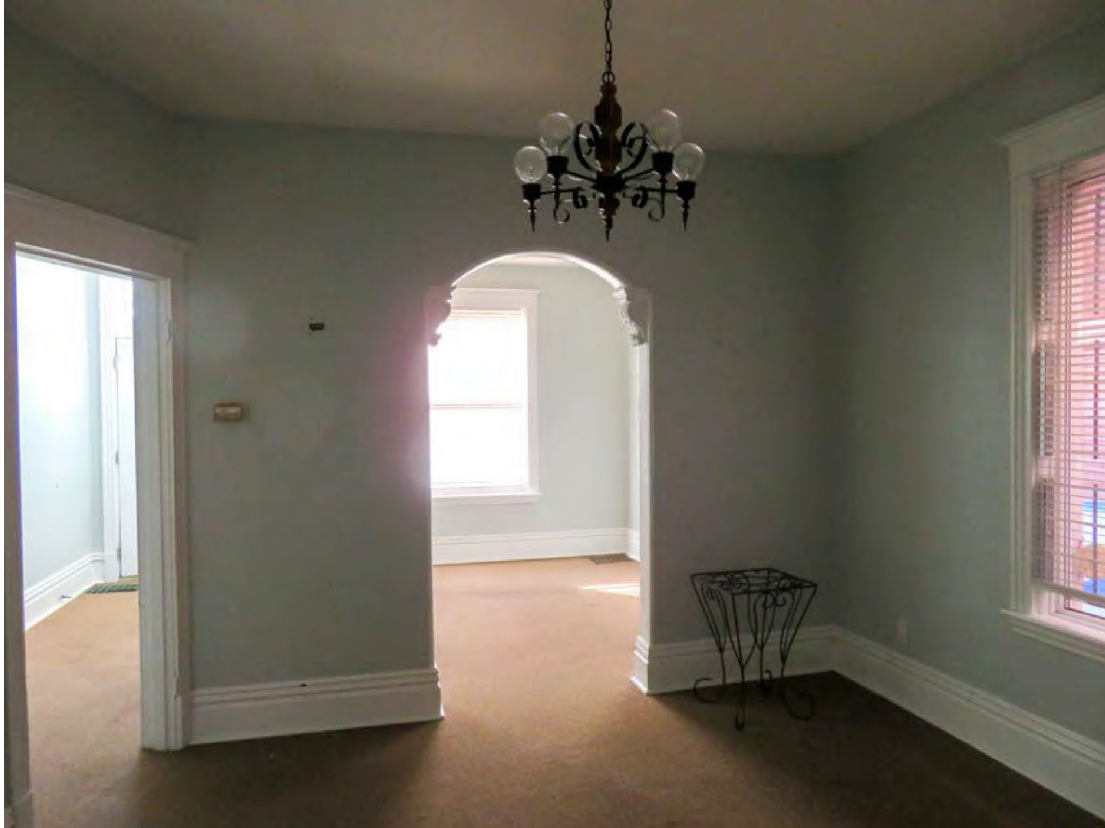
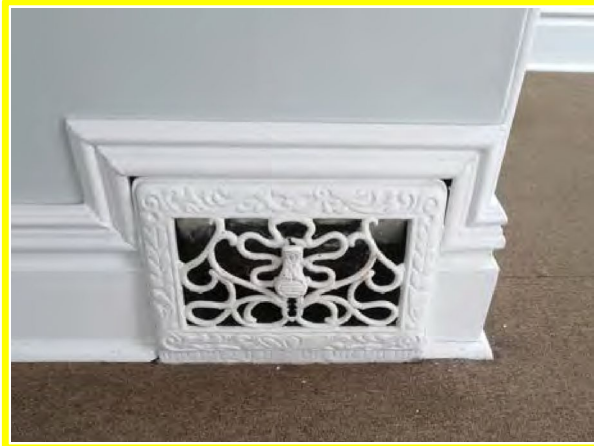
1902 Caretaker's House – interior – 1st floor – the front room has two arched openings with ornate scrolls – the ornate heat vent covers are original

POTENTIAL SALVAGE ITEMS: metal vent covers & decorative wall brackets

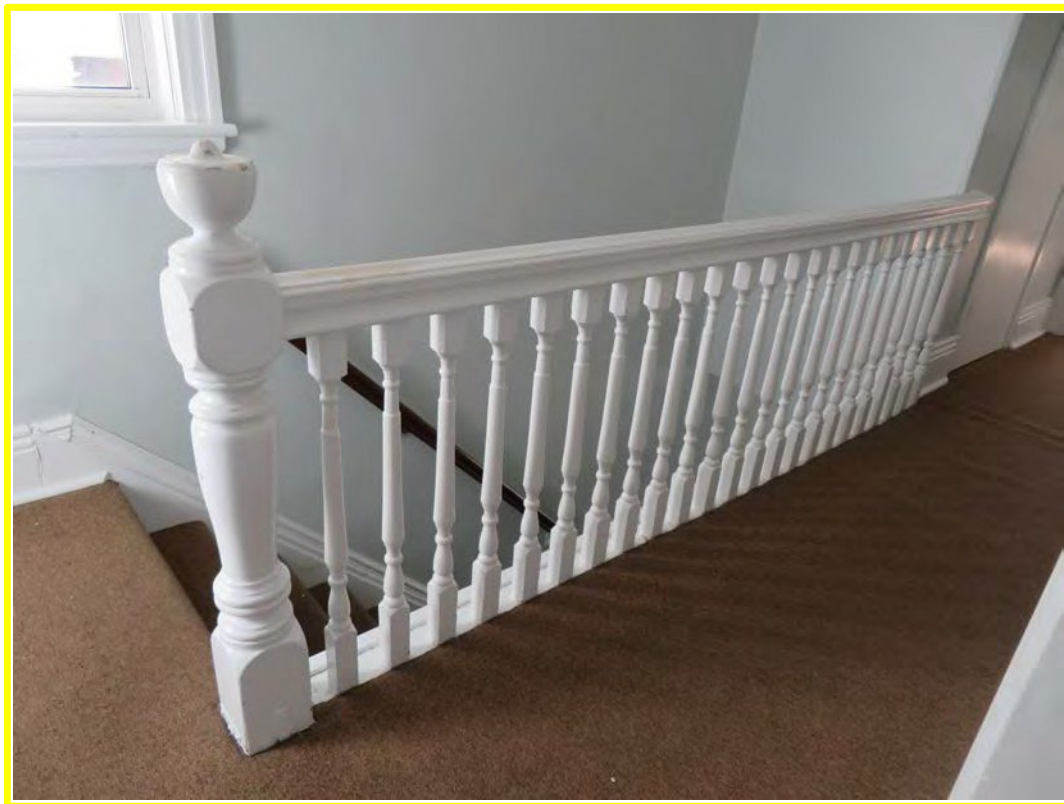
1902 Caretaker's House - original stair railing and newel post in the upstairs hallway

POTENTIAL SALVAGE ITEMS: stair newel, handrail & balusters

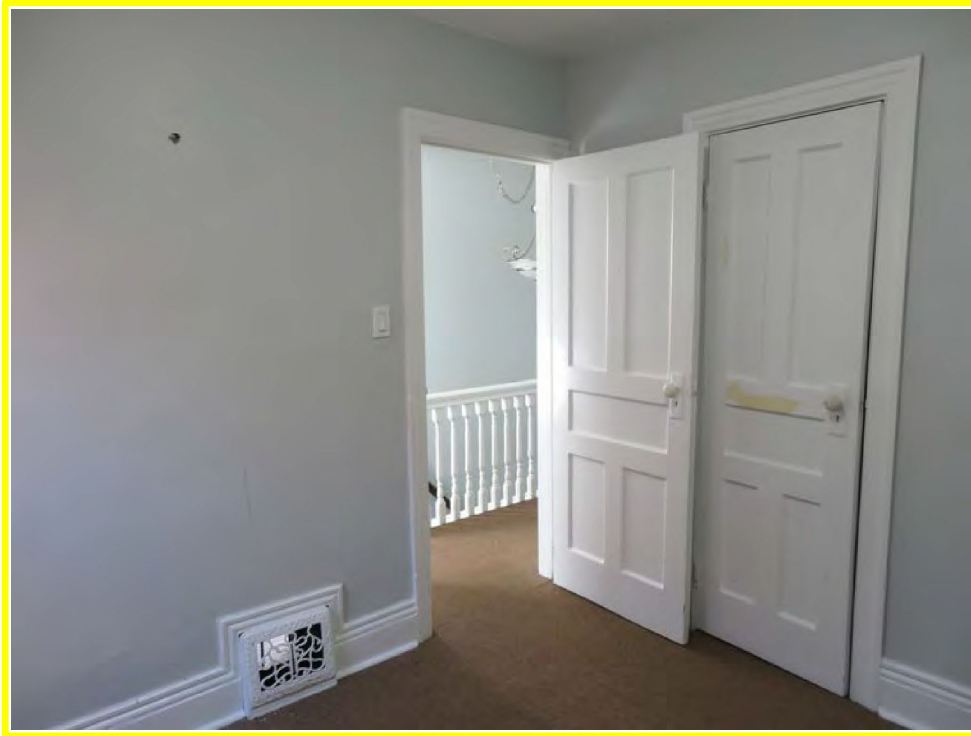
1902 Caretaker's House – interior – 2nd floor – original doors and vent covers

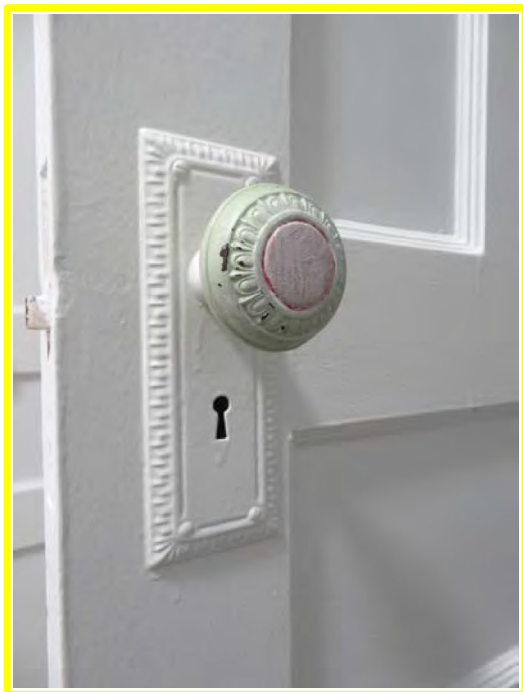
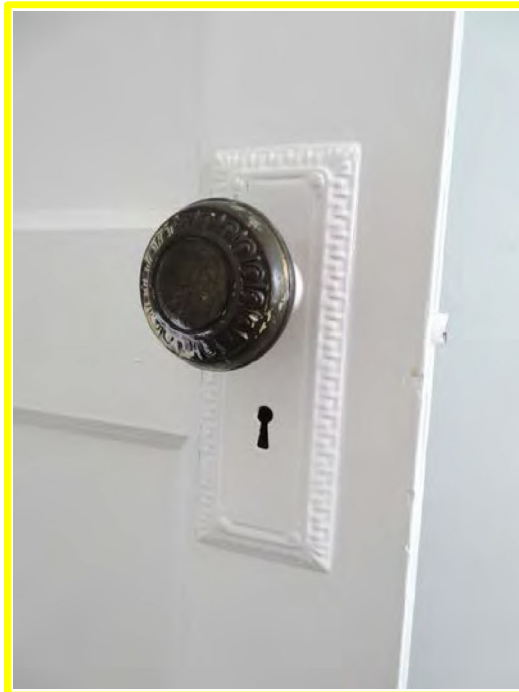
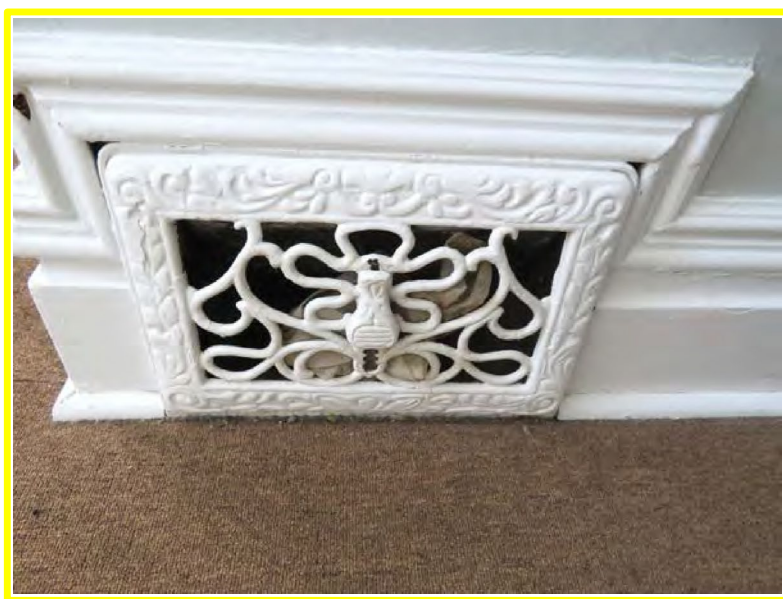
1902 Caretaker's House – interior – 2nd floor – original door hardware and vent covers

POTENTIAL SAVLAGE ITEMS: door hardware & decorative metal vent covers

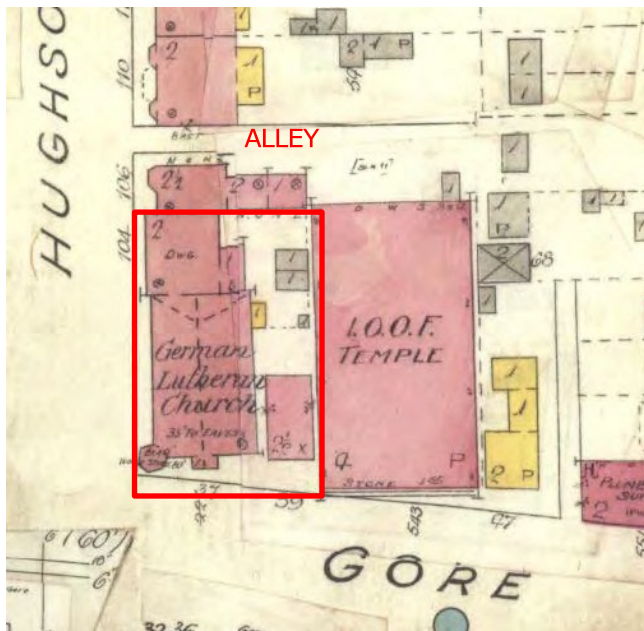
1911 FIRE INSURANCE PLAN, SHEET 16

- the Odd Fellows Hall next door on Wilson Street is now a warehouse with shipping entrance on Hughson
- the house next door on Hughson Street has been demolished & replaced by a loading dock
- the street address is #37-39 Gore Street and 104 Hughson Street North
- identified as St. Paul's Evangelical Lutheran Church
