# City of Hamilton HAMILTON MUNICIPAL HERITAGE COMMITTEE REVISED

Meeting #: 25-005

**Date:** April 25, 2025

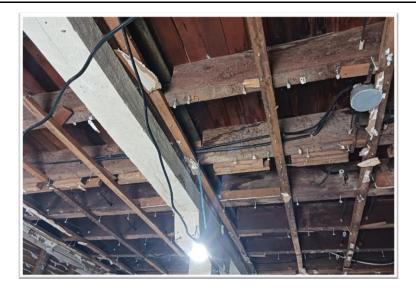
Figure 5: Compromised Joists Due to Top Cuts for Plumbing Installation

To restore structural integrity, proper reinforcement of the cut joists is necessary, either by installing sister joists or other structural strengthening measures. Without intervention, the weakened second-floor joists increase the likelihood of progressive structural failure.

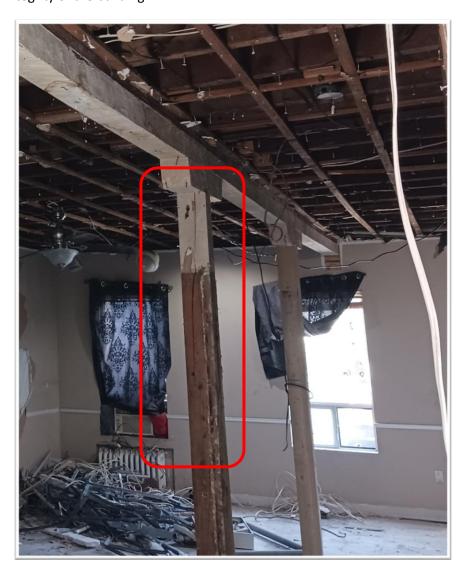
Figure 11: Cracked Structural Column

To prevent future failure, reinforcement or replacement of the column should be considered. If reinforcement is pursued, methods such as steel plate wrapping or bolted splints could be used to improve the column's load-bearing capacity and prevent further cracking. However, if the crack continues to grow and significantly compromises the column's strength, complete replacement will be necessary to ensure the structural integrity of the building.

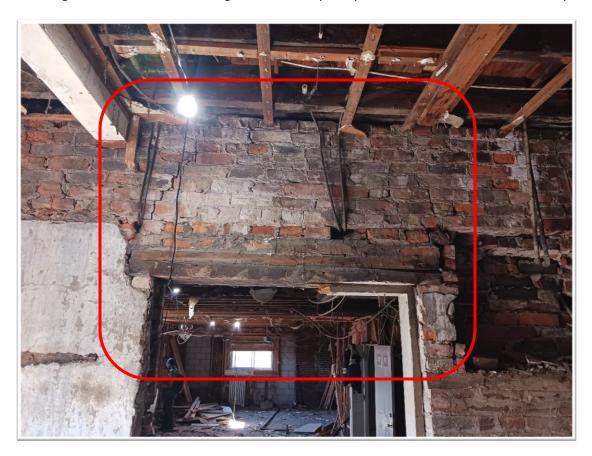
Figure 12:Deflected Lintel with Compromised Supports and Cracked Masonry Wall

Although this is a non-load-bearing wall, its current condition poses a significant risk of localized collapse. The extensive damage to both the lintel and its supports means that the entire section needs to be demolished and rebuilt to restore structural integrity. Proper reconstruction with a reinforced lintel and stable bearing conditions will ensure long-term durability and prevent further structural instability.

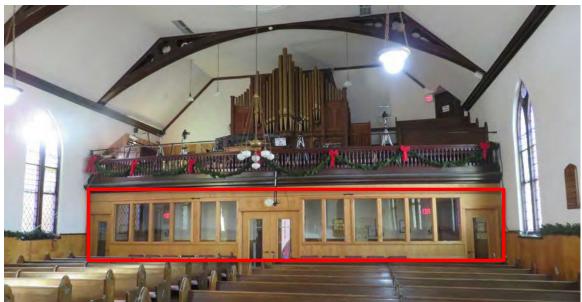
Proposed Interior Alterations to the Sanctuary - partition wall installed in 1991 to be removed - Gallery to remain

Minor changes will be made to the interior of the Sanctuary. The oak and glass partition wall at the south end of the Sanctuary that was installed in 1991 will be removed to enlarge the Sanctuary space. The existing passenger lift in this area will be removed since it will be replaced by a new elevator in the addition.

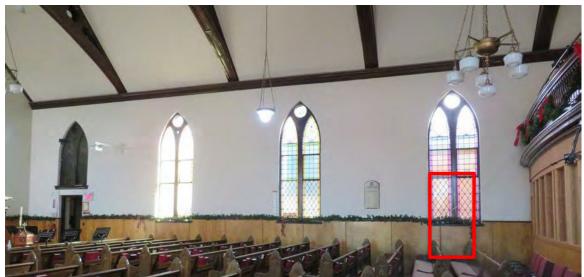
East wall of the Church – the stained-glass window in Bay 2 must be modified for a doorway into the proposed addition.

There will be direct impacts to one of the 1908 stained-glass windows in the east wall of the Sanctuary that is a heritage attribute. The lower portion must be removed so that a new doorway can be installed. Negative impacts can be mitigated by preserving the upper portion *in situ* and by salvaging and reusing any glass that is removed. The salvaged glass can be reused either as a feature in the new addition or for use as a repair material for any windows that require repairs. This work should be undertaken by a stained-glass expert.

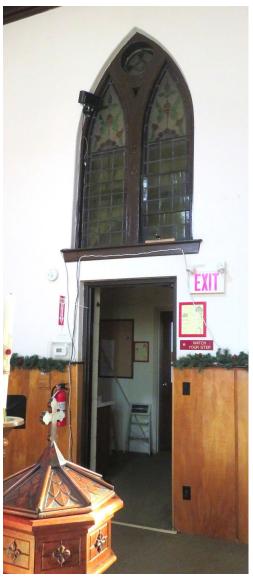
Church interior – Sanctuary east wall – stained-glass windows in Bays 1, 2, 3 & 4 (left) – there is a door in Bay 5 with stained glass above that matches the other windows

RECOMMENDED MITIGATION: salvage stained-glass from window to be modified for new doorway – work to be undertaken by stained-glass expert

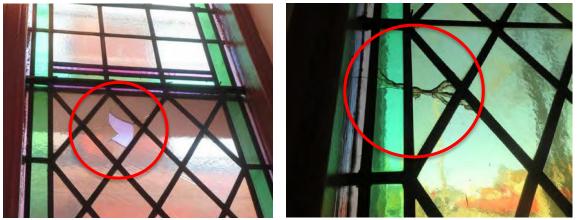
Church Interior – damaged 1908 stained-glass windows in the east (left) and west (right) side elevations

RECOMMENDED MITIGATION: stained glass expert to assess condition of stained-glass windows in East wall and provide protection measures

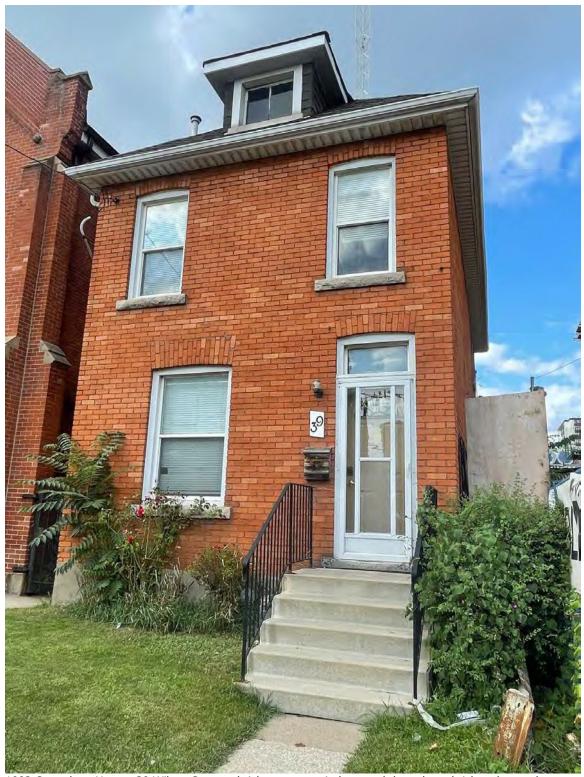
1902 Caretakers House, 39 Wilson Street – brick veneer – windows and doors have brick arches and cut stone sills – doors and windows have been replaced and concrete stairs have been installed at the front entrance on Wilson Street – foundation is parged
