**City of Hamilton**  
**HERITAGE PERMIT REVIEW SUB-COMMITTEE**  
**AGENDA**

**Date:** July 15, 2025

| 9.1 | HP2025-022 - 55 Main Street West, Hamilton (Former Hamilton Carnegie Building, Part IV) | 13 |
| 9.3 | HP2025-025 - 47 James Street South, Hamilton (Landed Bank and Loan Company Building, Part IV) | 79 |

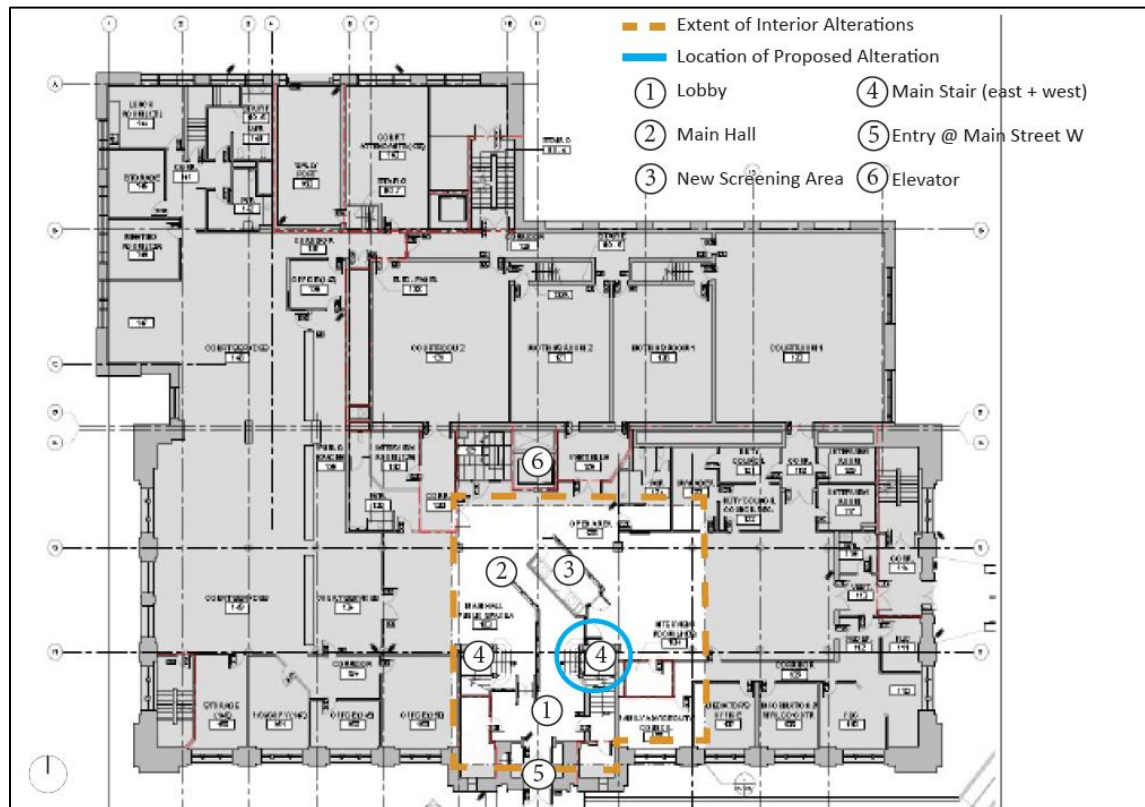
Figure 2: Main Floor Plan showing the location of the proposed alterations to the interior west marble stairs.

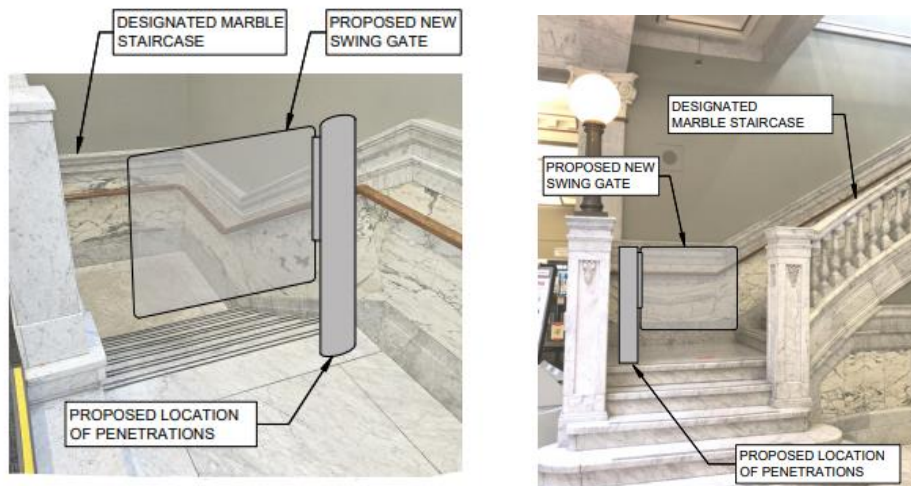
Figure 3: Mock-ups showing proposed locations of the top and bottom swing gates.

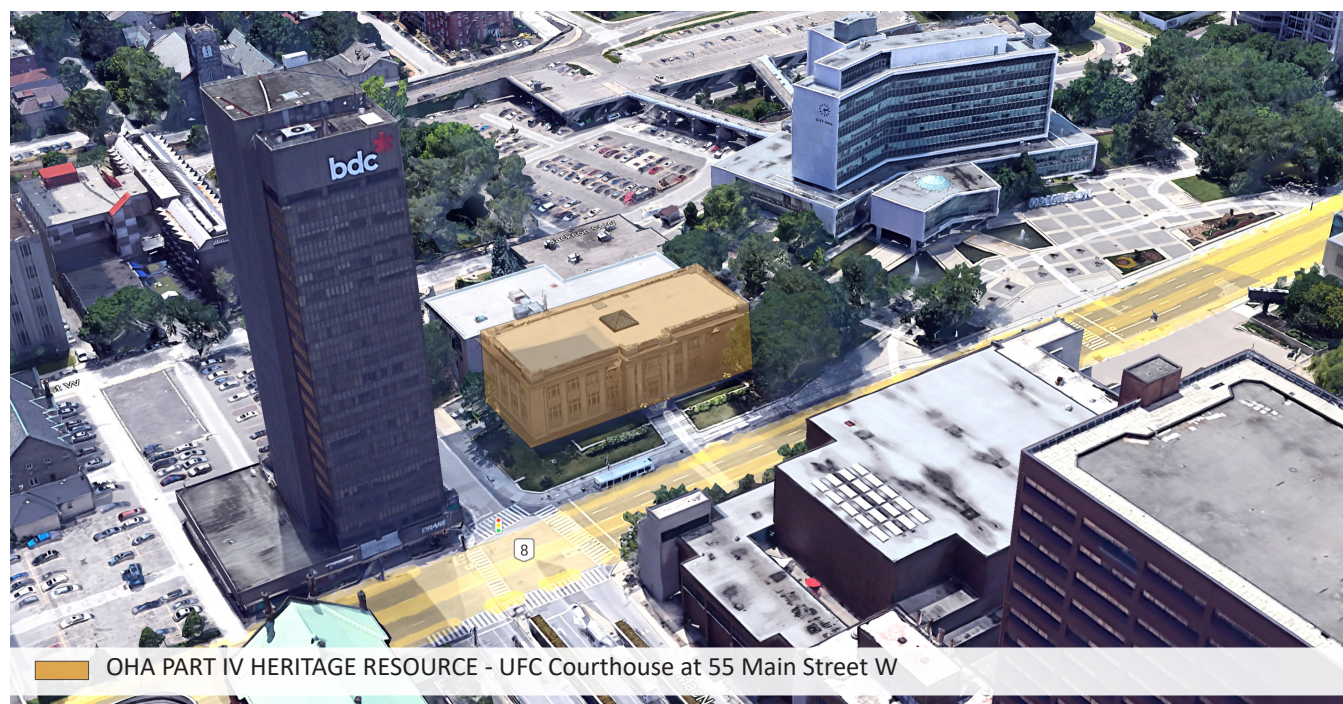
Image 3.2: 55 Main Street W, Hamilton, 3D Map, Google Images, March 2022.

The UFC Courthouse's 2-storey gray limestone facade creates a strong and imposing presence along Main Street W and MacNab Street S. The smooth ashlar facade runs up the two storeys where it terminates with a strong horizontal band. This prominent 'base' becomes more pronounced with the middle grand entrance off of Main Street W centered between the tall window bays along the street-facing facade. The deep recessed windows are set in between vertically fluted limestone pilasters. The building massing is of a monumental public scale, reinforcing the urban streetscape of Hamilton's downtown core.

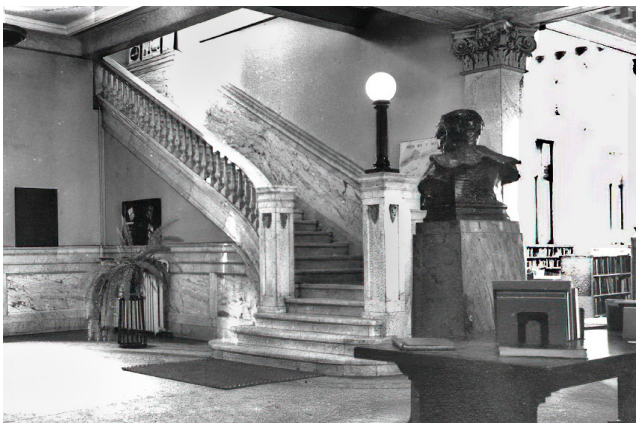
Image 3.9: Archive photo of Main Hall interior at east stair showing original floor which appears to be mosaic.

The floors at the Main Hall and Lobby are finished in a carrara marble tile which has a white body with grey veining. This flooring appears not to be original to the building and was more likely a part of a previous renovation, the marble selected to match the existing marble stairs, columns and pilasters. Historical images of the Main Hall appear to show a mosaic tile floor (refer to images #3.5 & 3.6 in Section 3.3).

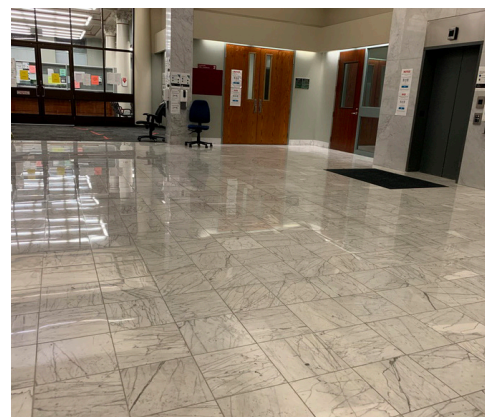
Image 3.11: Interior view of marble floors in the Main Hall

Perhaps the most striking elements in this grand space are the two marble staircases which are located at the Lobby space and open to the Main Hall. These stairs provide access to the upper floor to a large atrium space open to below and skylight above, with courtrooms and offices beyond. The marble used for the treads, square newel posts, balusters and balustrades, base and trim banding at the wainscoting is a carrara marble with the inset marble panels of the wainscoting being of a calacatta marble, which has a more white base with dark grey/black veining. Some minor alterations have been made to the double staircases over the years, including the addition of anti-slip tape at the stair nosings and a hand sanitizer unit mounted on the east stair wall.

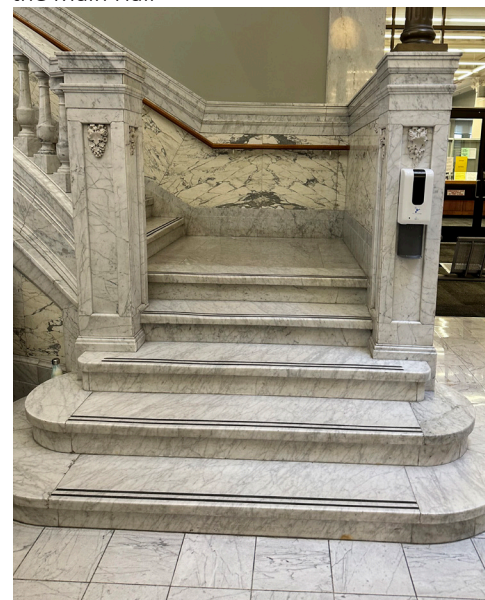
Image 3.12: Interior view of Heritage Stair (east).

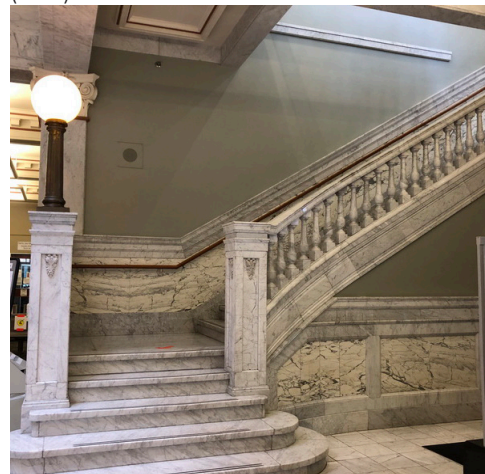
Image 3.13: Interior view of Heritage Stair (west).

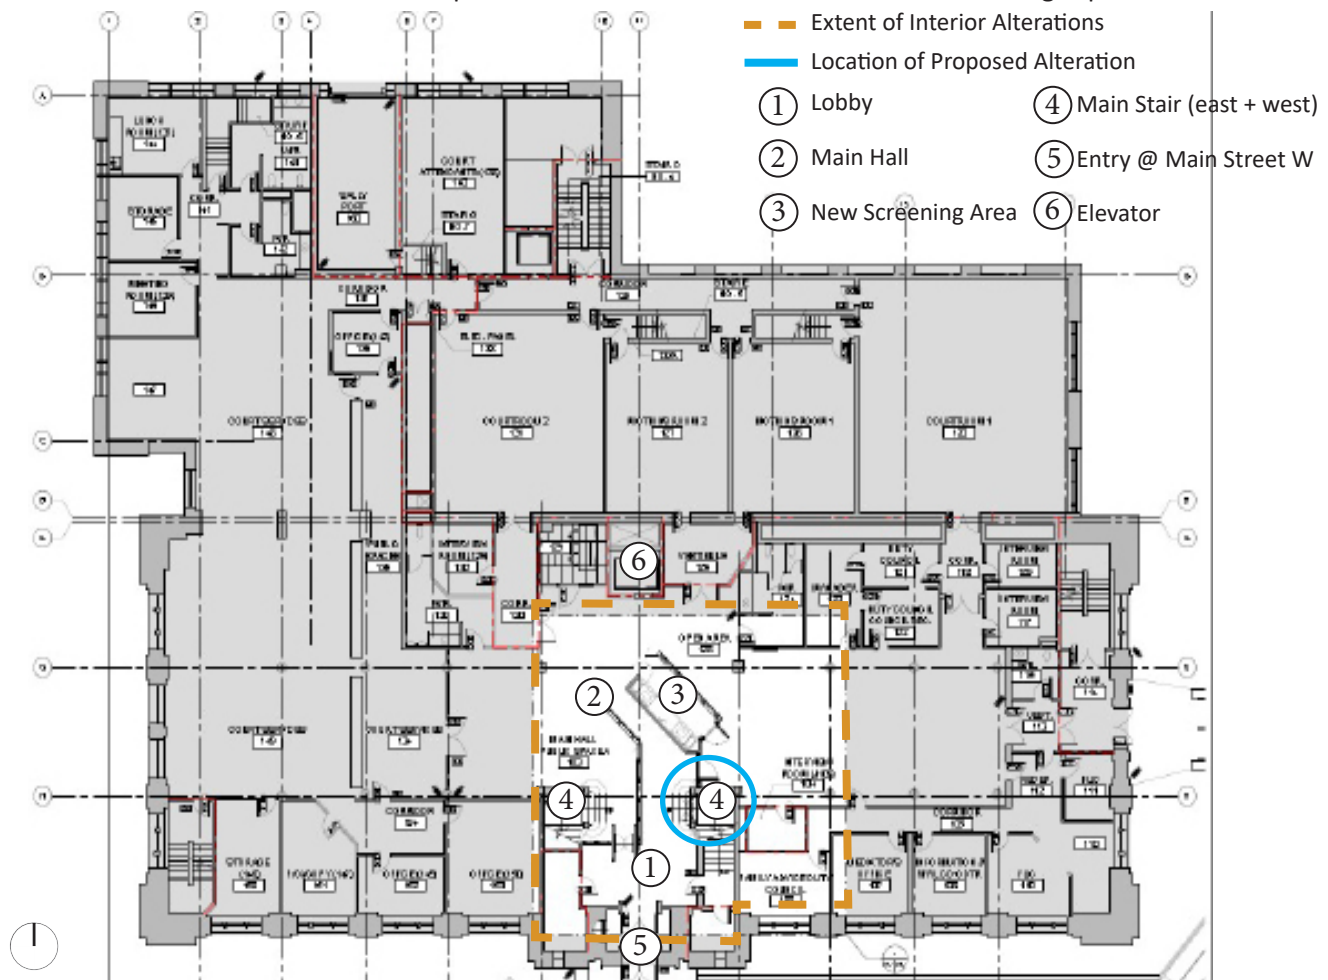
Image4.1: Main Floor Plan- layout by a+LiNK Architecture. Refer to Enlarged Plan in Appendices.

The interior alterations that are proposed in the Main Hall and Lobby Area involve the installation of security screens, gates and screening equipment for the new screening area. The installation of a swing gate at the top and bottom of the west marble stairs is also required to provide the additional security at this area. Due to the necessary renovations to provide the secure entrance for the Courthouse functions, the area to be focused on for this heritage assessment is at the Lobby interior, specifically the original set of marble stairs. Although the proposed renovations involve the addition of a new screening area in the Lobby space, the marble floor tiles in this area are not original to the building and therefore are not included in the heritage assessment. The proposed alterations will have the most direct impact on the west set of marble stairs in this heritage space.

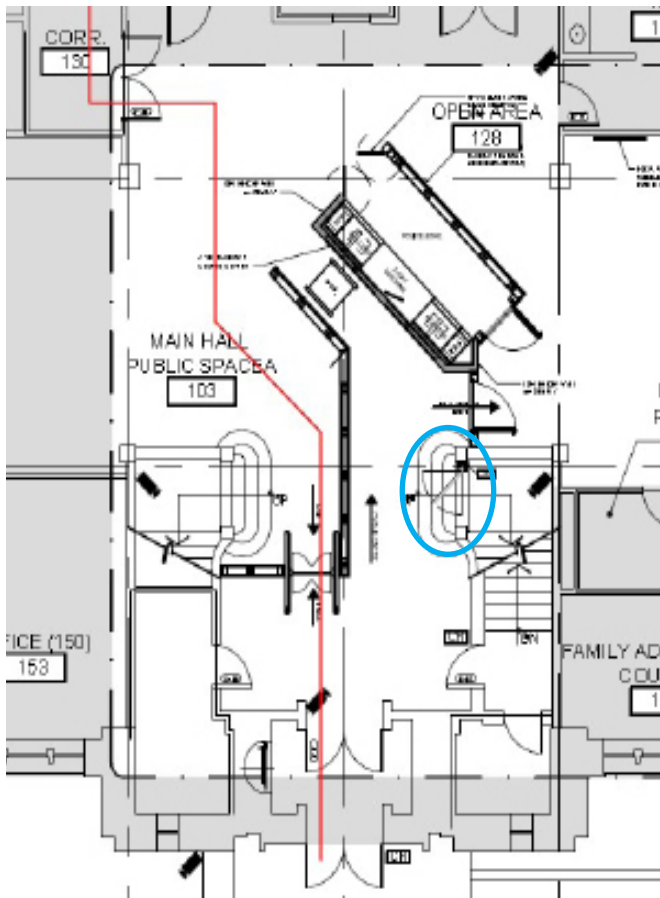
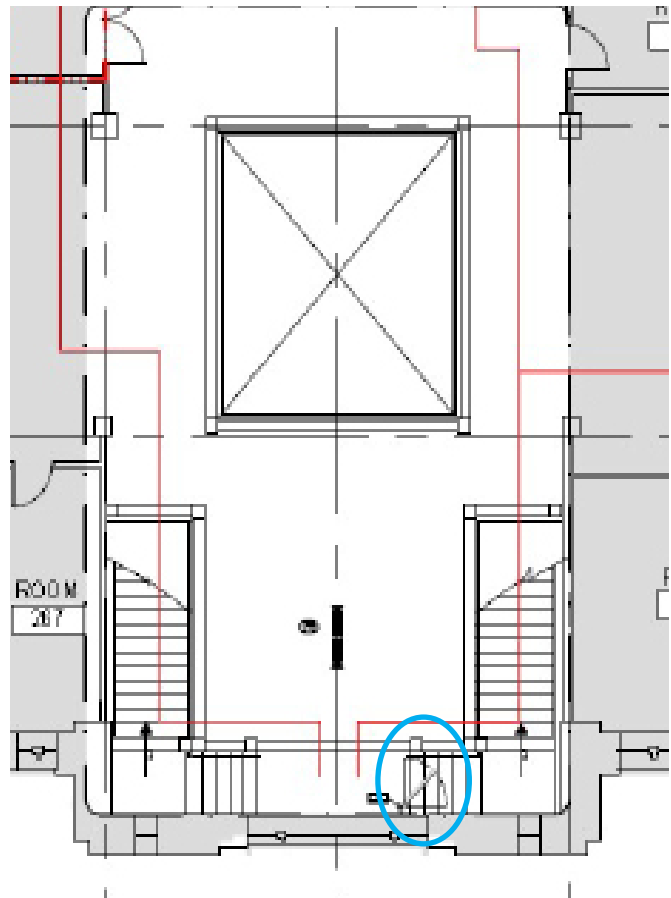
Images 4.2 & 4.3: Partial Main Floor and partial Second Floor plans indicating locations of proposed new swing gates - layouts by a+LiNK Architecture, February 2025

The partial main floor plan identified below (Image 4.2) is the current proposed design that is based on the security requirements of MAG (Enlarged Plan can be found within the Appendices). This layout provides direct access from the existing entry off of Main Street W. through to the screening area from the Lobby area the the Main Hall. The police zone is located in close proximity to the entry to allow for direct sightlines which are required for security to access incoming patrons. The proposed new security screening area has been located centrally in the Main Hall to maximize the visibility though the space, providing the optimal security requirements for MAG. The screening area is protected from the remainder of the space by glass partitions that are connected to anodized posts that are anchored to the floor. These posts require four (4) anchor bolts in order to securely and structurally anchor them to the floors. If required, these posts may be removed in the future with minimal disruption to the existing space. Being that the existing marble tiles at the Lobby area not identified heritage attributes, the direct physical impacts by the proposed alterations to the floors in this area are not included in this report.

Additional security is provided via a turnstile swing gate that is located at the top and bottom of the west stair. The lower gate is to be located at the edge of the stair landing while the top gate is to be at the first tread at the top of the stair. These single-swing gates are required to restrict public access up these stairs from the Lobby while allowing exiting down through the stair in the case of an emergency. Due to the concern for possible damage to the existing marble staircase, several options were explored in order to minimize the number of penetrations through the marble. These are described in Section 5 of this report.

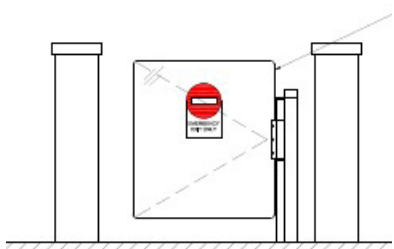
Image 4.5b: Drawing of the new swing gate at the top of the west stair.

The 168mm diameter gate post would be mounted on the marble step with a small vertical gap which would provide enough clearance from the face of the newel post to protect the marble finish and carved detail. The single gate panel is of a thick acrylic material, fastened to the cylindrical stainless steel post. It is the intention of this selection that the materiality of the post and the translucency of the gate panel result in minimal visual impact at the marble heritage stair.

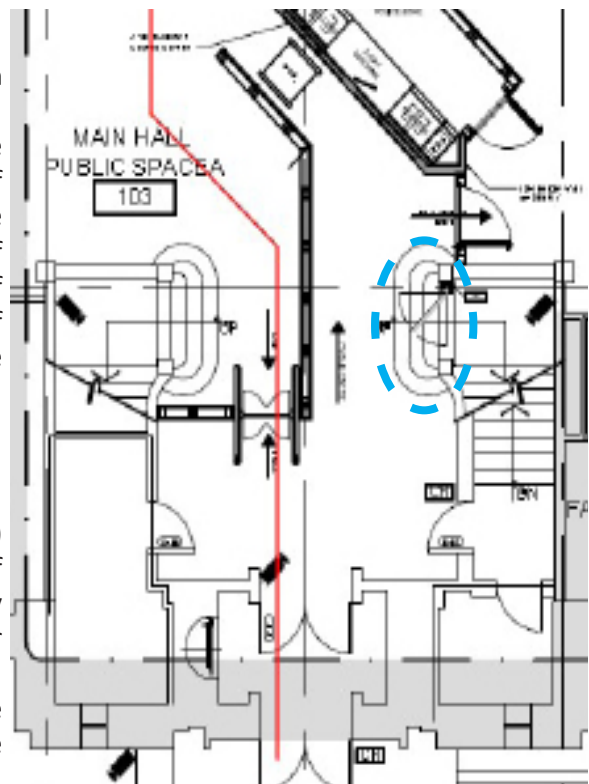
Image 8.1: Partial Ground Floor plan showing Alternate Option 1 layout, by a+LiNK Architecture.

An alternate option would be to place moveable (unattached) stanchions with retractable bands at the top and bottom of the stair to limit access. Although this would not require any penetrations to the marble treads, this would also pose a major risk to public safety, with potential threats to security, staff and courtroom spaces on the upper floor by not providing a more secure method of restricted access. An added risk would be the possibility of the moveable stanchion being used as a weapon which could result in potential bodily harm to the public or staff.

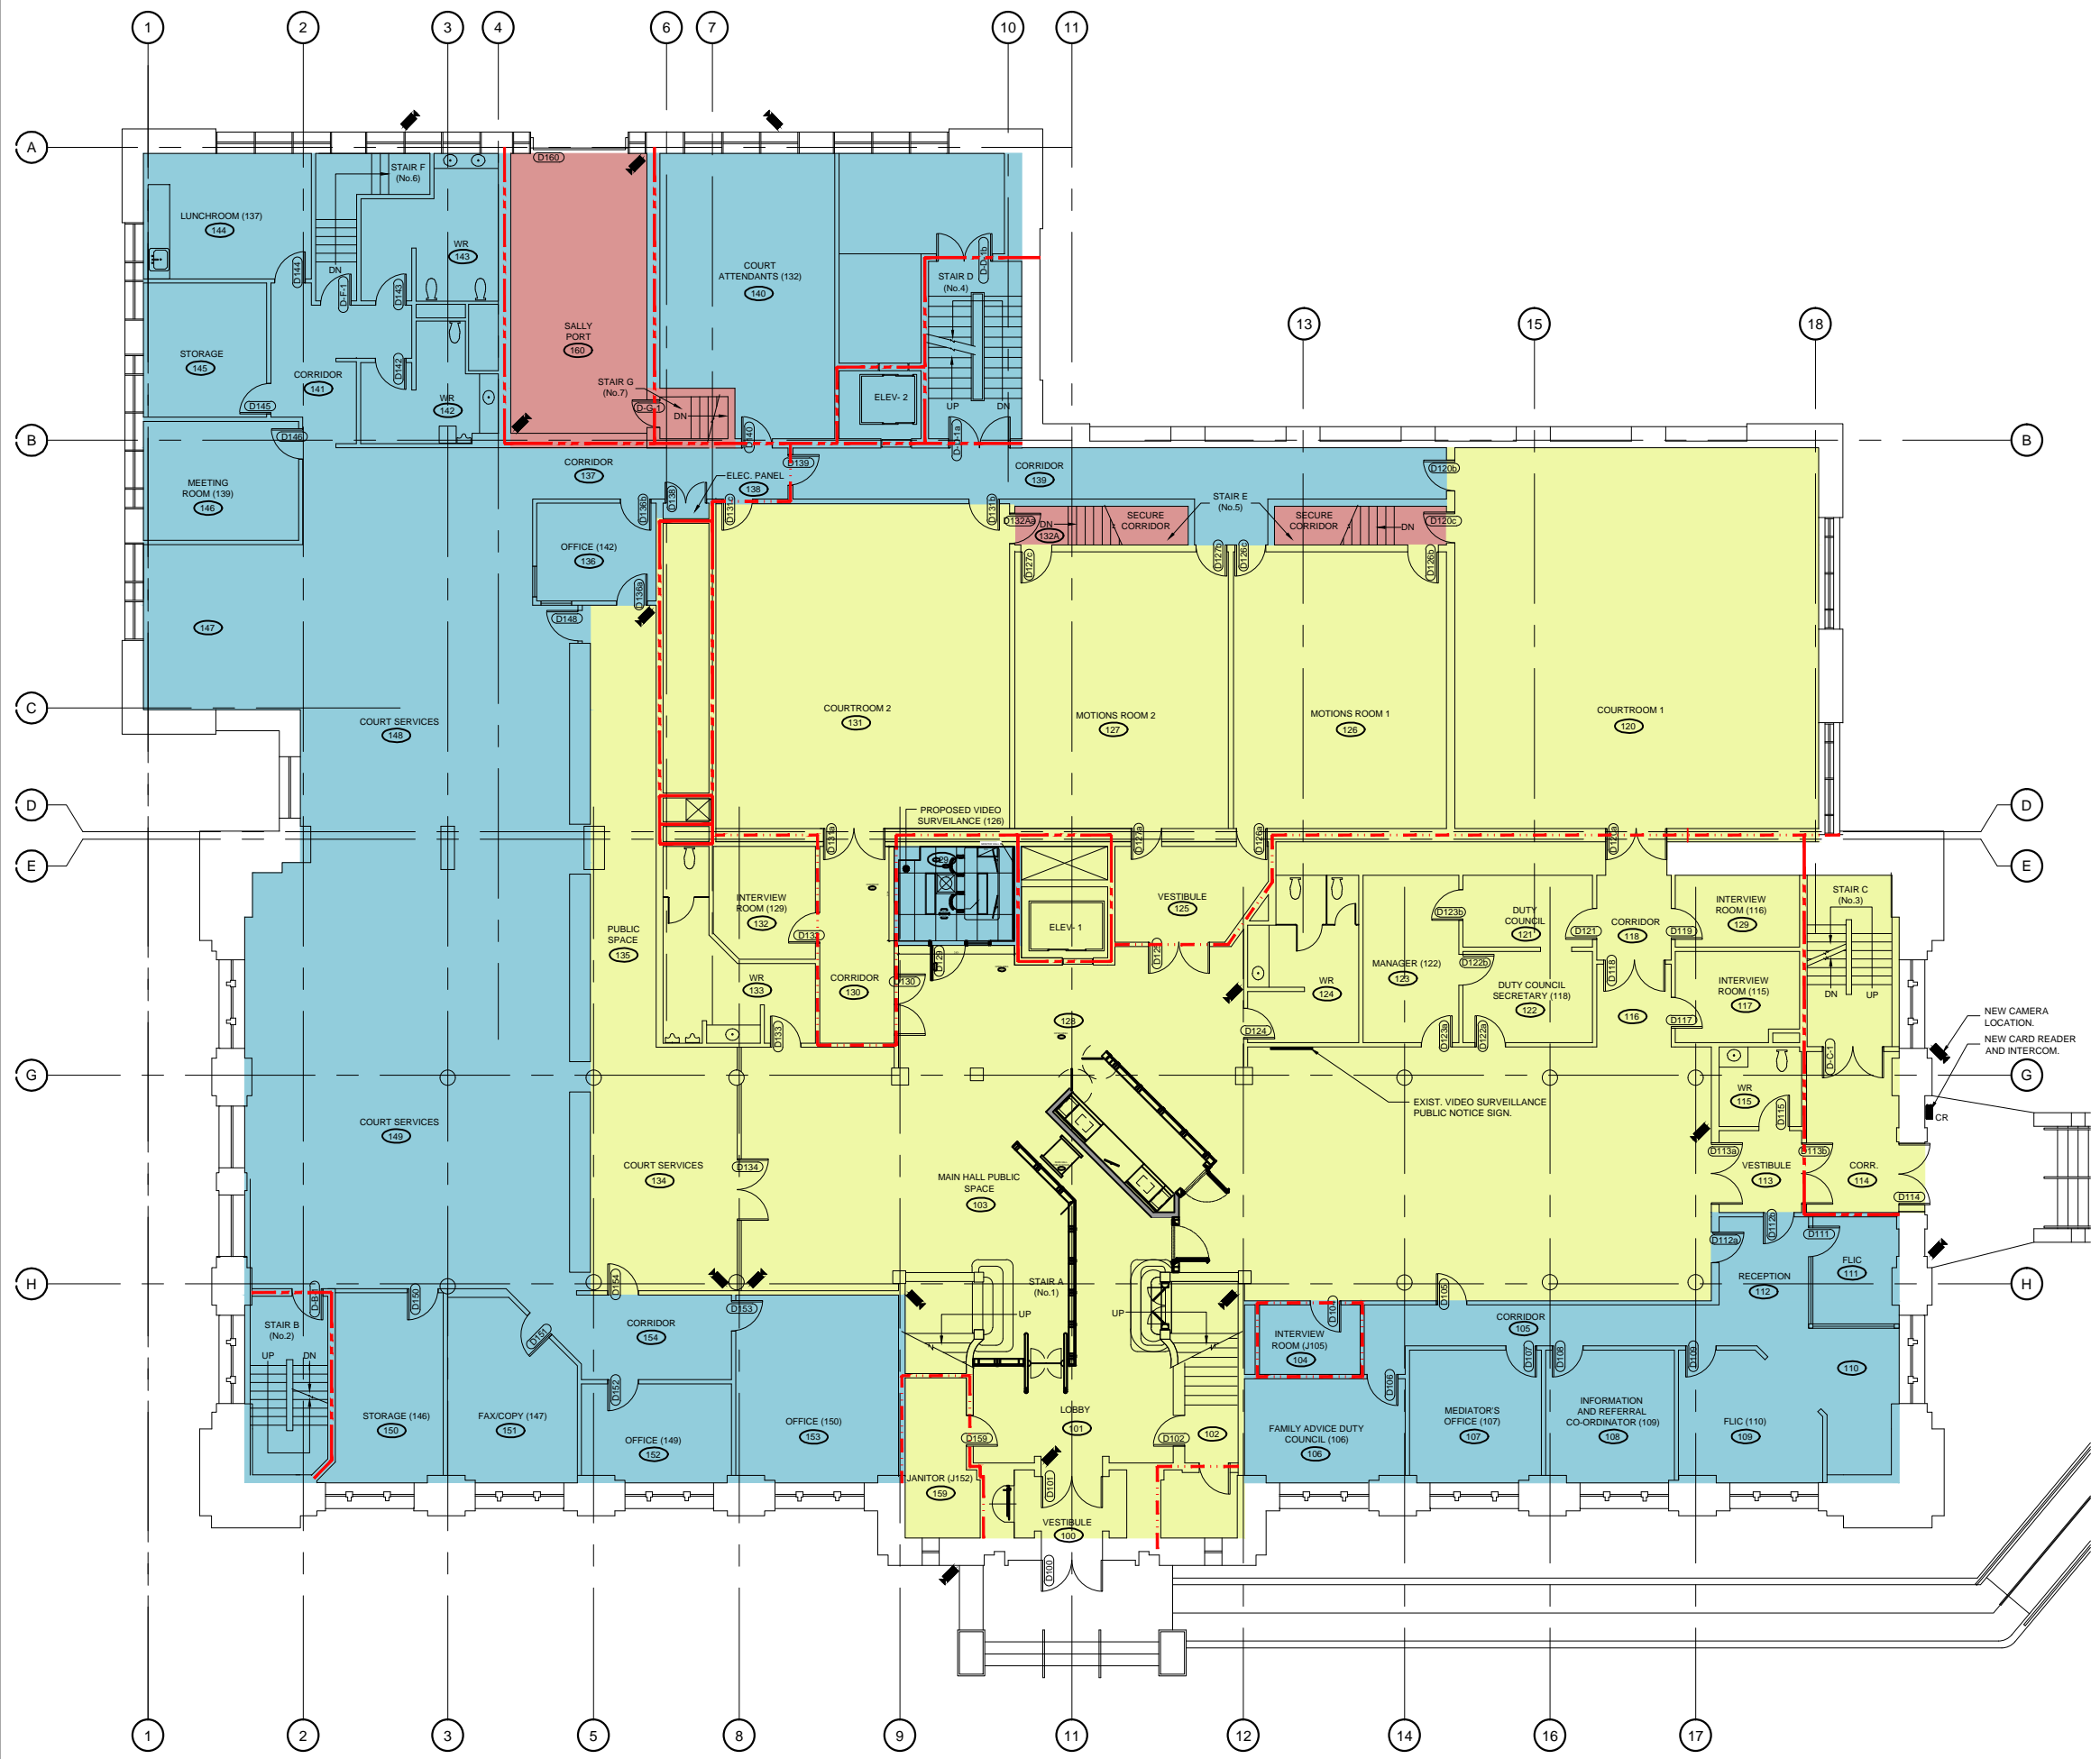
2  
SC2.1 SC2.1 SCALE: 1:200  
GROUND FLOOR PLAN

SECURITY HATCH LEGEND	
HATCH	DESCRIPTION
	PUBLIC ACCESS SPACES
	PRIVATE ACCESS SPACES
	SECURED ACCESS SPACES
	PARKING
	MECHANICAL & ELECTRICAL
	HIGH SECURITY
	PRISONER PATH OF TRAVEL

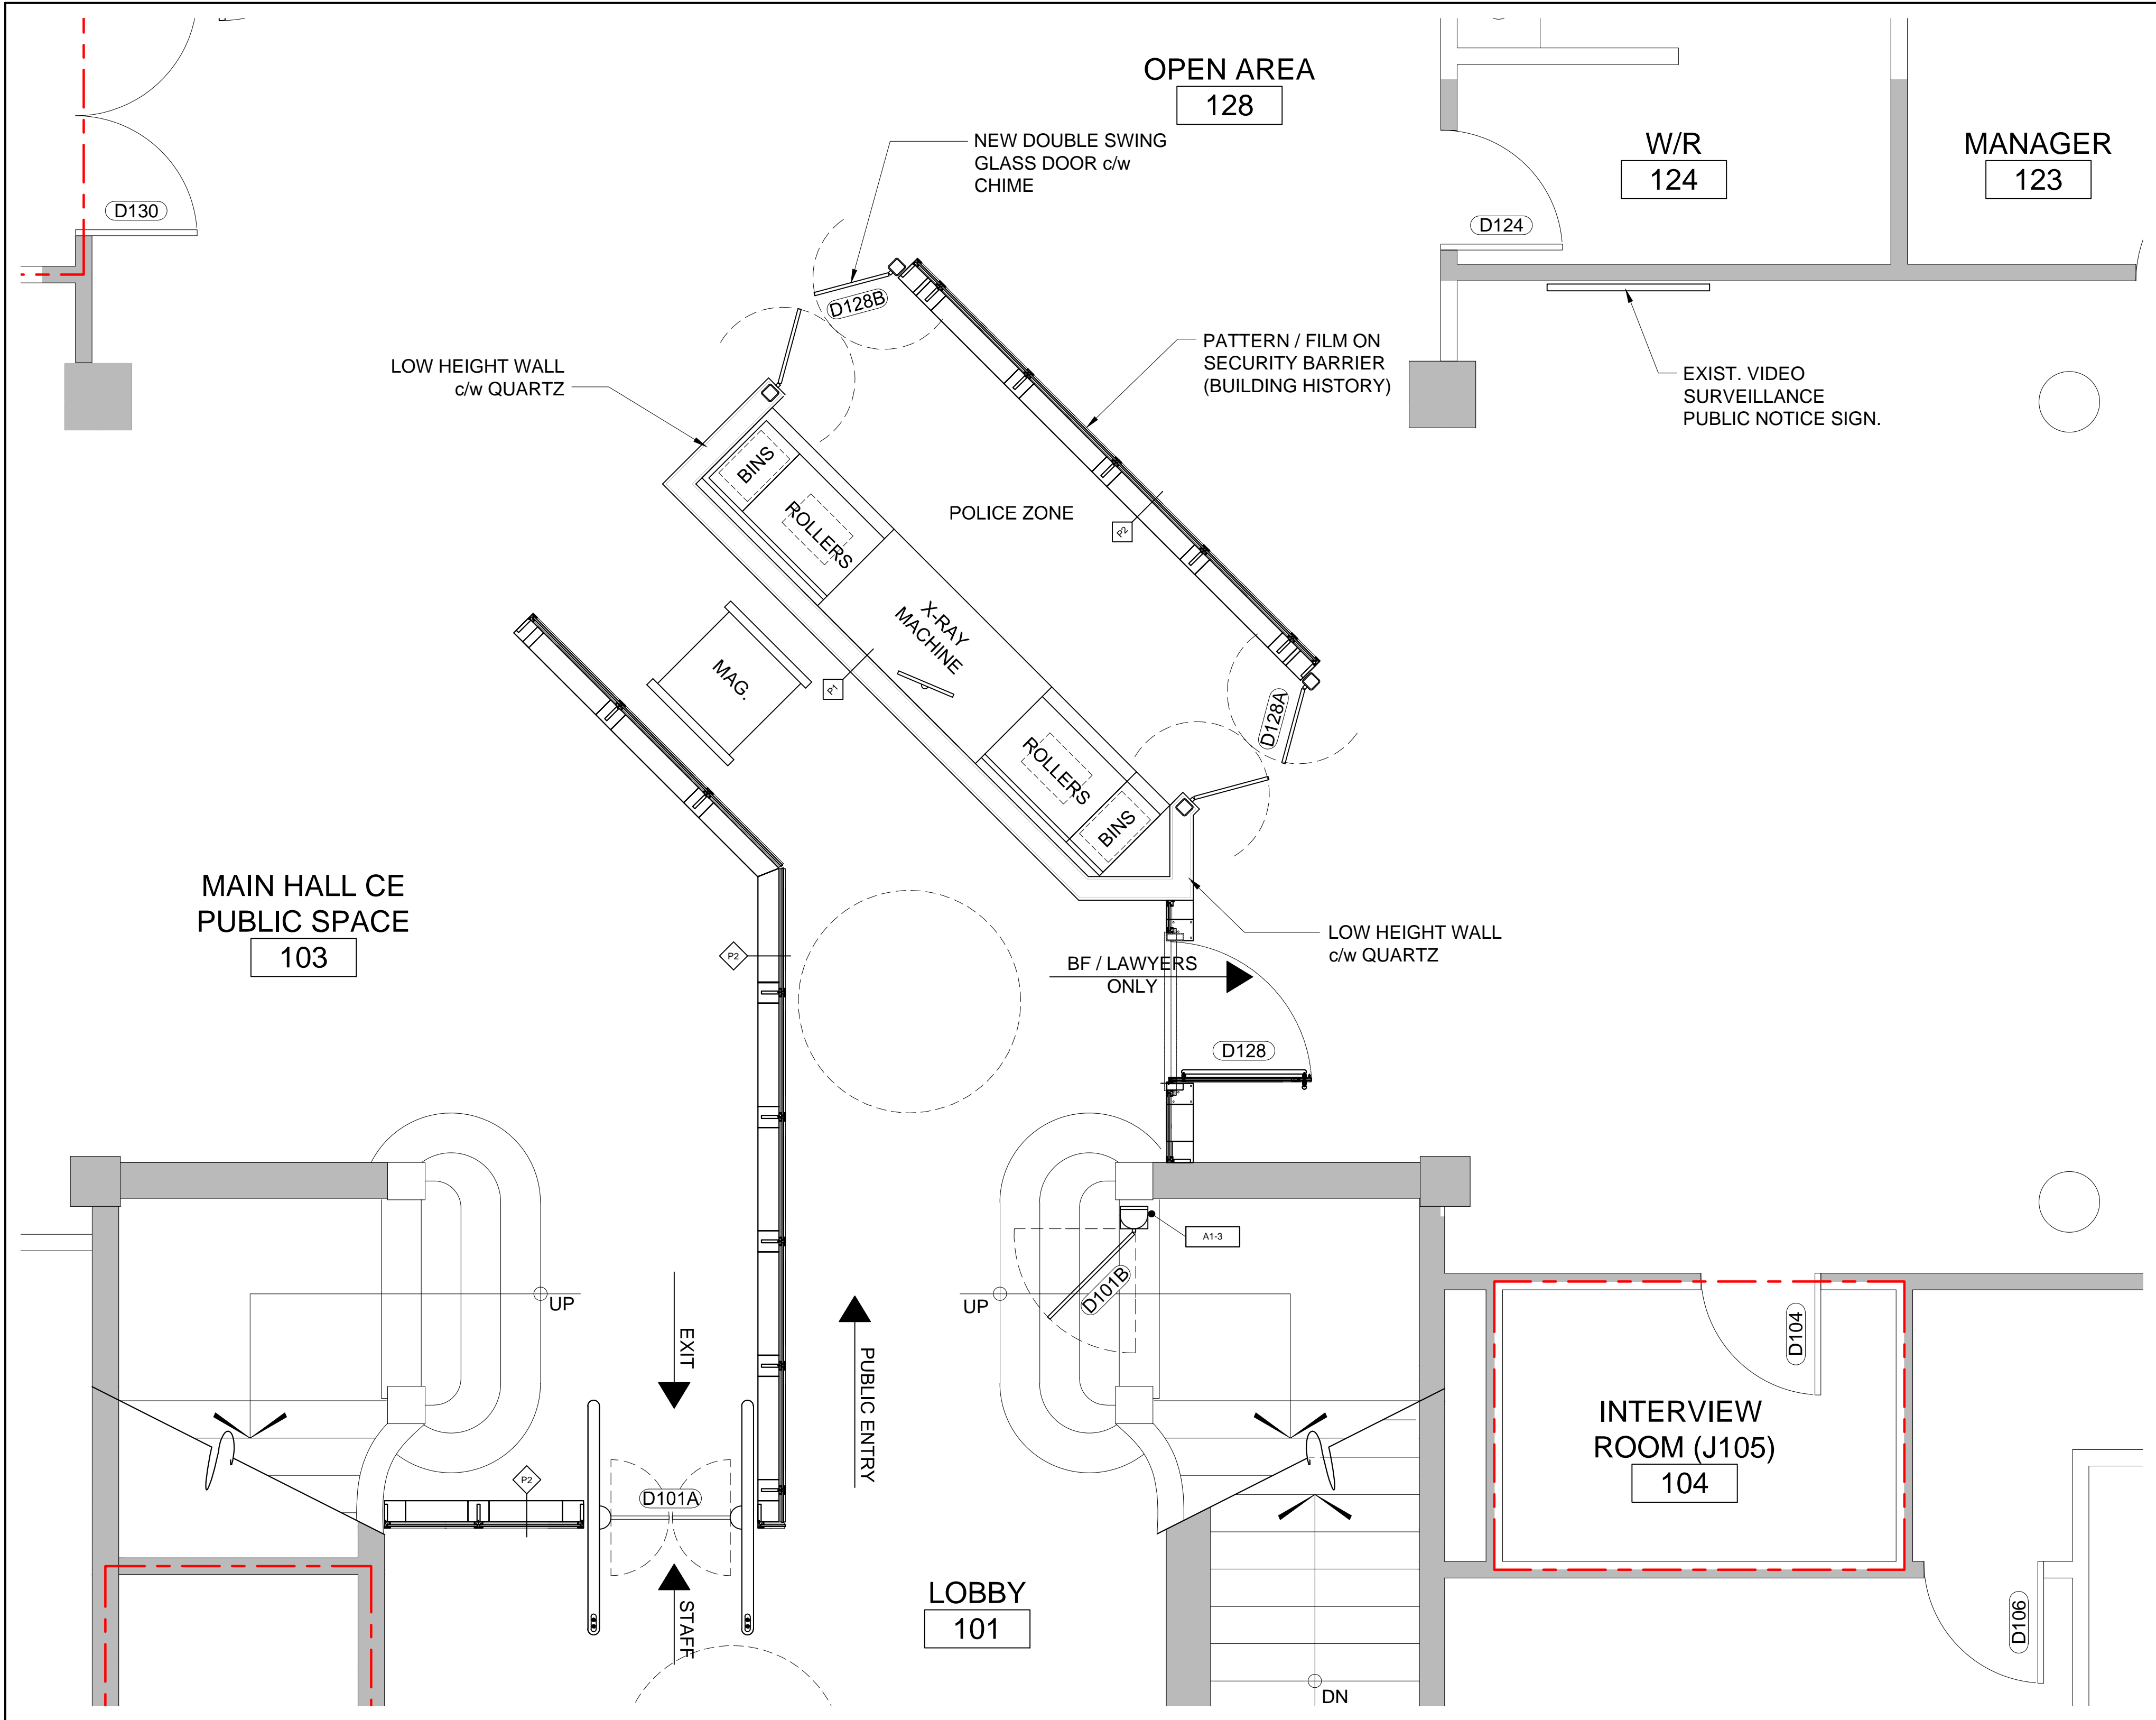
1  
A2.1 A5.3  
SCALE: 1:25  
MAIN ENTRANCE SECURITY BARRIER - PENETRATION

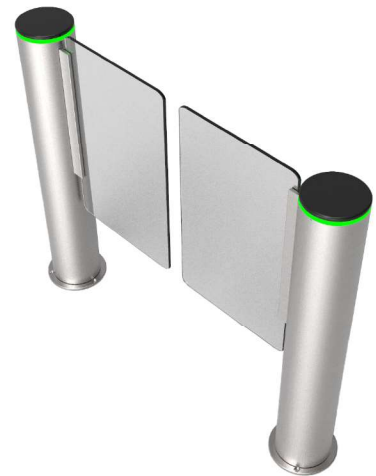
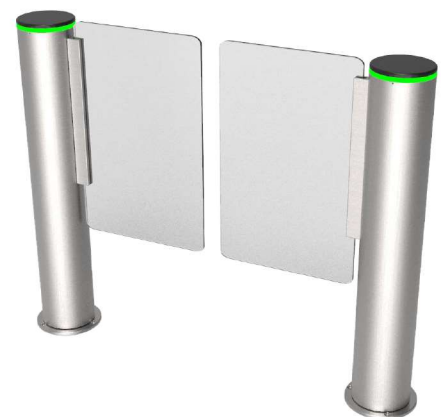
MT310-S can be set to allow access in a bi-direction or single-directional based on client's requirement.

Cylinder pedestrian swing gates are space-efficient and suitable for locations with limited space as they don't require much room for installation. These turnstiles are deployed in a wide range of environments, from public transit stations and airports to corporate offices, stadiums, and high-security facilities. They help regulate pedestrian flow and enhance security.

Dimension	φ168*1000mm (0.55*3.28*ft) (standard)
Material	SUS 304
Swing arm Material	Acrylic/Stainless steel
Passage Width (Single pcs)	600mm (1.97ft) -1000mm(3.28ft)
Passage Width of stainless steel arm (A pair)	600mm (1.97ft) -2000mm (6.56ft)
Passage Width of acrylic arm (A pair)	600mm (1.97ft) -1800mm (5.91ft)
Passage direction	Unidirectional/Bi-directional
Mechanism	Servo Motor 200W
Pass rate	40-50 persons/minute
Operating time	0.2 seconds
Power Supply	100V-240V 50/60Hz
Radar for automatic open	Unidirectional/Bi-directional
Open Signal	Passive Relay (Dry Contact)
Communication	RS485
MCBF	3,000,000 Cycles
Working Temperature	-35°C ~ 60°C
Working Environment	Indoor
Relative Humidity	95% Maximum

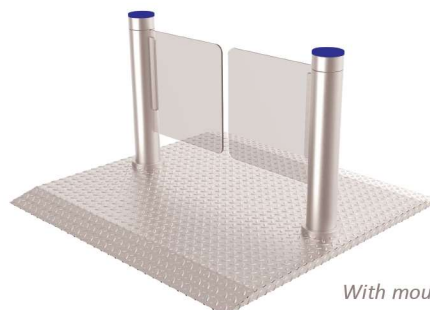
*Various swing arms available*

*With mounting base*

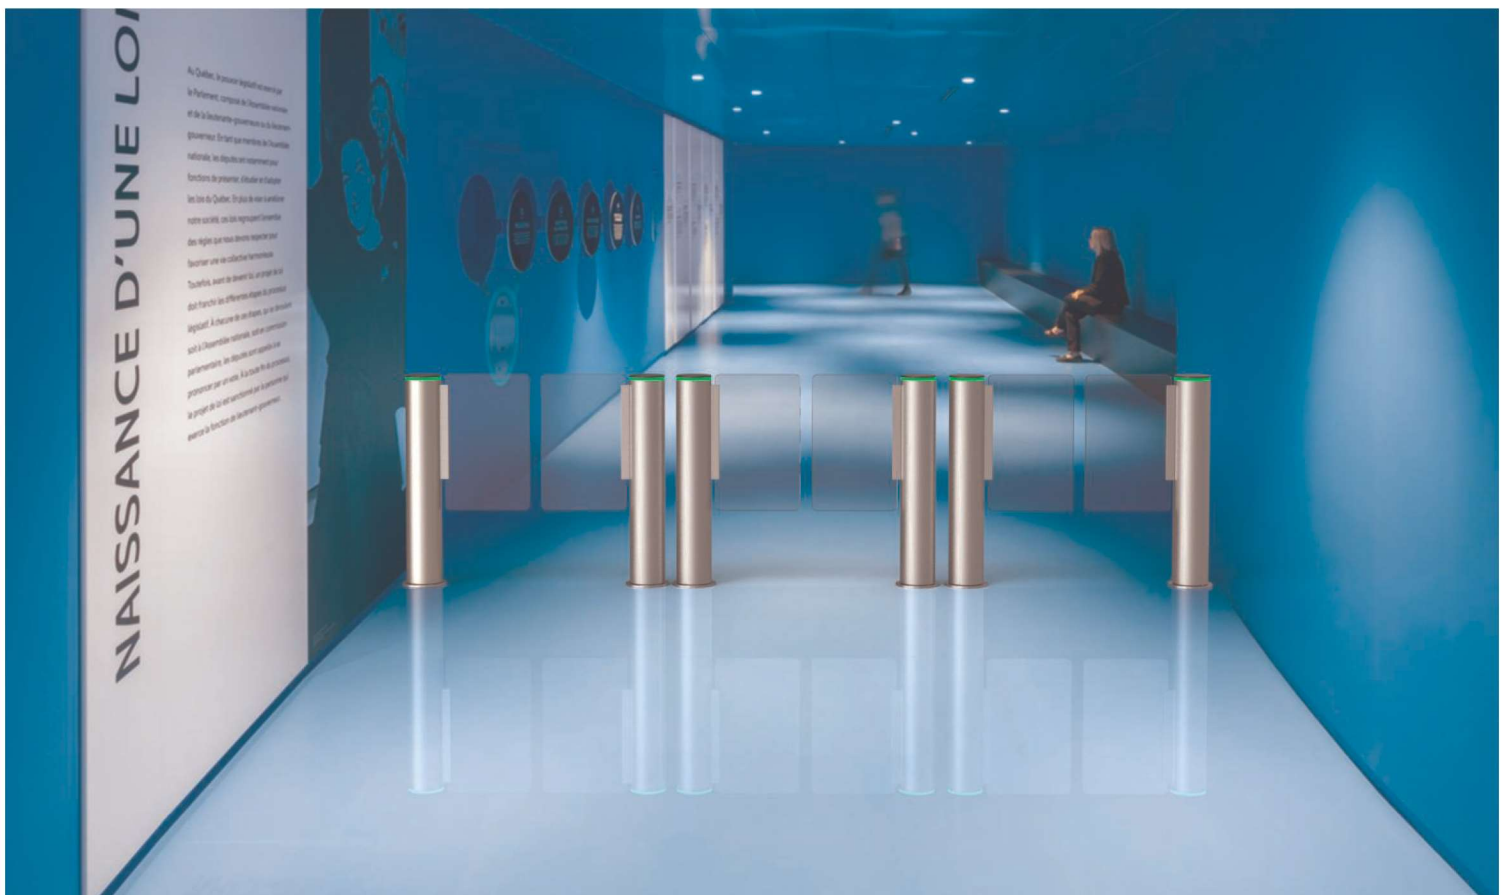
Two lanes (Supports various combinations)

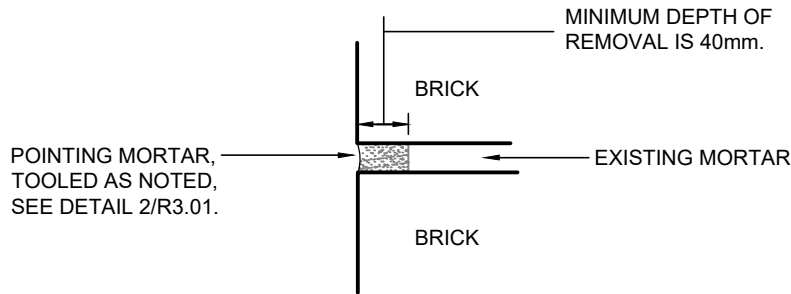
1 TYPICAL RAKING OUT DETAIL  
R3.01 NTS

RAKING OUT PROCEDURE:

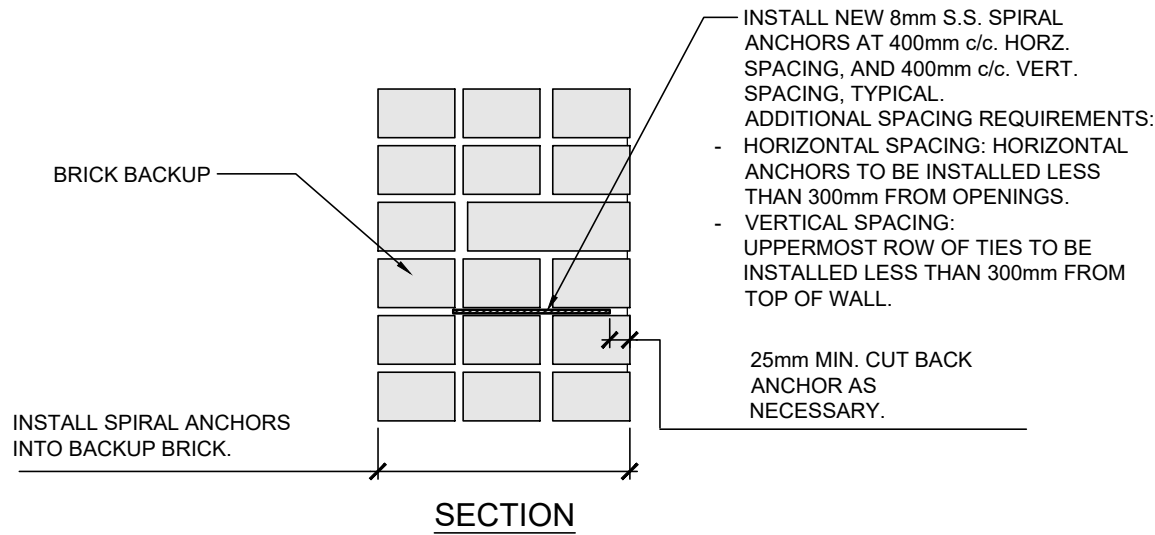
3 TYPICAL RETROFIT ANCHOR DETAIL  
R3.01 NTS

MATERIALS:

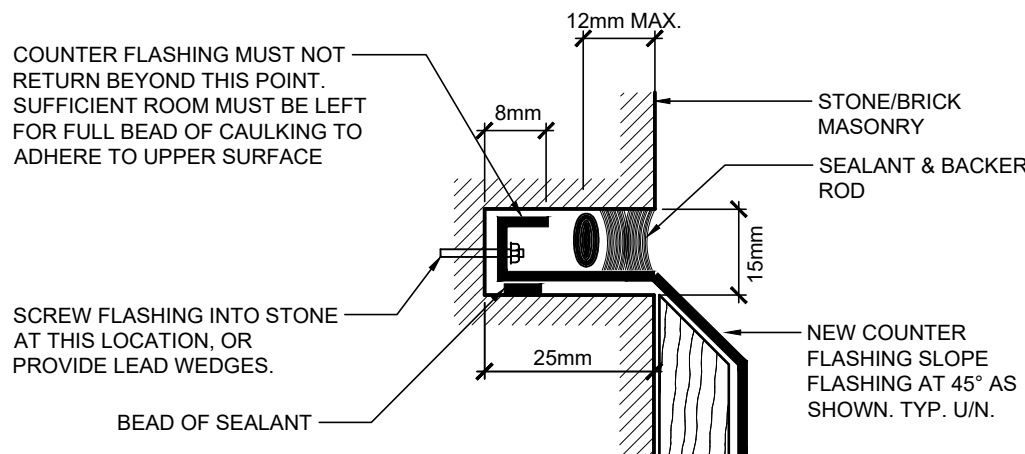
5 TYPICAL REGLET DETAIL CUT INTO STONE MASONRY  
R3.01 NTS

NOTES:

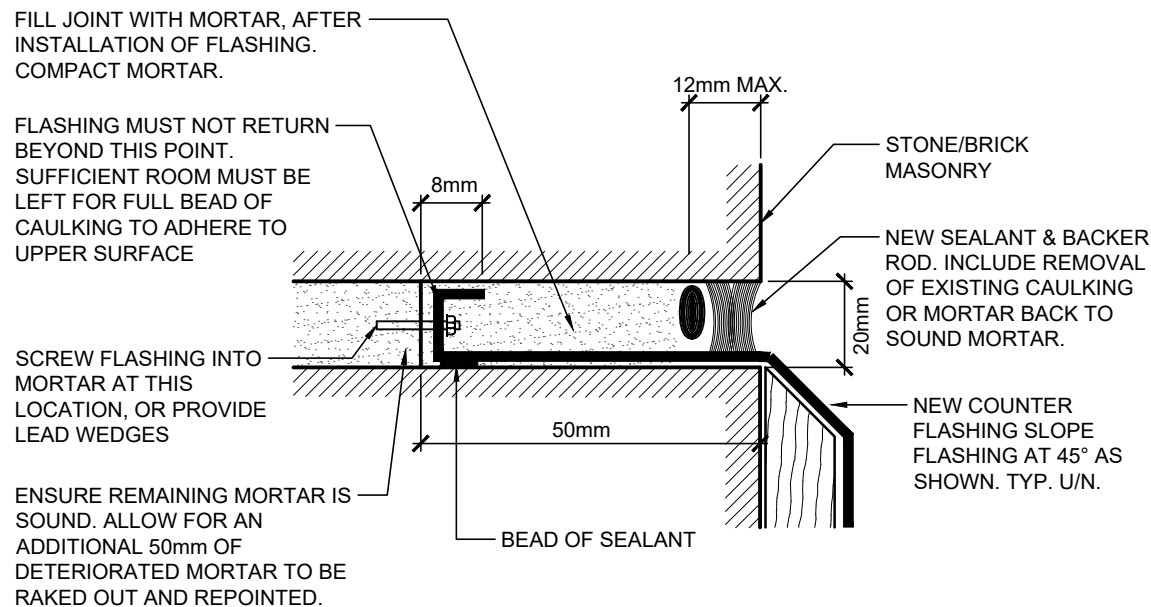
1. ALLOW FOR REPOINTING BEHIND ALL EXISTING FLASHING, ONCE EXISTING FLASHING IS REMOVED. ASSUMED RAKE OUR AND REPOINTING DEPTH IS 100mm. SEE DETAILS 1 AND 2 ON R3.01.
2. SEE ROOF REPLACEMENT DRAWINGS (BY OTHERS) FOR BALANCE OF ROOFING AND FLASHING WORK.
