City of Hamilton
HERITAGE PERMIT REVIEW SUB-COMMITTEE
REVISED

Date: July 15, 2025

| 9.1 | HP2025-022 - 55 Main Street West, Hamilton (Former Hamilton Carnegie Building, Part IV) | 13 |
| 9.3 | HP2025-025 - 47 James Street South, Hamilton (Landed Bank and Loan Company Building, Part IV) | 79 |

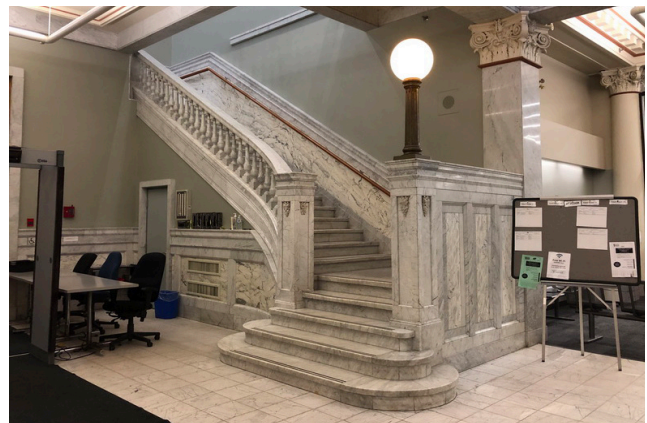
Image 3.10: Current view of east Heritage Stair in the Main Hall with existing 12"x12" marble tile flooring.

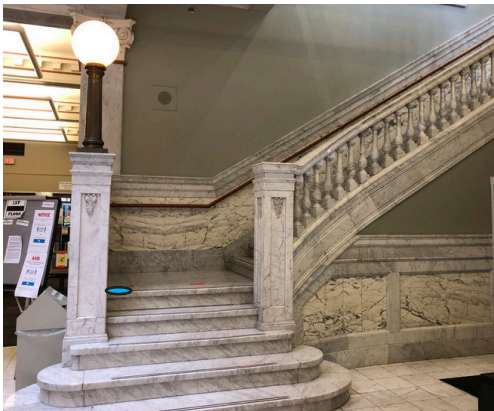
Image 4.4a: Proposed location of the new swing gate at the bottom of the west stair.

Immediately it was recognized that mounting to the vertical face of the marble newel posts was to be avoided as this alteration would be the most impactful to the heritage resource. The initial design involved a double swing gate requiring two posts which would have resulted in a total of 8 (eight) floor penetrations per gate. The type of gate that has been selected was carefully chosen in order to minimize the number of penetrations required. The proposed unit has a single swing gate that allows for only one stainless steel mounting post which is attached to the floor via three 12.5mm diameter fasteners. A fourth hole (50mm diameter) is required to bring in power to the unit for the control mechanism. This layout results in a total of approximately 4 (four) penetrations for the gate's vertical support post required for the proposed security access.

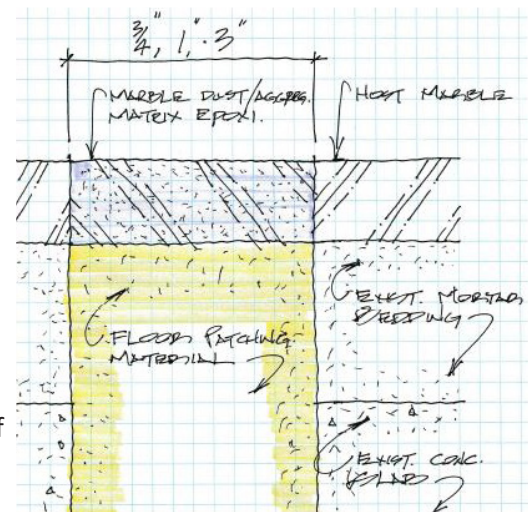
Image 8.2: Marble Dust Aggregate detail

a) **Marble Dust Aggregate:** this repair uses the existing marble fragment materials and mixed with a non-yellowing epoxy matrix to create a patching mortar to repair smaller holes, less than 1" in diameter, in the future (Refer to image 8.2). The process would involve the following:

In the future, when the holes need to be repaired the contents of each bag is to be mixed with a non-yellowing epoxy and inserted into the prepared holes in the floor. Once dry the repair patch is to be ground and polished smooth to suit the surrounding marble. The complete stripping and refinishing of the entire tread would be required to ensure a uniform appearance once repaired. This is common form of floor maintenance and does not have a negative impact on the marble.

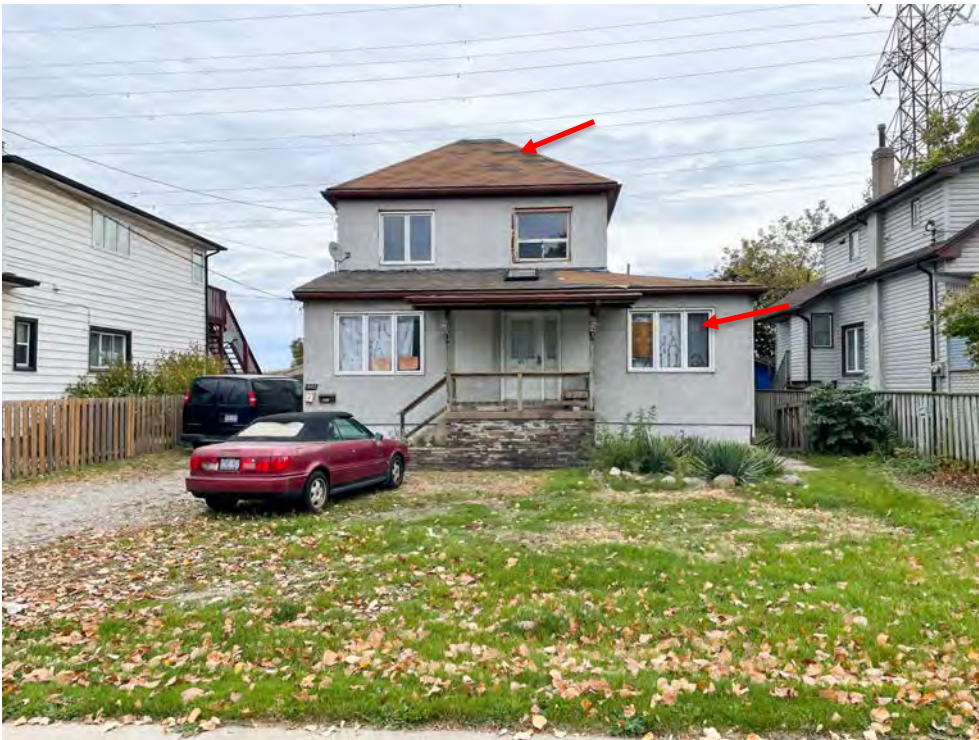
Front elevation – roof and replacement windows in very poor condition

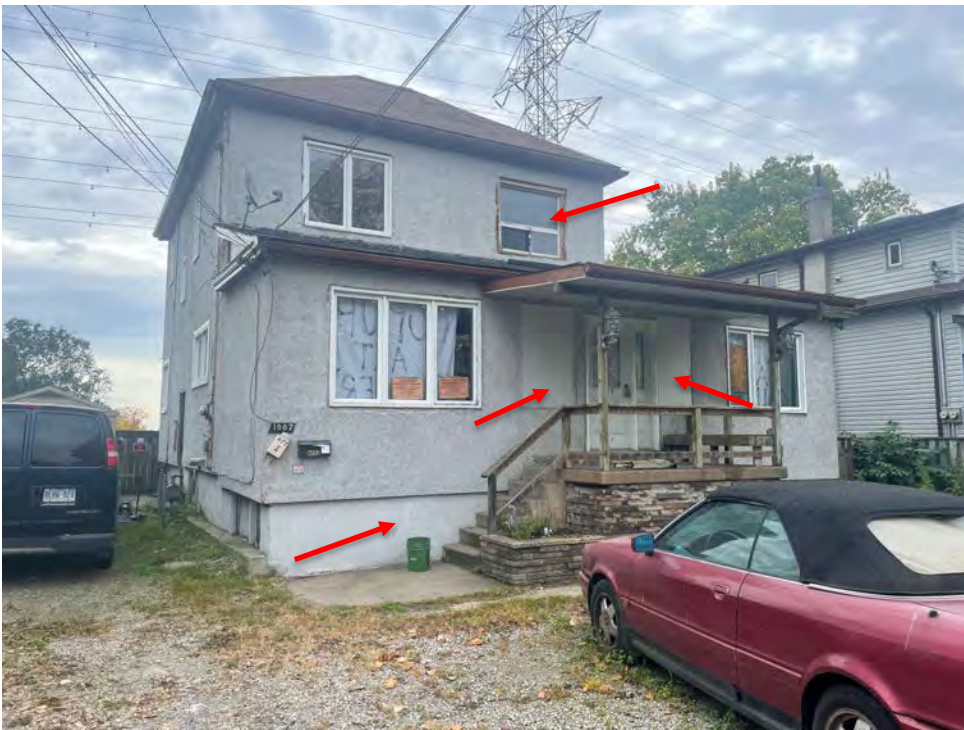
Front entrance – cracks visible in the parged foundation – original openings boarded up – mis-matched replacement windows

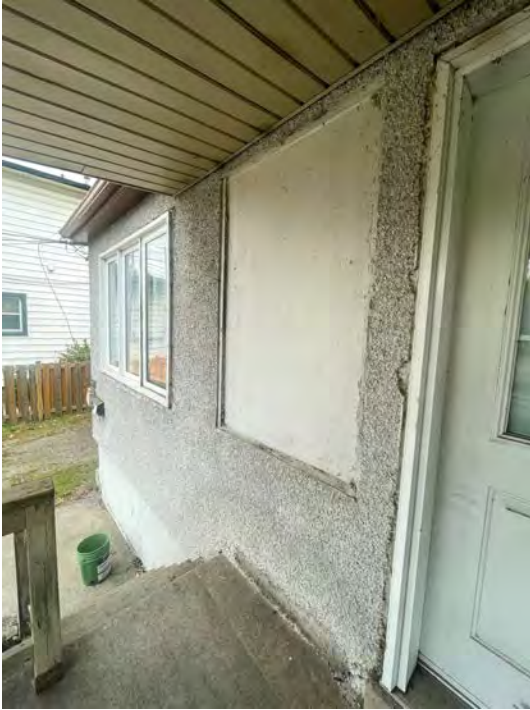
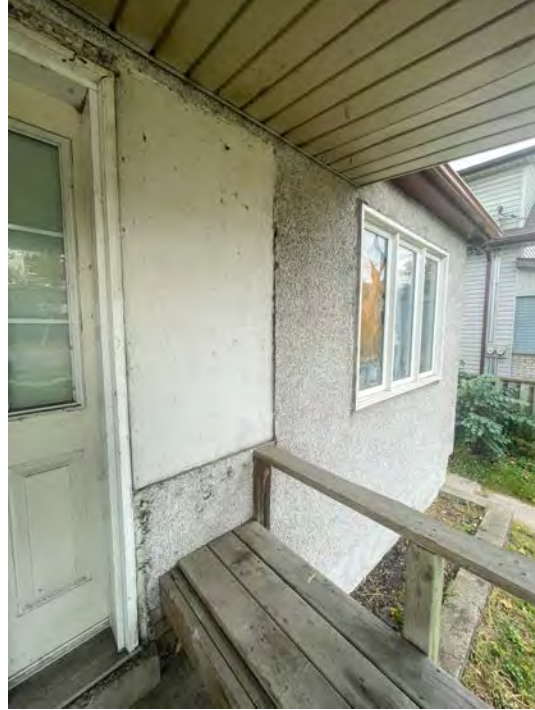
Boarded up openings – vinyl replacement doors and windows – locations and sizes of windows have been changed

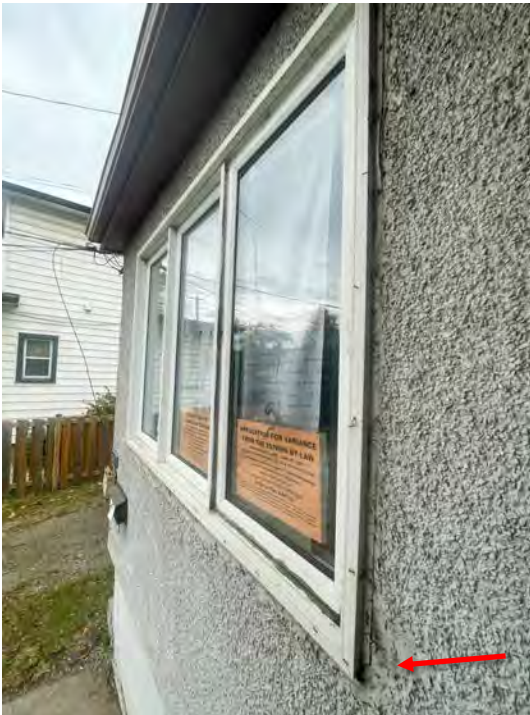
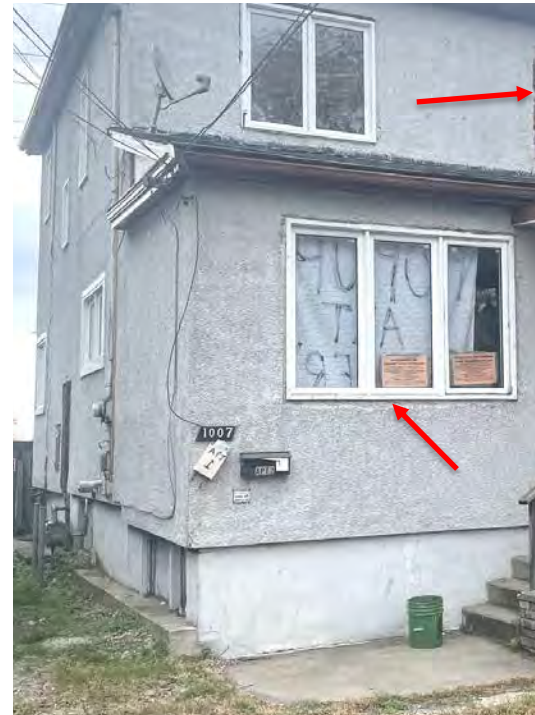
Poorly installed vinyl replacement windows – modern cement parging with patching and gaps around window openings

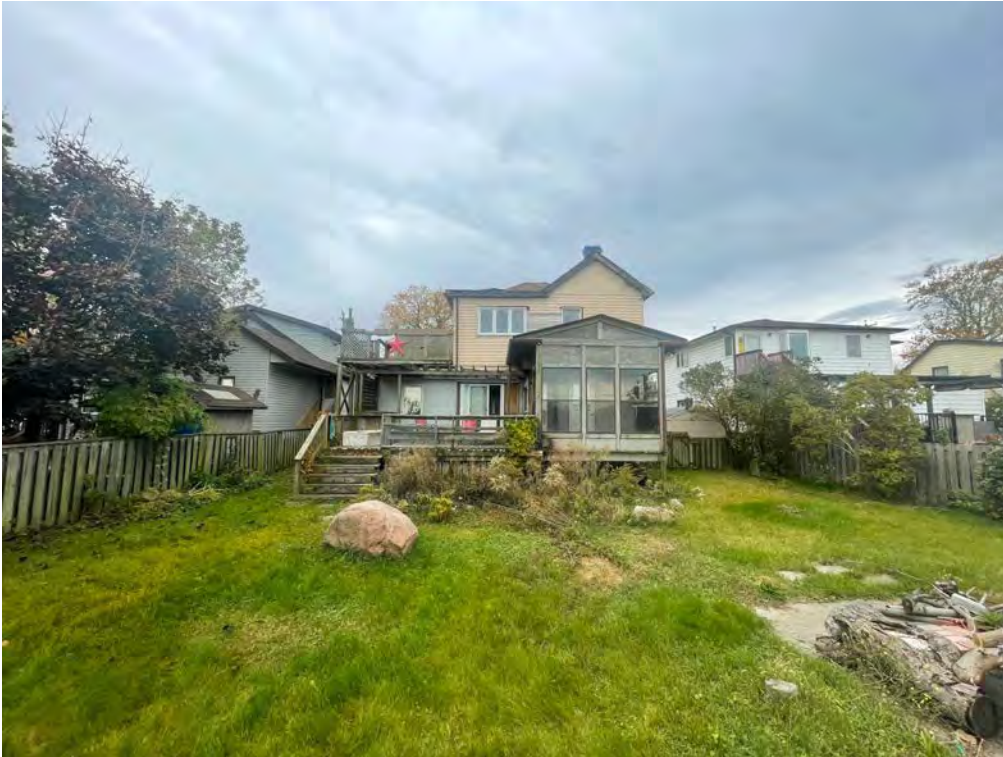
Rear elevation – replacement vinyl doors and windows – vinyl cladding on 2nd floor – poorly constructed enclosed porch and decks – poorly installed replacement vinyl windows

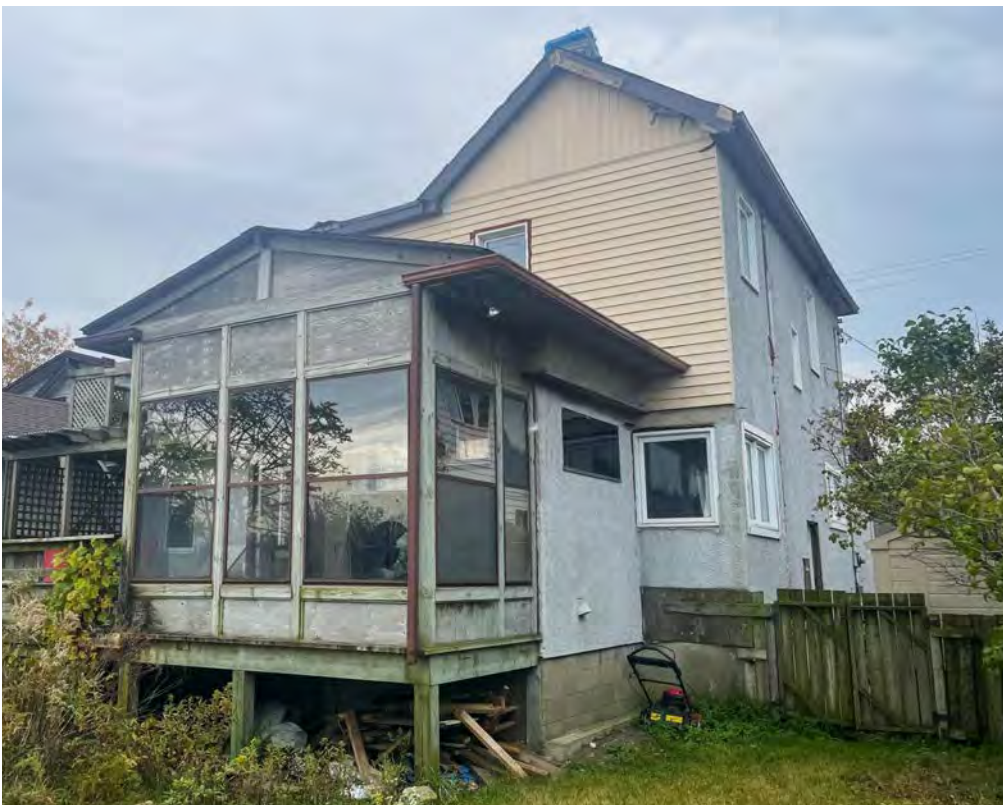
Rear and north side elevation – mish-mash of materials – poorly installed replacement vinyl windows

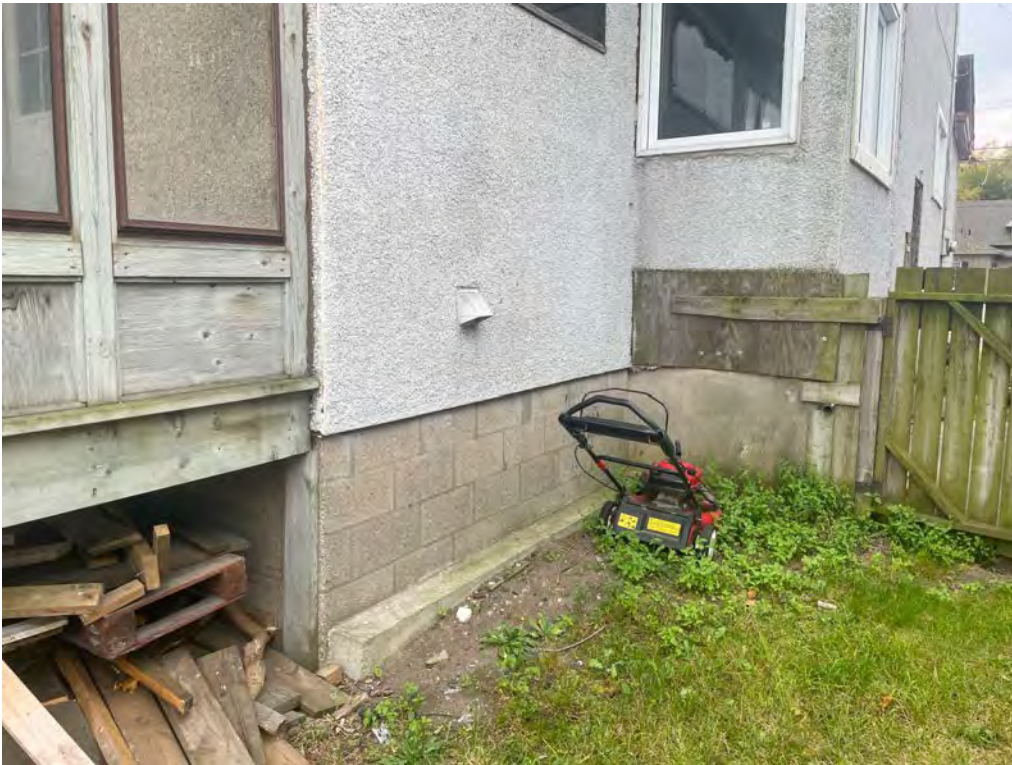
REAR ADDITION – concrete block foundation – cement parging above

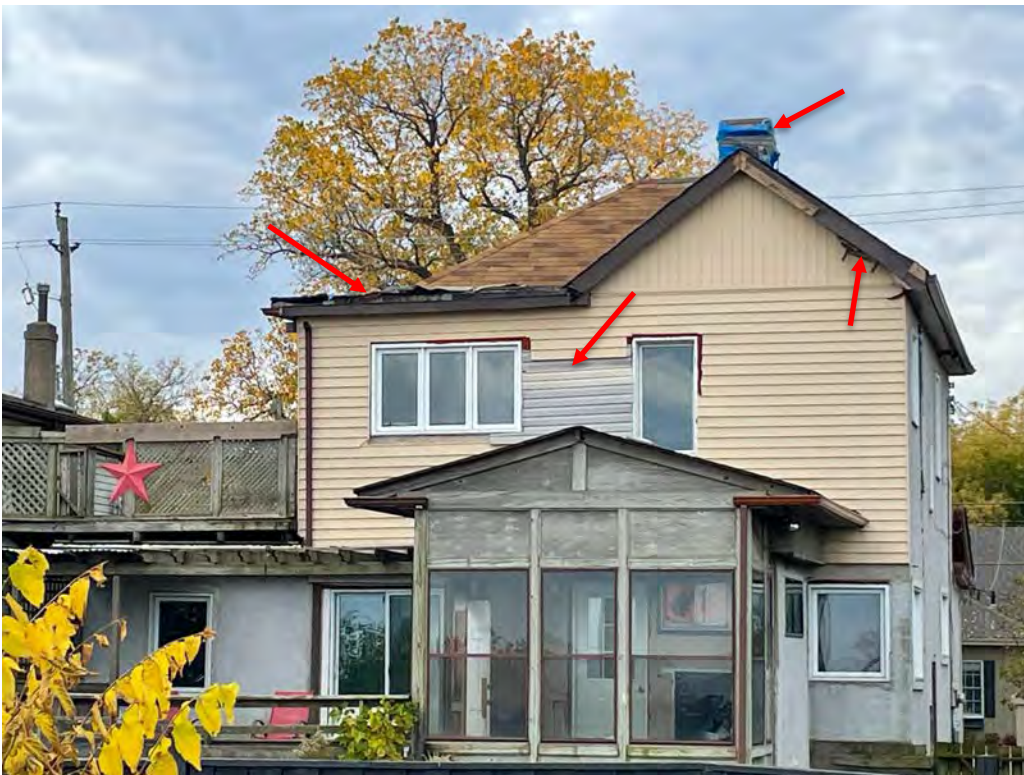
REAR ELEVATION – roof is in very poor condition – shingles lifting and tarp on chimney – rotted soffit & fascia boards – poorly fitted replacement windows – patched siding

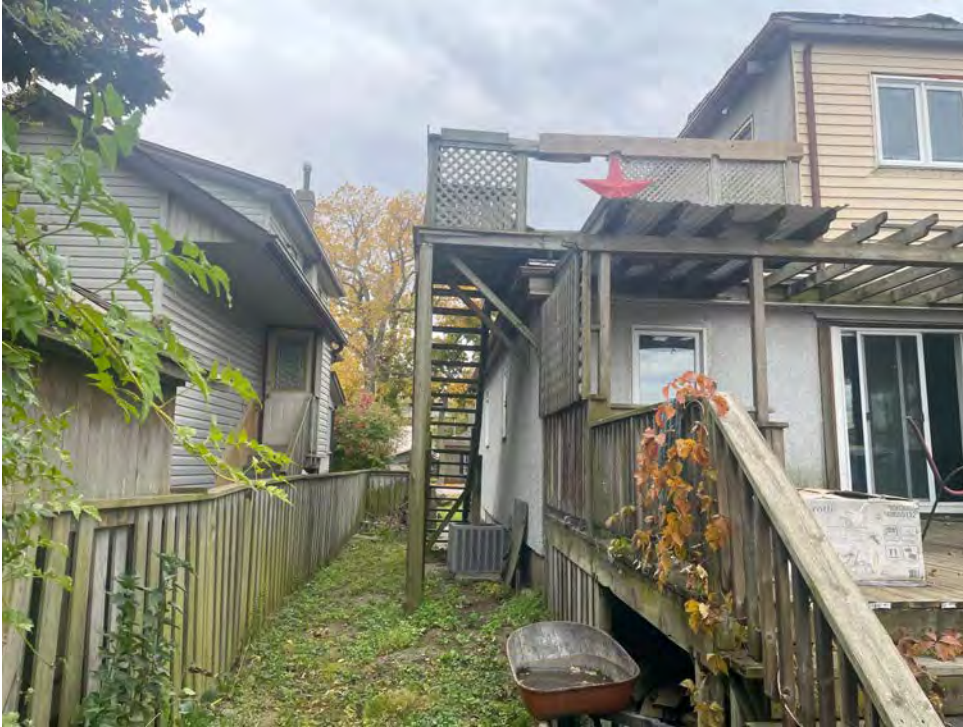
South side yard – poorly constructed deck and exit stair

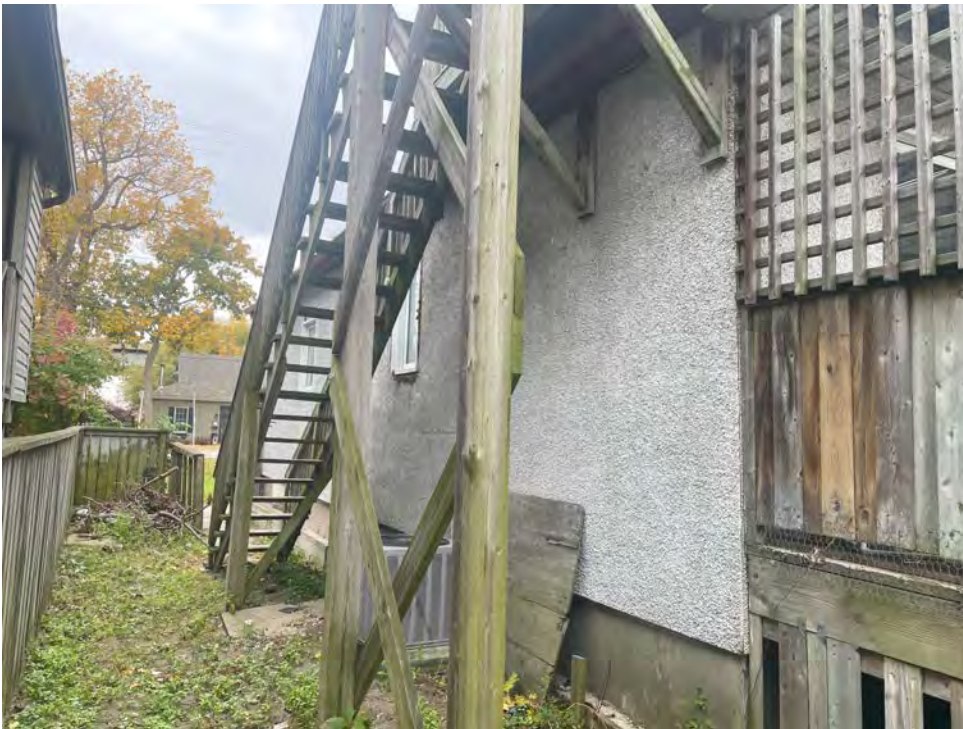
SIDE ELEVATION - parge foundation with cement stucco above – wood fire escape attached to stucco

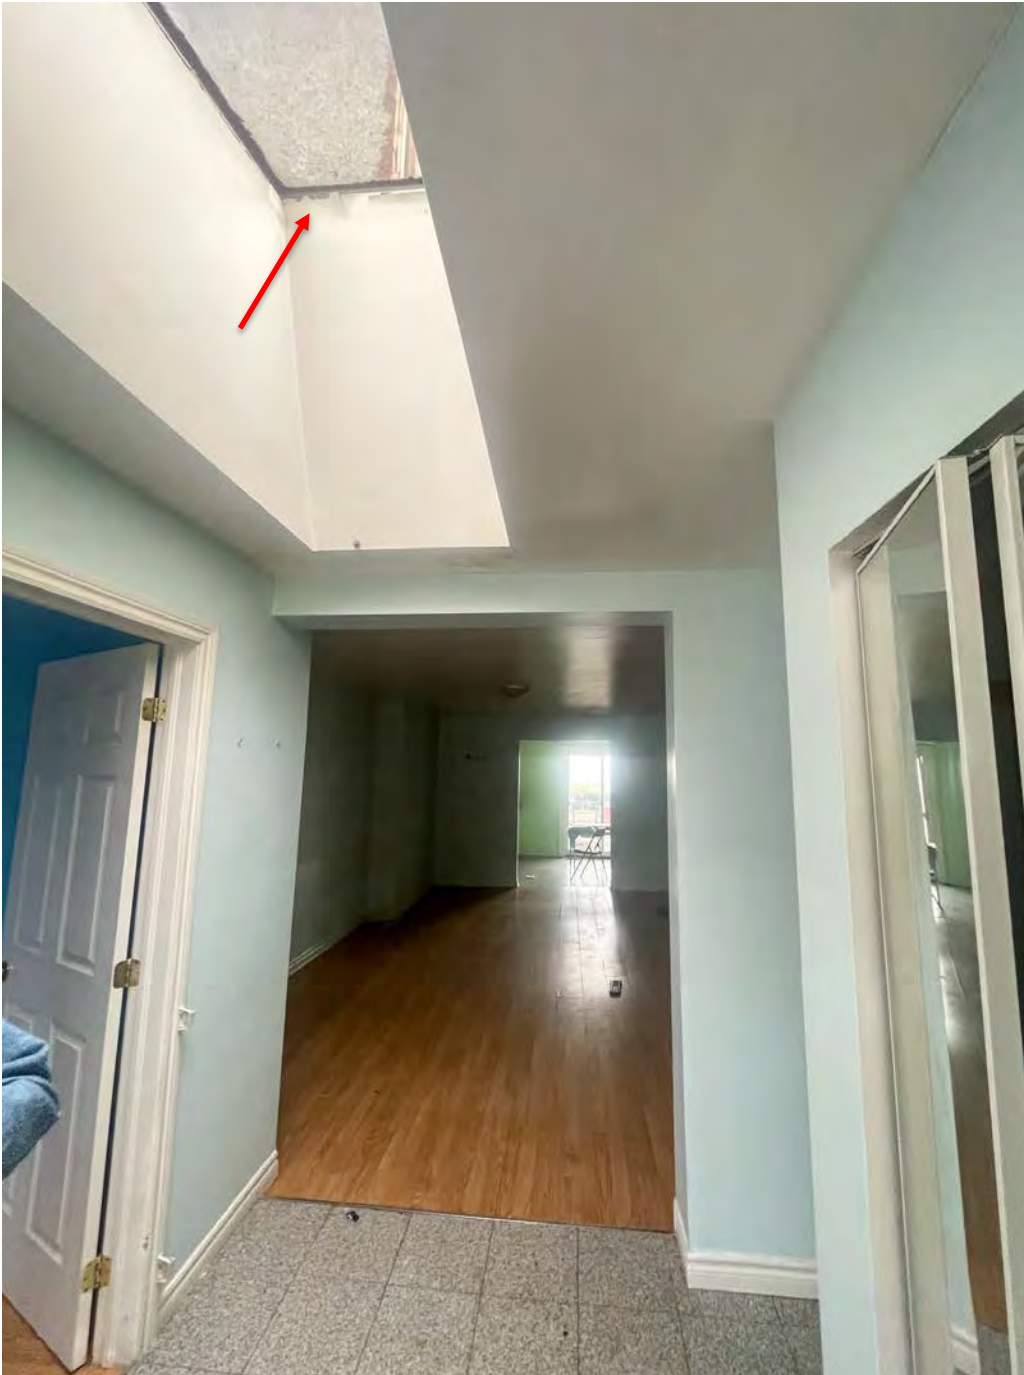
INTERIOR – modern skylight in entrance hall is leaking – modern finishes – no historic features or finishes

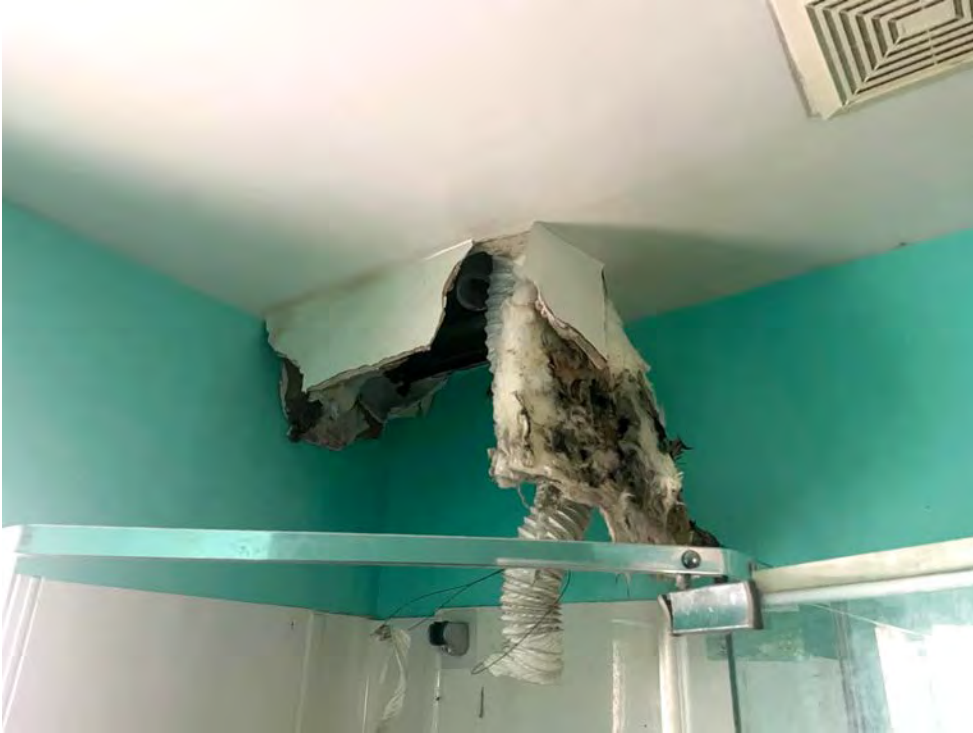
Interior – 1st floor bathroom – water damage

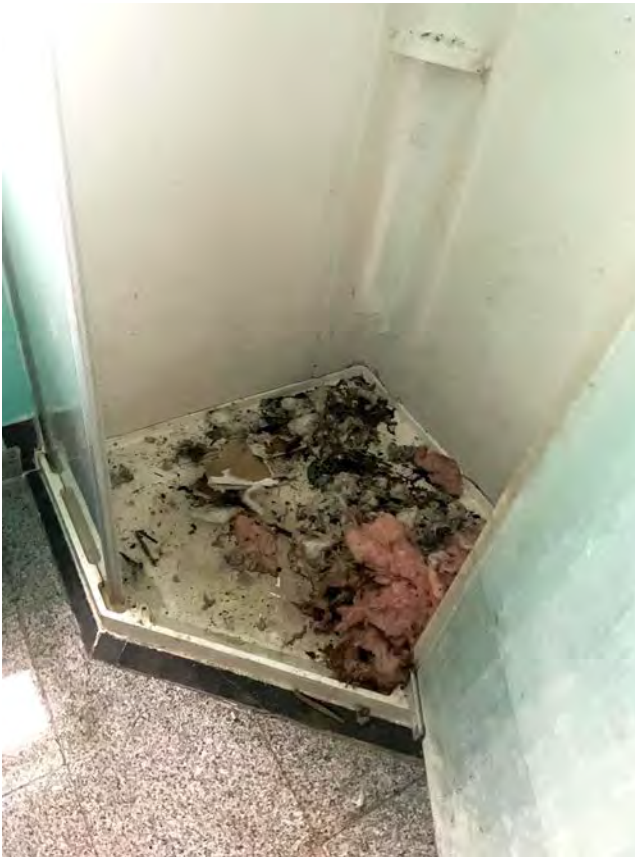
Interior – 1st floor bathroom – wet insulation and drywall debris where a portion of the ceiling has collapses

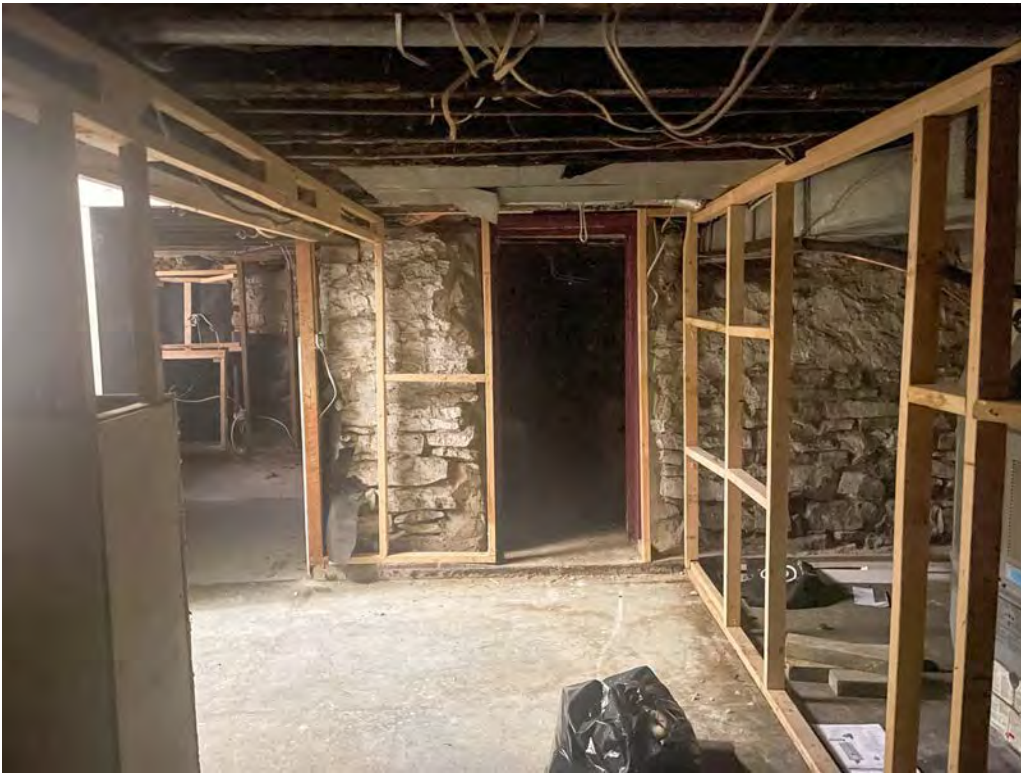
Basement – rubblestone – remnants of a late-19th or early 20th century foundation

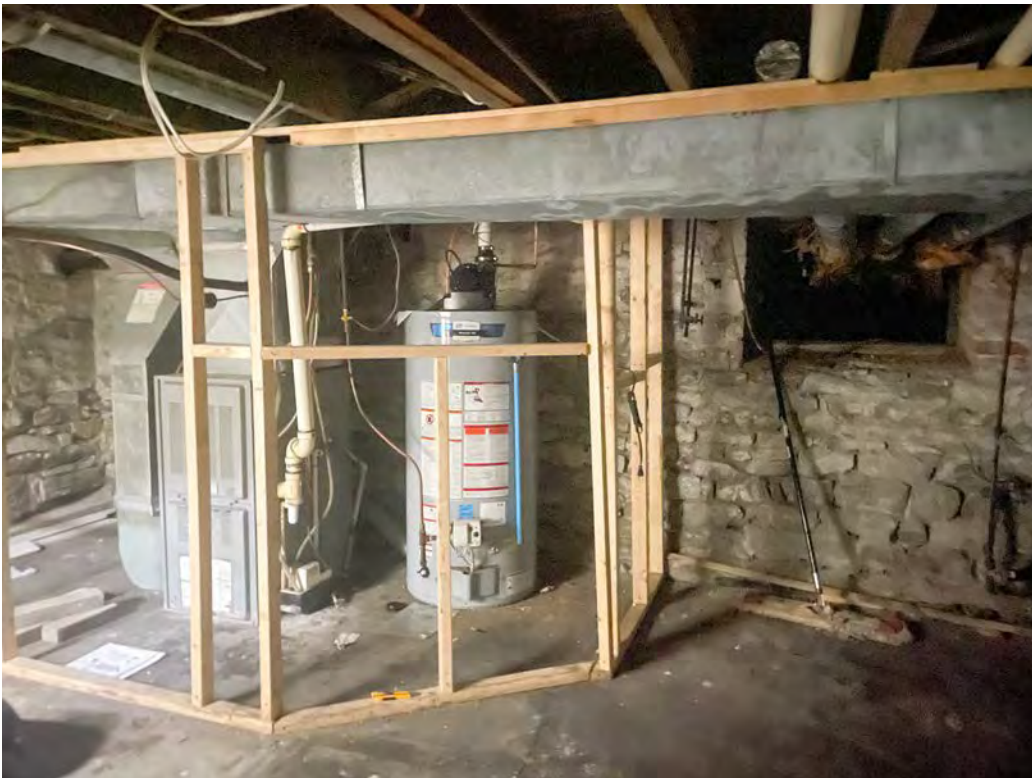
Basement – rubblestone – remnants of a late-19th or early 20th century foundation

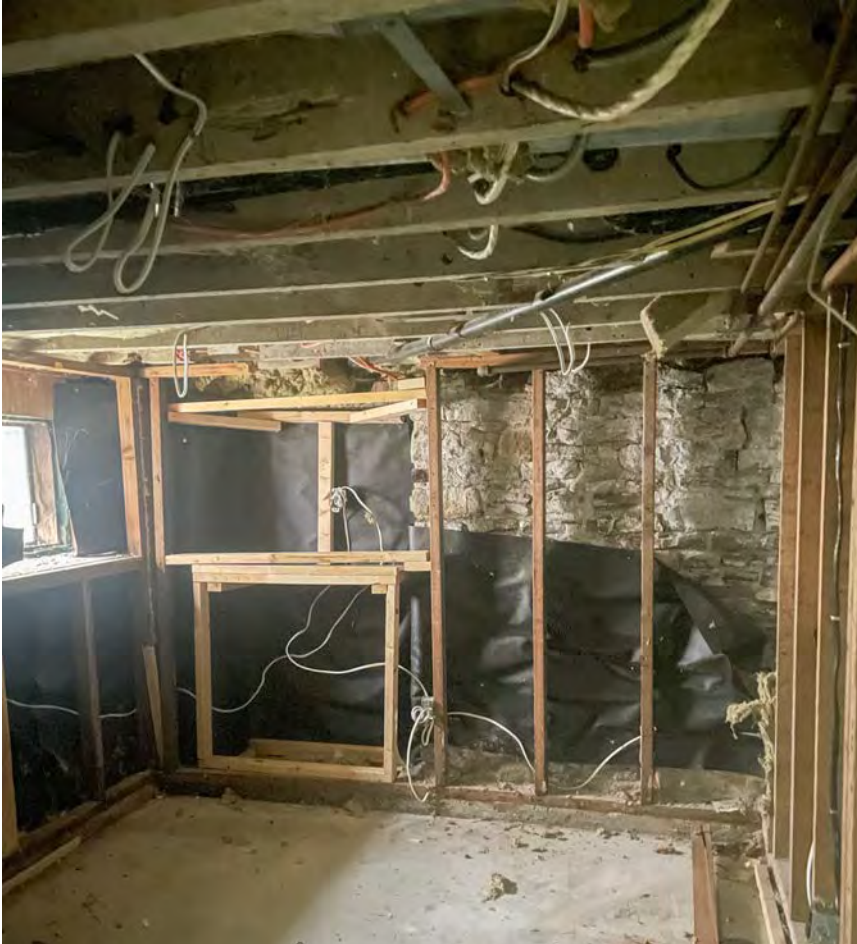
Basement – waterproof membrane installed in some areas of the basement to address damp issues

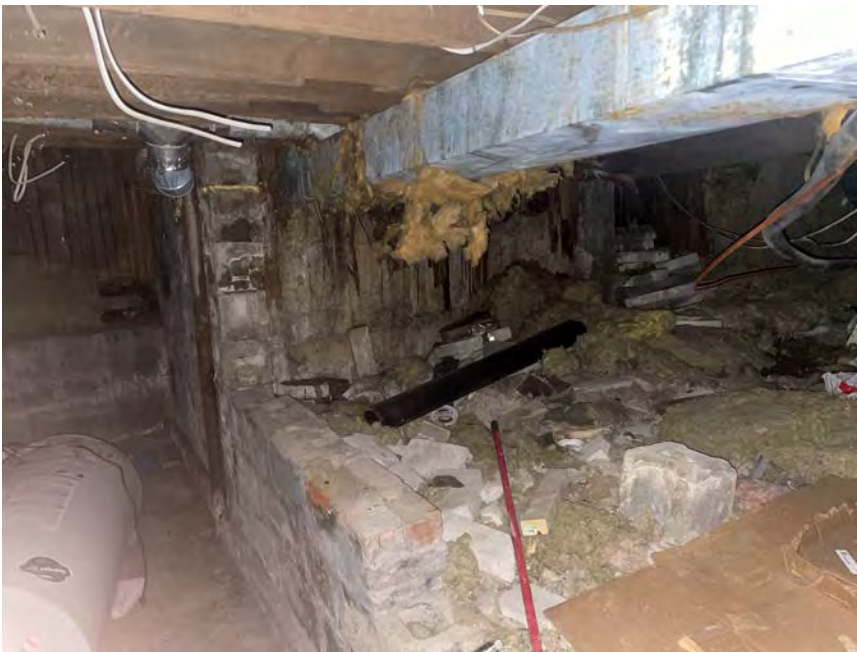
Basement – modern ducting installed through older foundation and wood joists – insulation debris and damp conditions
