**Item 7.3**  
**Public Works Committee**  
**April 22, 2014**

**Transit Bus Stops Accessibility Review**  
**(PW14041)(City Wide)**

## Phase 1 Audit Results of 28 Stops

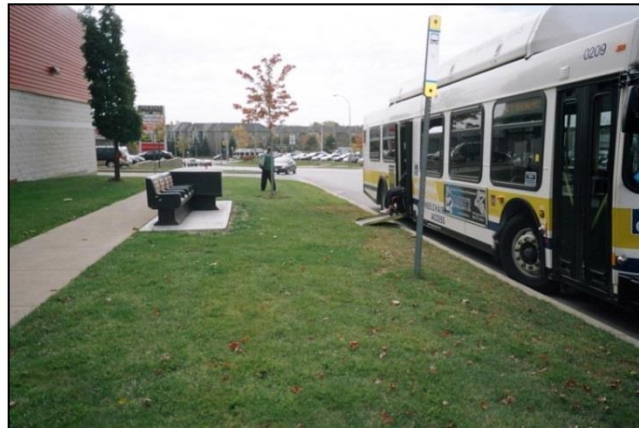
Example: Meadowlands, Neville Drive

**ACPD Presentation:**  
Inappropriate location for ramp deployment (never on grass)

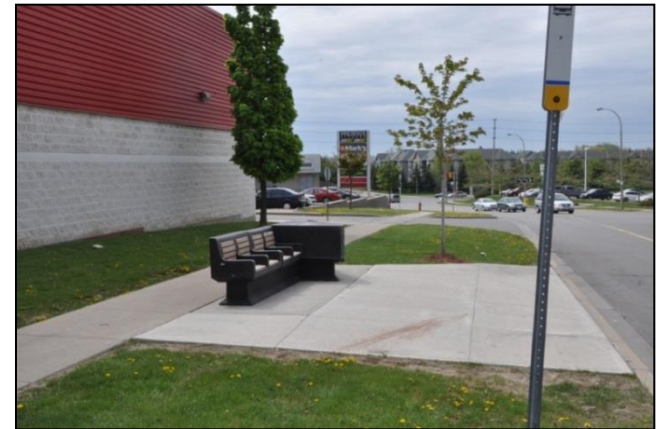
**Audit Result:**  
Stop retrofitted prior to March 18, 2013

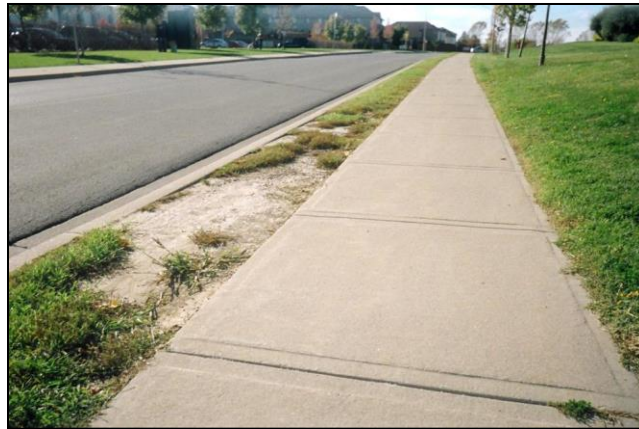
Example: Chedoke Arena (Chedmac opposite Southridge & opposite Hepburn)

**ACPD Presentation:** Ramp does not meet sidewalk, grading, uneven height

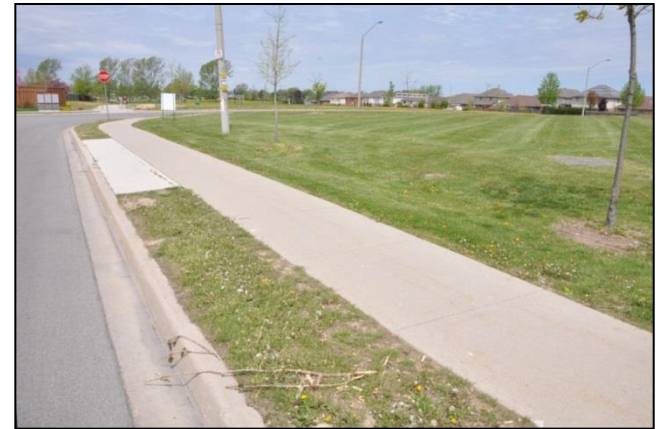
**Audit Result:** Stop retrofitted prior to March 18, 2013

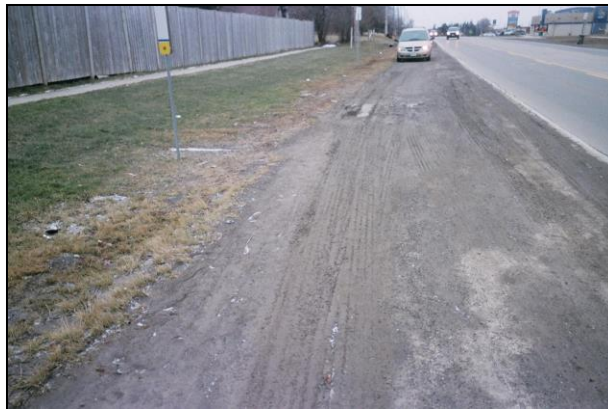
**ACPD Presentation:** Ramp deploys too steep into mud, grass, no curb

**Audit Result:**  
Rural cross sections will be retrofitted at time of urbanization

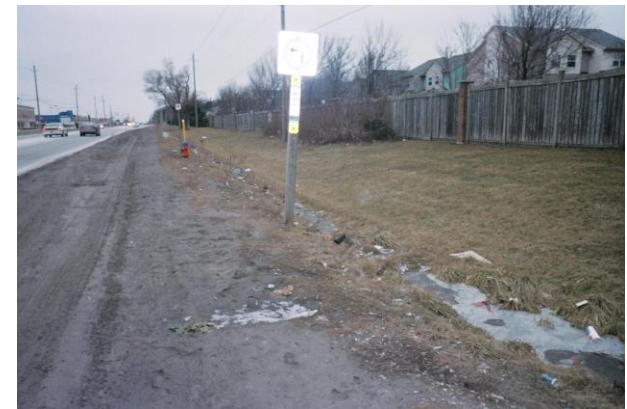
**ACPD Presentation:** Ramp deploys into ditch

**Audit Result:**  
Rural cross sections will be retrofitted at time of urbanization

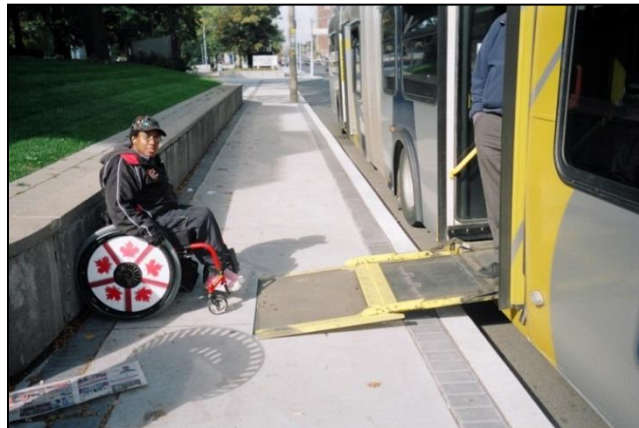
**ACPD Presentation:** Lack of room for ramp deployment

**Audit Result:**  
To be re-constructed as part of “Quick Wins” A & B Line Amenities

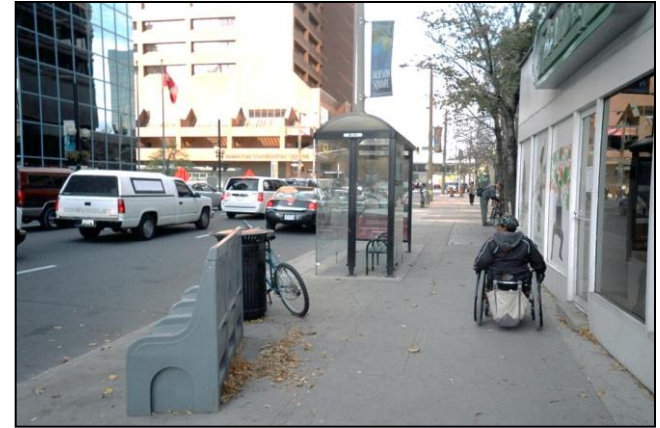
**ACPD Presentation:** Furniture placement

**Audit Result:**  
To be re-constructed as part of “Quick Wins” A & B Line Amenities

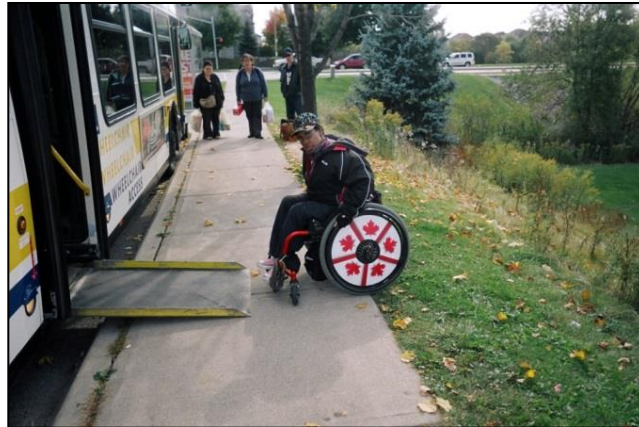
**ACPD Presentation:**  
Dangerous location,  
deployment down a slope-  
Meadowlands Stop

**Audit Result:**  
Add guide rail & widen  
deployment and loading area.

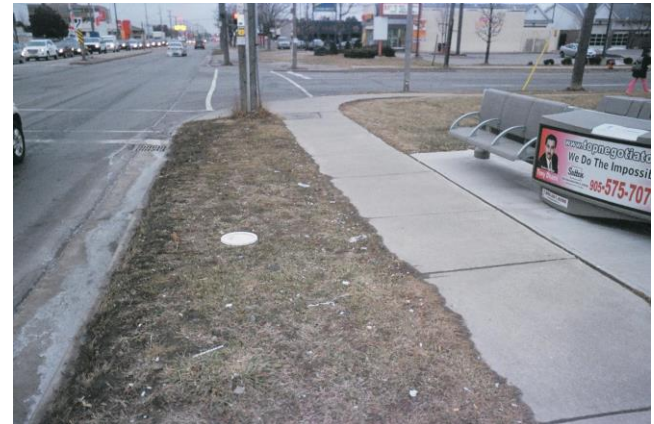
**ACPD Presentation:** Ramp  
deploys onto grass

**Audit Result:**  
Construct landing pad
