Request for Traffic Calming on Charlton Ave E

Matthew Froese P. Eng.

June 2, 2014

The Rail Trail crossing at Wentworth St S is
dangerous

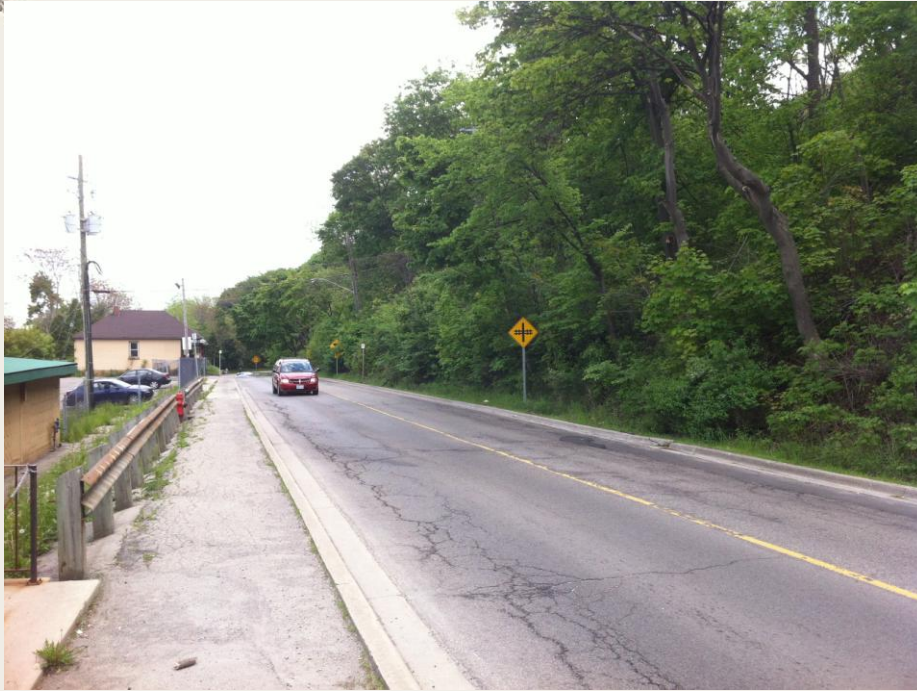
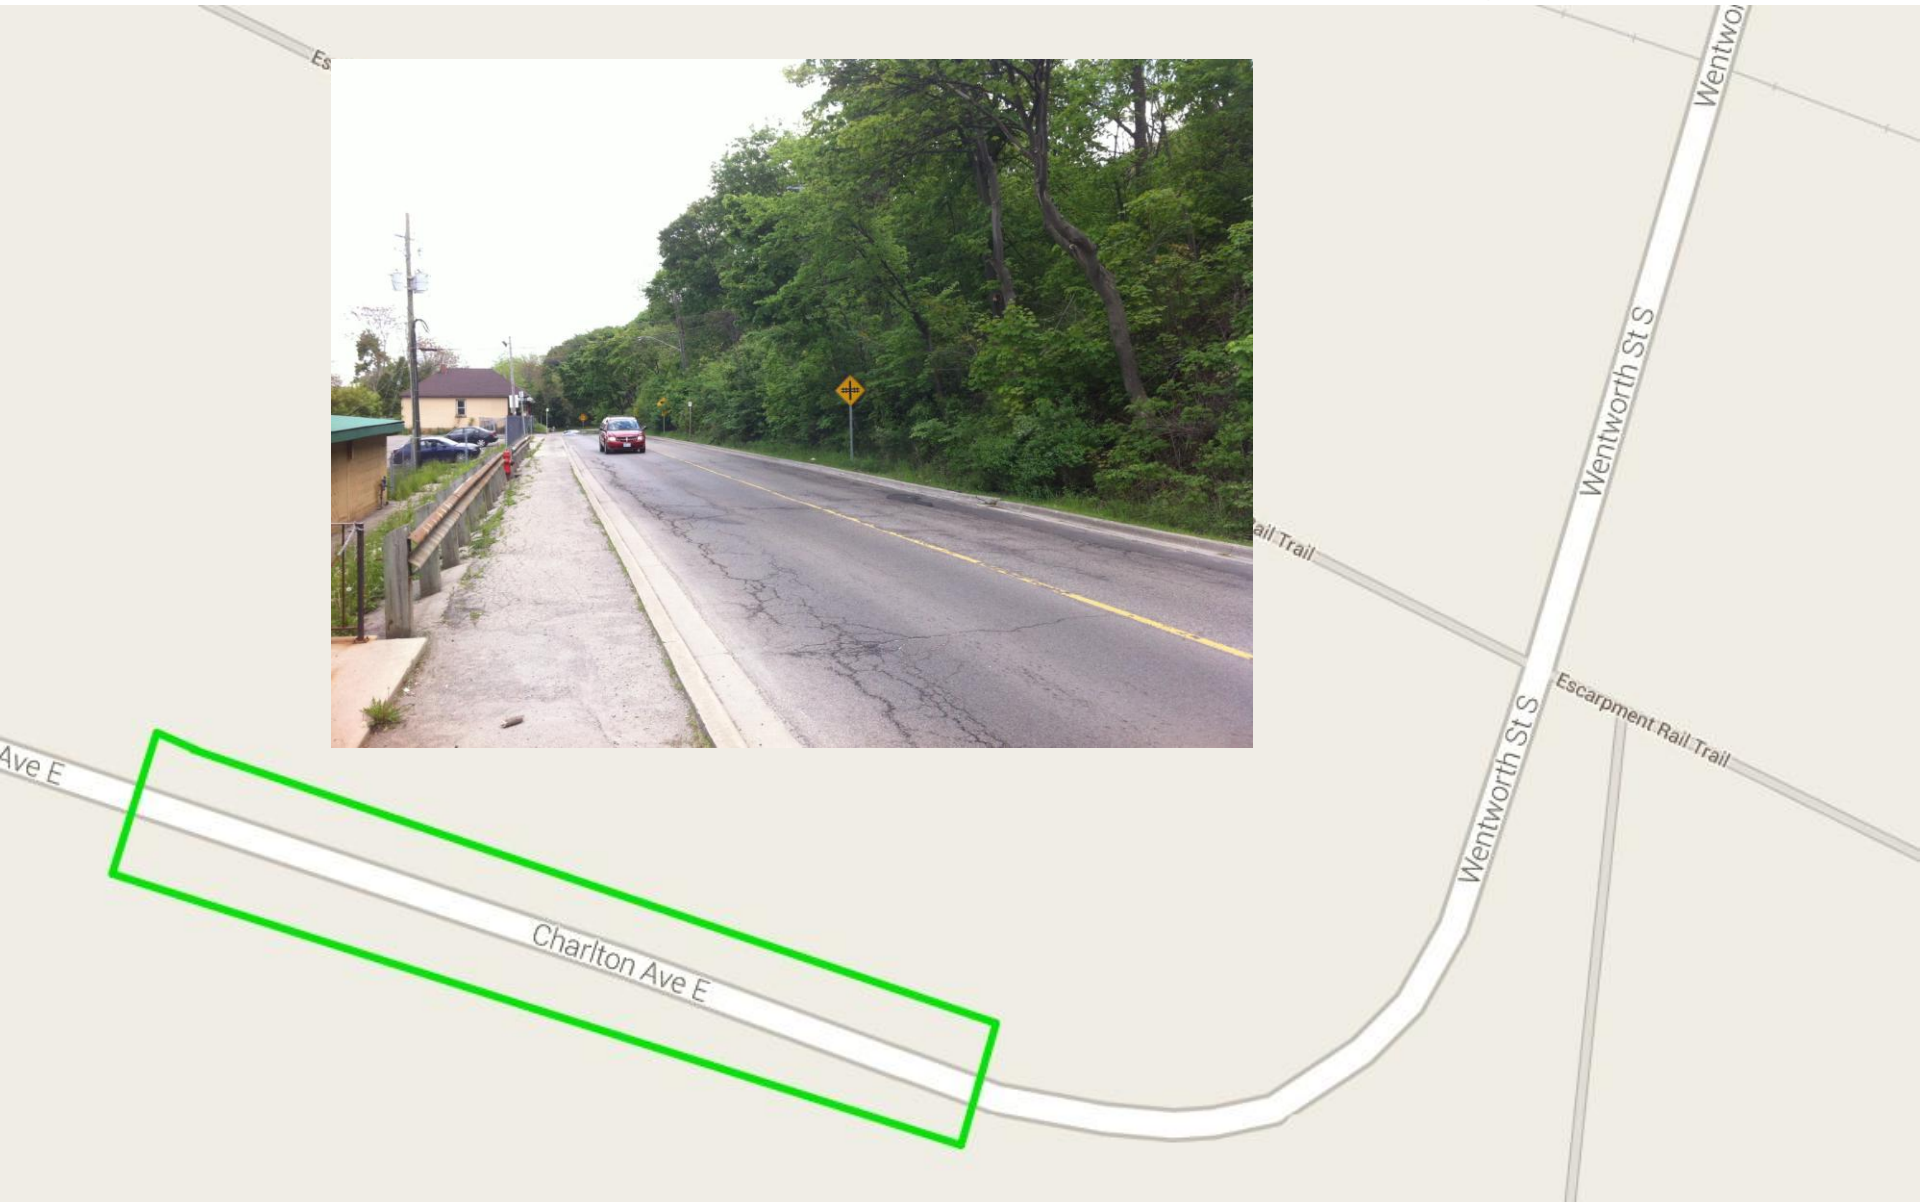
Area for Traffic Calming

- Eastbound traffic is subject to limited visibility and a difficult corner
- Vehicle speed dictates risk
- Traffic calming (speed hump) ahead of the corner would lower vehicle speeds and reduce risk
