CULTURAL HERITAGE IMPACT ASSESSMENT

**The Former Anglican Church of St. Thomas
Parsonage
18 West Avenue South
City of Hamilton, Ontario**

Report Number: 1547492-1000-R01

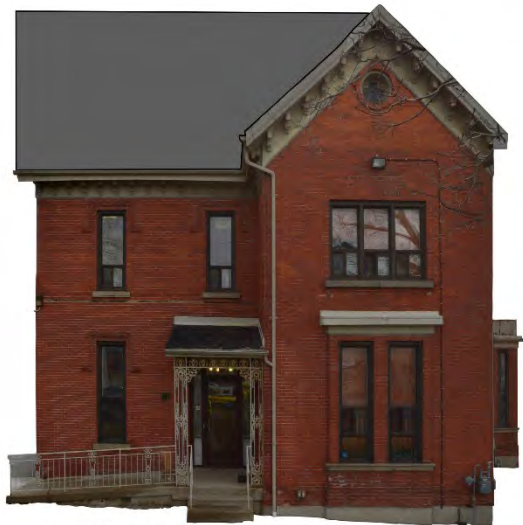
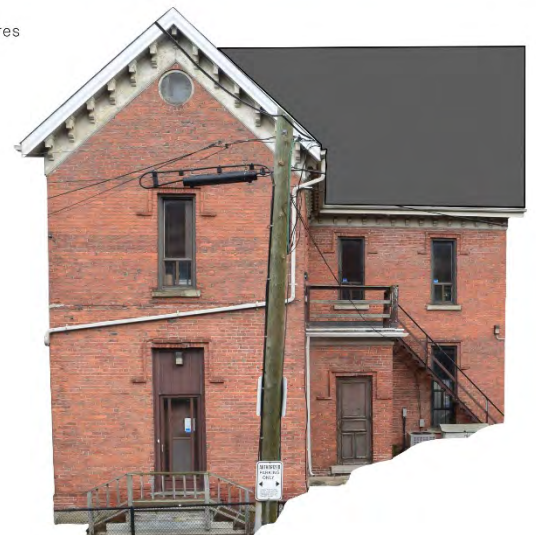
Figure 21: Rectified photography of the east, north, and west façades of the Parsonage.

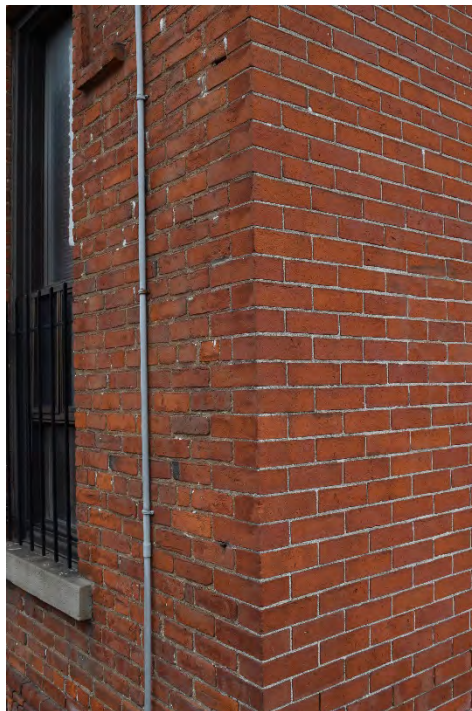
Figure 27: The southeast corner of the Parsonage showing the difference in brick bonding between the east façade (right) and south façade (left).

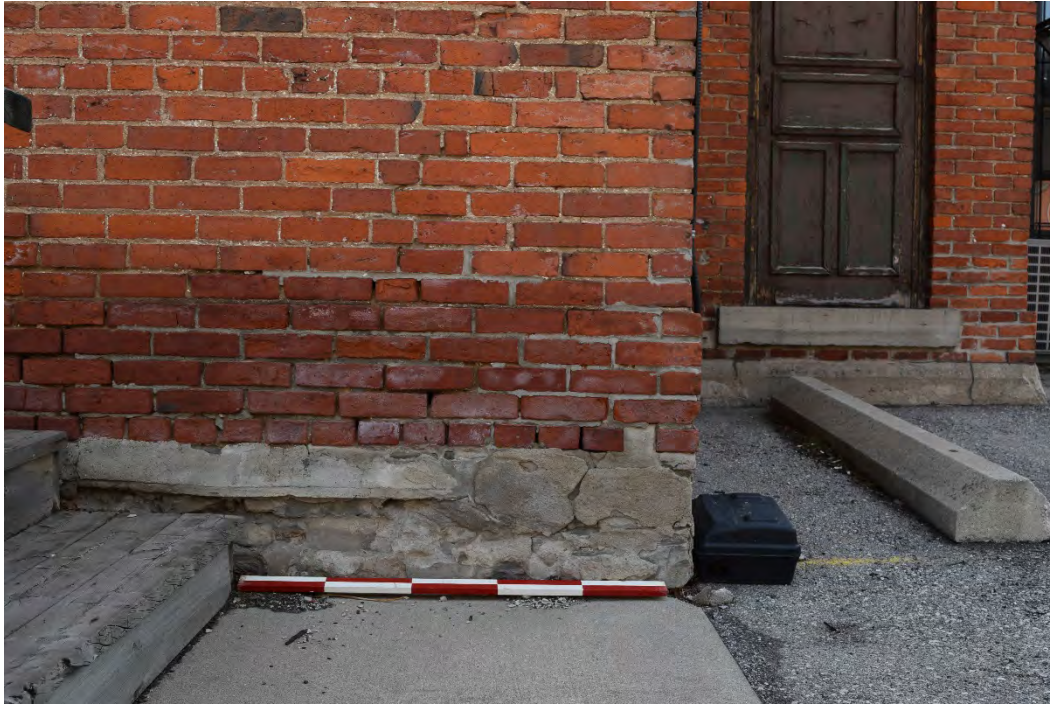
Figure 28: The brick plinth and parging over the squared stone foundation at the southwest corner of the north section.

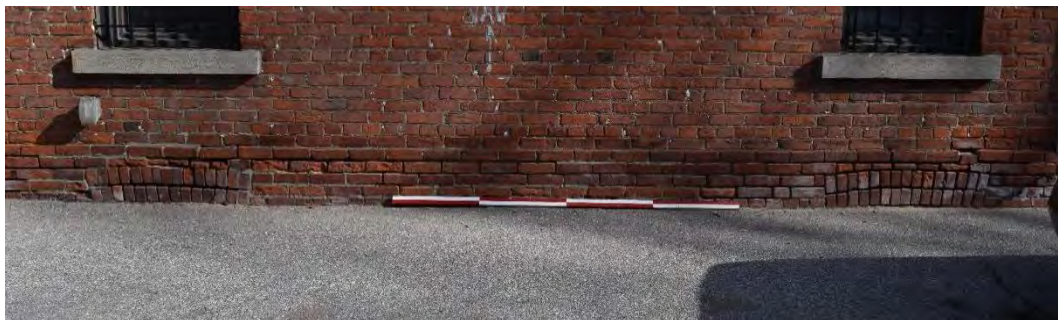
Figure 37: The two brick arches seen in the plinth of the south end wall. .

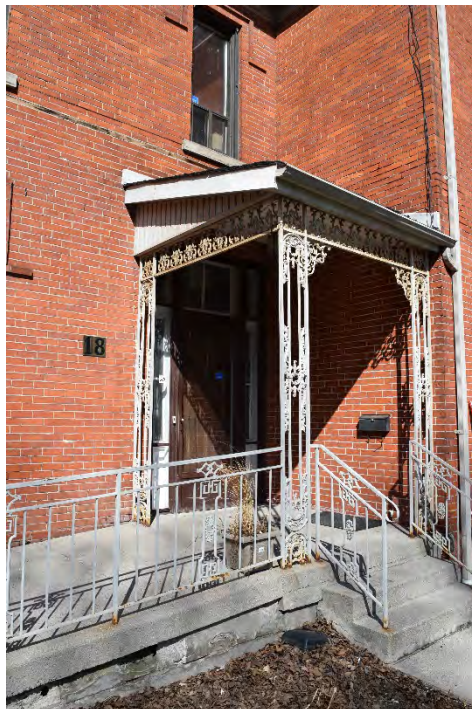
Figure 39: The east porch. Wood remnants of the earlier porch can be seen in the masonry above the present shed roof.

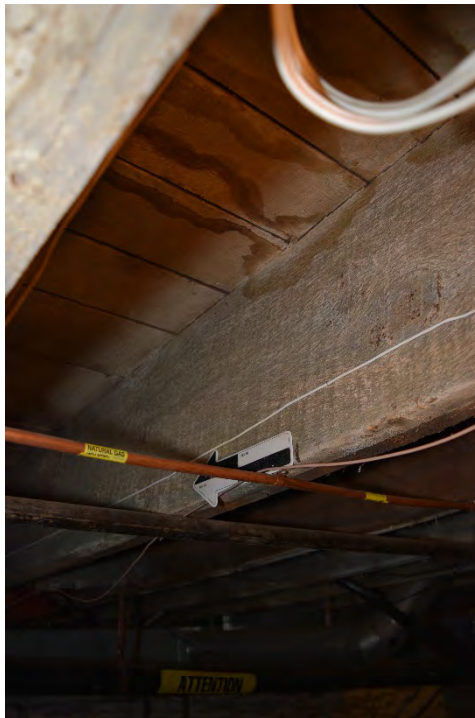
In addition to the foundation and openings mentioned above, the basement also provides a picture of the floor construction. For this, large circular sawn 12 × 3 inch floor joists running north-south are covered by 6-inch wide floor boards oriented east-west (Figure 41).

Figure 41: Circular saw marks are visible on the joists.

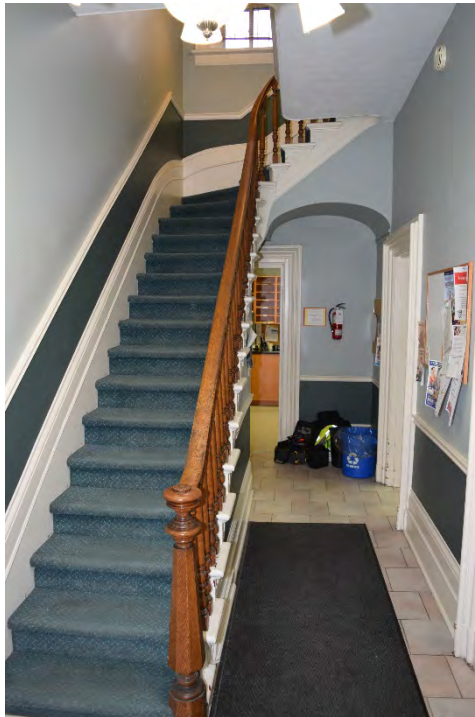
The entranceway, as mentioned above, retains the 19th century panelling, glazing, door, and mouldings, as do the doorways to the rooms in the south wing and north section. The north and south walls of the entrance passage have tall moulded baseboard and a moulded chair rail. The stairway has dark stained, turned-wood balusters and a combined turned wood and octagonal-shaped newel post with a newel cap carved as a rosette (Figure 42 and Figure 43). The railing is rounded and has an up-easing from the newel post that does not appear to have been built in segments but rather shaped as a single, curved rail section. There are curvilinear skirt brackets on the white-painted stringers, and there are also mouldings beneath the tread nosing (Figure 44). On the wall side of the stair case is a tall and rounded baseboard and above it a moulded chair rail. At the second level the stairs turn 90 degrees on a sharp curve, which the woodwork follows. Beneath it is a segmental arch formed with plasterwork (Figure 45).

Figure 45: The stairway and associated arch.
