West Harbour Waterfront

Bayfront Beach Water Quality Investigation

APRIL 20, 2017

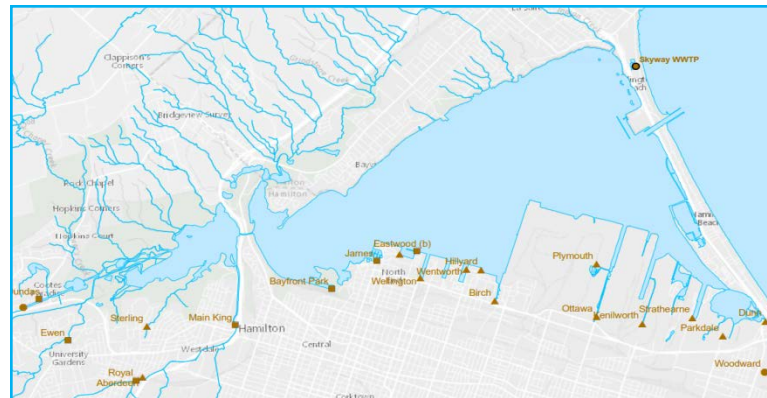
Point Sources

- ▲ CSO
- CSO with Tank
- WWTP
