**Public Works Committee  
June 19, 2017  
Item 7.1**

**Public Works Department  
Engineering Services Division**

**Escarpment Rehabilitation & Strategy Plan**

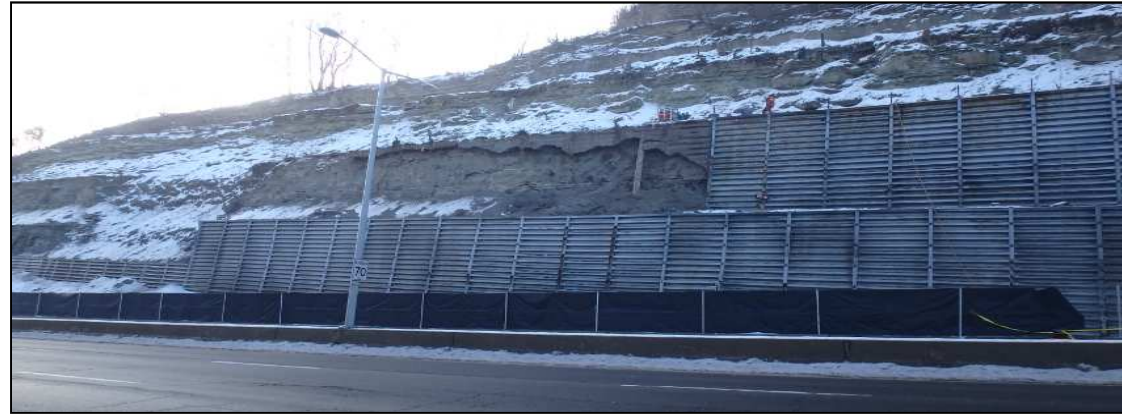
Bin Wall Failure – 2012 & 2016

### Completed Short-term Mitigation Measures

1. Removal of 1091m<sup>2</sup> Steel Panels
2. Installation of tie-back anchors and ropes
3. Installation of a 300m rock fall protection fence

Estimated total cost to date \$1.35 M
