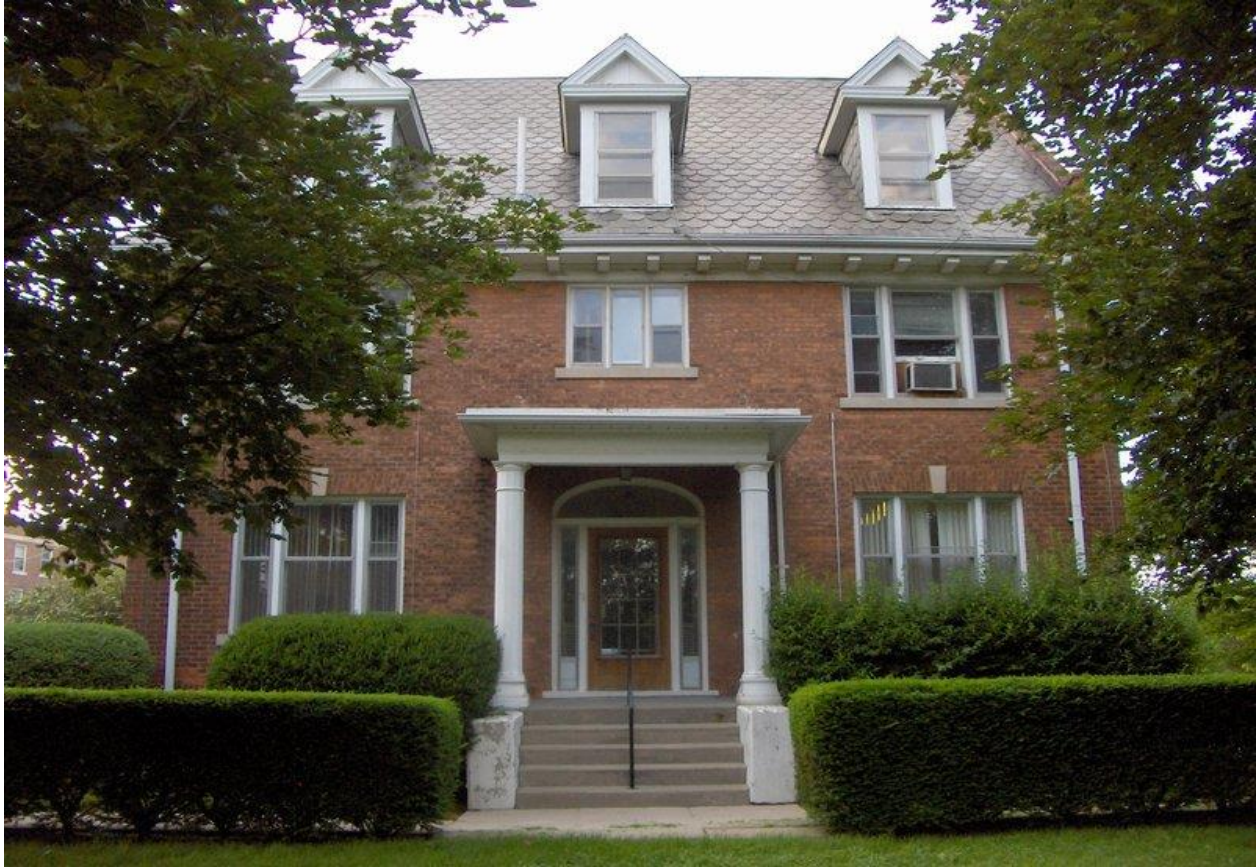
**Figure 1:** Front (south) façade of the former Medical Superintendent’s Residence, the “San House”, at 650 Sanatorium Road, Hamilton (Historical Hamilton, 2015).

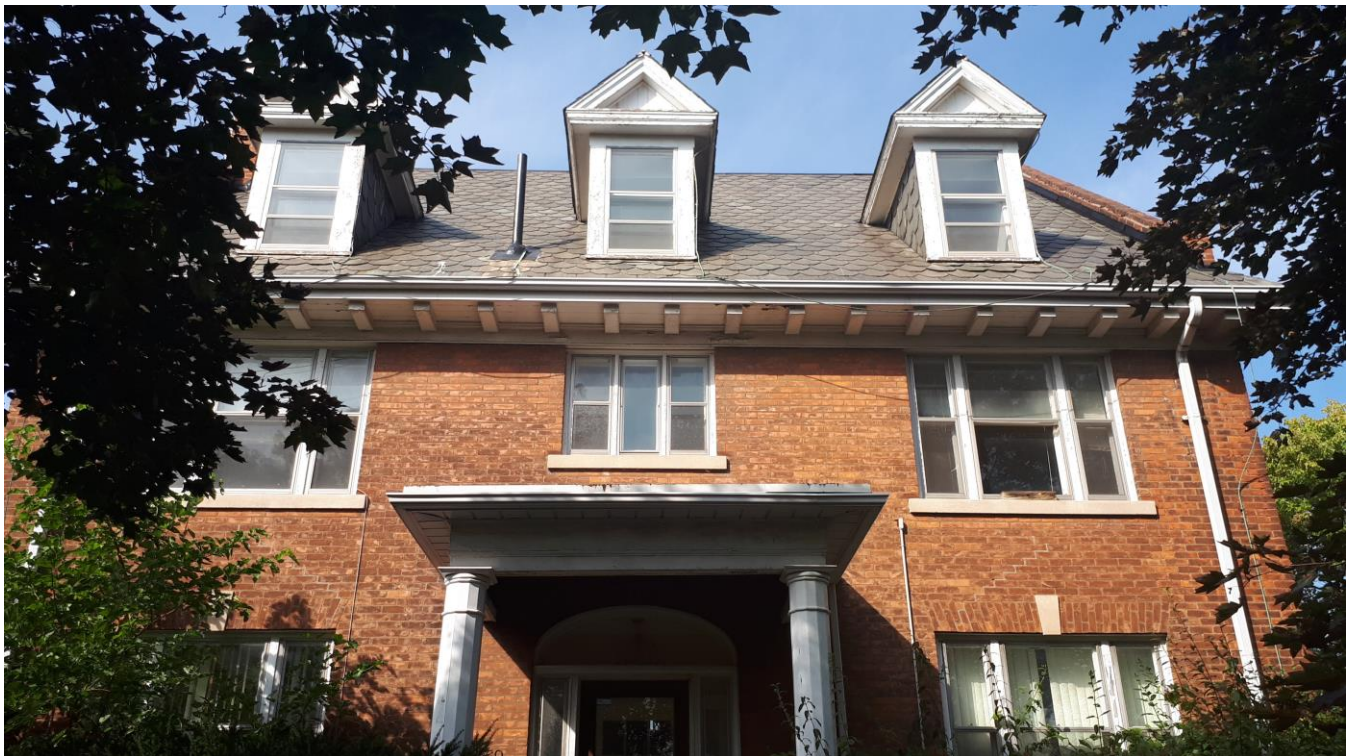
**Figure 2:** A closer view of the symmetrical southern façade showing the columned portico, window keystones, slate roof, and Classical pedimented dormers (2017).

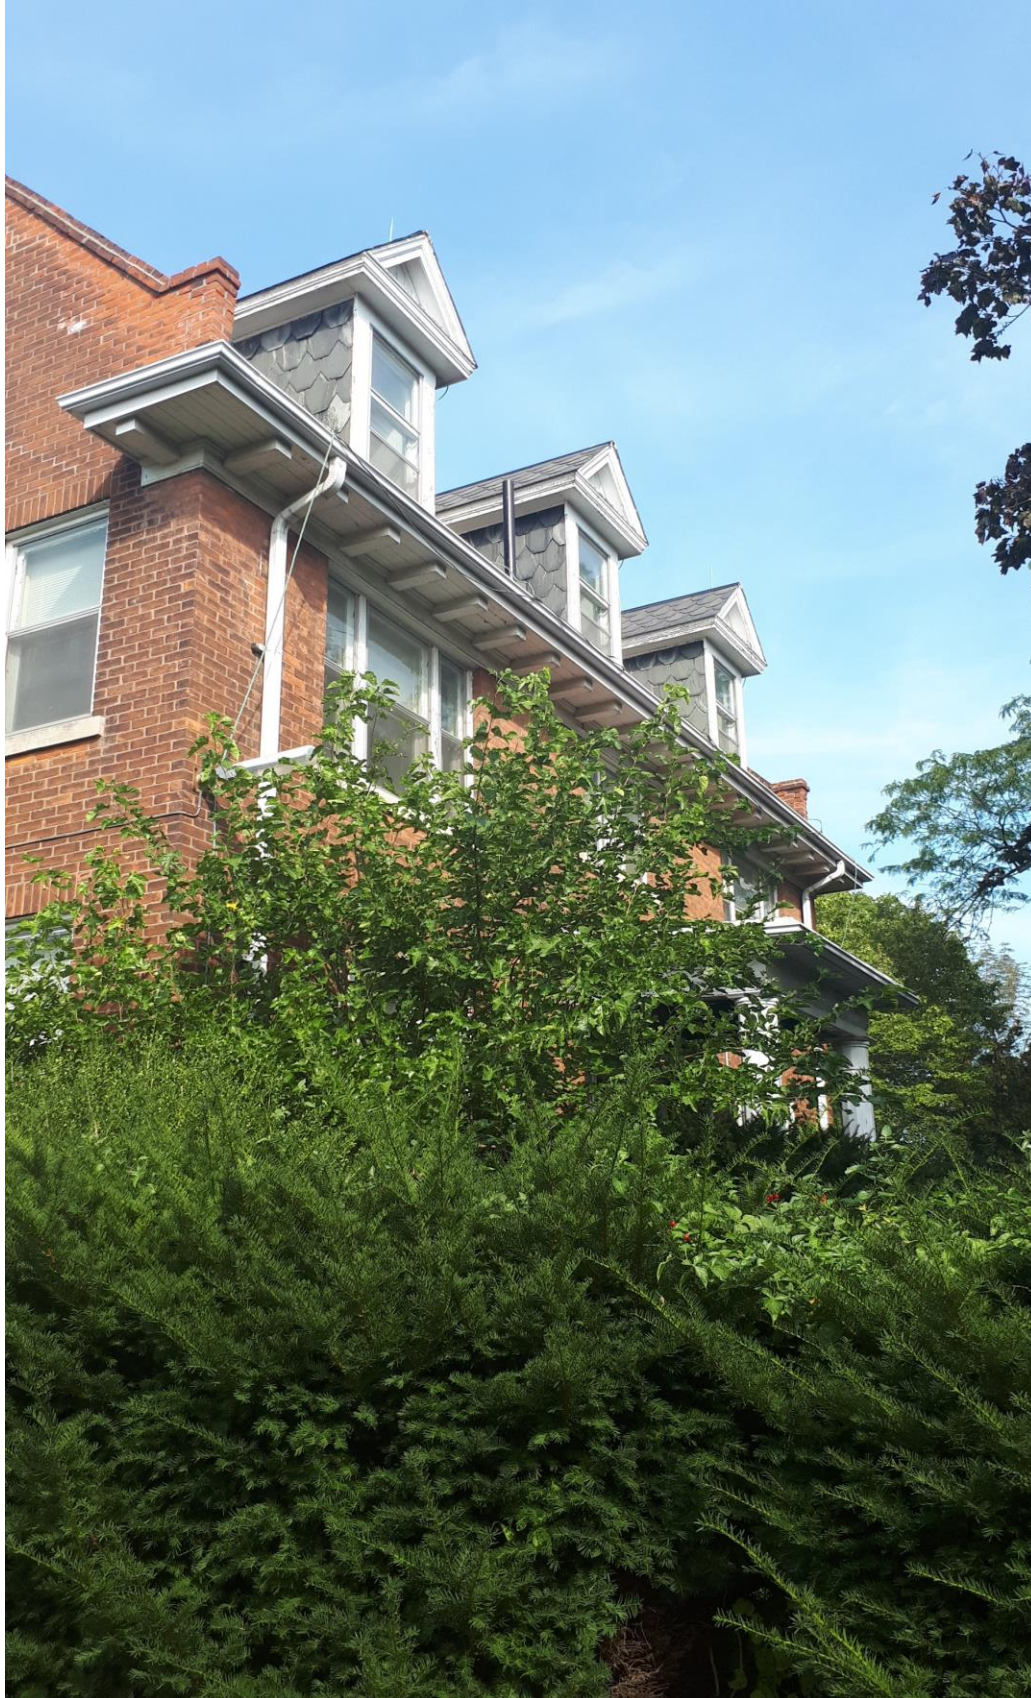
**Figure 3:** View from the southwest corner of the roofline profile. The image displays slate siding on the dormers, projected brick corbel corners, and modillion brackets on the underside of an extended cornice soffit (2017).

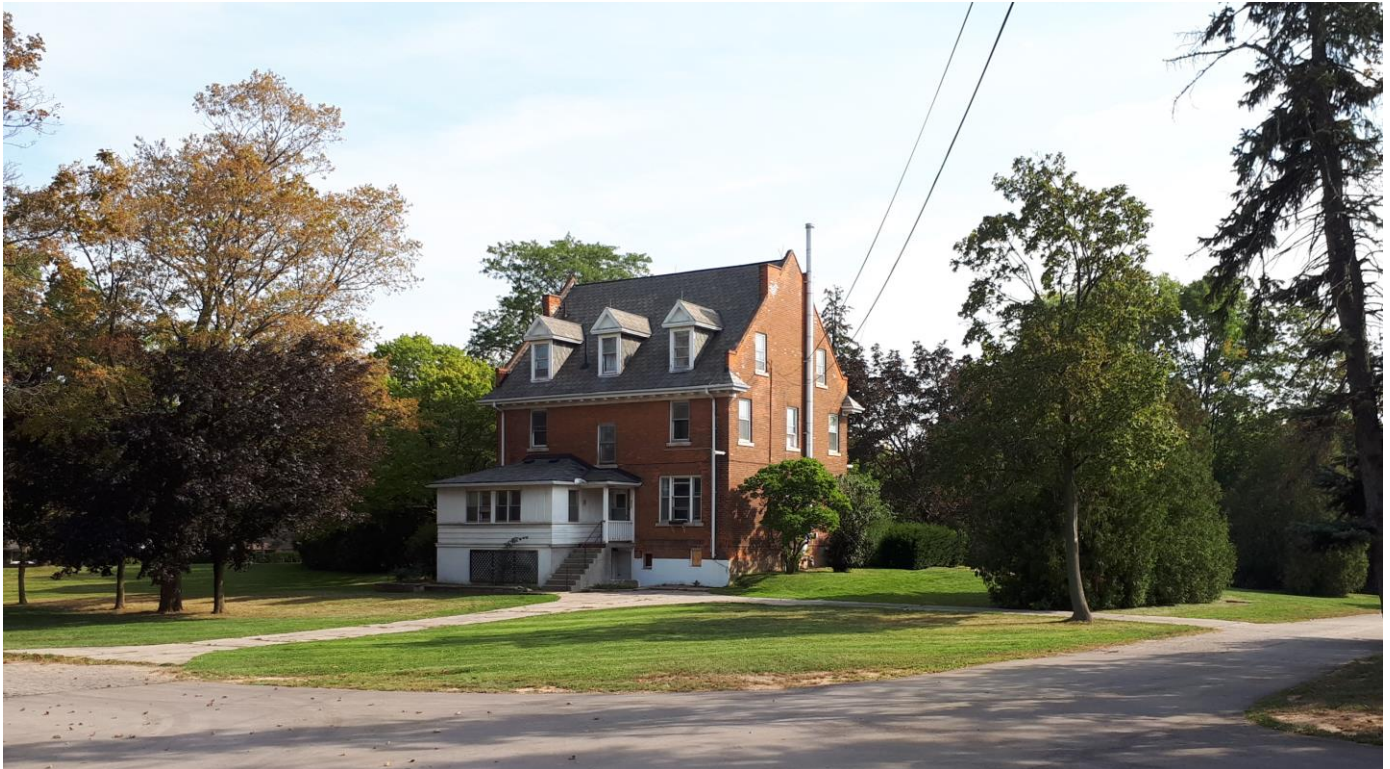
**Figure 4:** View of the rear of the building (north and west elevations) showing a matching profile with equivalent pedimented dormers. An early one-and-a-half storey aluminum and wooden-clad addition is shown on the eastern portion of the rear façade (2017).

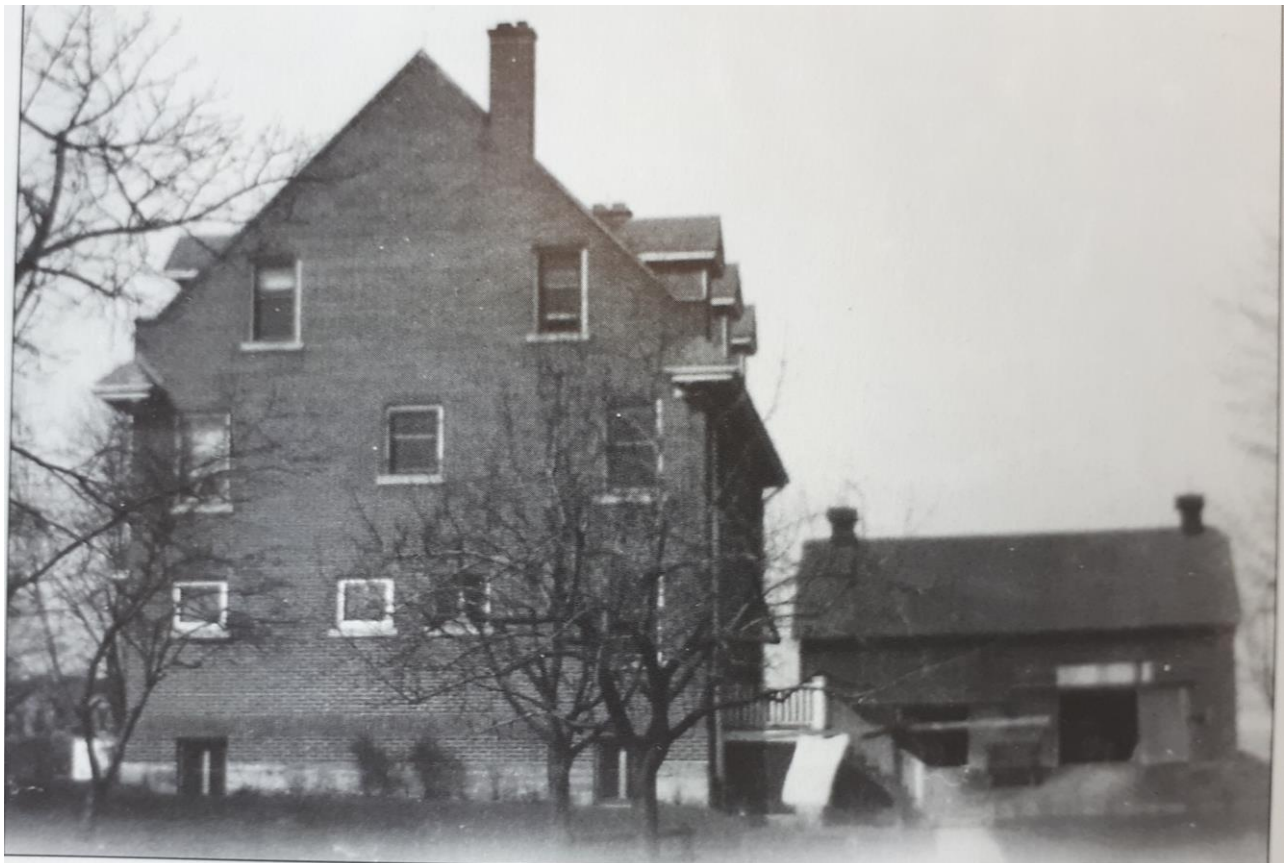
**Figure 7:** An early photograph of the San House, looking west. A bank barn which was believed to be torn down in the late 1930s can be seen in the background (Ralph Wilson, *Chedoke: More Than a Sanatorium*, 2006).

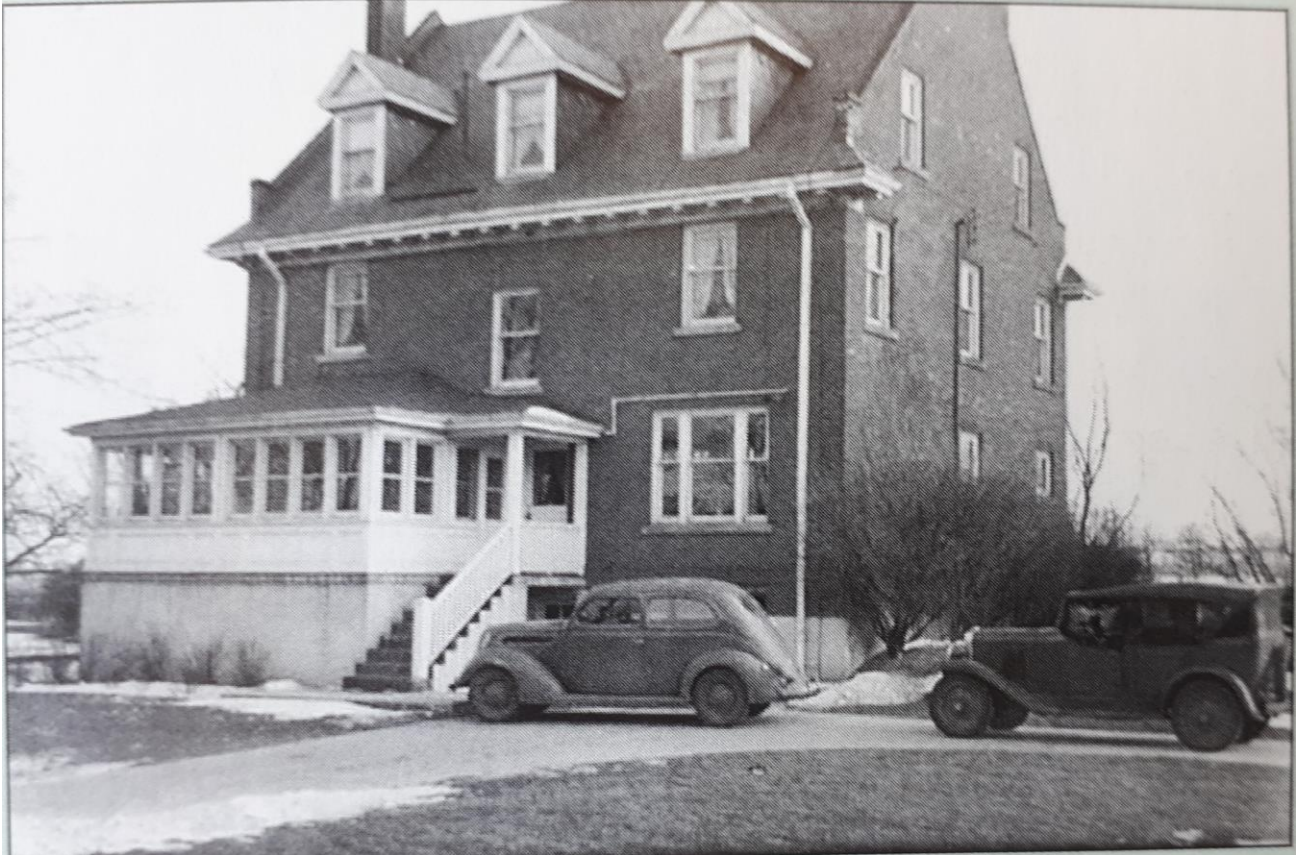
**Figure 8:** A circa 1930s photograph showing the rear of the building, the early wood-clad addition, and two automobiles (Wilson, *Chedoke*, 2006).

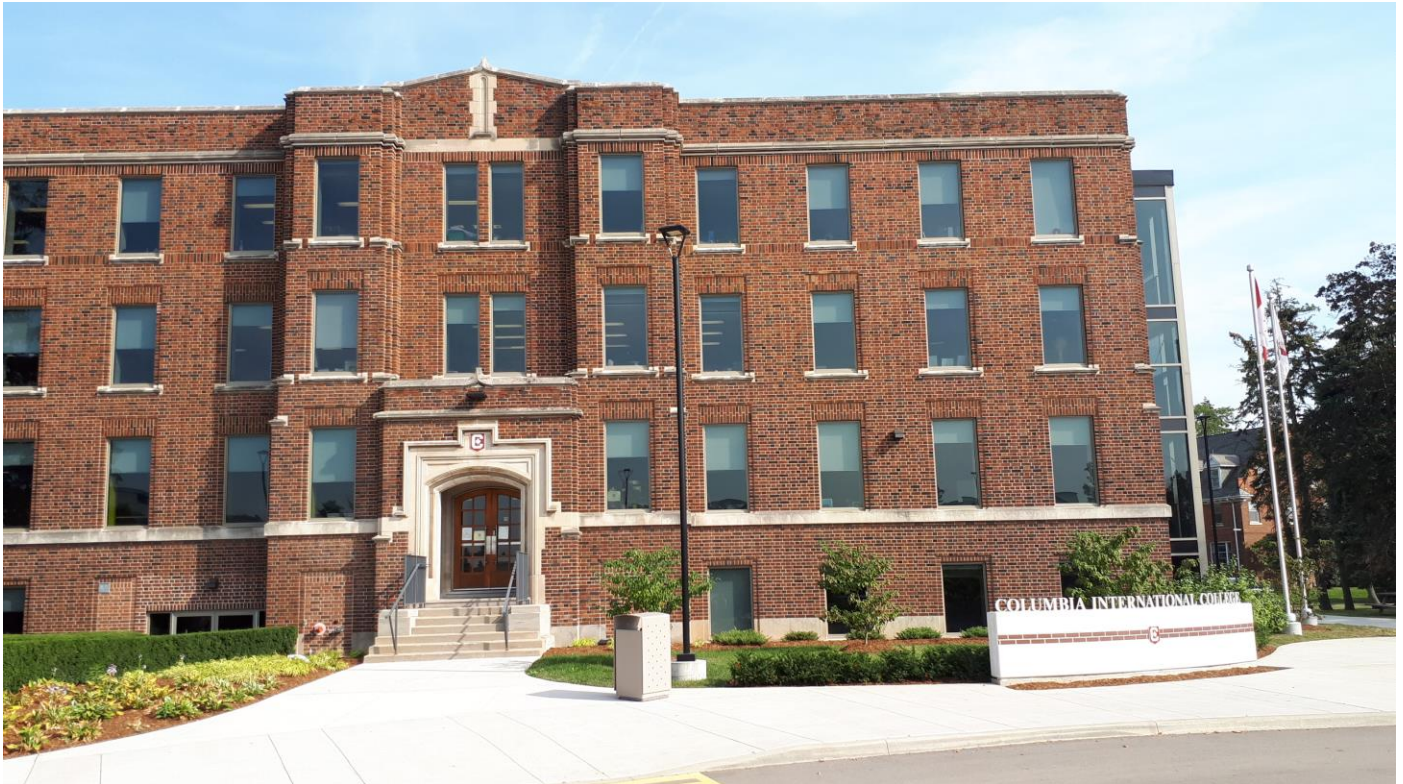
**Figure 12:** The southern end of the front (west) façade of the Patterson Building now owned and adaptively-reused by Columbia International College. The projected entrance features a subtle ogee arch peak and an attractive hood moulding made of stone (2017).

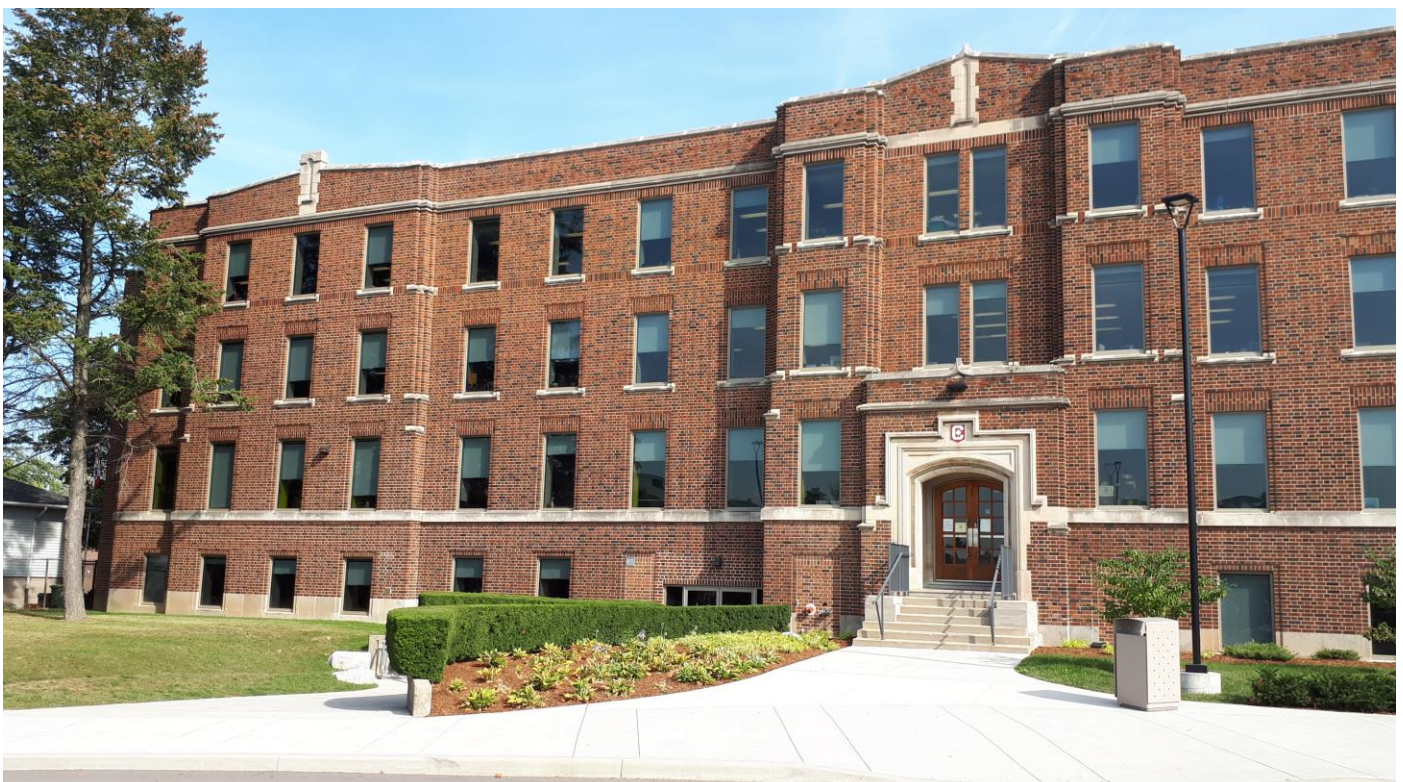
**Figure 13:** The northern end of the front façade. The building displays a restrained application of the Gothic Collegiate style with roofline enhanced with open stone niches (2017).

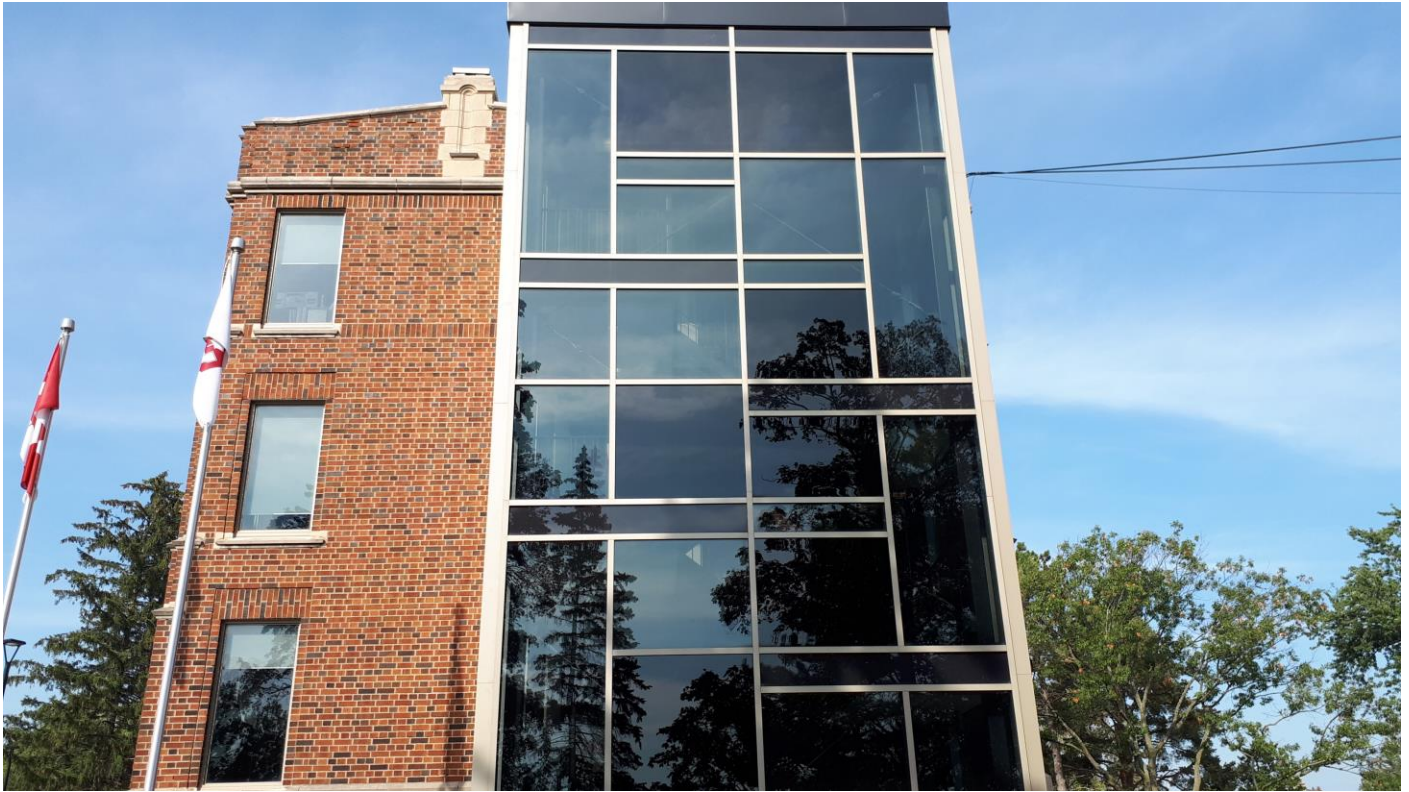
**Figure 14:** The southern end of the rectangular Patterson Building with a projecting modern glass addition housing a connecting stairwell (2017).

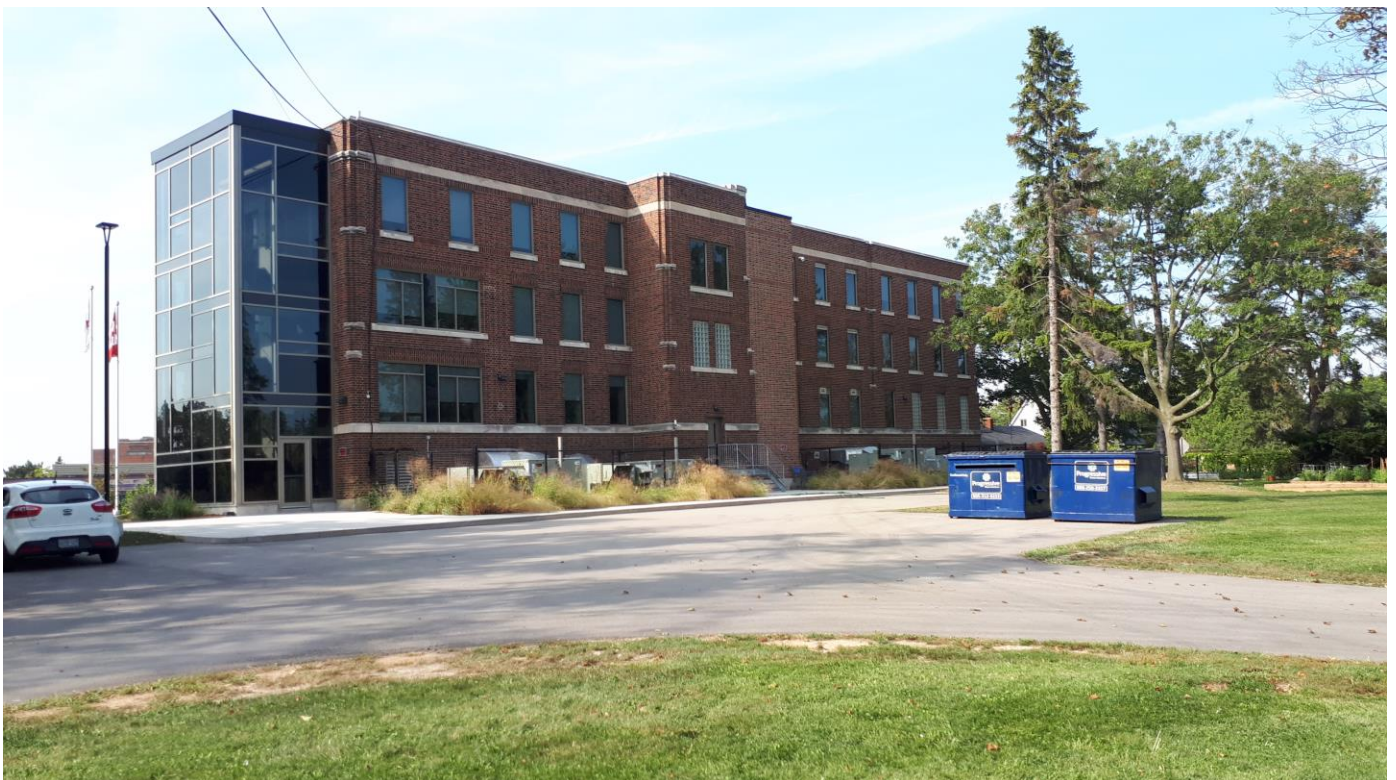
**Figure 15:** The rear (east) portion of the building. Note the modern addition, off-colour brick elevator addition, and modern windows. The brick building features a simple rear façade with stone sills, soldier course brick lintels, and stone stringcourses running the length of the façade (2017).
