BUILT HERITAGE INVENTORY FORM

Address 1320 WOODBURN ROAD Community GLANBROOK
 Also known as The Edmonds House Legal Description Binbrook Con 2 Pt BLK 2; Lots 1 to 3
 P.I.N. 173800373 Roll No. 251890121039600 Ward 11 Neighbourhood WOODBURN

1320 Woodburn Road

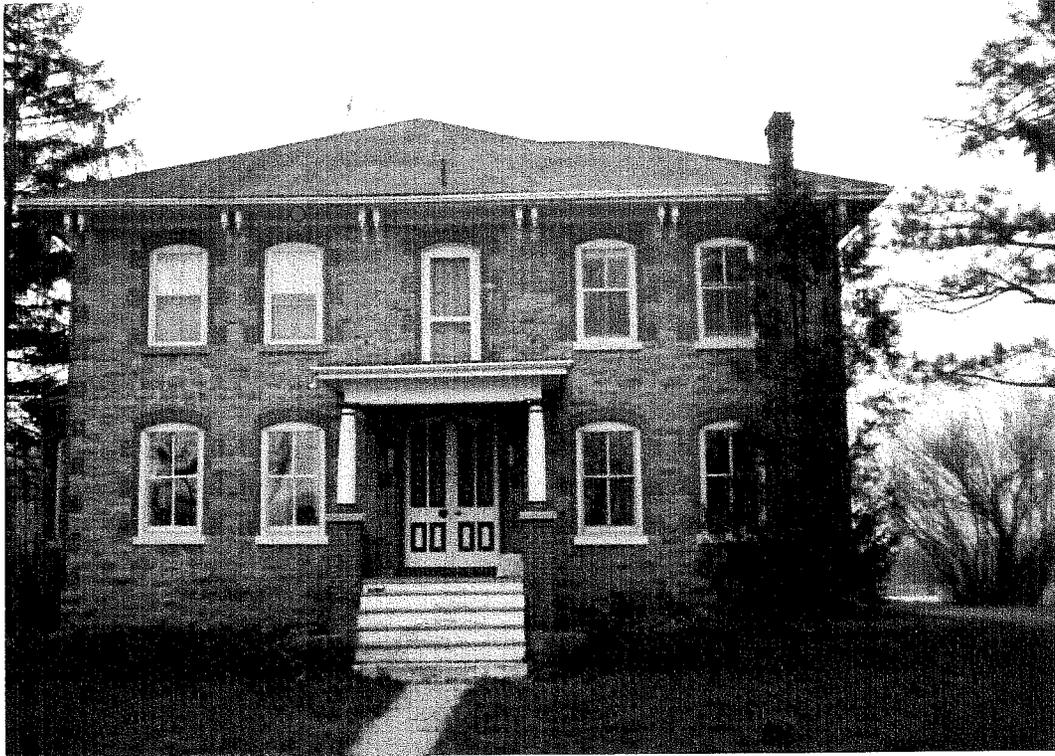
- full basement, divided by a stone wall for support

- walls composed of solid stone with plaster on the inside
- stones were drawn from Oakville by oxen
- walls are two feet thick
- pine floors
- original front doors
- original staircase ; the same as the staircase in the Ridge, and the Bailey home
- two storey, single house
- this stone house would have been considered a "rich" person's home when it was built

- the roof is now asphalt shingles
