# FirstOntario Centre

## ARENA RENOVATION STUDY

**BBB ARCHITECTS**

Stadium Consultants International

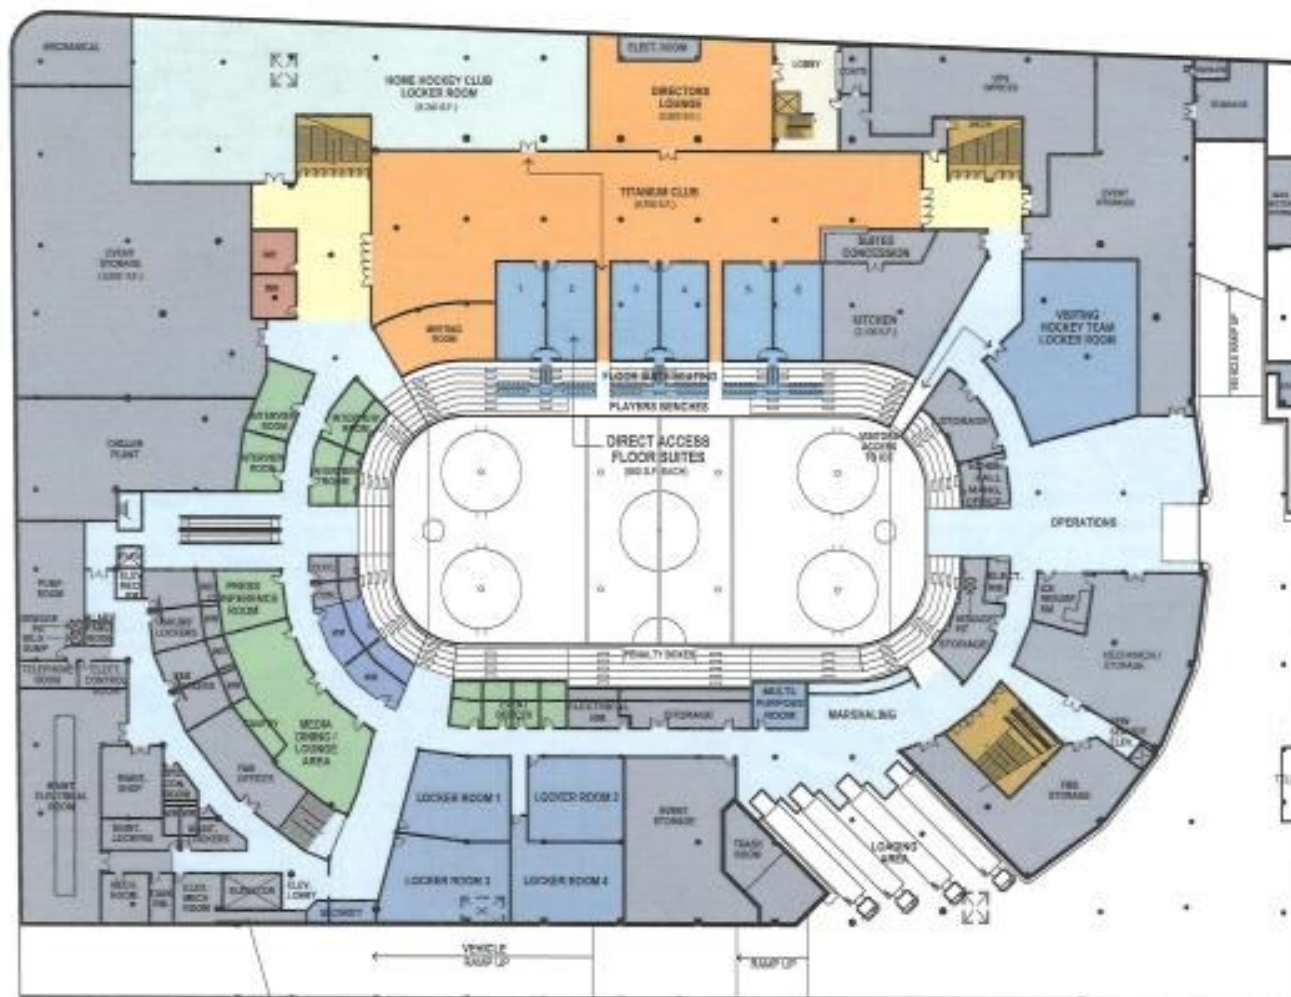
OPTION 1 - ARENA  
RENOVATION STUDY

L1 - EVENT LEVEL

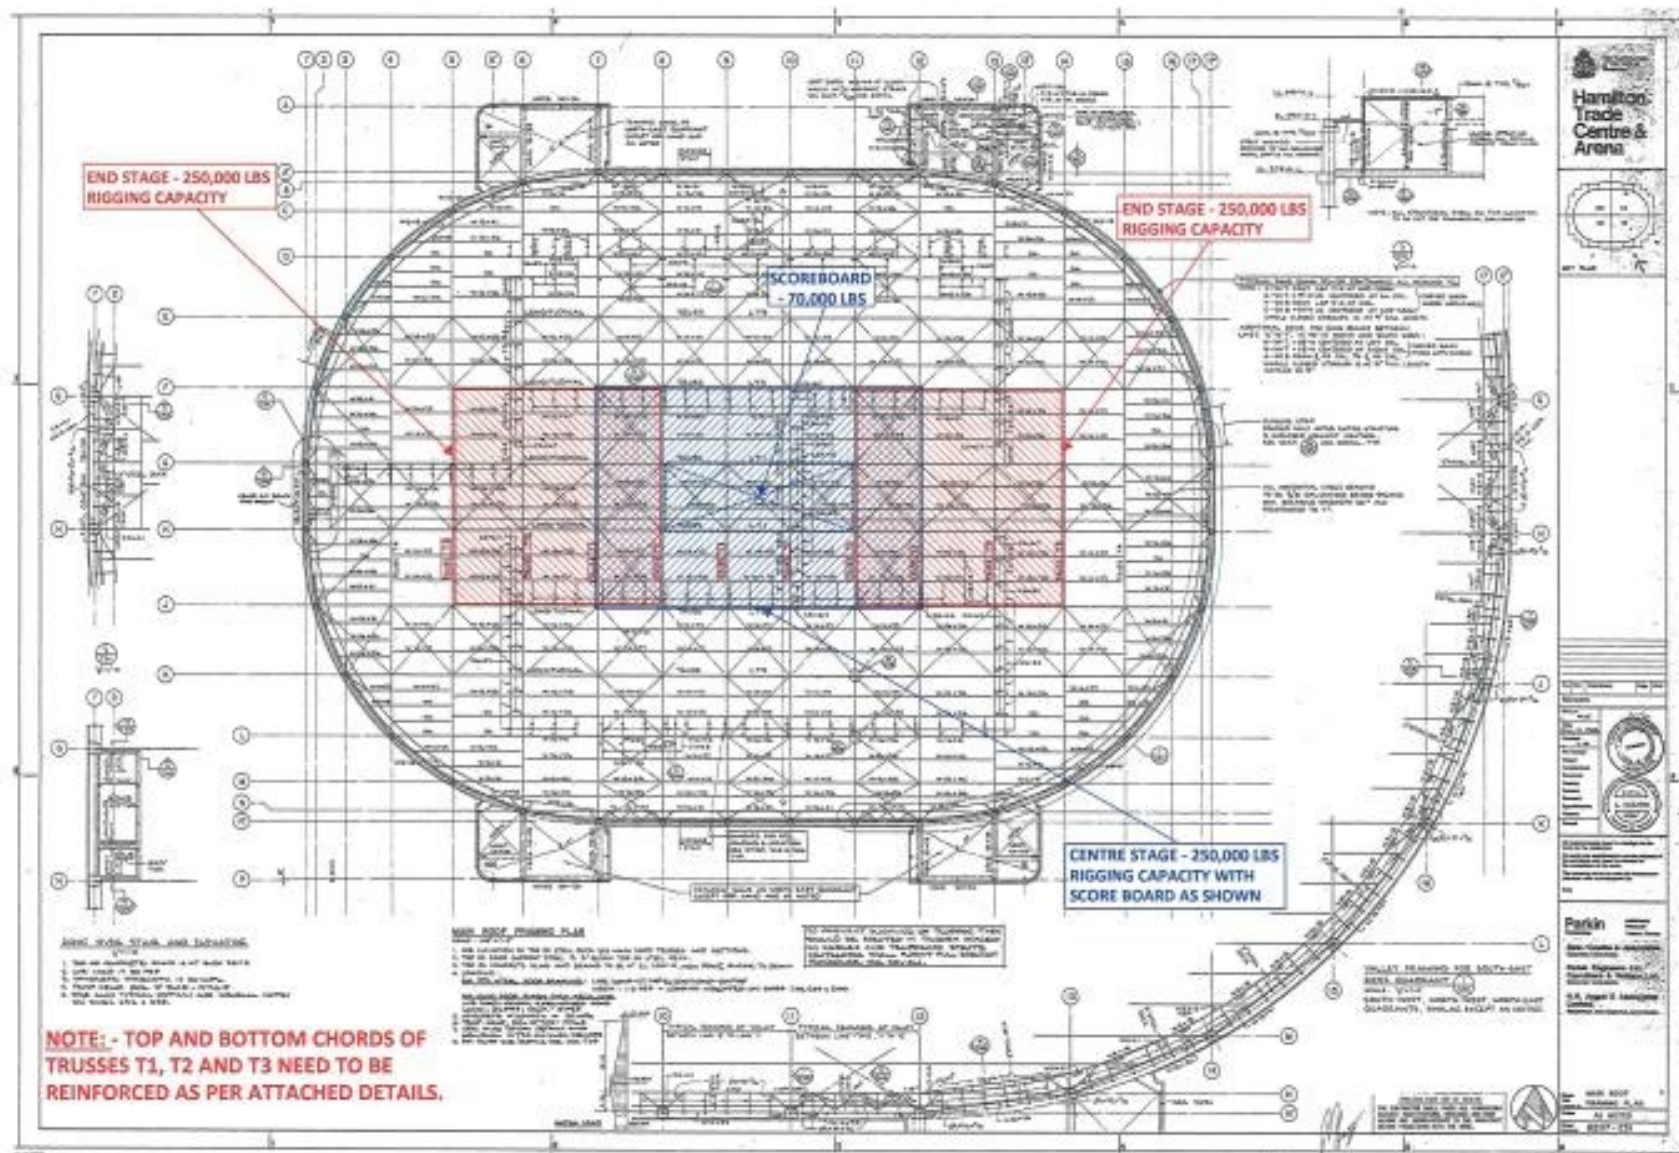
NEW HSS 8x8 ES - TOP CHORD REINFORCEMENT

NEW W8 - BOTTOM CHORD  
REINFORCEMENT - TYP.

FIELD BOLTED SPLICE PLATE

NEW HSS 6x5 ES - TOP  
CHORD REINFORCEMENT

INTERMITTENT STAGGERED WELD - TYP

NEWWB - BOTTOM CHORD  
REINFORCEMENT

INTERMITTENT STAGGERED WELD
