**INTEGRATED MONITORING PLAN  
RED HILL VALLEY PROJECT  
COMPREHENSIVE 5-YEAR SUMMARY**

**CITY OF HAMILTON**

**FINAL REPORT**

**May 2015 (June 2018)**

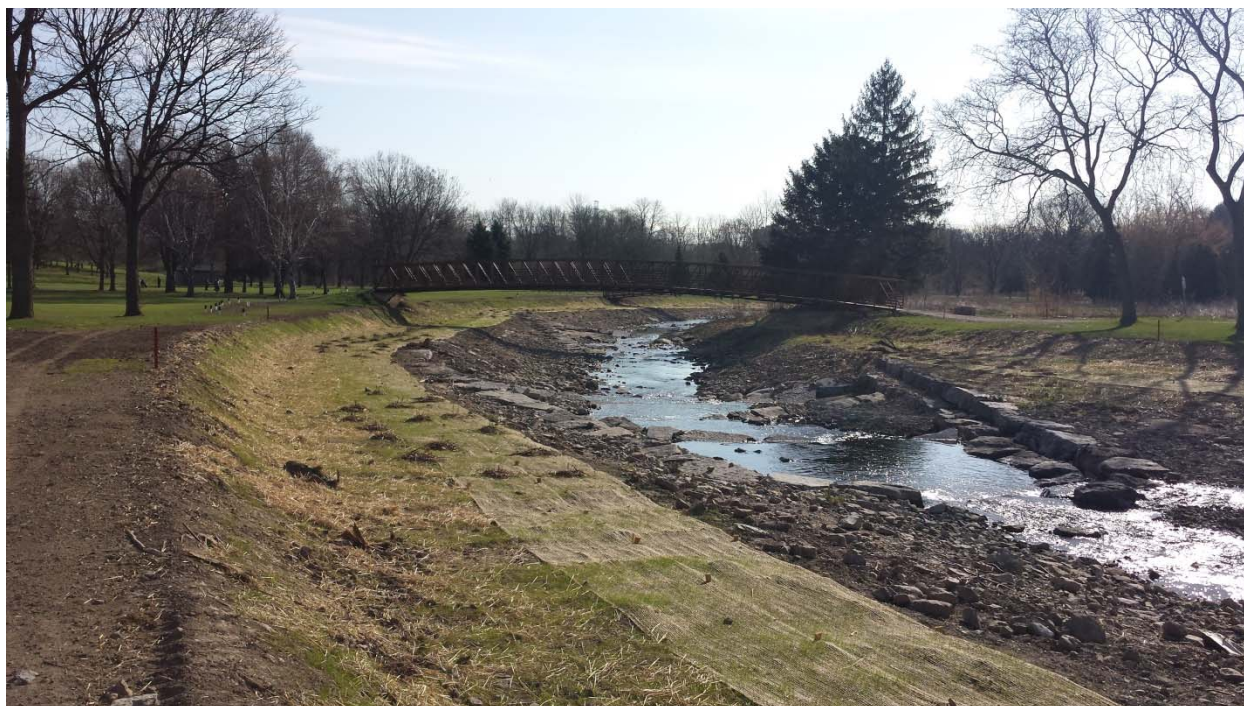
**Figure 2.4.3 2015 channel works through King's Forest Golf course which shows increased golf cart bridge spans, floodplain benches and modified in-stream structures.**

the steepest. The decreased number of monitoring cross sections observing erosion in excess of 0.3 m is a combined result of the lower magnitude event, relative to the July 2009 event, enhancements made to many of the in-stream structures further mitigating channel erosion (discussed further), and the increased density in riparian vegetation downstream of King's Forest Golf Course. Subsequent to observing the channel responses from the July 2012 storm and based upon continued monitoring and adaptive management, the initial design constraints of limited floodplain width and golf cart bridge spans, narrower than those recommended and constructed for the remainder of the rehabilitated reach, were re-addressed. In the spring of 2014, golf cart bridge spans were increased to 38 m and installed. In the winter and summer of 2015, increased floodplain connectivity by widening the existing creek floodplain corridor and the re-construction of the in-stream structures with further enhancements are currently underway (Figure 2.4.3).

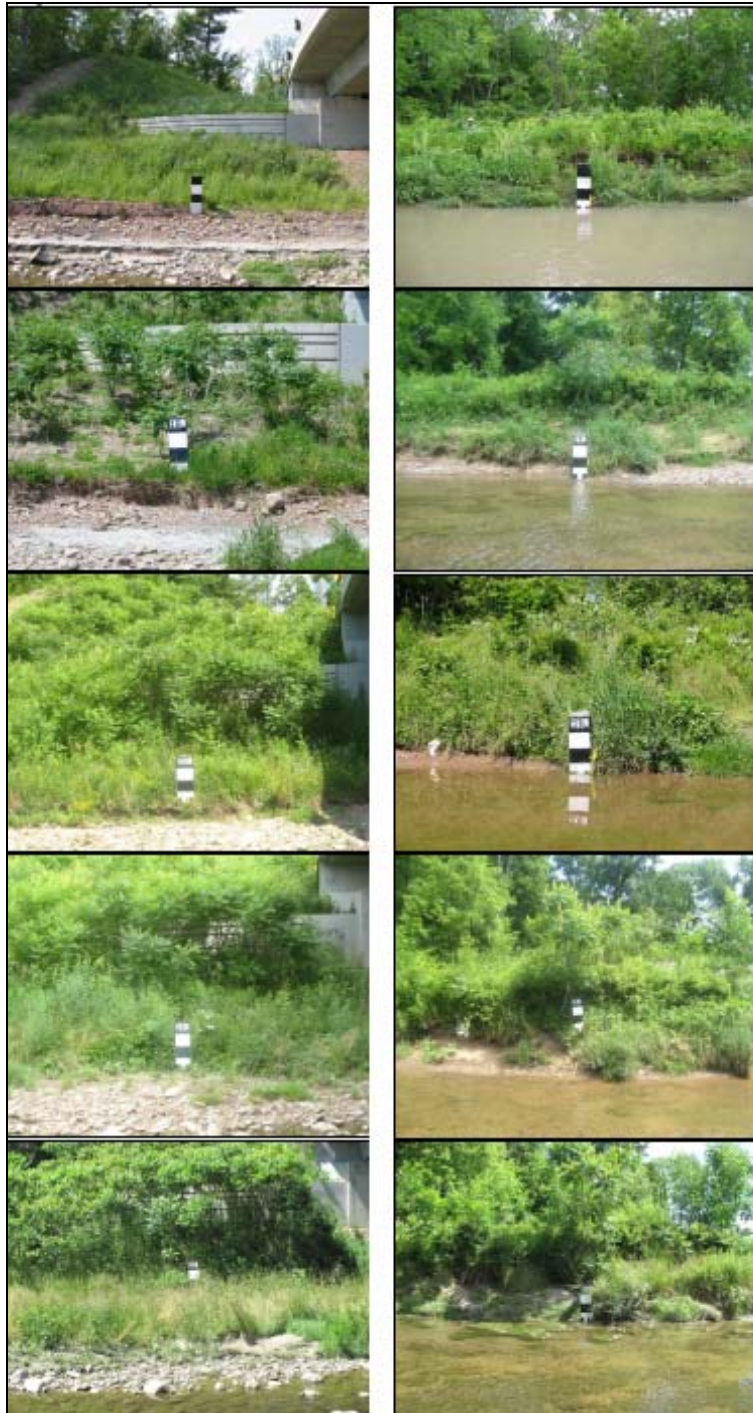
Figure 3. Photo monitoring images for transects 15 (left) and transect 19 (right) from 2008 – 2012.

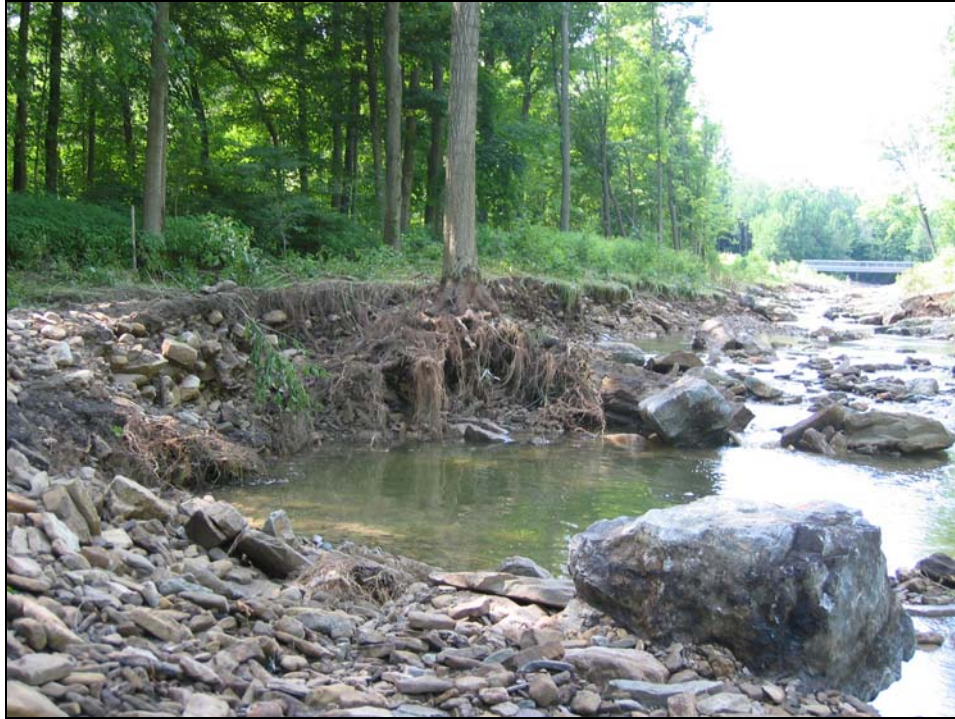
**Figure 4. Extensive erosion of the creek channel and embankment following the flood on July 29th, 2009. King's Forest between transects 2 and 3.**

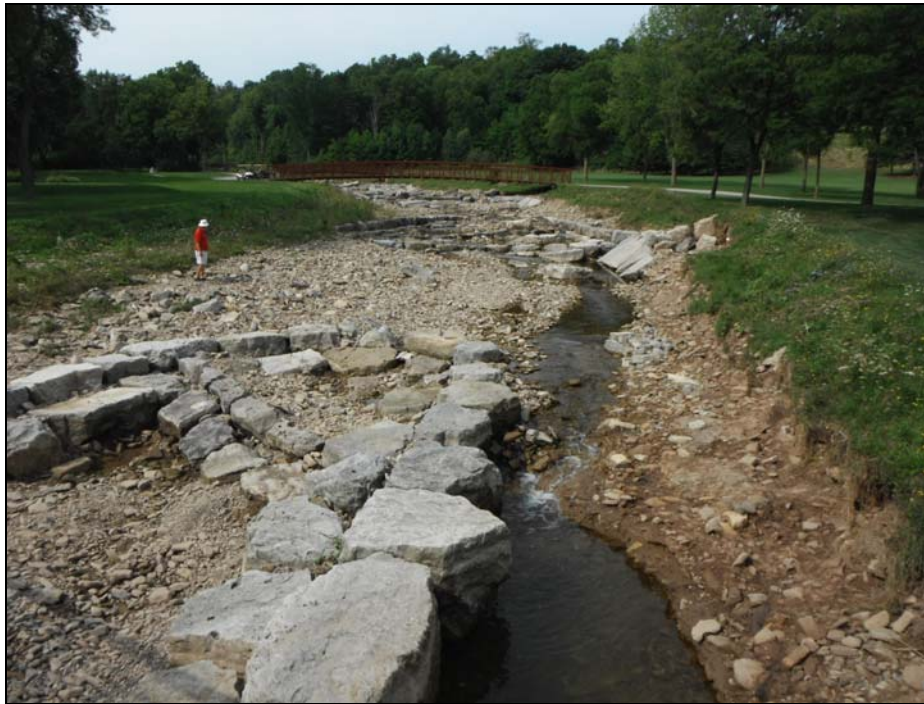
Figure 5. Red Hill Creek post-flood event on August 9<sup>th</sup>, 2012 showing extensive scouring of the channel bank and loss of vegetation in King's Forest Golf Course.

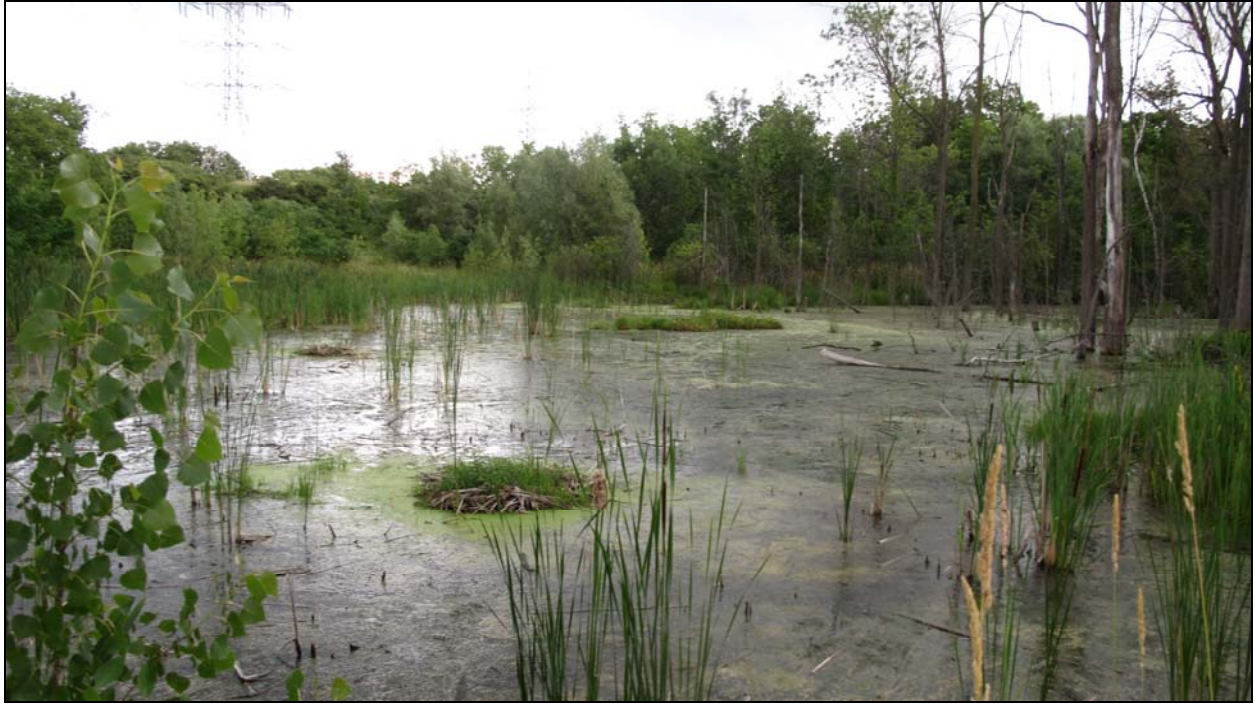
Figure 7. Shallow marsh developing within former floodplain forest near Rosedale Park following restoration. Photo taken July 4th 2014.
