CITY OF HAMILTON'S
DRINKING WATER SYSTEMS (DWS) COMPLIANCE
SUMMARY REPORT FOR MUNICIPALITIES

2018

Safe Drinking Water Act, Ontario Regulation, 170/03,
Schedule 22

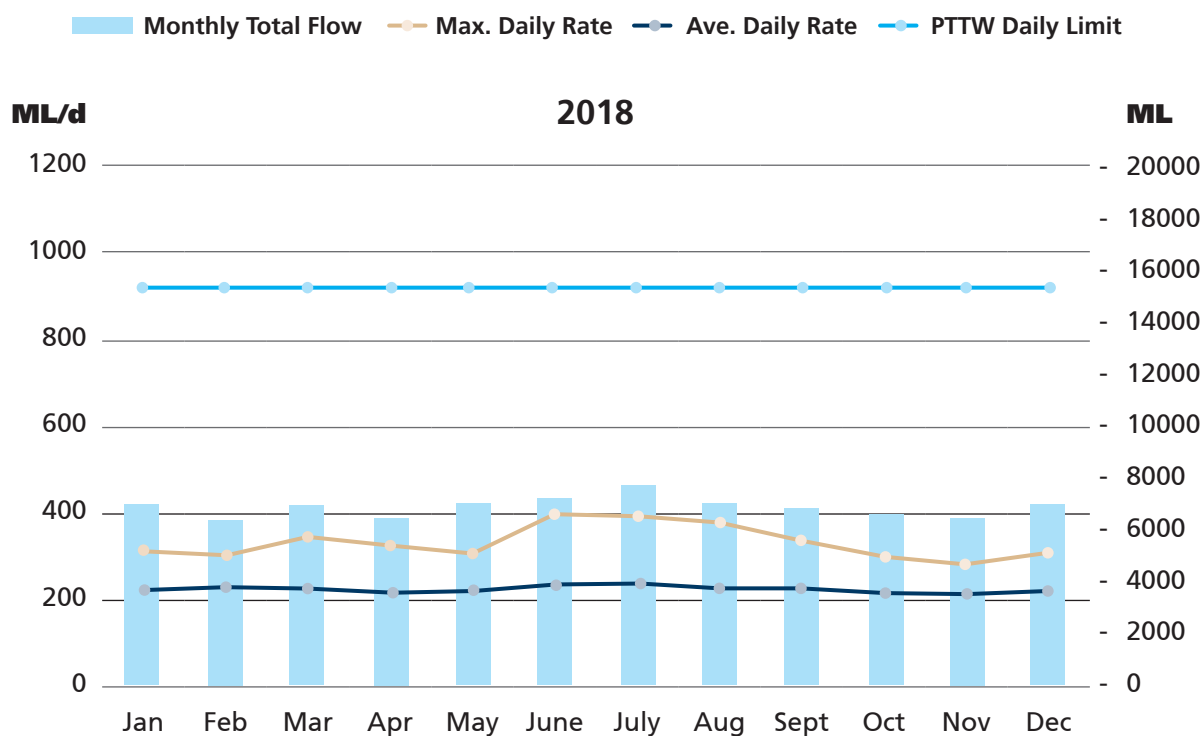
FIGURE 2-1: WOODWARD TREATMENT PLANT - 2018 MONTHLY PRODUCTION (SUMMARY)

The following provides a summary of daily flow rates and instantaneous peak flow rates in comparison to the capacity of the water works as identified in the Permit to Take Water. This information is tabulated in the accompanying tables.

WOODWARD	UNITS	JAN.	FEB.	MAR.	APR.	MAY	JUNE	JULY	AUG.	SEPT.	OCT.	NOV.	DEC.
Total	ML	7,051	6,457	7,102	6,551	7,132	7,430	7,896	7,277	6,949	6,651	6,573	7,127
Average	ML/d	227	231	229	218	230	248	255	235	232	215	219	230
Maximum	ML/d	314	306	345	327	313	400	397	377	334	298	290	316
PTTW	ML/d	909	909	909	909	909	909	909	909	909	909	909	909

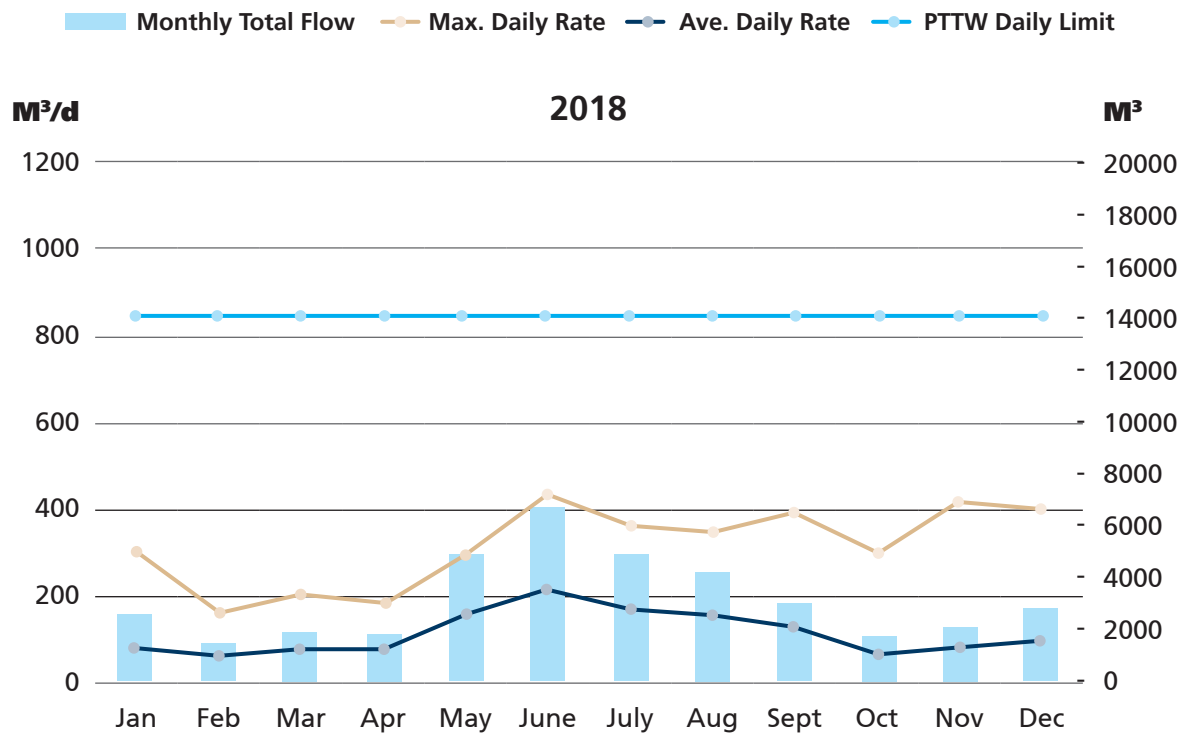
FIGURE 4-1: CARLISLE WELLS (FDC01 & FDC02) - 2018 MONTHLY PRODUCTION (SUMMARY)

The following provides a summary of daily flow rates and instantaneous peak flow rates in comparison to the capacity of the water works as identified in the Permit to Take Water. This information is tabulated in the accompanying tables.

FDC01 & 02	UNITS	JAN.	FEB.	MAR.	APR.	MAY	JUNE	JULY	AUG.	SEPT.	OCT.	NOV.	DEC.
Total	m ³	2,676	1,547	2,303	2,258	5,024	6,721	5,074	4,244	3,042	1,884	2,214	2,807
Average	m ³ /d	86	55	74	75	162	224	164	137	101	61	74	91
Maximum	m ³ /d	301	160	204	185	305	439	363	344	401	315	421	407
PTTW	m ³ /d	851	851	851	851	851	851	851	851	851	851	851	851

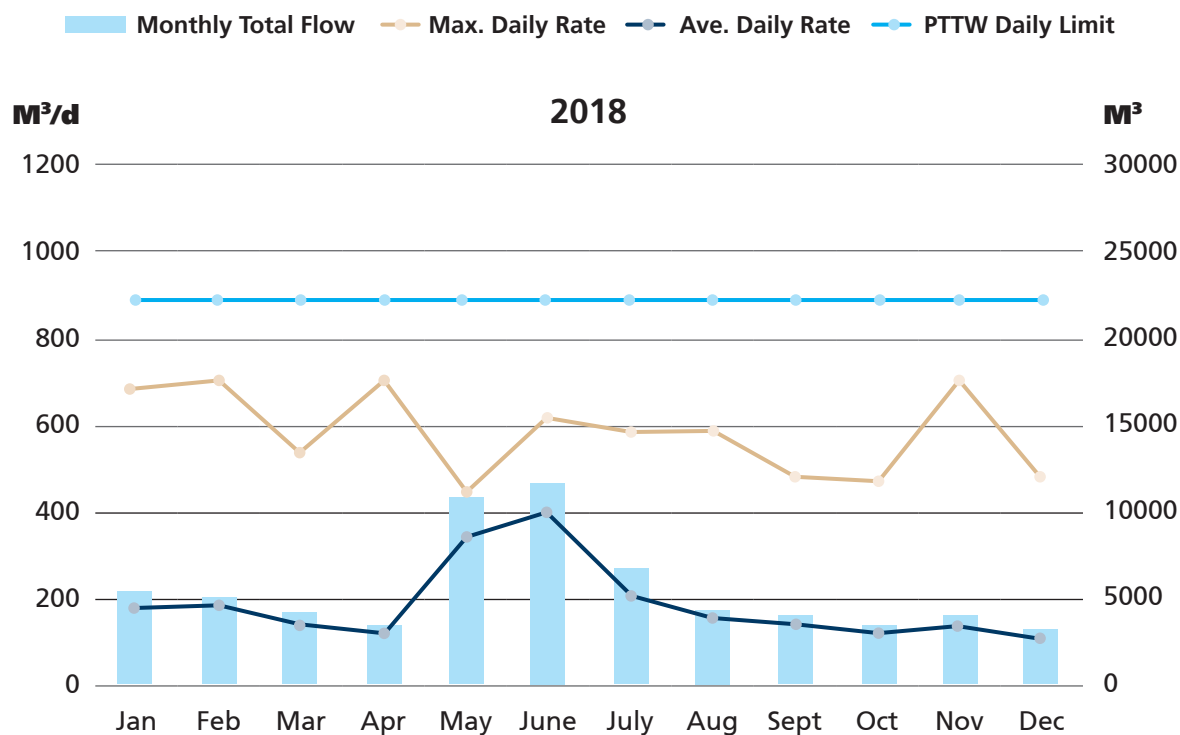
FIGURE 5-1: FREELTON WELL (FDF01) - 2018 MONTHLY PRODUCTION (SUMMARY)

The following provides a summary of daily flow rates and instantaneous peak flow rates in comparison to the capacity of the water works as identified in the Permit to Take Water. This information is tabulated in the accompanying tables.

FDC01 & 02	UNITS	JAN.	FEB.	MAR.	APR.	MAY	JUNE	JULY	AUG.	SEPT.	OCT.	NOV.	DEC.
Total	m ³	5,468	5,100	4,318	3,740	11,226	11,863	6,449	4,226	3,958	3,534	3,985	3,161
Average	m ³ /d	176	182	139	125	362	395	208	136	132	114	133	102
Maximum	m ³ /d	677	691	540	693	456	623	586	585	475	466	692	484
PTTW	m ³ /d	878	878	878	878	878	878	878	878	878	878	878	878

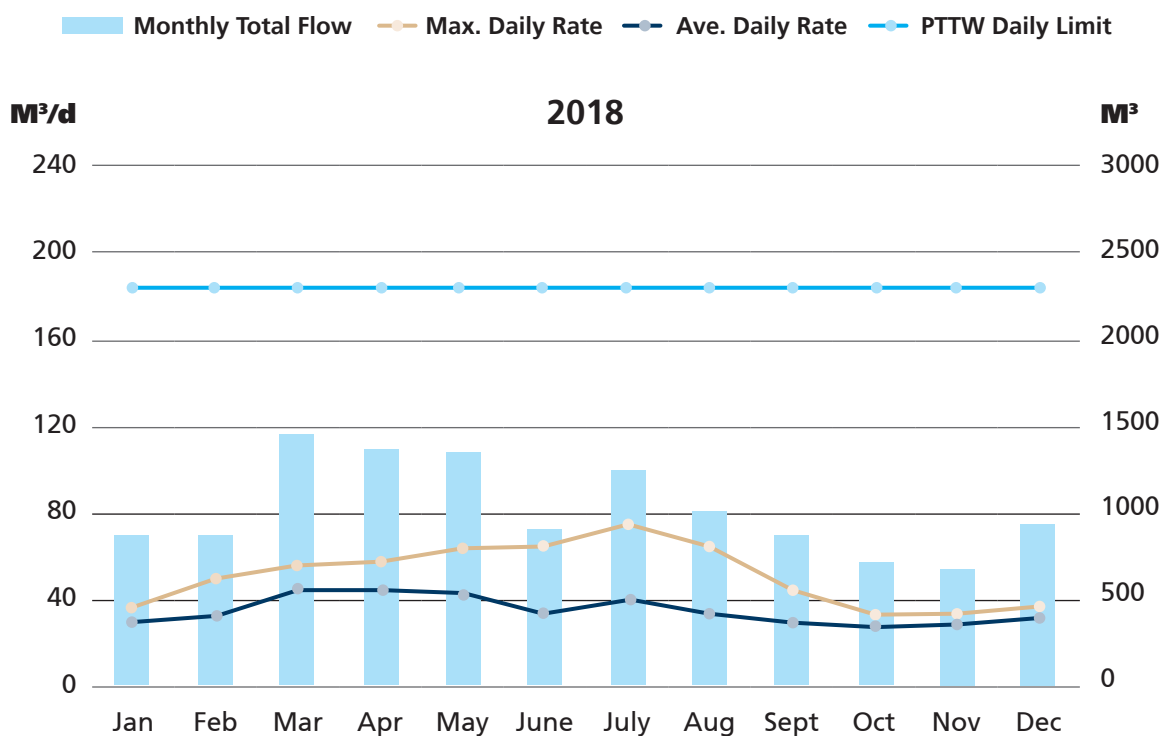
FIGURE 6-1: GREENSVILLE WELL (FDG01) - 2018 MONTHLY PRODUCTION (SUMMARY)

The following provides a summary of daily flow rates and instantaneous peak flow rates in comparison to the capacity of the water works as identified in the Permit to Take Water. This information is tabulated in the accompanying tables.

WOODWARD	UNITS	JAN.	FEB.	MAR.	APR.	MAY	JUNE	JULY	AUG.	SEPT.	OCT.	NOV.	DEC.
Total	m ³	862	856	1,453	1,373	1,360	939	1,236	1,005	855	691	666	917
Average	m ³ /d	28	31	47	46	44	31	40	32	28	22	22	30
Maximum	m ³ /d	34	45	55	54	63	62	74	61	43	26	25	37
PTTW	m ³ /d	197	197	197	197	197	197	197	197	197	197	197	197

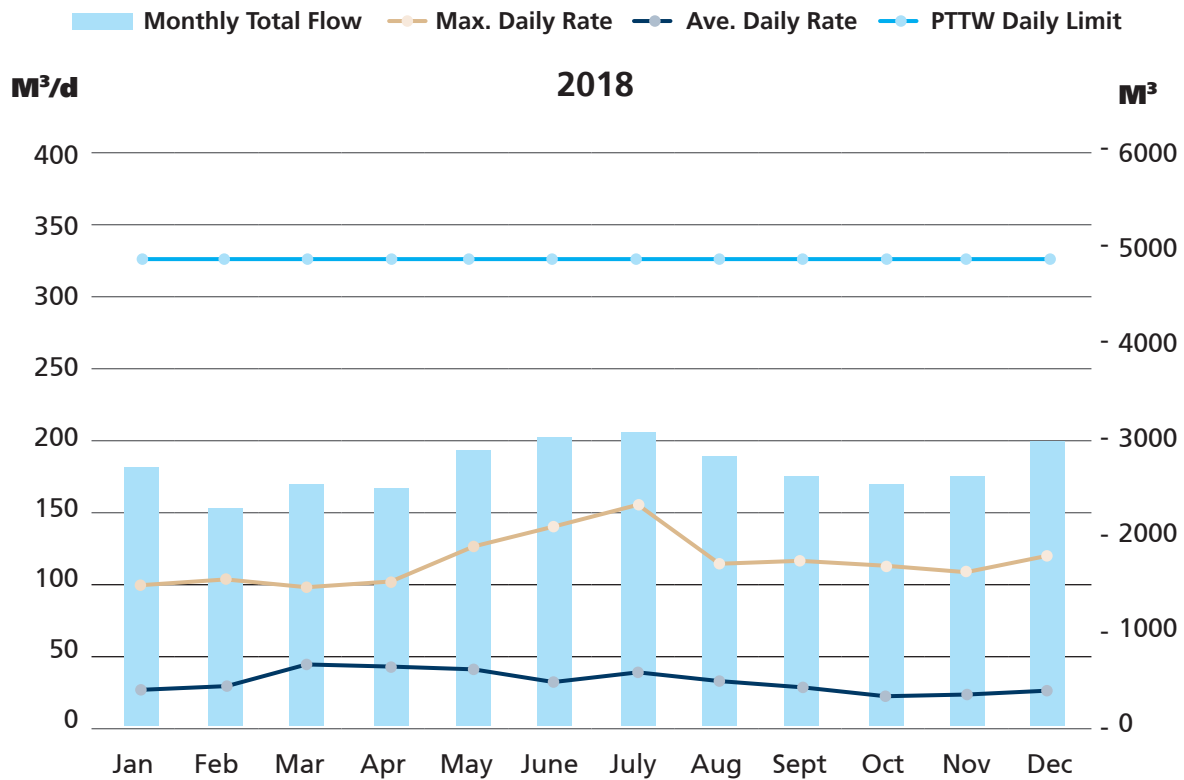
FIGURE 7-1: LYNDEN WELL (FDL01) - 2018 MONTHLY PRODUCTION (SUMMARY)

The following provides a summary of daily flow rates and instantaneous peak flow rates in comparison to the capacity of the water works as identified in the Permit to Take Water. This information is tabulated in the accompanying tables.

FDC01 & 02	UNITS	JAN.	FEB.	MAR.	APR.	MAY	JUNE	JULY	AUG.	SEPT.	OCT.	NOV.	DEC.
Total	m ³	2,678	2,336	2,522	2,477	2,907	3,022	3,074	2,851	2,622	2,545	2,702	2,971
Average	m ³ /d	86	83	81	83	94	101	99	92	87	82	90	96
Maximum	m ³ /d	98	106	96	100	123	136	155	116	119	113	110	122
PTTW	m ³ /d	327	327	327	327	327	327	327	327	327	327	327	327
