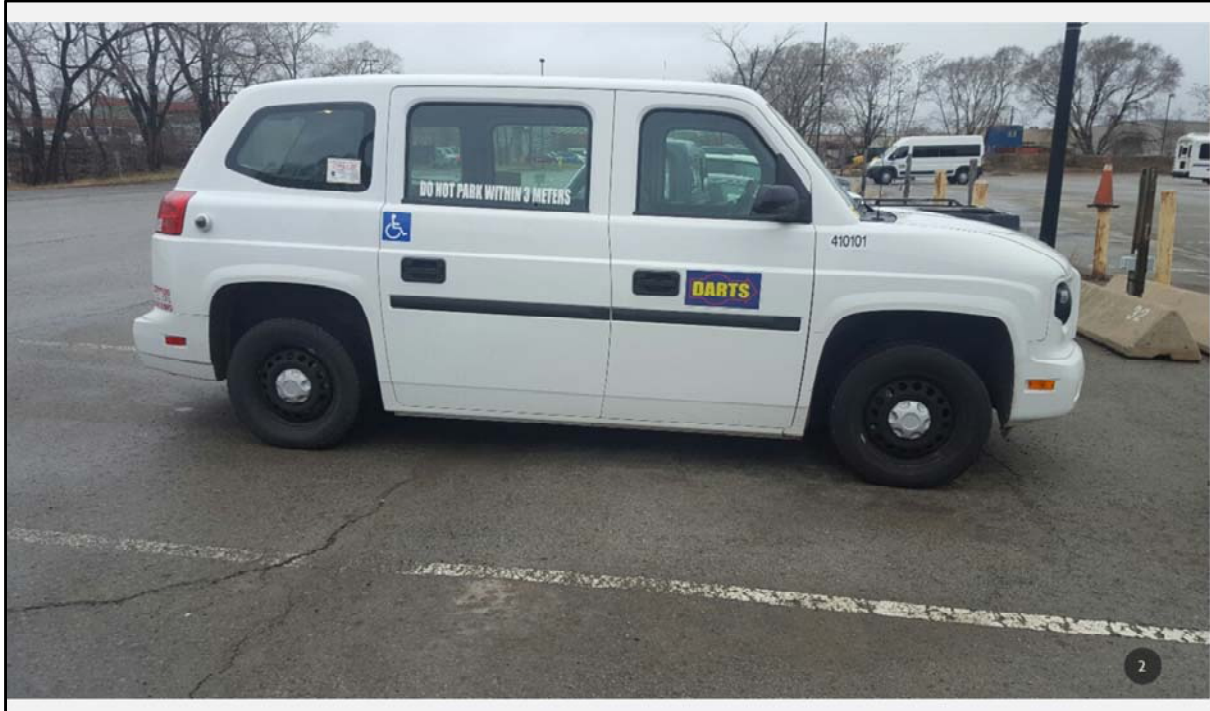
Outside view of a MV-1 vehicle.

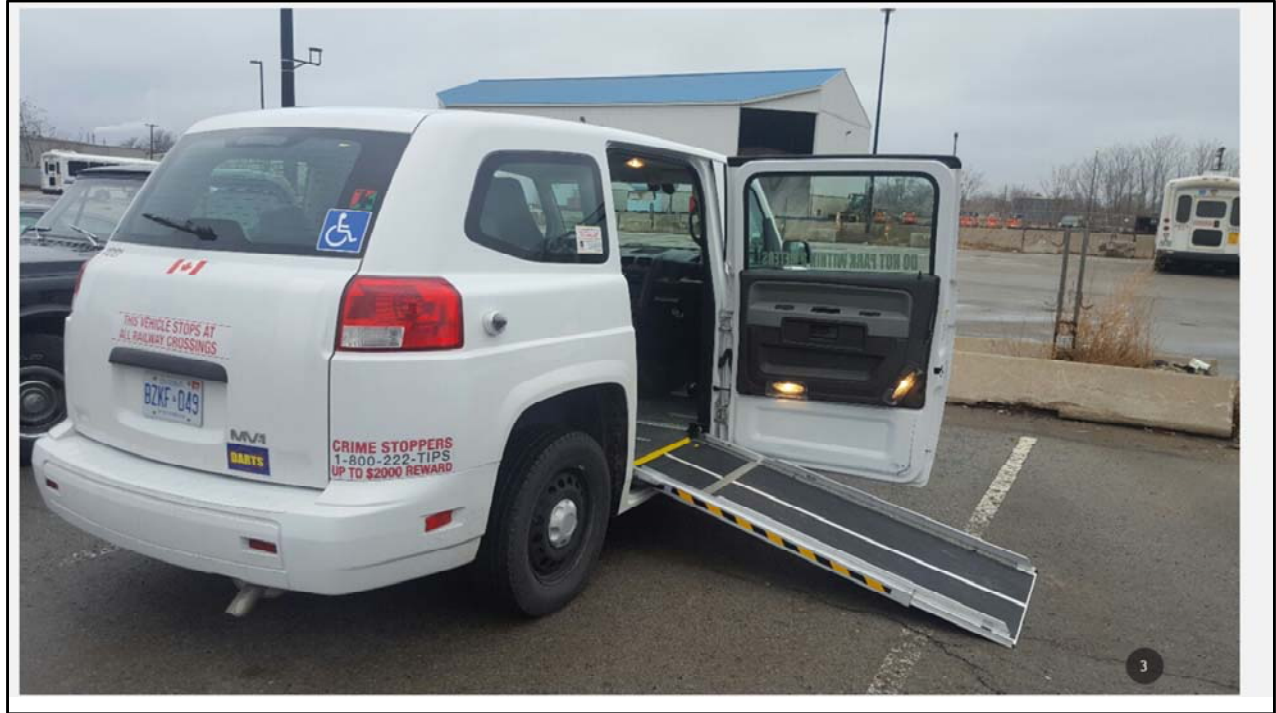
MV-1 with the ramp extended.

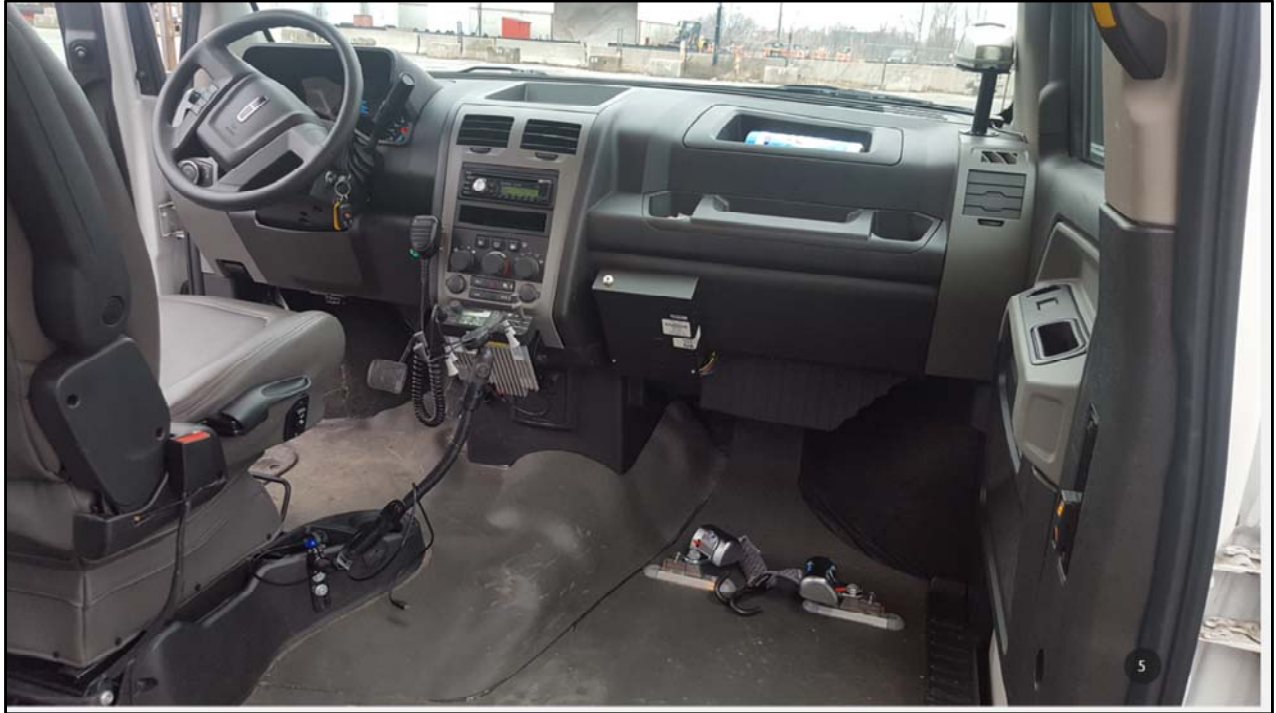
Inside the MV-1 vehicle looking forward. Shows the position of the one wheelchair spot in the front passenger position.

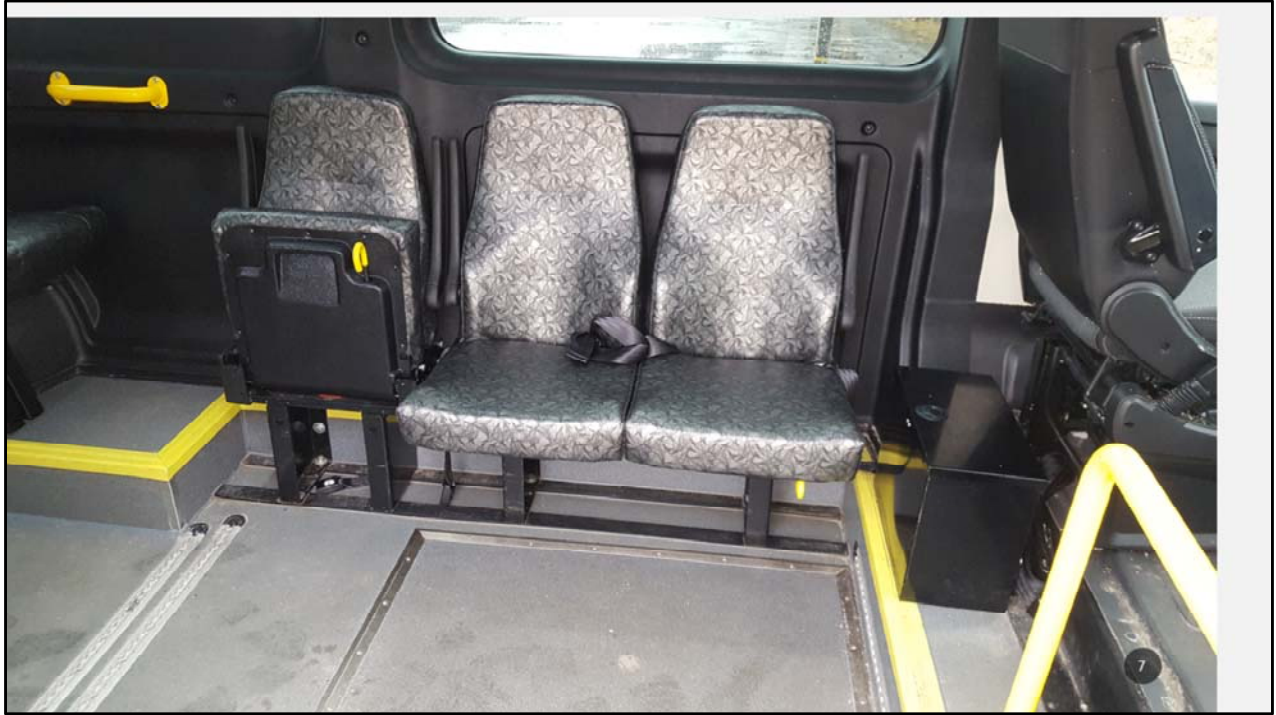
Inside the Promaster showing the three bench seats on the far wall of the vehicle.

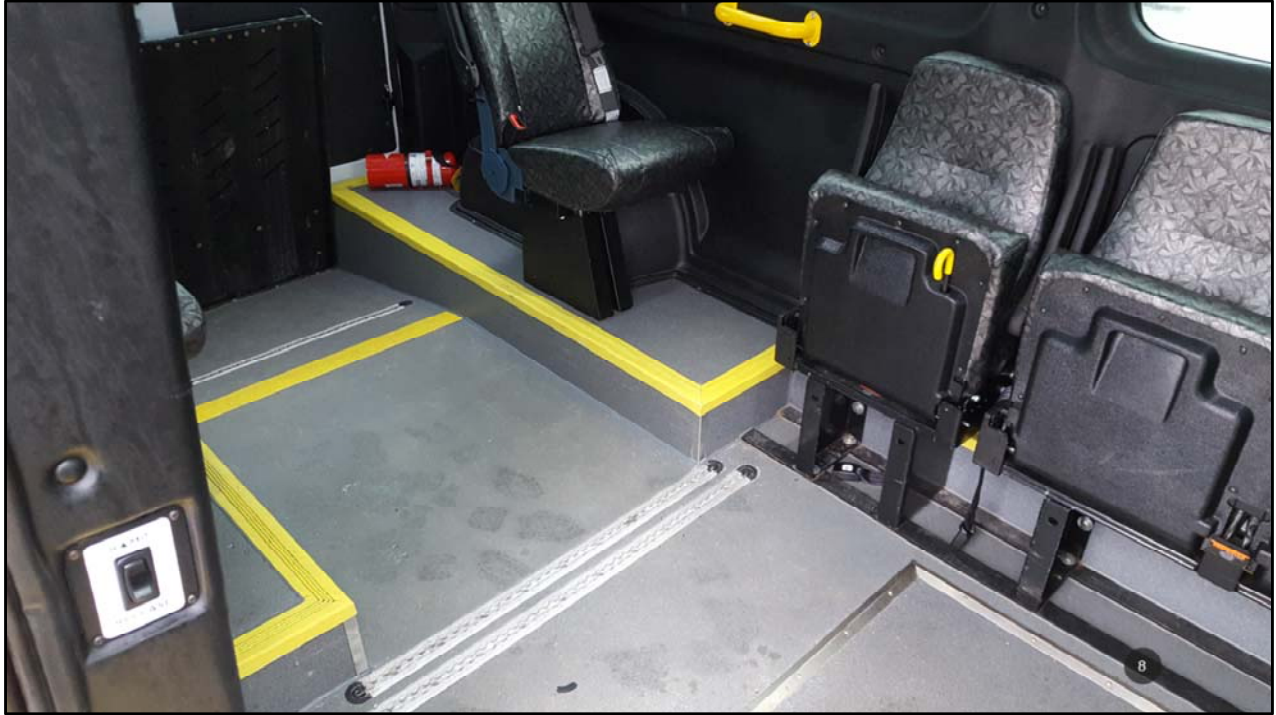
Inside the Promaster showing the floor space for the 2 wheelchairs. Also shows the two seats that are elevated on the back wheel hubs. These are the seats that the travelling public has issue with.

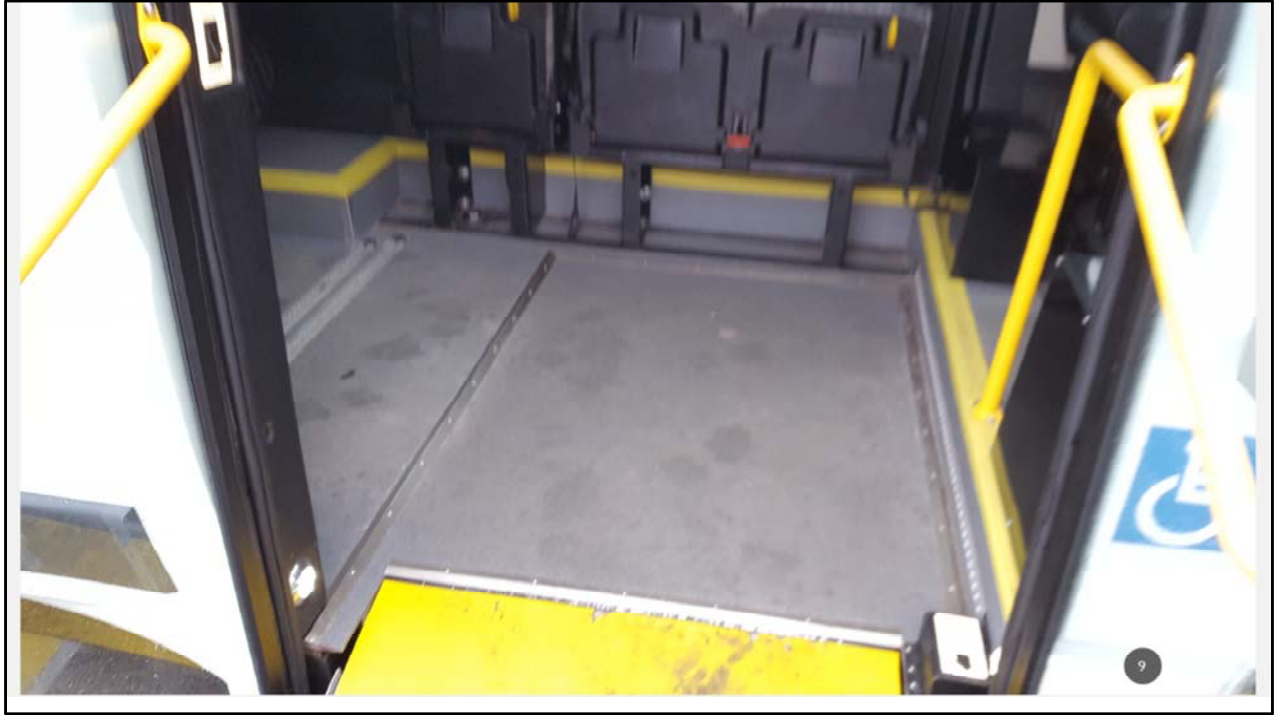
The door of the Promaster showing the floor space for two wheelchairs.

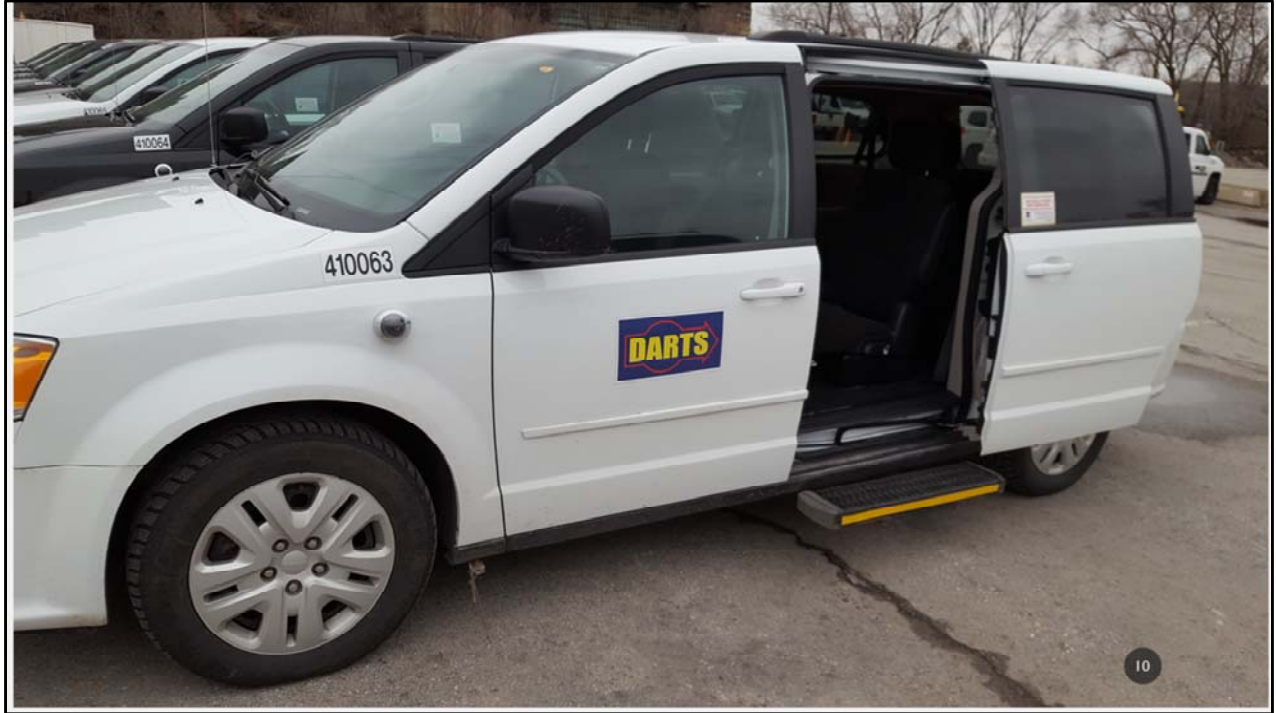
DARTS van showing the installed step (these are on both sides of the vehicle) to assist seniors with entering the van.

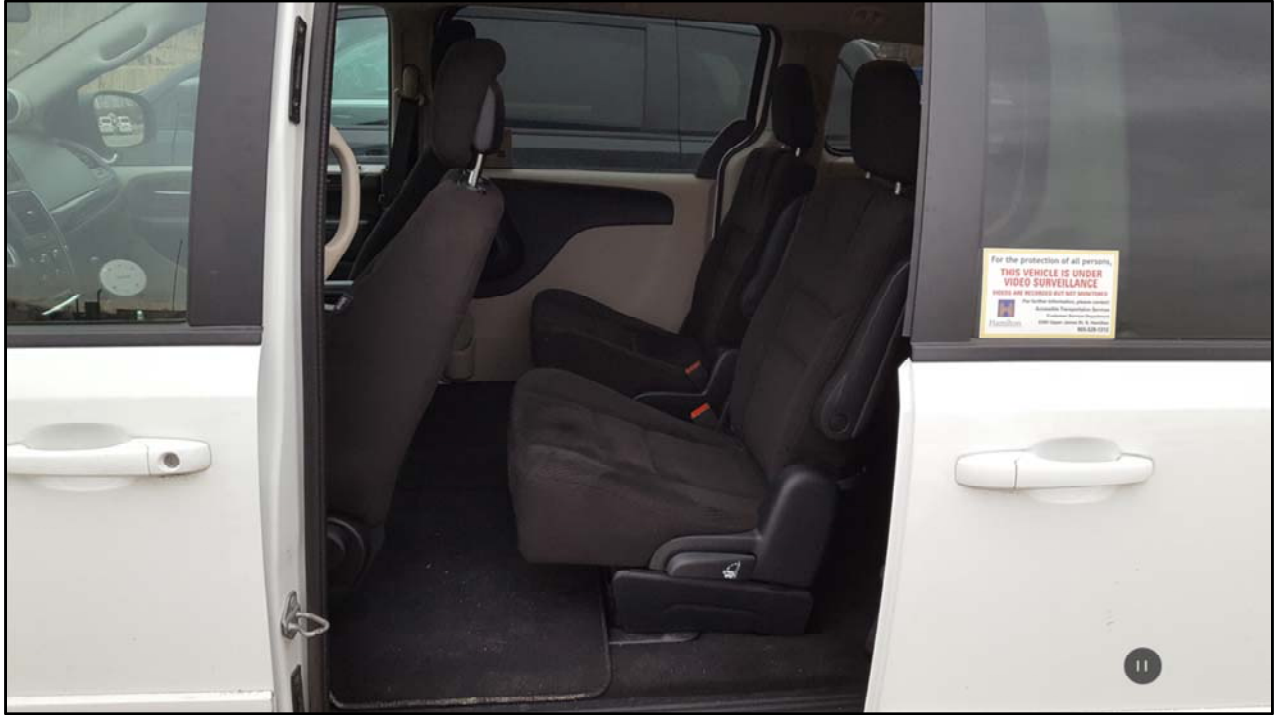
Showing the back seats of the DARTS vans.

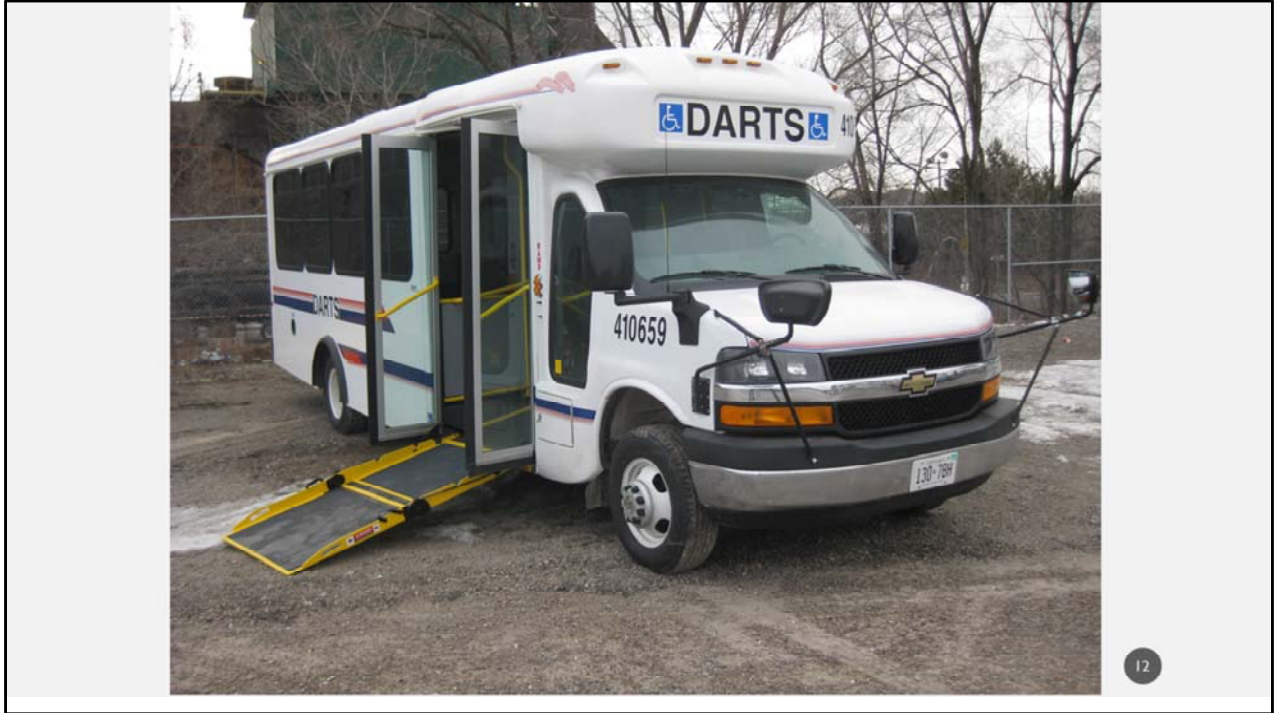
ARBOC bus with the ramp extended.

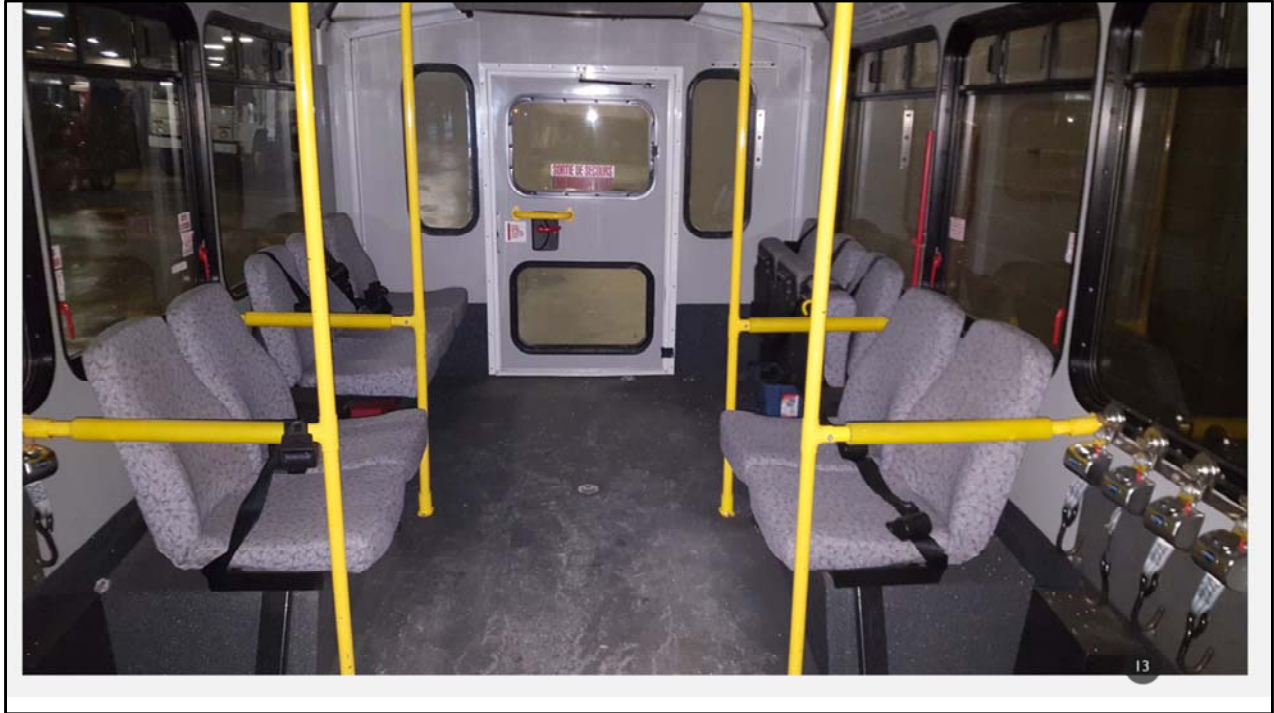
Inside the ARBOC bus looking towards the back. The very back seats can flip up to expose two wheelchair spots.

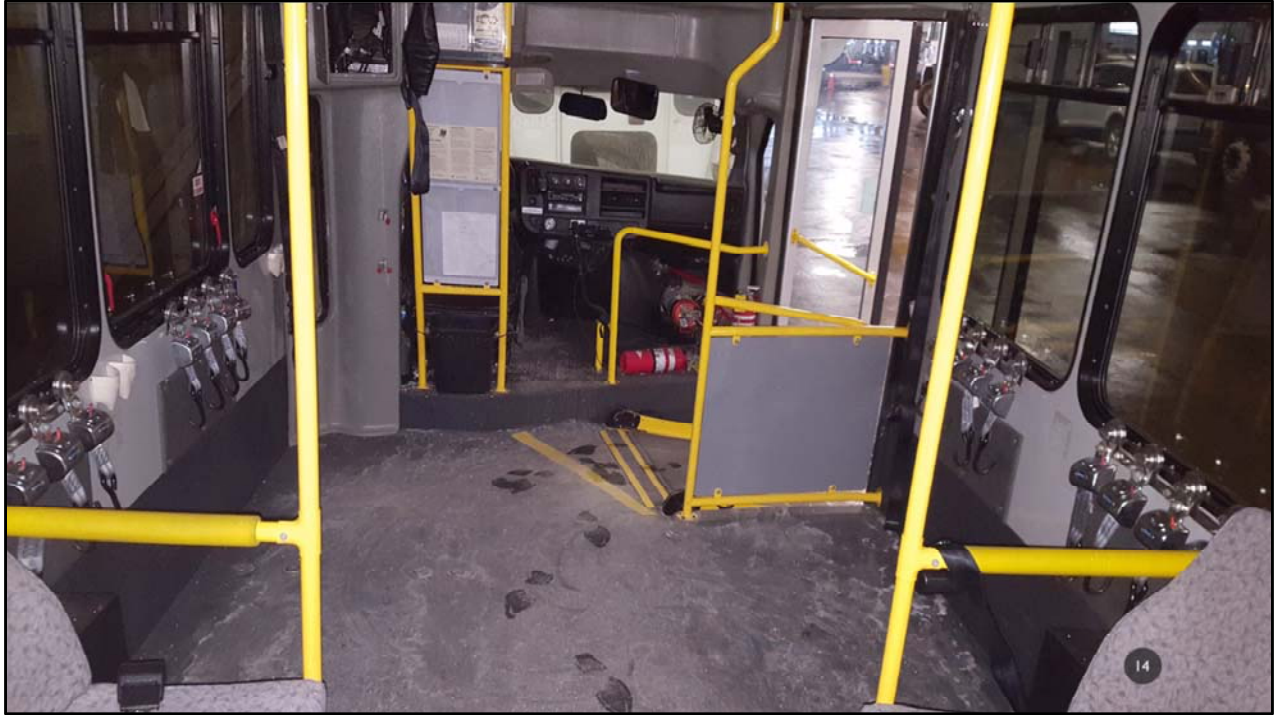
Inside the ARBOC bus standing at the back looking forward. Note the space for wheelchairs and the greater width of the floor space relative to the Promaster.

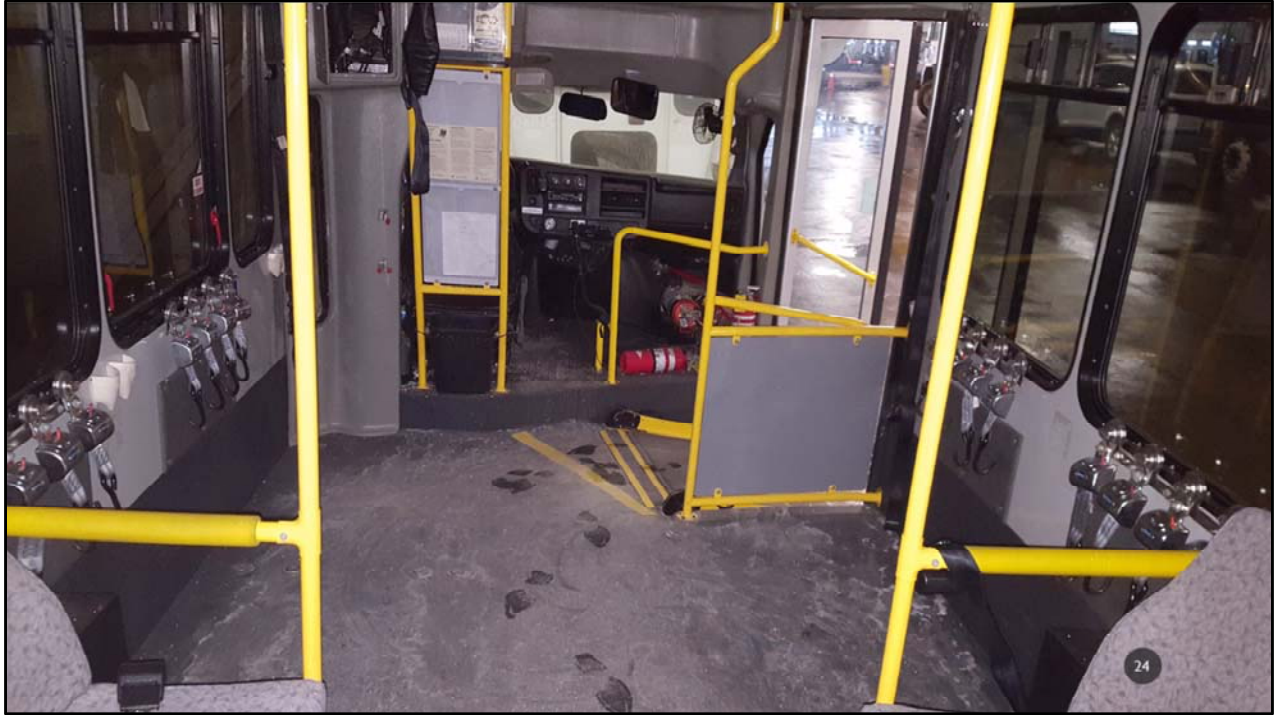
Note the increase floor space on buses making it easier to navigate when loading and unloading multiple passengers in wheelchairs.

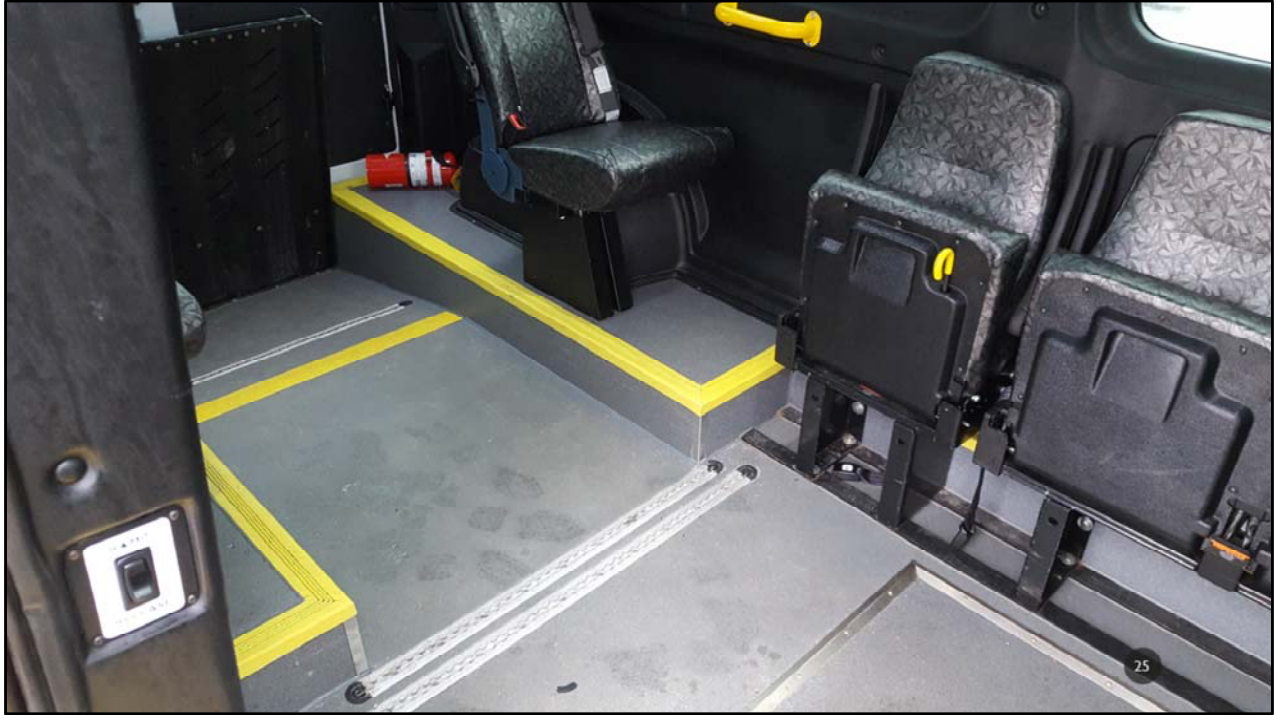
Much smaller area in the Promaster relative to the bus (in the previous slide).
