HAMILTON FUTURE FUND PROGRESS REPORT No. 2

Project Title:	Albion Falls South Viewing Platform and Access	Date Agreement Signed by General Manager of Public Works:	March 28, 2018
Report Prepared By:	Louise Thomassin, Landscape Architect – Project Manager	Expiry Date of HFF Agreement:	March 28, 2020
Date of Report:	December 05, 2018	Reporting Period:	June 2018 – December 2018
General Purpose:	Progress of works funded by HFF (Environmental Impact Statement Report, Geotechnical Investigations; and Archaeology Investigations)

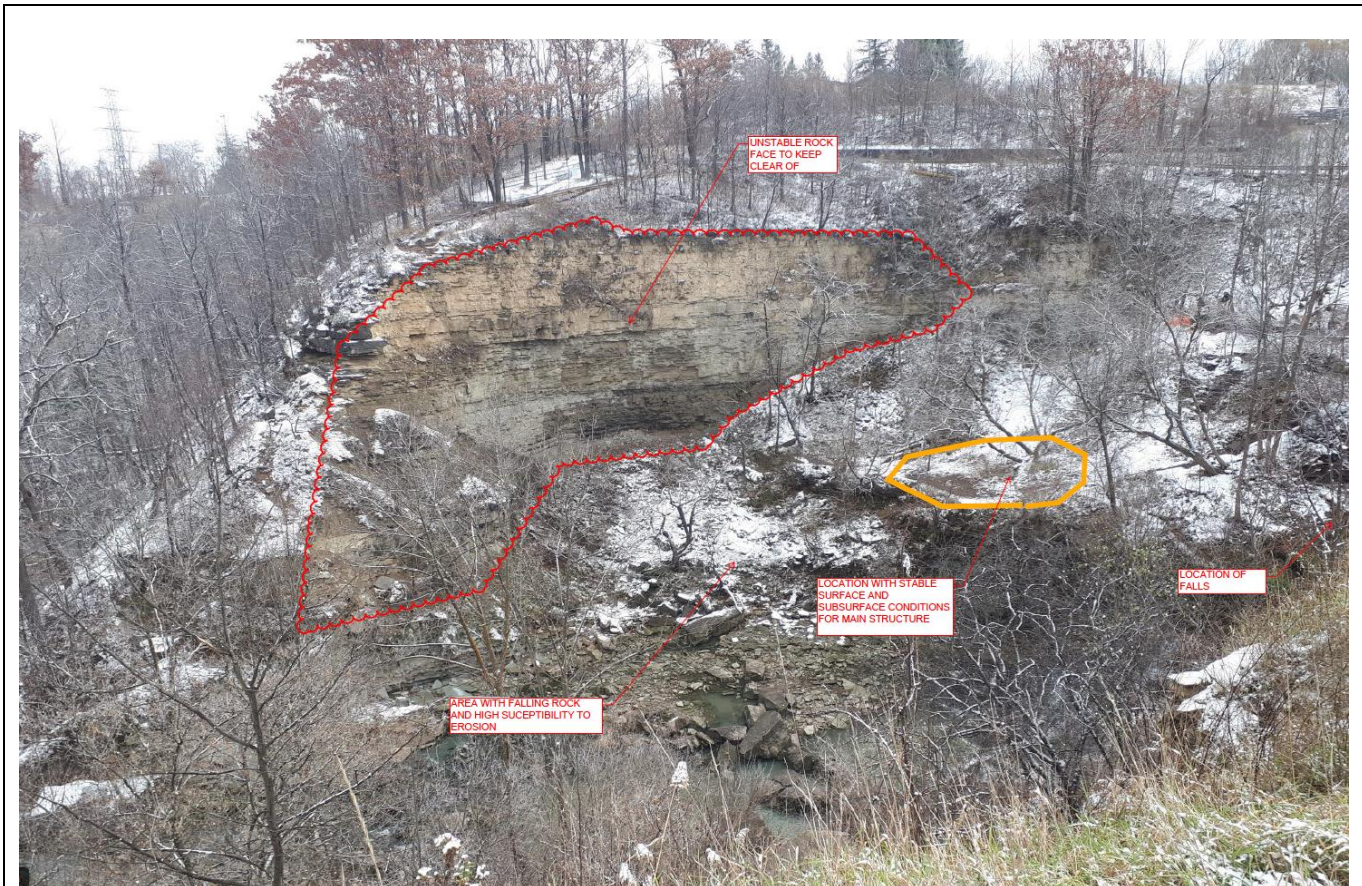
Image ID: 1

Location: Mountainbrow Boulevard looking east.

Overview of geotechnical findings to determine feasible location of main viewing platform.

2.1	A Purchase Order was received in May of 2018.	
2.2	Site inspections have been conducted in summer and fall of 2018 to determine a location for the main viewing platform structure based on stability of soil and subsurface material and potential hazards posed from steep rock face. See image 1 for a site photograph mark-up.	1

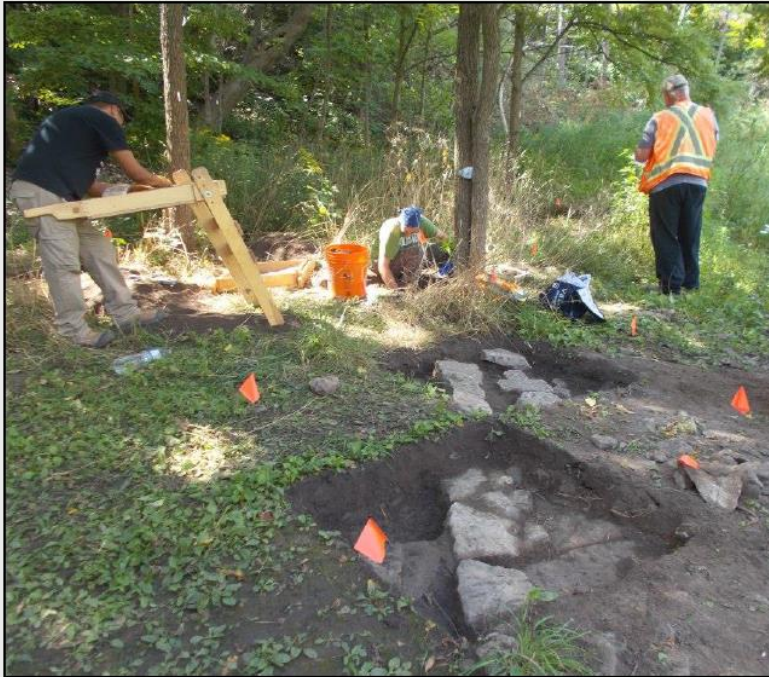
Image ID: 6

Facing southwest towards Feature #2 in Stage 3 test units 500N-190E and 499N-189E and Wood archaeologist excavating unit 497N-188E, also containing a portion of Feature #3. See also Figure C2 in Appendix C.

Potential wall foundation of former mill outbuilding uncovered during Stage 3 field investigations and requiring further exploration.

3.3	<p>A Purchase Order was issued to Wood in October of 2018 to conduct a Stage 4 Archaeological Assessment. Wood began the Stage 4 field work in late November of 2018 and will be finished the field work in December of 2018.</p> <p>The field work includes the hand-excavation of approximately sixty-seven (67) one-meter test units within the area identified in the Stage 3 report to fully expose the Euro-Canadian wall feature and further explore the midden feature for retrieval of artifacts.</p>
