***MECP Order # 1-J25YB Item 1b***  
**Chedoke Creek Natural Environment and  
Sediment Quality Assessment and Remediation  
Report**

Hamilton, Ontario  
Project # TPB188127

January 24, 2019

**Wood Environment & Infrastructure Solutions  
a Division of Wood Canada Limited**

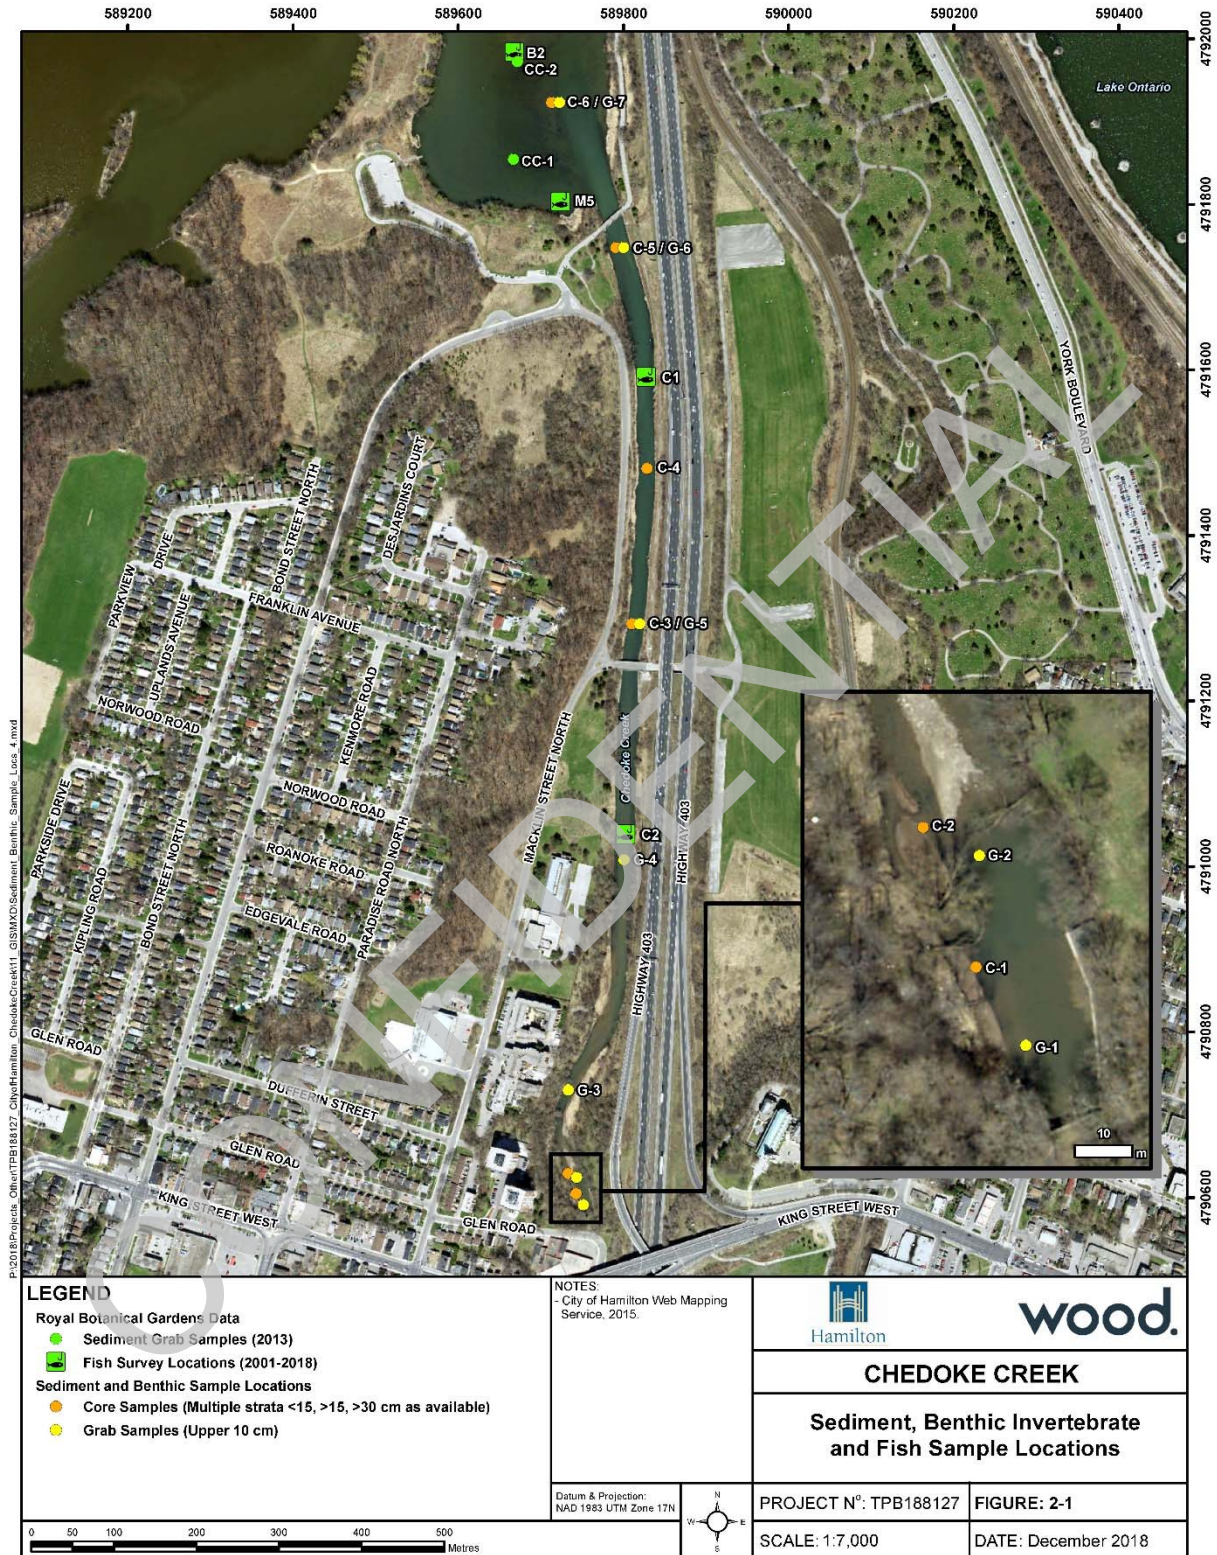
Figure 2-1: Sediment, Benthic Invertebrate and Fish Sample Locations

Benthic invertebrate sampling has been conducted in tandem with sediment quality assessments. Sampling has been conducted at seven (7) sampling transects co-located with the sediment grab sampling transects (Figure 2-1). Benthic invertebrates have been sampled from each of 3 replicate grabs within each transect. This approach has provided a total of 21 samples for analysis by an accredited invertebrate taxonomist. Information collected at each sampling station has included a description of benthic habitat (water depth, observed water velocity, substrate type, aquatic vegetation and available cover).

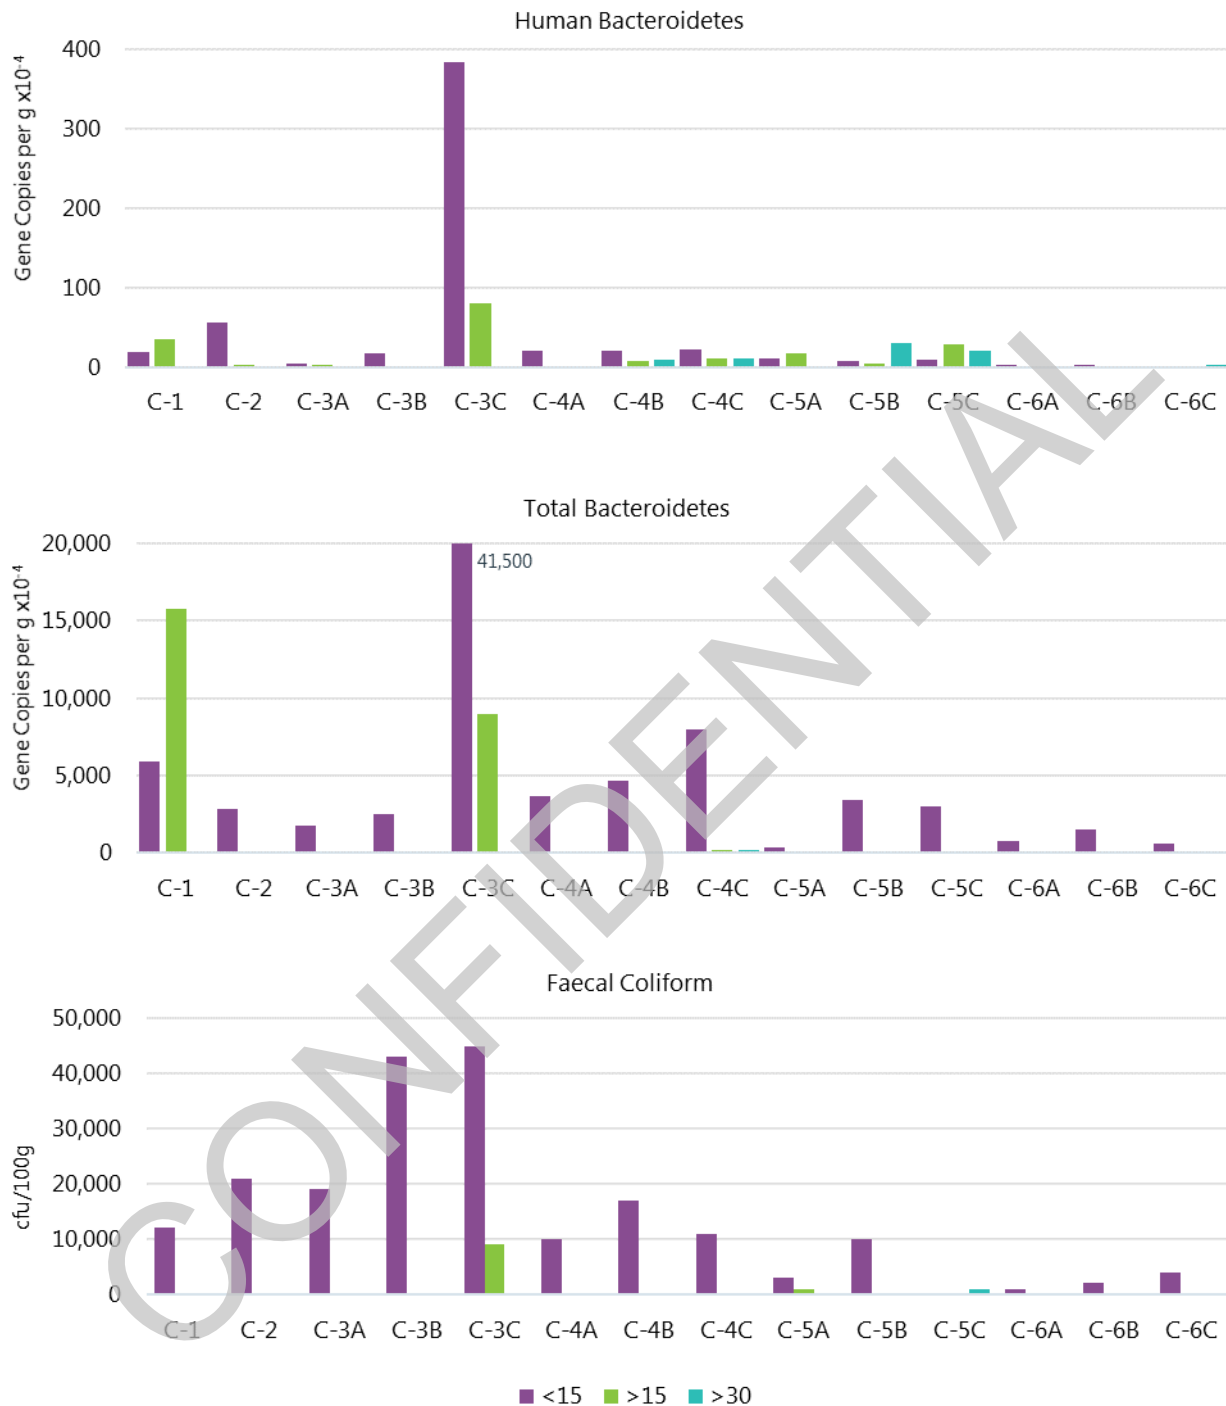
The bacteroidetes and faecal coliform sample results show the highest concentrations were found at the C-3/G-5 sample transect, downstream of the Kay Drage Park bridge (Figure 3-3). Faecal coliform in surface waters are present due to fecal excrement of humans (sewage releases), livestock and wildlife. The qPCR results show the highest human and total bacteroidetes were present in the surface strata (0 to 15 cm) at the C-3C replicate sample located near the west shoreline shows. Concentrations in the mid-strata aliquot (15 to 30 cm) of C-3C were also higher than most other mid-strata samples. The bacteroidetes and faecal coliform results from the downstream sample transects show lower concentrations, with most of the lowest values at the C-6/G-7 sample location within Cootes Paradise (further from the Main/King CSO source).

**Figure 3-3: Sediment Bacteroidetes and Faecal Coliform by Core Sample Location**

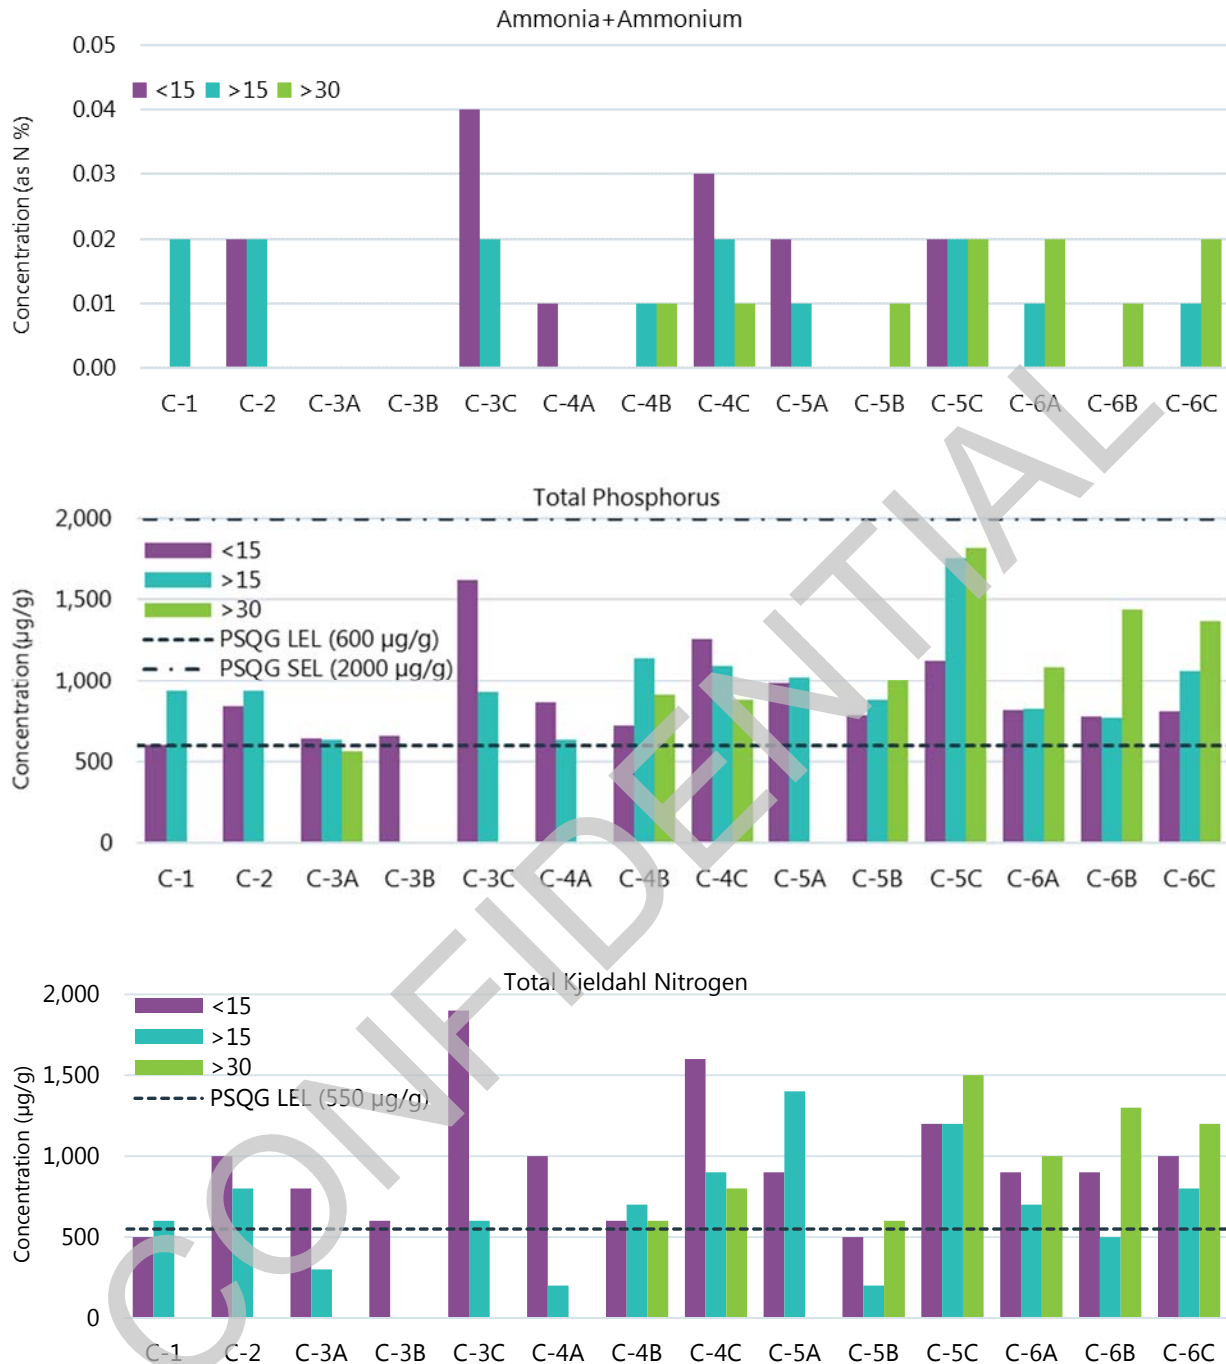
Sediment quality nutrients of interest include ammonia+ammonium, total phosphorus and total Kjeldahl nitrogen (TKN), all of which were found in the highest concentration within the surface strata (0 to 15 cm) at the C-3/G-5 sample transect, specifically the C-3C sample location (Figure 3-4). The next highest surface strata nutrient concentrations were found at the C-4C sample location, and both locations were positioned near the west shoreline, in areas of soft organic sediment. These sample locations were situated between the Kay Drage Park and Princess Point bridges, showing higher nutrient concentrations are present within this reach and are mostly higher than the surface strata within the Cootes Paradise sample location (C-6/G-7). Nearly all TKN concentrations in surface strata were above the PSQG LEL (550 µg/g), suggesting these sediments contain a level of contamination that can be tolerated by the majority of sediment-dwelling organisms, but not necessarily stress-intolerance taxa as discussed in Section 4.1. Total phosphorus concentrations in all sediment strata samples were greater than the PSQG LEL (600 µg/g) between transects C-4 and C-6/G-7, with the highest concentrations observed at transect C-5/G-6. The phosphorus SEL (2,000 µg/g) was not exceeded by any sample concentration.

**Figure 3-4: Sediment Nutrient Concentrations – NH<sub>3</sub>+NH<sub>4</sub>, P, TKN by Core Sample Location**

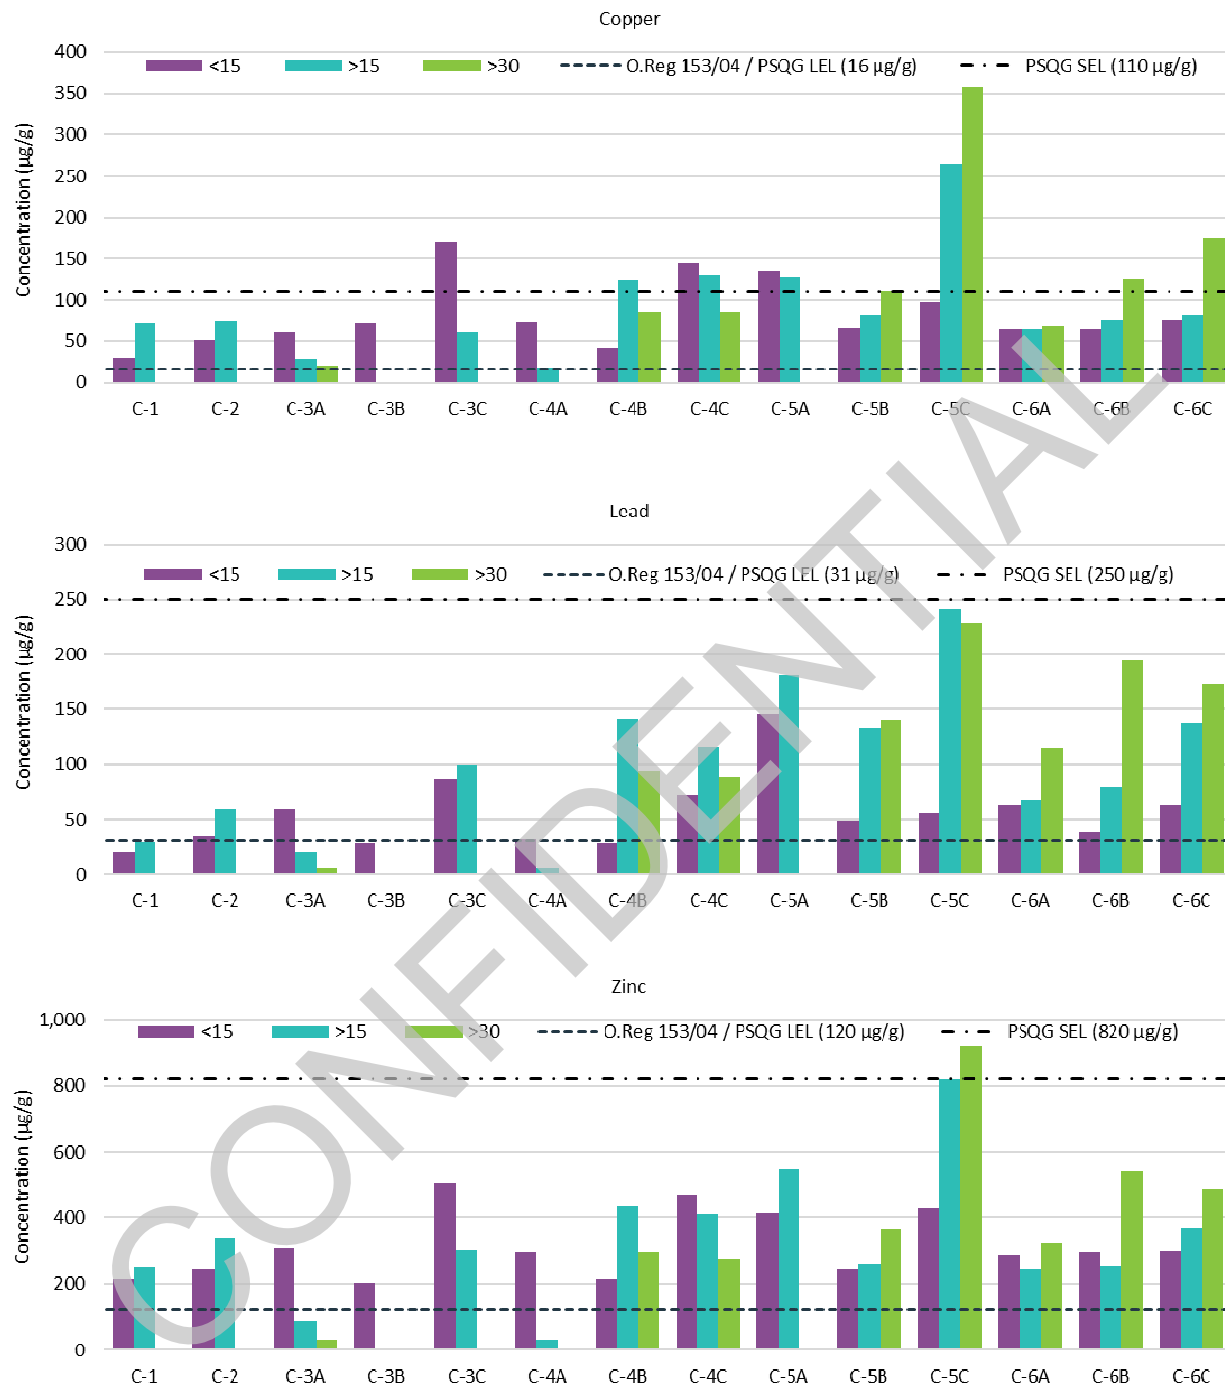
Most of the highest heavy metal concentrations of interest (Cu, Pb and Zn) within surface strata (0 to 15 cm) were found between the C-3/G-5 and C-5/G-6 sample transects (Figure 3-5) which were similar to the results found for other parameters. Other metals with O. Reg. 153/04 and PSQG sediment quality values include arsenic, cadmium, cobalt, chromium, nickel and silver. Graphs of these metals and their respective regulation values are provided in Appendix B1.

**Figure 3-5: Sediment Metal Concentrations – Cu, Pb, Zn by Core Sample Location**

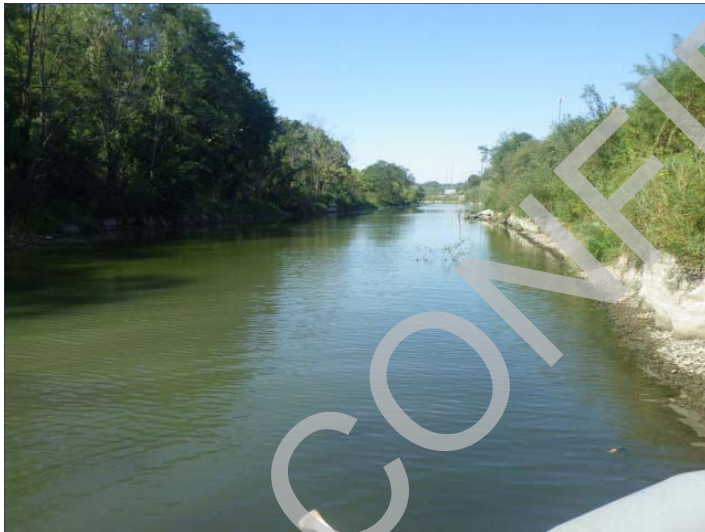
Sample location G-3/G-5 was positioned downstream of the Kay Drage Park bridge. A surface layer of green algae (resembling cyanobacteria; "blue-green algae") was observed mostly near the west bank, but the bloom also extended across the channel at other locations between this transect and the Princess Point bridge. Armour stone blocks were present on both banks, however, the steeper sloping east side had less near-shore vegetation overhanging the creek compared to the riparian vegetation growing close to the edge of water along the west bank. Fallen trees were observed near this sample location, as well as plywood and lumber debris.

Algae bloom near west bank at sample transect C-3/G-5.

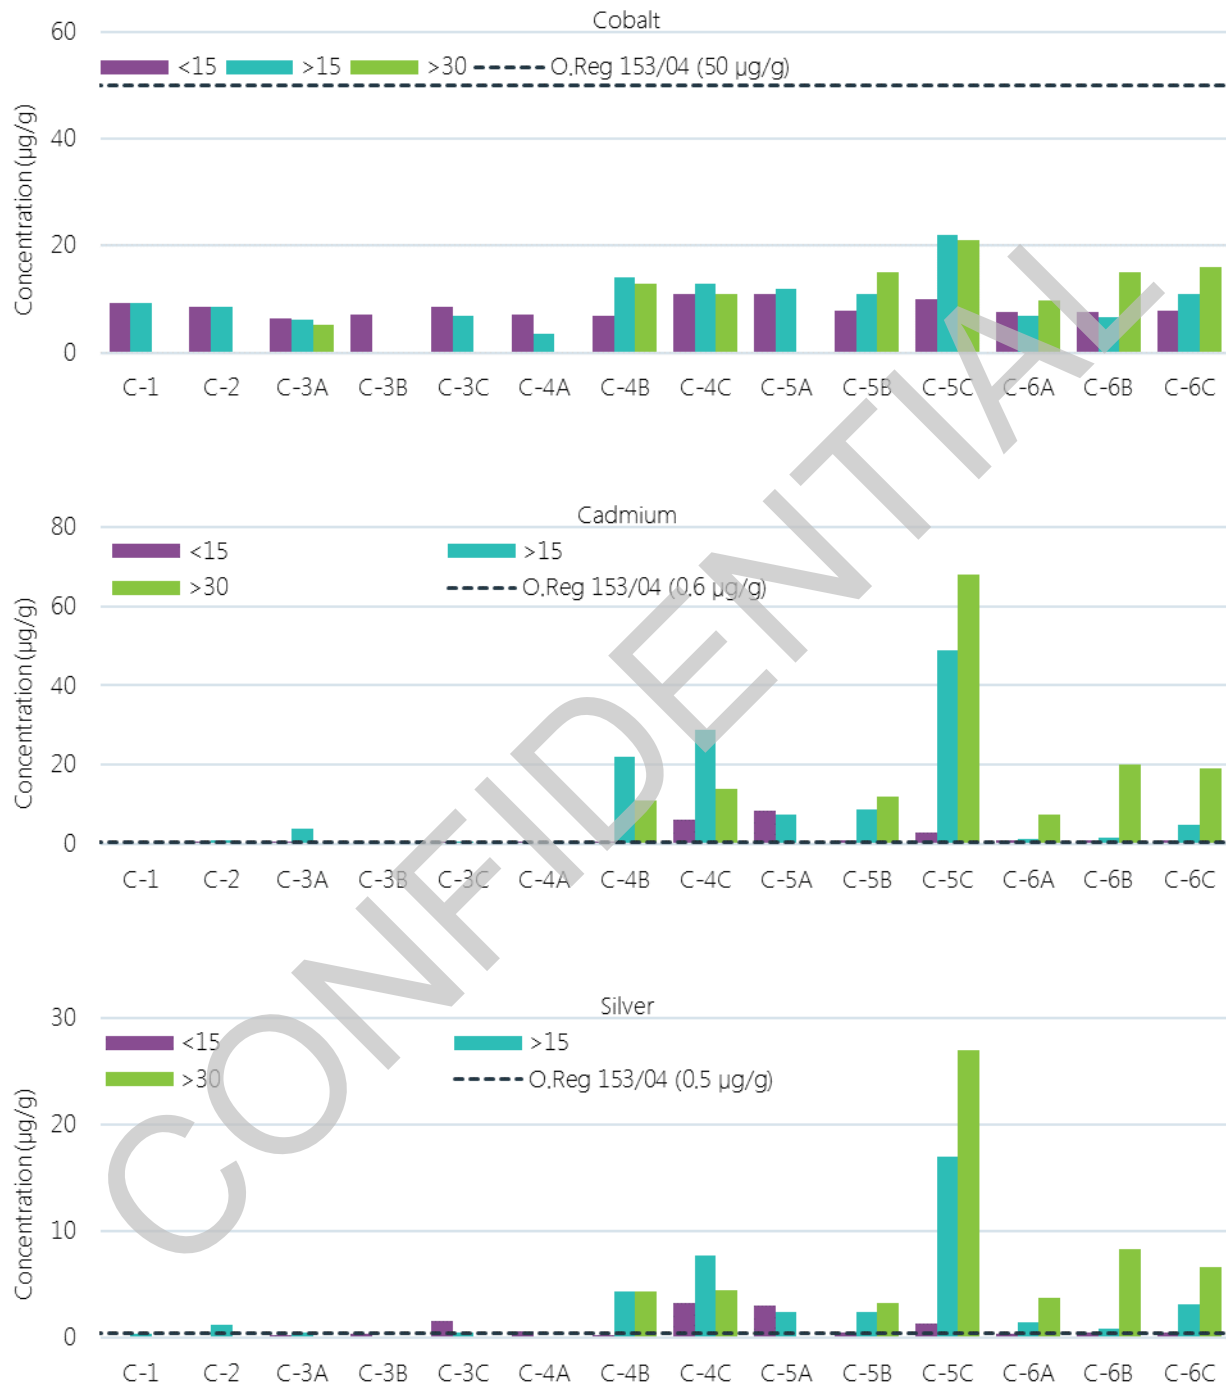
**Figure B1-1: Sediment Metal Concentrations – Co, Cd, Ag by Core Sample Location**

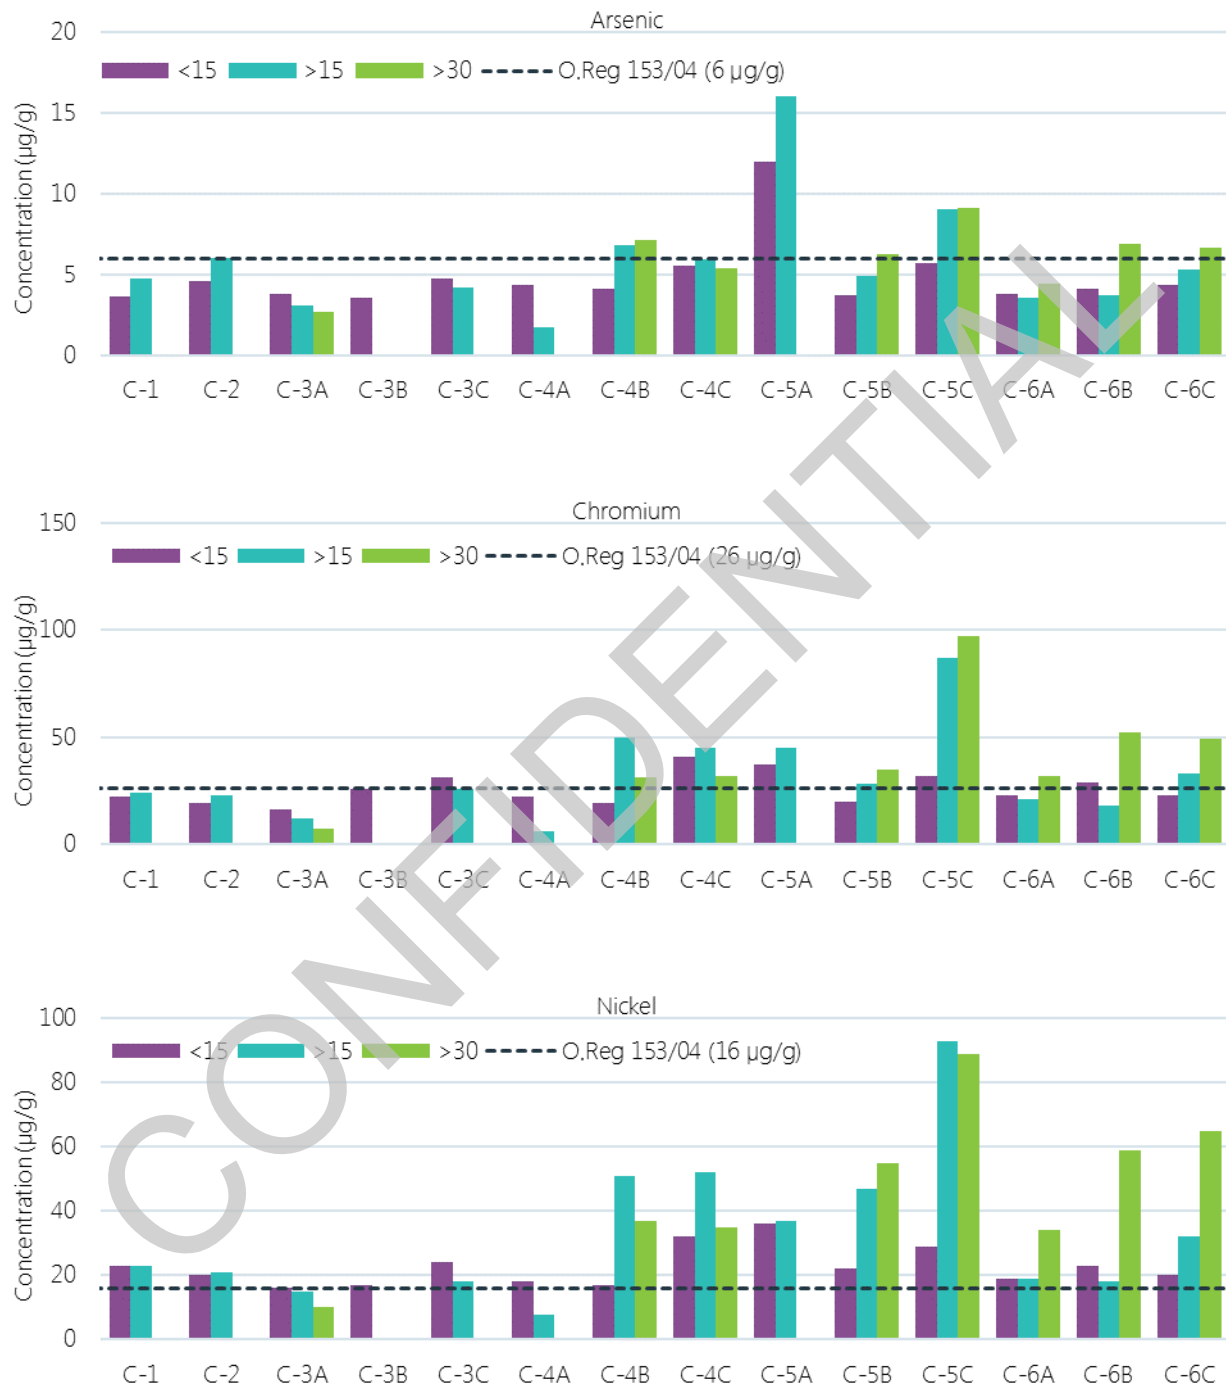
**Figure B1-2: Sediment Metal Concentrations – As, Cr, Ni by Core Sample Location**
