**Cootes Paradise: Environmental Impact Evaluation
Hamilton, Ontario**

City of Hamilton

**April 2020
SLR Project No.: 209.40666.00001**

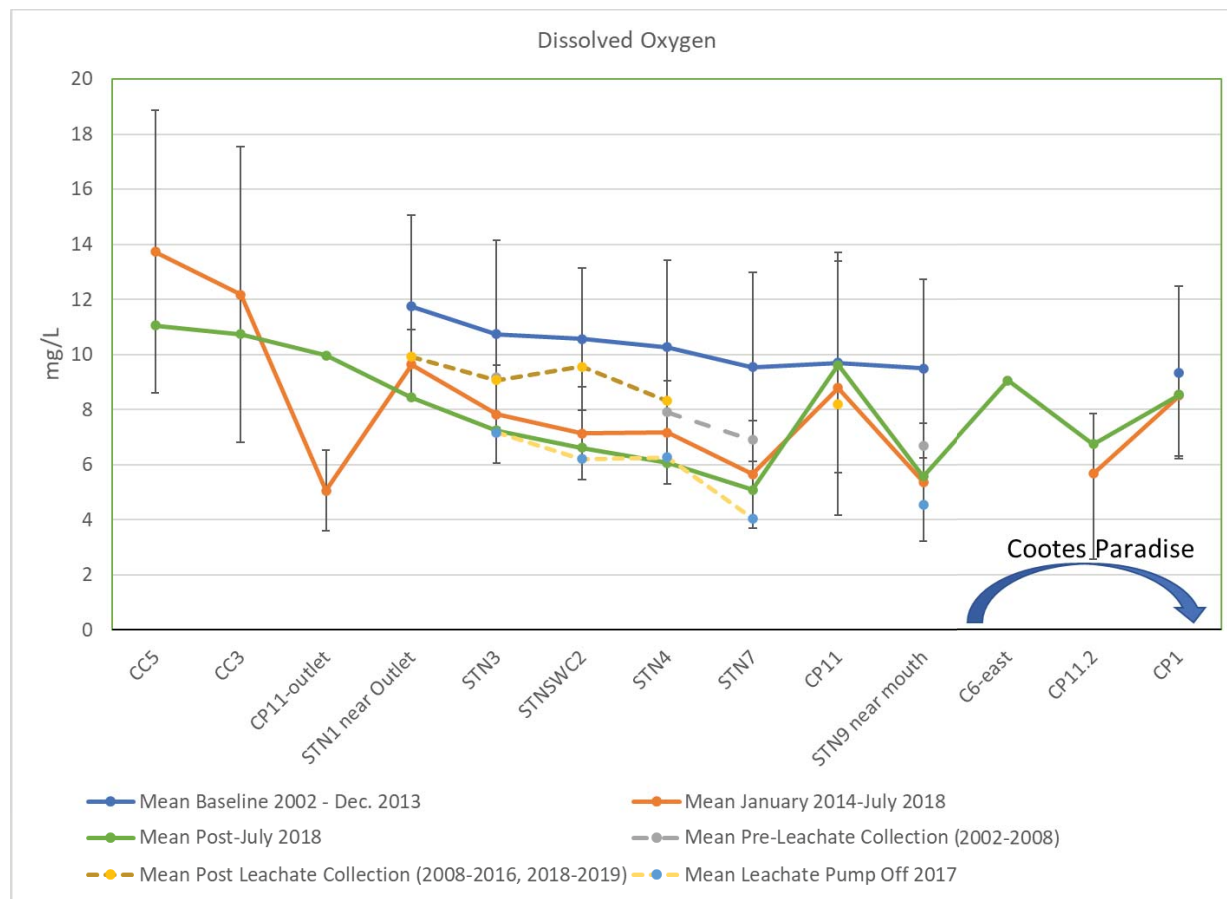
**Figure 5-2:
Chedoke Creek and Cootes Paradise dissolved oxygen concentrations**

Except for CP11, the post July 2018 data set does not return to the DO levels that apparently existed prior to the discharge event. This may be due to the limited number of samples used to characterize conditions post July 2018 (e.g. 6 samples at STN 1 versus 34 samples at CP11).

The increase in DO at CP11 shown on Figure 5-2 for the periods before, during and after the discharge generally reflects the large number of samples taken at this location relative to other sample sites. The additional samples at CP11 provide a better characterization of baseline (n = 97), discharge event (n = 79) and post discharge event (n = 35) over a broader range of conditions as compared to the other sites. By comparison, the DO average concentration for the STN7, immediately upstream, is based on n= 22 for baseline conditions, n = 14 for the discharge event and n = 3 for the post discharge event period. Similarly, the low DO measurements at CP11-Outlet were based on only 3 samples representing the discharge event in 2018 and these three samples do not adequately represent conditions over the four years of the discharge event.

The DO concentrations for the pre-leachate collection period, the mean post-leachate collection period and the period when the leachate pump was off are also illustrated here. UEM (2016) reported quite variable DO concentrations in groundwater from the landfill from 1.4 to 7.8 mg/L. It appears that leachate entering the creek may be causing the DO sag downstream of STN1. This is supported by the post July 2018 data which parallel the DO concentrations measured in 2017 when the leachate pump was shut down which would result in a higher loading of leachate to the creek. The impact of the leachate on DO in Chedoke Creek is less apparent with the more extensive sampling conducted at CP11 and this may be attributable to the sample number differential (n = 6 for post July, 2018 at STN1 versus n = 35 for CP11). When data were available, concentrations of DO rose in Cootes Paradise relative to Chedoke Creek. Sediment samples collected in Chedoke Creek in 2019 by SLR consisted predominantly of sand and silt with low organic matter which would not result in an oxygen demand within the creek itself.

In conclusion, the discharge event appeared to have a short-lived impact on DO in Chedoke Creek, but this was mitigated fully by the aeration achieved at the drop structure. The DO sag in Chedoke Creek downstream of STN1 is probably due to the continuous loading of low DO leachate water into the creek especially during baseflow conditions typified by the SNC-Lavalin data set. Data limitations complicate the interpretation of the data and the differentiation of a cause-effect relationship with respect to the discharge event.

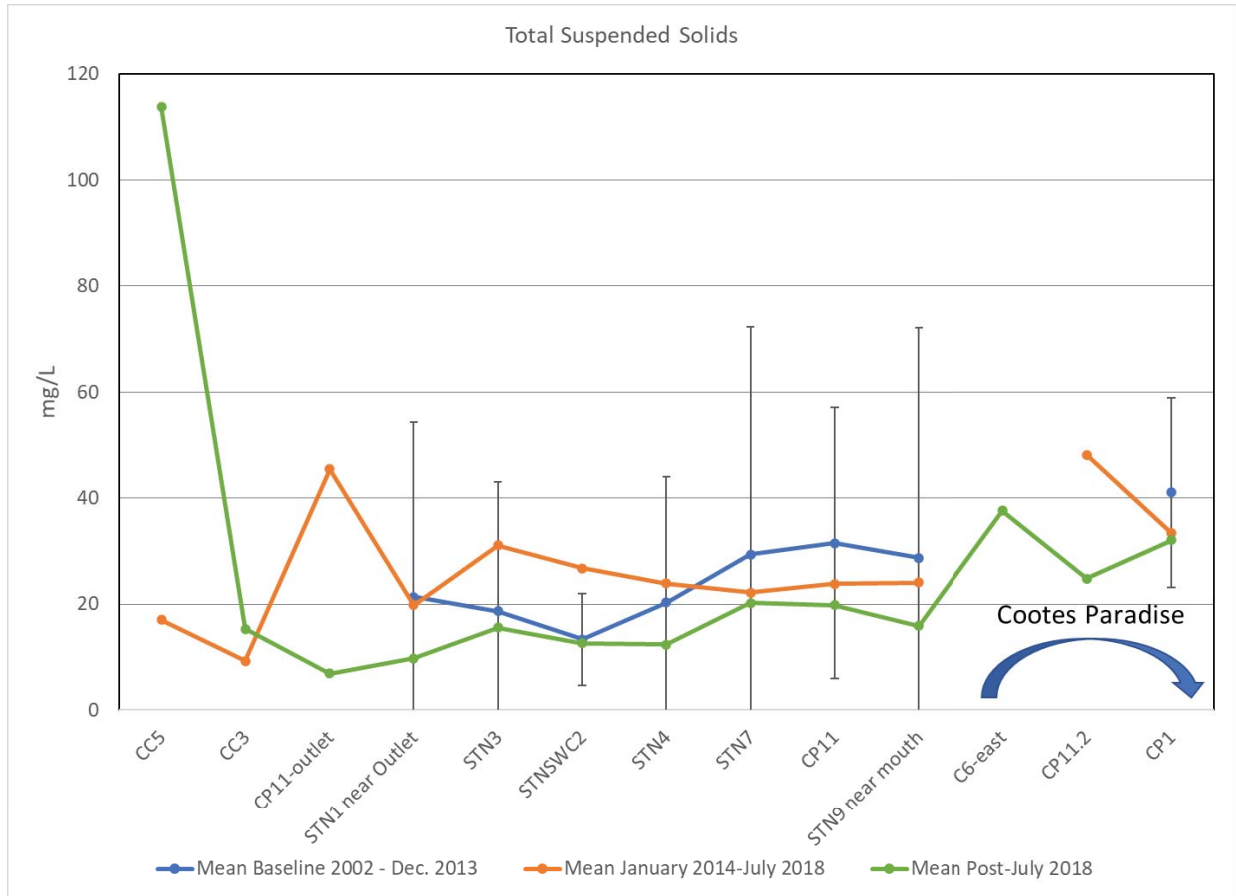
Figure 5-3:
Chedoke Creek and Cootes Paradise total suspended solids concentrations

Average baseline concentrations of TSS (pre-2014) in Chedoke Creek ranged between 15 and 30 mg/L with considerable individual sample variability as evidenced by the 1 standard deviation bars provided in Figure 5-3. Relative to these baseline conditions and the TSS concentrations post-July 2018, the CSO discharge event tended to increase TSS concentration on average by 25 to 40 mg/L. However, this is within the range of the natural variance of TSS at STN1 prior to 2014. Downstream of STN1, TSS ranged from 12 to 31 mg/L through to STN 9 with a high degree of individual sample variability. TSS did rise in Cootes Paradise likely due to factors unrelated to input from Chedoke Creek.

Groundwater carrying leachate will not contain significant concentrations of particles: therefore, the TSS impact of the leachate will be minimal. In summary, while the discharge event did have some direct impact on TSS in Chedoke Creek, this was quickly assimilated downstream and was not outside of the natural variability of TSS within this section of Chedoke Creek.

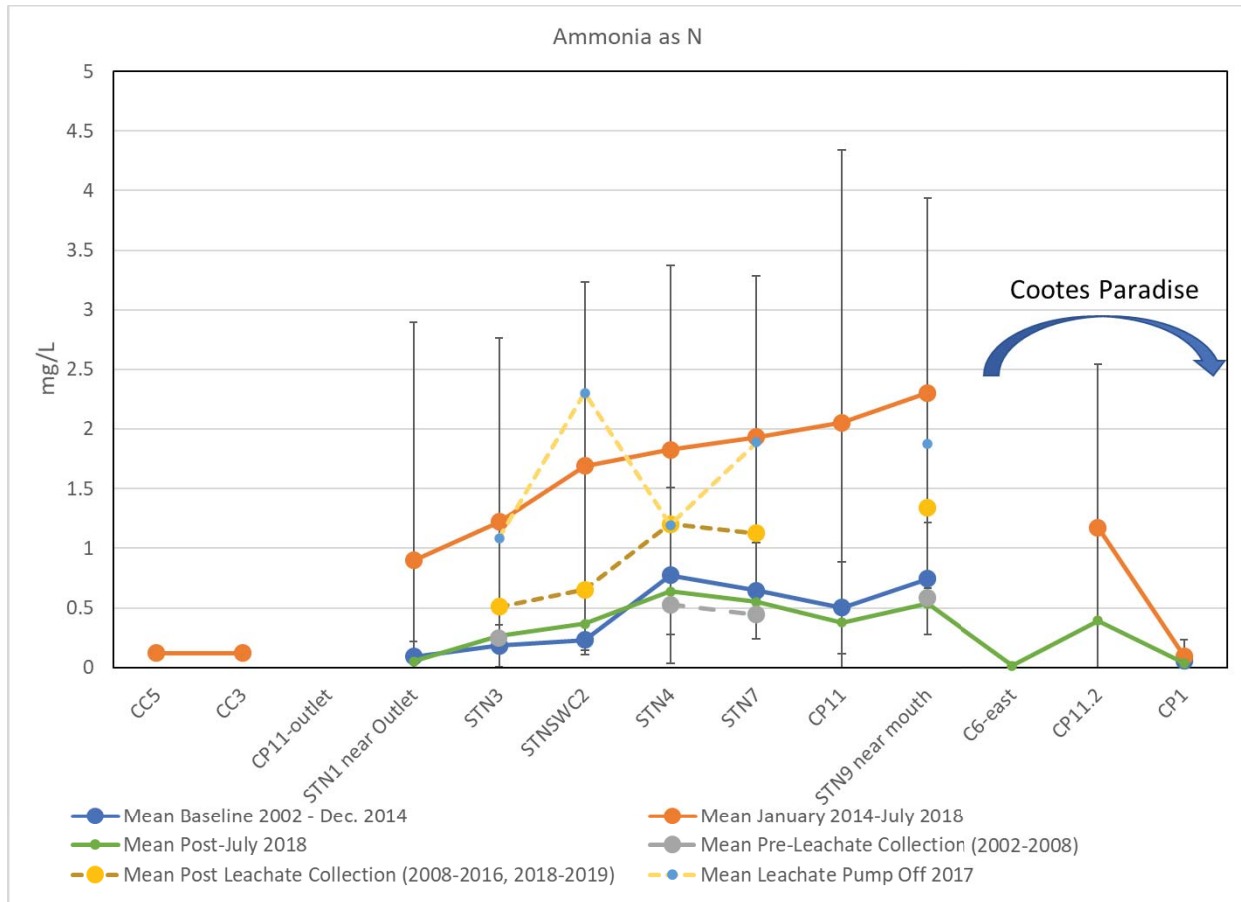
Figure 5-4:
Chedoke Creek and Cootes Paradise ammonia as N concentrations

Ammonia measured as N baseline concentrations in Chedoke Creek show low levels at Stn. 1 (0.09 mg/L) but concentrations rise consistently downstream peaking an order of magnitude higher at STN4 and STN9 at 0.77 and 0.75 mg/L, respectively (Figure 5-4). These concentrations

are very similar to concentrations measured after July 2018. When the stream data for post-leachate collection and with the leachate pump off in 2017 are plotted, it is evident that there is a contribution of ammonia from the leachate both when the pump is operating and especially when the pump was not operating in 2017. Unfortunately, there are no data for CP11 – Outlet although the mean concentrations between January 2014 and July 2018 suggest there is a bump of about 1 mg/L at STN1 with a gradual rise through the system to STN9 at 2.3 mg/L. This increase would appear to be primarily attributable to the unquantified impact of leachate reaching Chedoke Creek. Concentrations in Cootes Paradise near the mouth of Chedoke Creek quickly declined to around 0.01 mg/L during the discharge event.

In conclusion, while there appears to have been some impact on ammonia as N concentrations in Chedoke Creek resulting in an increase in ammonia of about 1 mg/L at Stn. 1, there has been an ongoing influence from leachate reaching the watercourse. The natural variability of ammonia concentrations precludes a conclusion regarding a statistically significant impact of either the discharge event or the leachate.

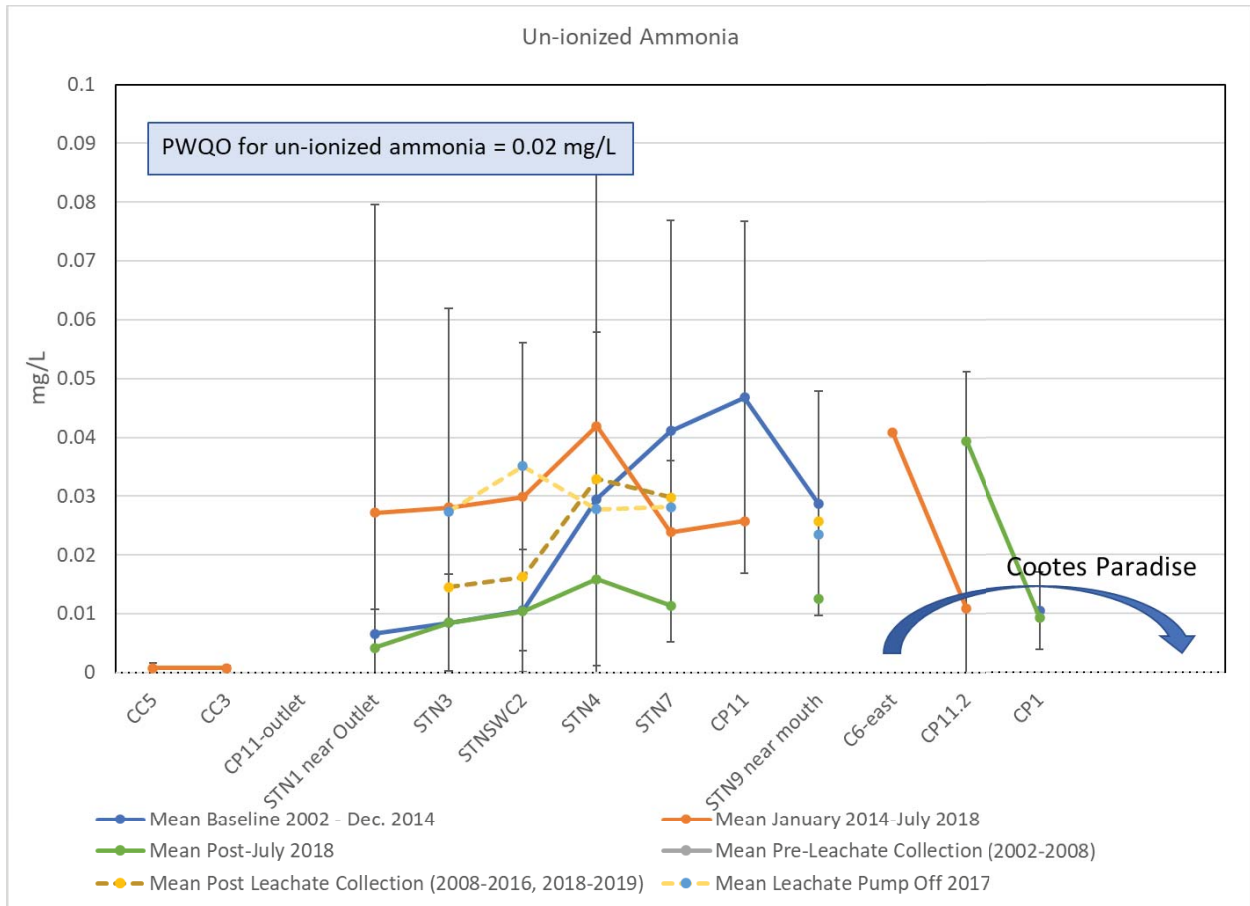
Figure 5-5:
Chedoke Creek and Cootes Paradise un-ionized ammonia concentrations

Although the data are limited, un-ionized ammonia, not surprisingly, has a similar interpretation to that of ammonia. Upstream concentrations are very low and these increase at STN1 during the 2014 to 2018 period by 0.027 mg/L (Figure 5-5) over upstream and 0.020 mg/L over baseline

conditions at STN1. However, the continued increase in un-ionized ammonia downstream appears to be a result of the contribution from leachate or other unquantified sources to Chedoke Creek. Un-ionized ammonia concentrations are highly variable because they are calculated based on total ammonia concentrations and are dependent on water temperature and pH. After July 2018, un-ionized ammonia concentrations in Chedoke Creek are all less than the PWQO. The undifferentiable influence from the discharge event and the leachate; however, have had no identified impact on Cootes Paradise as un-ionized ammonia concentrations at CP11-2 after July 2018 (n = 16) were comparable to upstream baseline concentrations and upstream discharge event concentrations; but all decreased to below the PWQO of 0.02 mg/L at CP1 (n = 14).

In summary, the discharge event had no differentiable impact on un-ionized ammonia in Chedoke Creek.

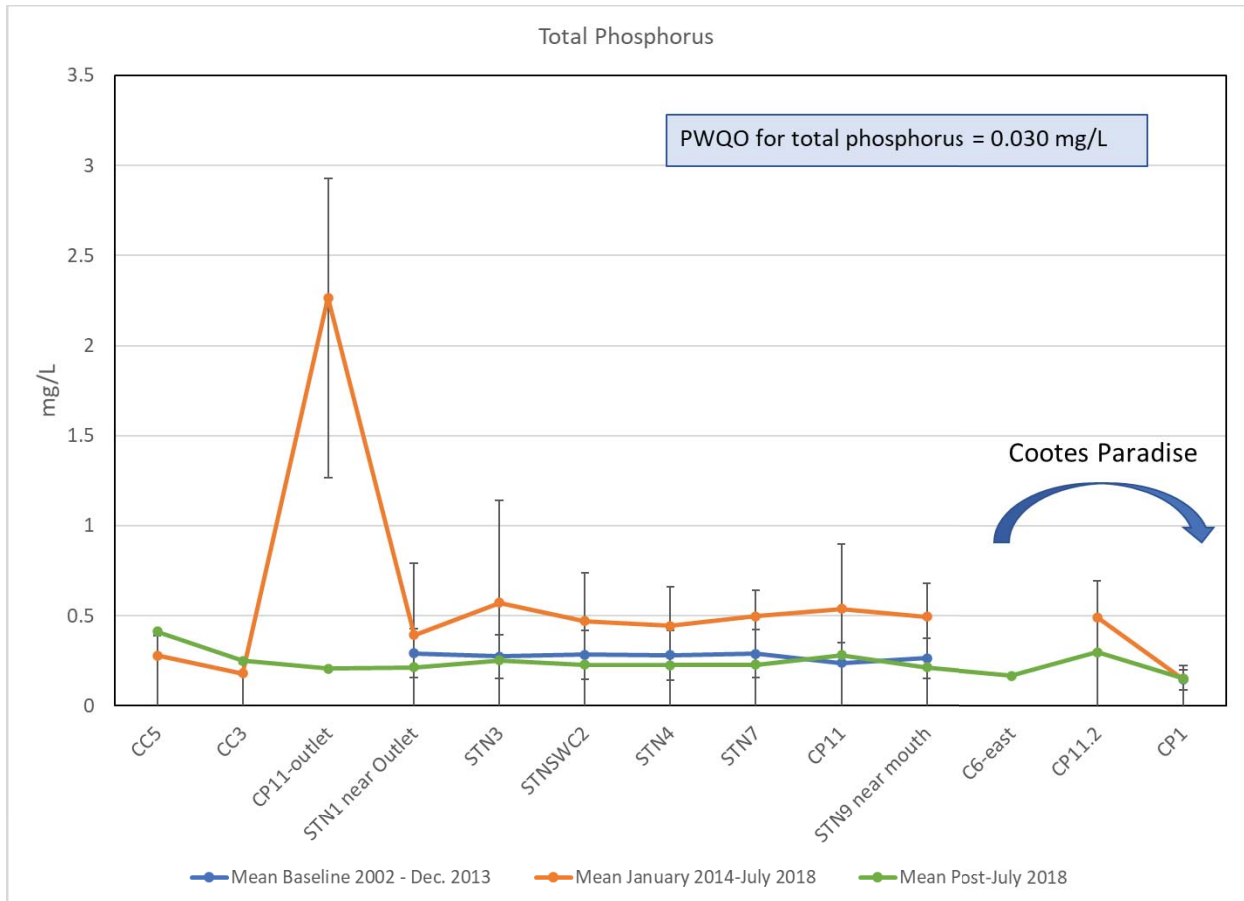
Figure 5-6:
Chedoke Creek and Cootes Paradise total phosphorus concentrations

The discharge event evidently produced elevated TP concentrations at CP11-Outlet averaging 2.3 mg/L and about 2 mg/L above the upstream concentrations and the baseline concentrations in Chedoke Creek. However, TP concentrations were quickly assimilated in the creek returning to concentrations that were about 0.5 mg/L or double the baseline and post discharge event concentrations (Figure 5-6). TP concentrations vary widely and there is no indication that the average in-stream concentration during the 2014 to 2018 period can be statistically differentiated

from background concentrations. TP concentrations in both Chedoke Creek and Cootes Paradise exceed its PWQO (0.03 mg/L).

In summary, the discharge event contributed TP to Chedoke Creek, but elevated concentrations were quickly assimilated in the creek and the inherently variable concentrations in the creek do not indicate a statistically significant increase over baseline conditions.

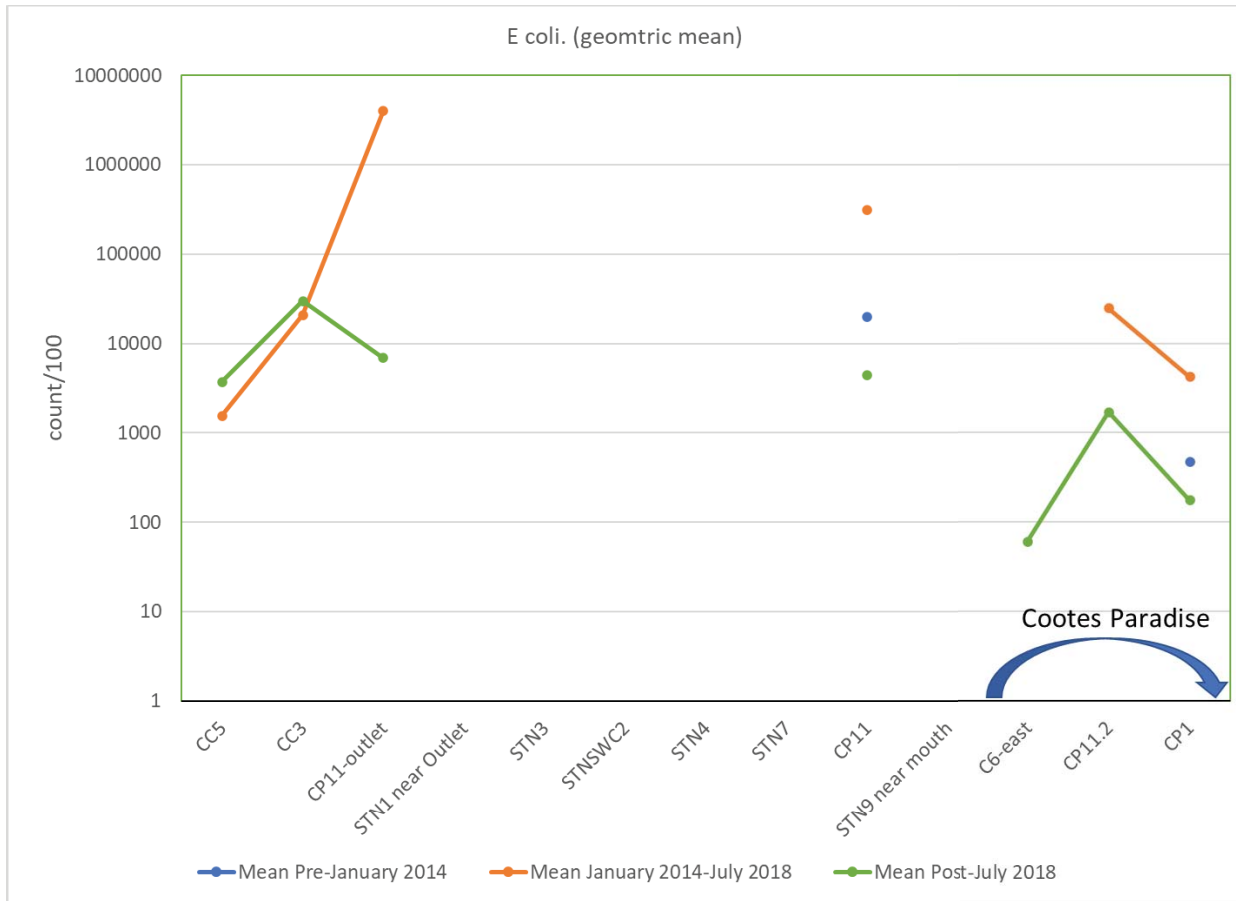
Figure 5-7:
Chedoke Creek and Cootes Paradise *E. coli* measurements

The available *E. coli* data are presented in Figure 5-7. It appears that the discharge event resulted in elevated bacterial measurements at CP11-Outlet. Measurements decreased downstream but there are insufficient data to conclude anything specifically other than that concentrations of *E. coli* were relatively low in Cootes Paradise near the mouth of Chedoke Creek.

E. coli counts are generally elevated throughout Chedoke Creek subwatershed. *E. coli* levels were measured in the study area (CP11) and at the two locations upstream of the Main/King CSO (CC-5, CC3) in 2018. The results are provided in Table 5-3 for two time periods during the discharge and after the discharge. The results show that *E. coli* levels were higher at station CP11 than in the upstream stations during the discharge. However, after the discharge, *E. coli* at station CP11 decreased to levels lower than those observed at the upstream location CC-3. This illustrates the presence of multiple sources of *E. coli* in Chedoke Creek subwatershed.

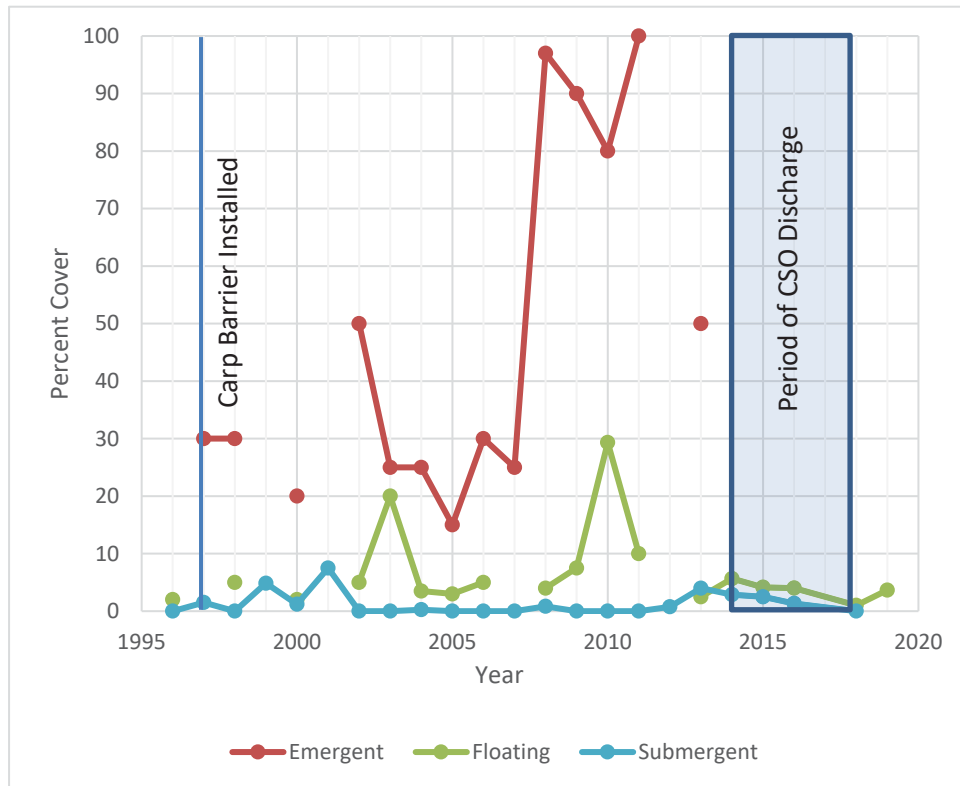
Figure 5-8:
Vegetation Trends for Location in or Near Lower Chedoke Creek

- Magnitude of increases and decreases in percent cover for floating and submergent vegetation types during the CSO discharge were similar to, or smaller than fluctuations prior to the CSO discharge at locations both far from, in or near Lower Chedoke Creek, thus within background variation (Figure 5-9).
- This assessment of available information does not show impacts on aquatic vegetation in Cootes Paradise associated with the CSO discharge, independent from other potential influencing factors.

The observed vegetation trends are generally consistent with previous findings reported for Cootes Paradise by Theysmeÿer et. al (2016) and Leisti et al (2016). In some instances where emergent, submergent and floating vegetation expanded their coverage this was followed with setbacks due to damage as a result of high-water levels, common carp activity, and periods of eutrophic or hypereutrophic conditions which may occur annually (in late summer). Hypereutrophic conditions can result in algae blooms and declines in plant communities (e.g. submergent group). Other factors potentially influencing percent coverage of aquatic vegetation include the regulation of Lake Ontario water levels, resuspension and inputs of sediment from tributaries along with high nutrient levels which may promote algal blooms thus reducing dissolved oxygen (Leisti et al., 2016). These factors influence aquatic vegetation in Cootes Paradise at a much larger scale than the CSO discharge, were occurring before the CSO event and continue as key issues maintaining degraded conditions in Cootes Paradise (Leisti et al., 2016).

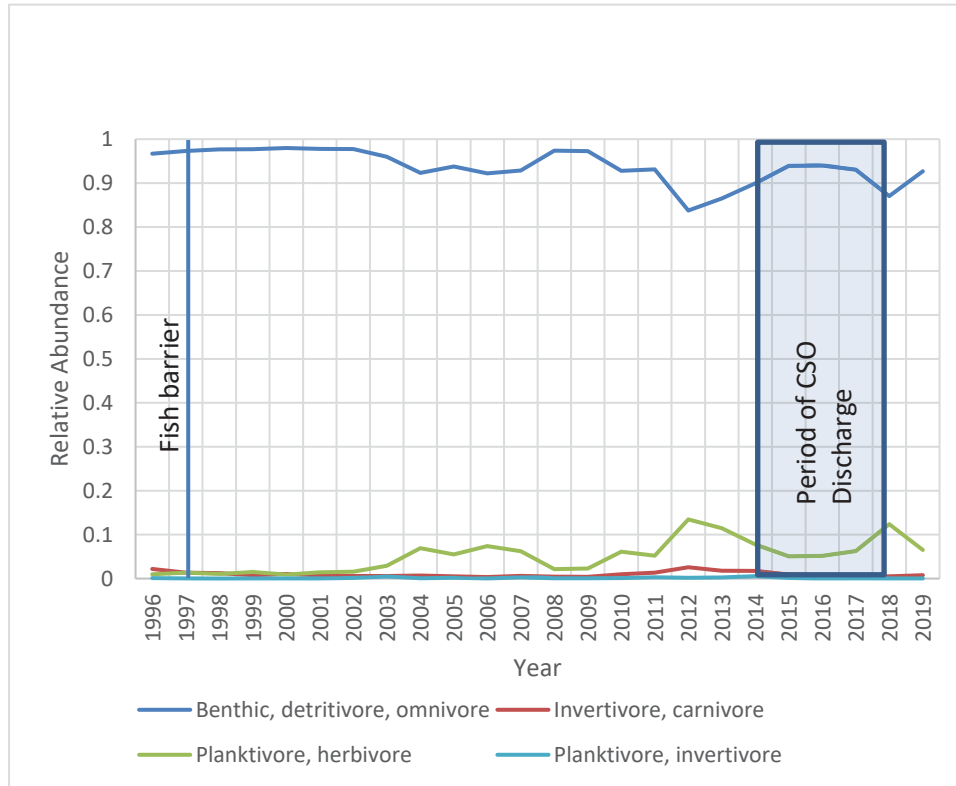
Figure 5-11:
Trends in Trophic Feeding Groups at the Fishway in Cootes Paradise

Benthic-detrivore-omnivore is the numerically dominant trophic feeding group represented at the fishway fish collection location. This group is also the most tolerant of present aquatic ecosystem conditions in Cootes Paradise. Relative abundance of the benthic-detrivore-omnivore group began increasing approximately two years before the CSO discharge period, but this increase is within the range of pre-discharge variation. Relative abundance then decreased during the CSO discharge period to approximate pre-discharge levels (Figure 5-11).

Relative abundance of species more dependent on sight feeding (planktivore-herbivore) showed increased relative abundance approximately two years prior to, but then started declining prior to the CSO discharge (Figure 5-11). Relative abundance of the planktivore-herbivore group started to increase during the discharge period. This increase would not be expected if impacts from the discharge were negatively affecting fish species at the fishway.

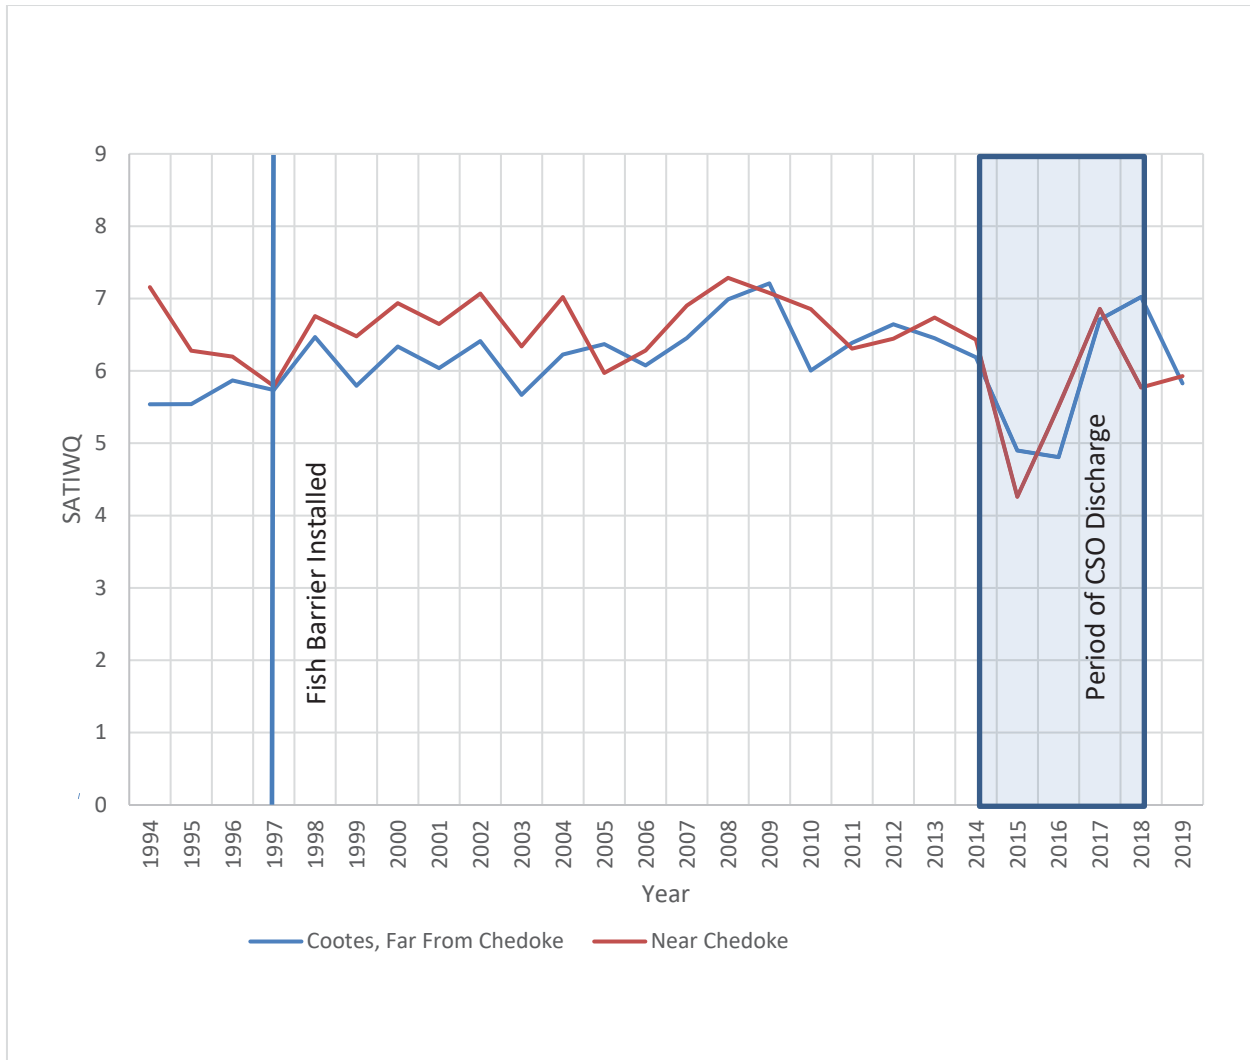
Figure 5-12:
Trends in Water Quality Sensitivity in Cootes Paradise Near and Far From Chedoke Creek Outlet

Variation in species sensitivity shows a similar pattern at sampling locations in Cootes Paradise near and far from Lower Chedoke Creek. Fish collected from all sites in Cootes Paradise show a decline followed by an increase in water quality sensitivity during the CSO discharge period (Figure 5-12). Similarity in pattern and timing suggest that the fish community in Cootes Paradise does not respond to impacts of the CSO discharge independent of other potential influencing factors.

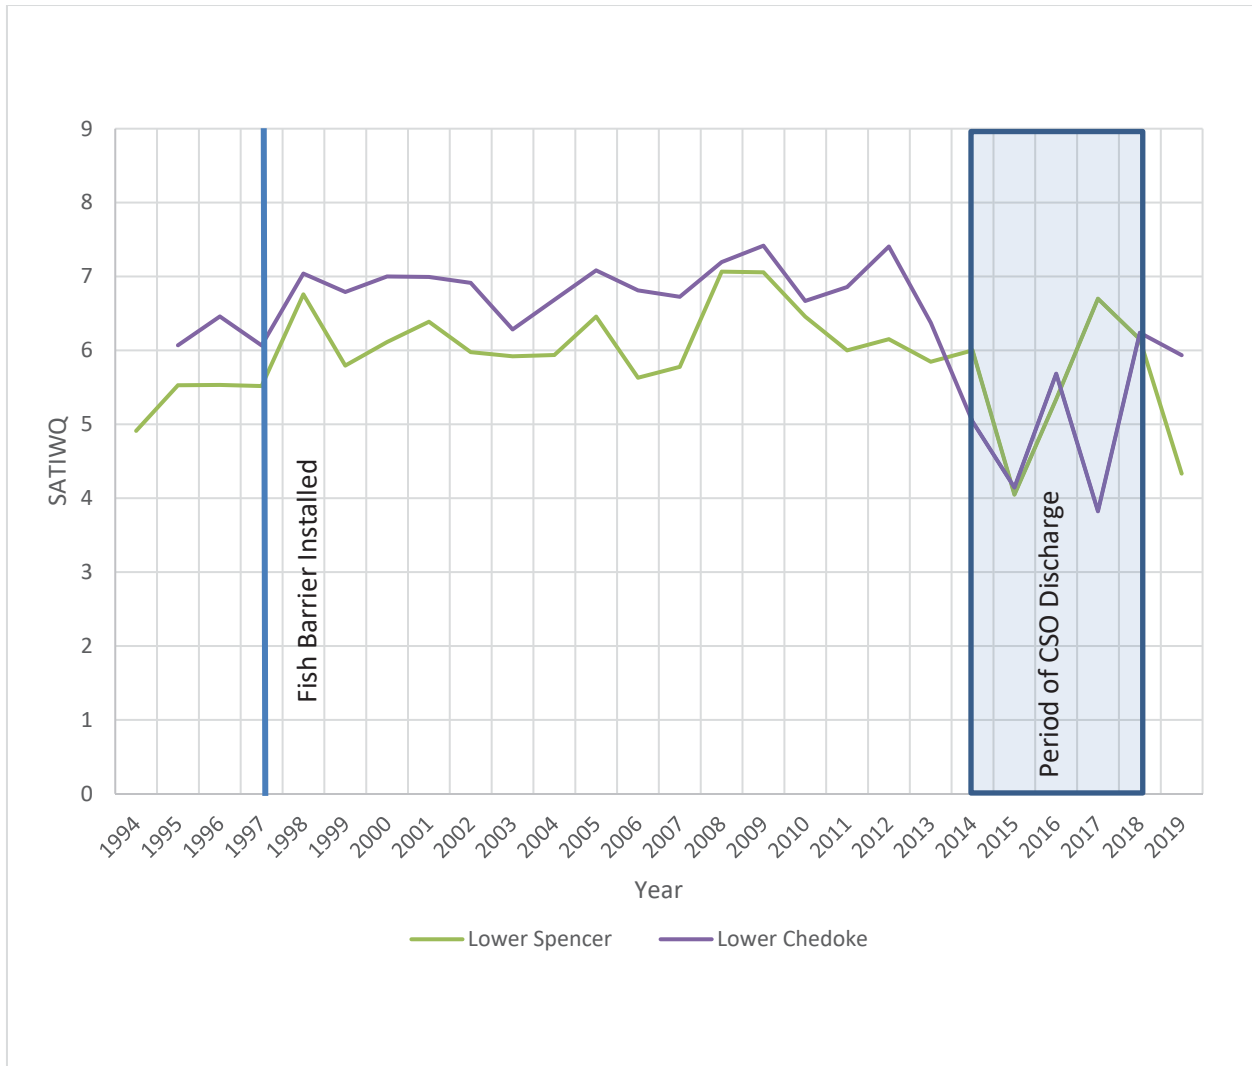
Figure 5-15:
Trends in Water Quality Sensitivity in Lower Spencer Creek and Lower Chedoke Creek

Fish collected from locations in the vicinity of Lower Spencer Creek and Lower Chedoke Creek show a similar pattern of decline followed by an increase in species sensitivity to water quality during the CSO discharge period (Figure 5-15). Similarity in pattern and timing suggest that the fish community in Cootes Paradise does not respond to impacts of the CSO discharge independent of other potential influencing factors. The species sensitivity in the vicinity of Lower Spencer Creek is typically as low or lower than the species sensitivity to water quality for fish species in Lower Chedoke Creek.

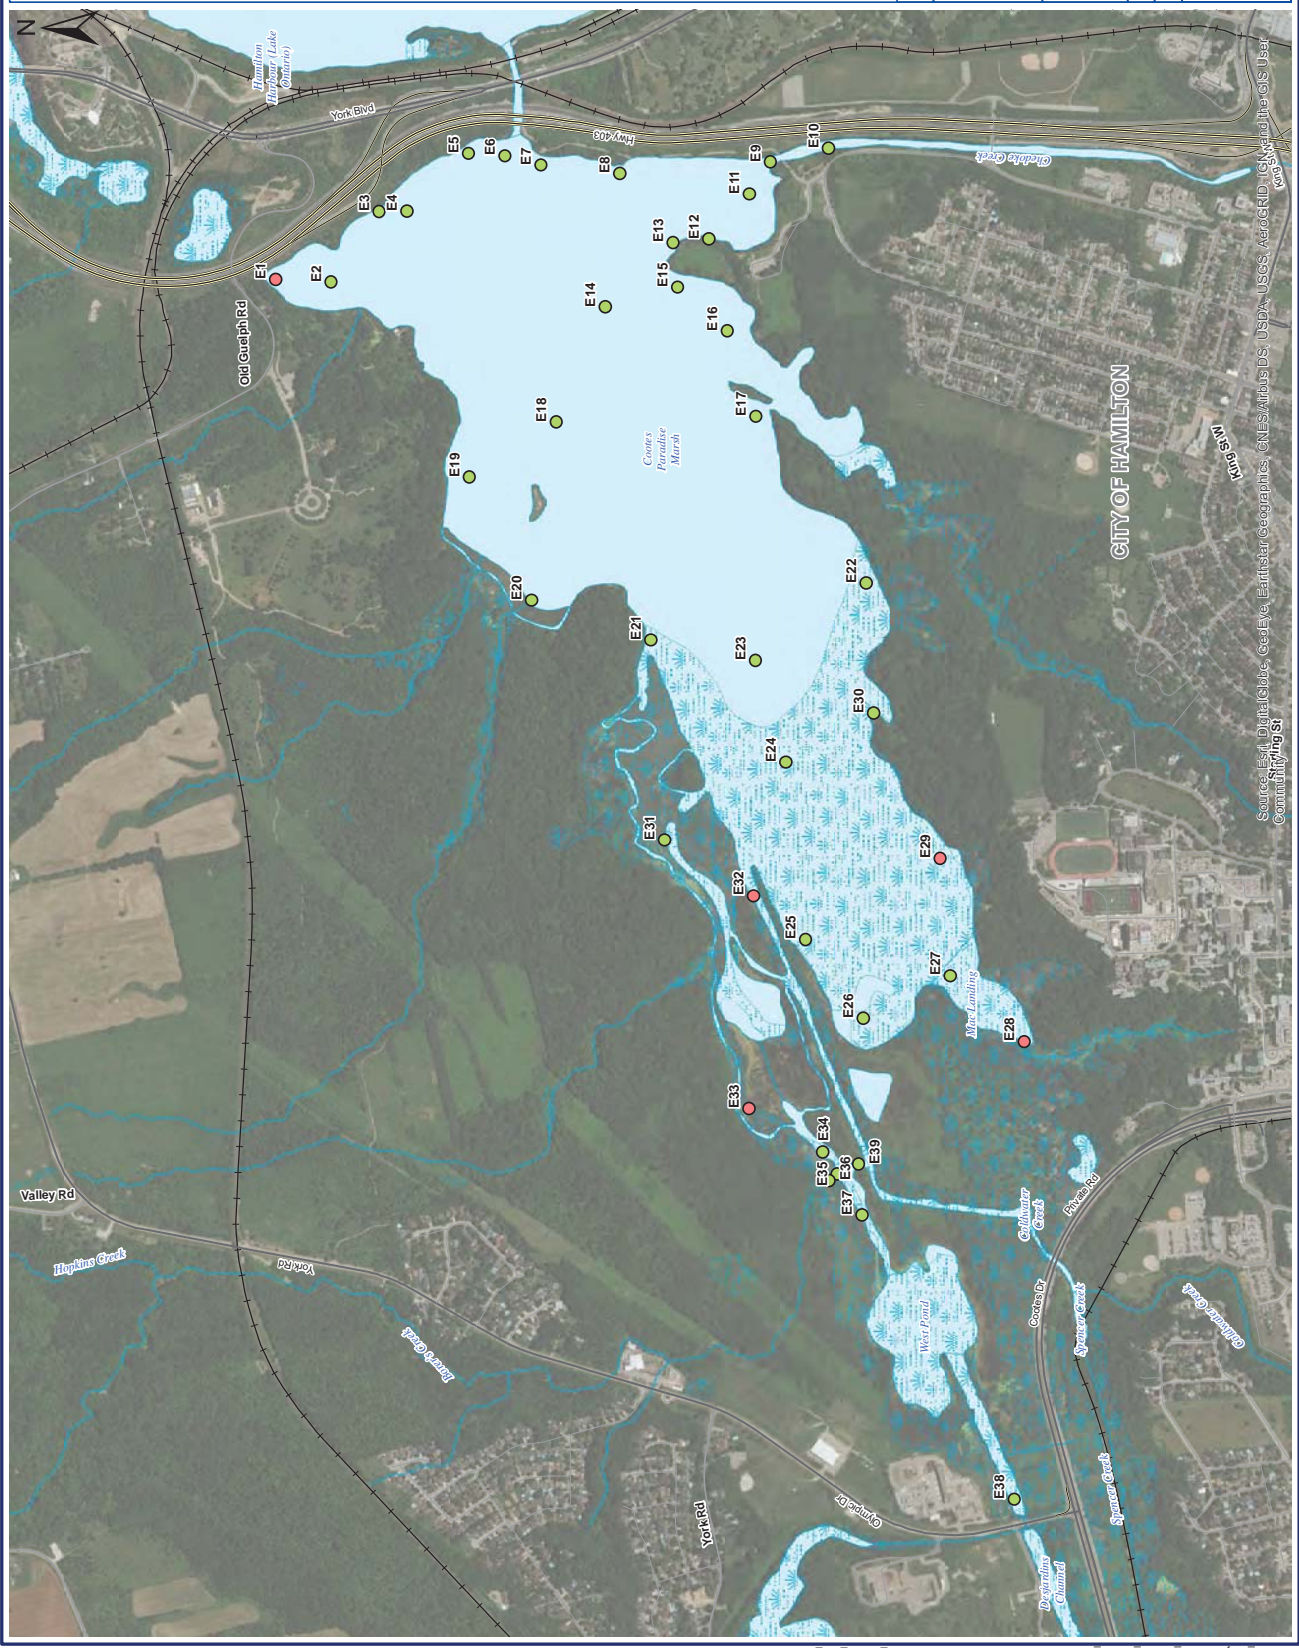
COOTES PARADISE JULY 27, 2018
E COLI COMPARISONS TO
HHRAP TARGET
