Road Safety Audit (Detail Design Stage) Final Report

Keddy Access Trail
Hamilton, Ontario, Canada

March 3, 2020

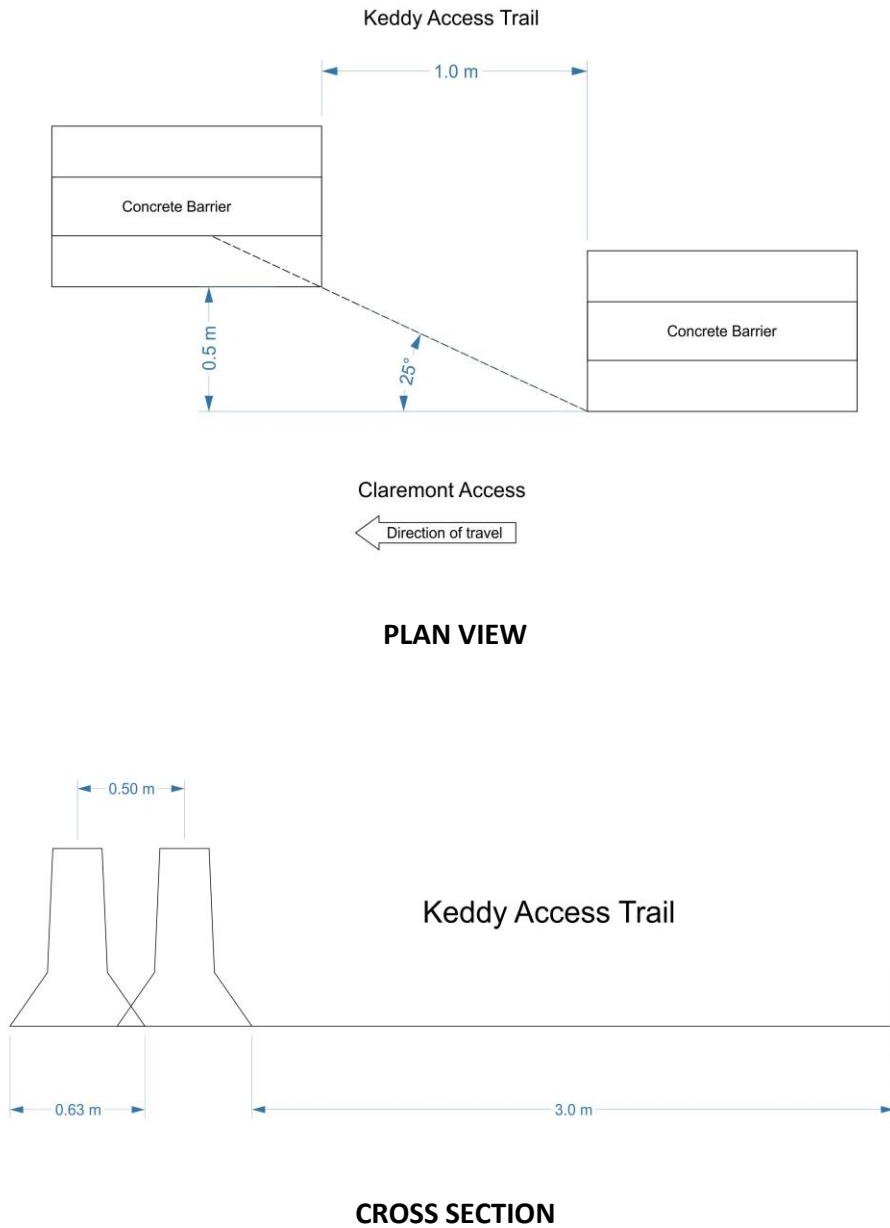
FIGURE 1: Emergency and Pedestrian Openings

- 2.2.12 Having stated the above, it is noted that the pedestrian crossing located at or near Southam Park requires a short break/opening in the barrier system. Furthermore, it is planned to have other short breaks/openings in the barrier system to accommodate MUT access by emergency services. The breaks/openings will be approximately 1.0 metres wide.

- 2.2.13 The unprotected, blunt end of a concrete barrier is a significant safety hazard to errant road/trail users. If the ends of the barrier cannot be protected by an industry-approved end treatment it is recommended that barriers be offset as shown in Figure 1. Most vehicles will depart the roadway at an angle of 25 degrees or less. Offsetting the downstream barrier effectively shields the exposed end of the downstream barrier with the upstream barrier.

2.2.14 While the offset addresses safety concerns for motorists on the Claremont Access and downbound MUT users, the offset does not address the exposed end hazard for upbound MUT users. However, given the grade of the Keddy Access Trail, operating speeds of upbound MUT users is not expected to be very high. As a result, the risk presented by the exposed end of the barrier is low. No action is required, however, a hazard marker or

similar delineation may be placed in the exposed end to warn upbound MUT users of the existence of the hazard.

- 2.2.15 The barrier offset makes the opening slightly more obvious to upbound MUT users – leading to potential confusion about whether the opening is an allowable route. This is expected to be a minor concern, since the opening is relatively small and the offset still results in the base of the concrete barriers visually overlapping (see the Cross Section in Figure 1). If desired, measures may be taken to minimize the probability of upbound MUT users passing through the opening to the Claremont Access. For example, a directional dividing line and/or edge lines may be marked on the trail from 20 metres in advance of, and through the opening. Also, signing may be used to direct upbound trail users to keep to the right at these locations. Alternatively, if it is acceptable to the emergency services, a movable or breakable horizontal beam or member could be erected across the opening. The beam is intended to be a visual obstruction that discourages MUT users from entering the opening, but not a substantive structural measure that would inhibit emergency services from using the opening.

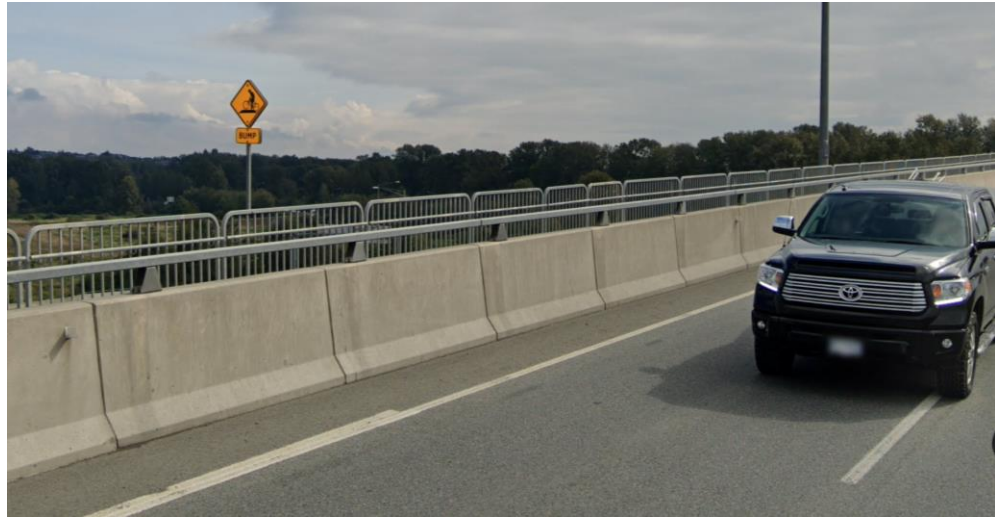
FIGURE 2: BUMP Warning Sign on the Port Mann Bridge⁴

⁴ The speed hump is not visible but is denoted by the warning sign shown at the side of the MUT.

- 2.4.4 Nonetheless, faster-moving cyclists on a MUT can be a hazard to pedestrians (and themselves). When steep grades and higher cyclist speeds cannot be avoided (such as on the Keddy Access Trail), higher cyclist speeds should be mitigated through the use of regularly-spaced speed reducing measures. The following measures are available for use and should be considered by the designer/owner.

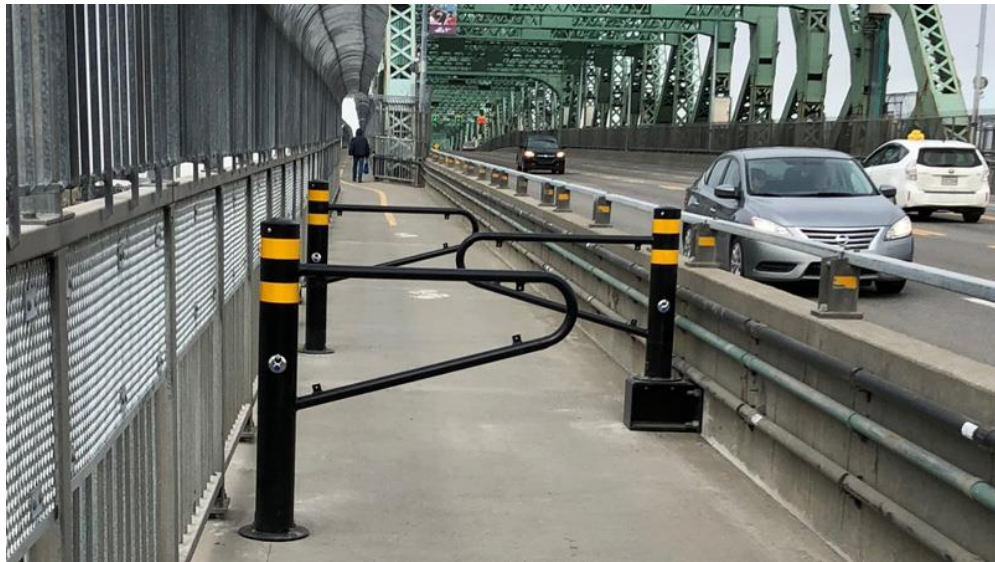
FIGURE 3: Chicane on the Jacques Cartier Champlain Bridge⁵

⁵ The chicanes have the ability to be swung "open" for emergencies and/or snow removal in winter. The distance between the barriers is sufficient for bicycles as well as bicycles with child trailers to pass through without dismounting. Signs and reflective materials assist path users in identifying the chicanes during times of low light.

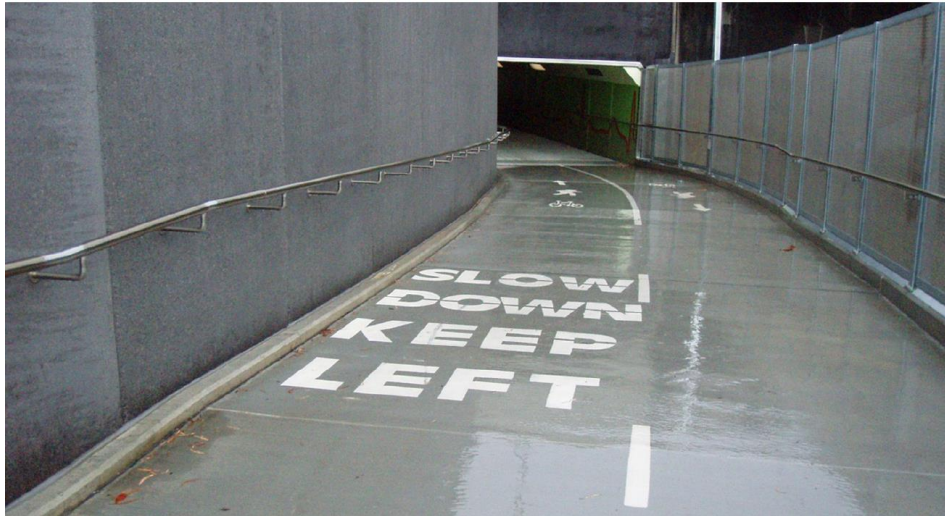
FIGURE 4: SLOW Pavement Marking (Brisbane, Australia)⁶

⁶ Note that the KEEP LEFT message is used because Australian rules of the road require cyclists to operate on the left side of the road.
