## **City of Hamilton**

# **Red Hill Valley Parkway Analysis**

**Final Report**

April 28, 2020

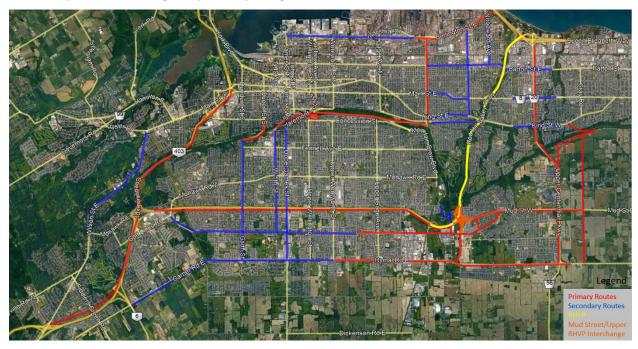
Figure 3: Travel Time Routes (Source: Google Earth©)

The City identified several routes to be considered for travel time assessment. The following Figure 3 depicts the travel time routes used for this analysis, which are categorized into Primary and Secondary routes, shown with red and blue lines, respectively. The RHVP and Mud/North RHVP interchange are shown in yellow and orange respectively in Figure 3.

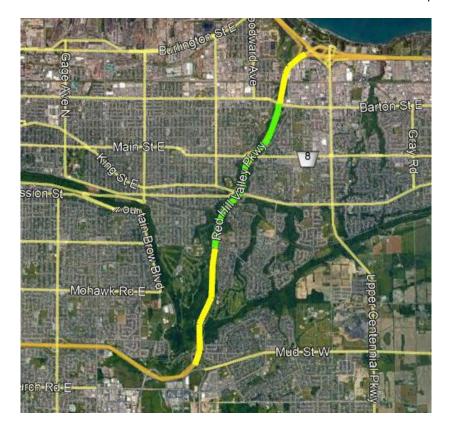
Figure 4: Speed Analysis Study Area (Source: Google Earth)

Figure 4 highlights the speed assessment study area. The green line highlights the extent of the speed limit change along the RHVP (between the Barton Street East and Greenhill Avenue interchanges) where the posted speed limit was reduced from 90 km/h to 80 km/h. The yellow line indicates the entire stretch of RHVP, the rest of which remains at a speed of 90 km/h.

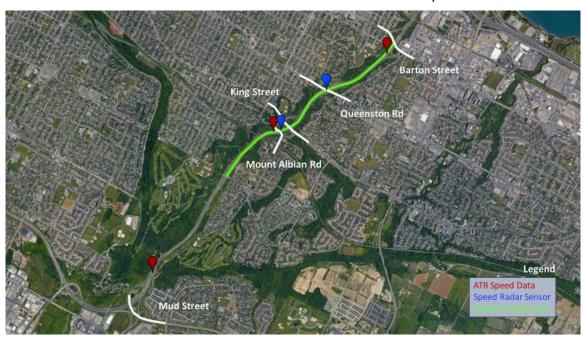
Figure 6: Speed Data Collection Stations (Radar and ATR)

Figure 6 shows the locations where speed data were available. It should be noted that the calibration details for the radar sensors data were not available at the time of this study.

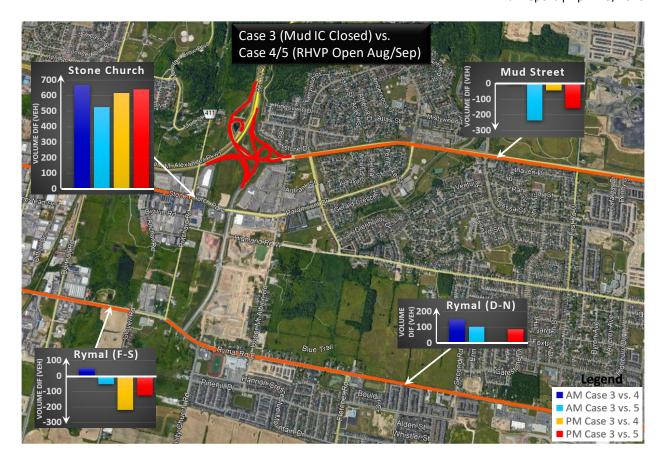
Figure 23: Volume Diversion Comparison: Case 3-Mud IC vs. Case 4-Open Aug and Case 5-Open Sep

Figure 23 depicts changes in traffic volume during Case 3-Mud IC compared with Case 4-Open Aug and Case 5-Open Sep. The observed data indicates that most of the traffic diverted during the closure of ramps from Mud Street and Upper RHVP had used Stone Church Street during the AM and PM peak hours.
