Inventory & Research Working Group (IRWG)

Meeting Notes

Monday, April 26, 2021 (6:00 pm – 8:00 pm)

APPENDIX A: 54-56 Hess Street South

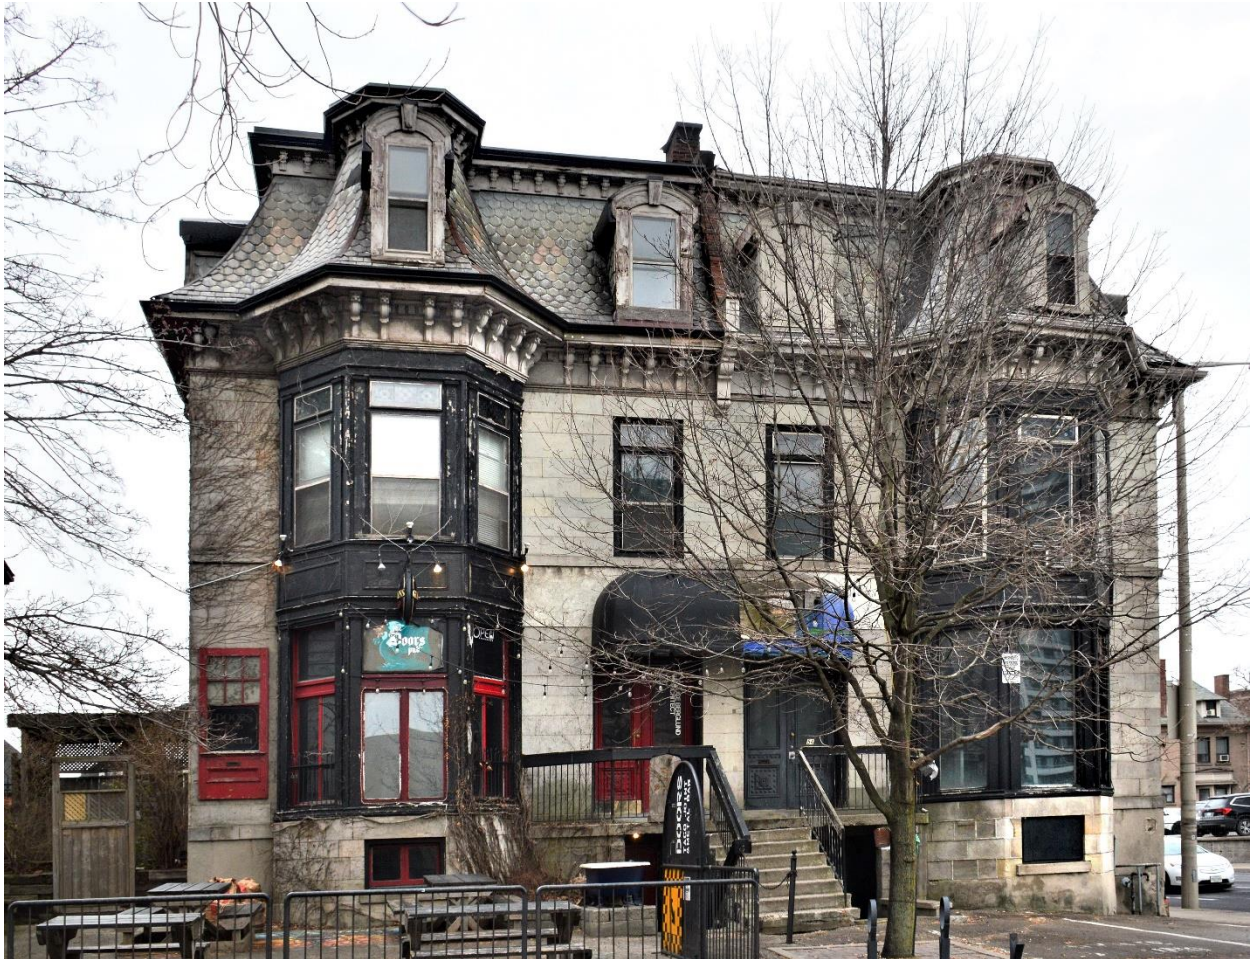
Image: 54-56 Hess Street South, Hamilton. Photo courtesy of Jim Charlton.

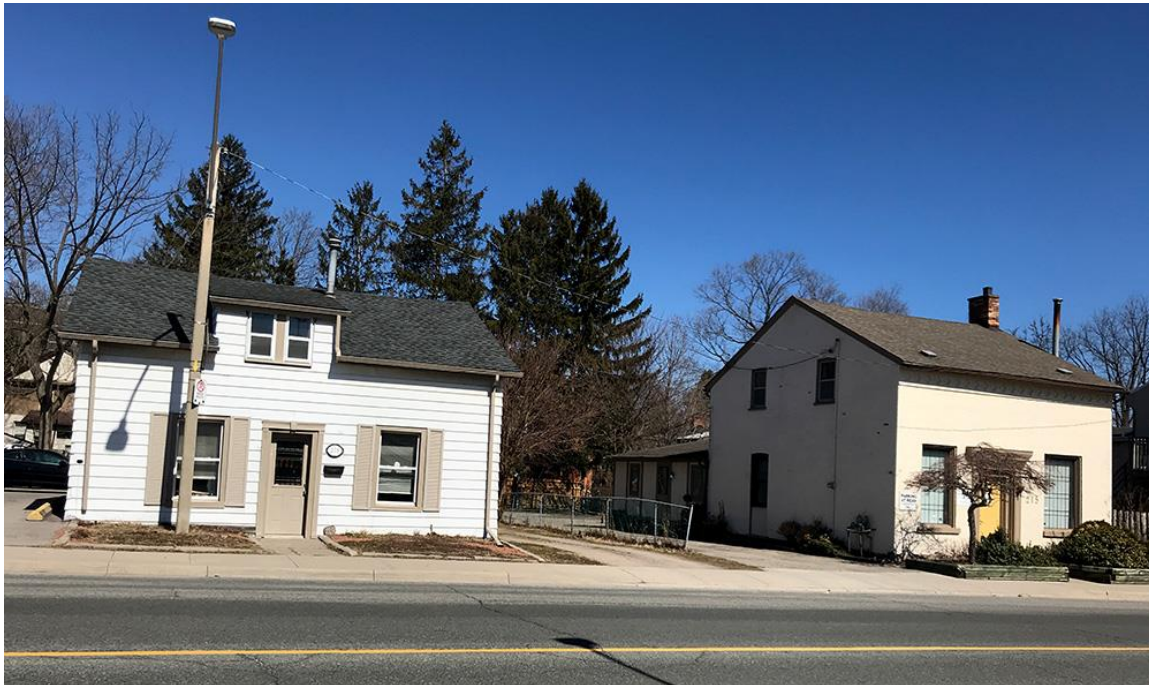
1½ storey cottages at 219 and 215 King Street West, just west of Market Street.
Photo credit: Ann Gillespie, March 2021

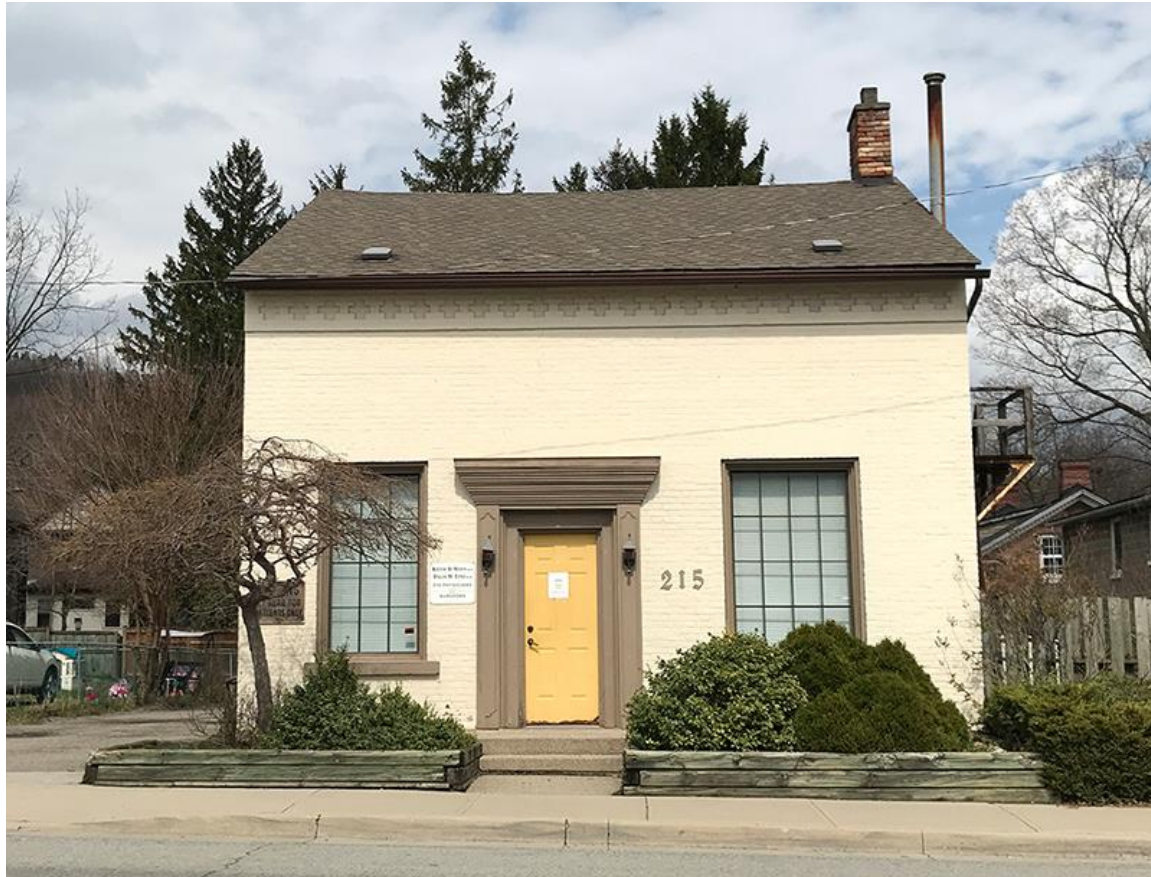
Front (south) façade of #215 showing the decorative course of brickwork below the eaves, and the altered front doorway and windows (thermopane replacements with fake mullions).
Photo credit: Ann Gillespie, March 2021

Alterations include the painting of the brick masonry, replacement of the original six-over-six paned sash windows, replacement of the front door, and the addition of an elaborate door surround, which obscures the original transom light, a characteristic feature of many examples of this form of cottage in Dundas. An original doorway on the west façade has also been converted to a window.

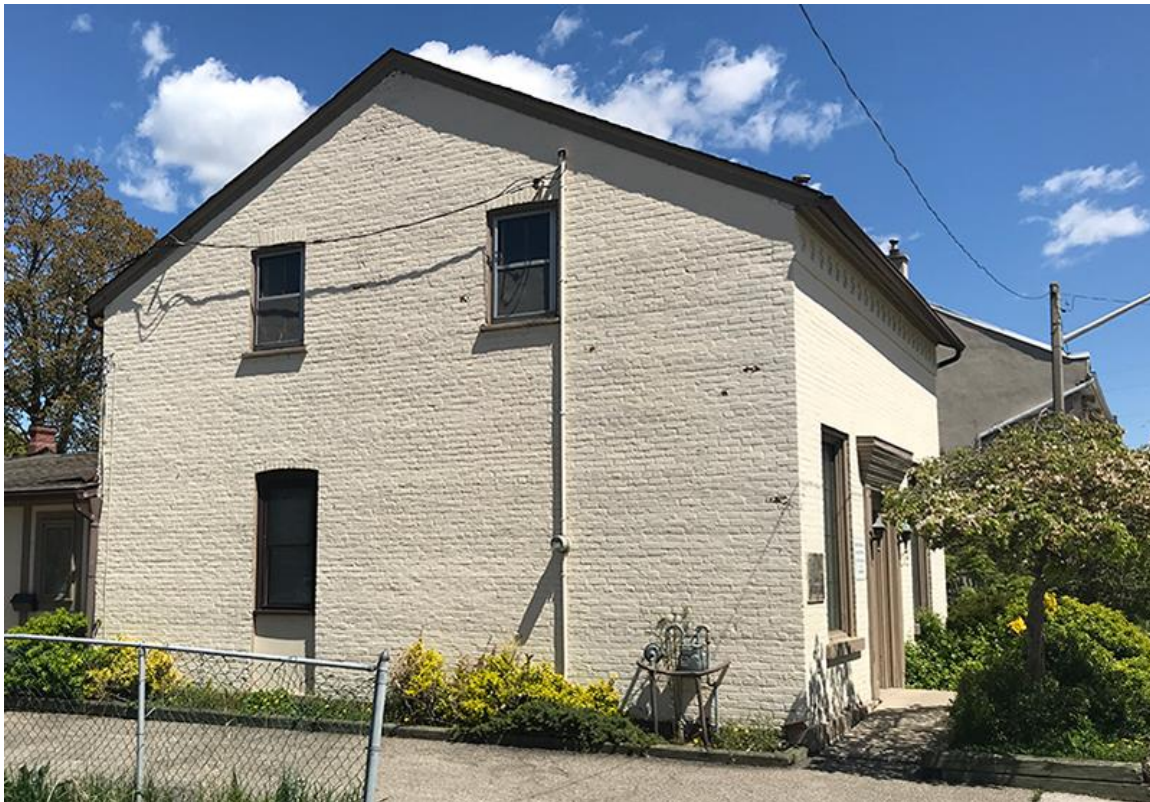
West façade showing the upper storey windows for second floor bedrooms, the converted doorway and the common bond brickwork of the side and rear walls, with one row of headers for every five rows of stretchers. Photo credit: Ann Gillespie, May 2021

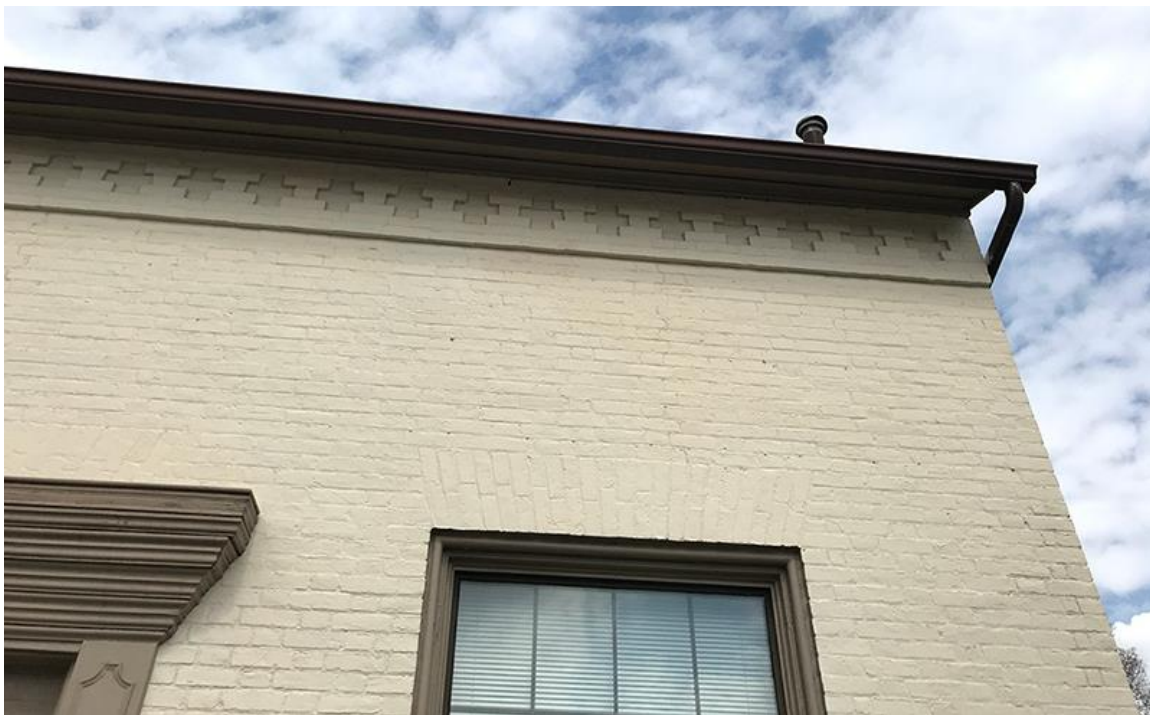
Close-up view of the decorative band of raised brickwork with the cross motif. Also shows the Flemish bond brickwork of the front façade and the flat voussoir arched window and door lintels. The door lintel is largely obscured by the added wood lintel and pilasters. Photo credit: Ann Gillespie, March 2021

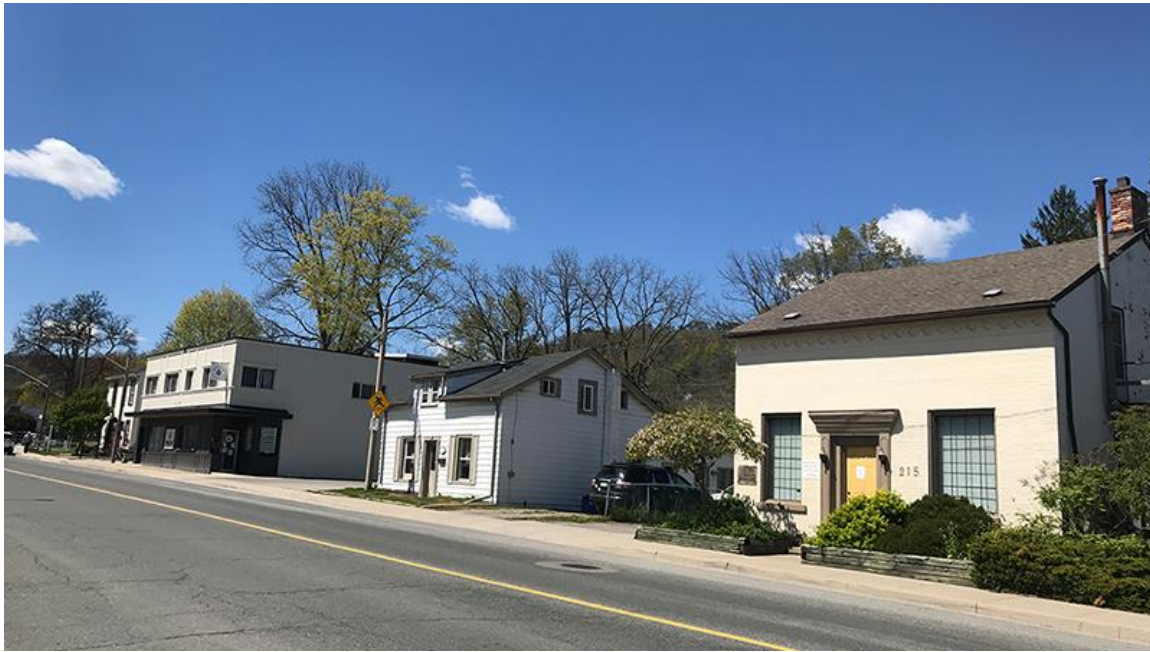
215, 219 and 225 King Street West (Betula Restaurant and Dundas Osteopathy with apartments above). Photo credit: Ann Gillespie, May 2021

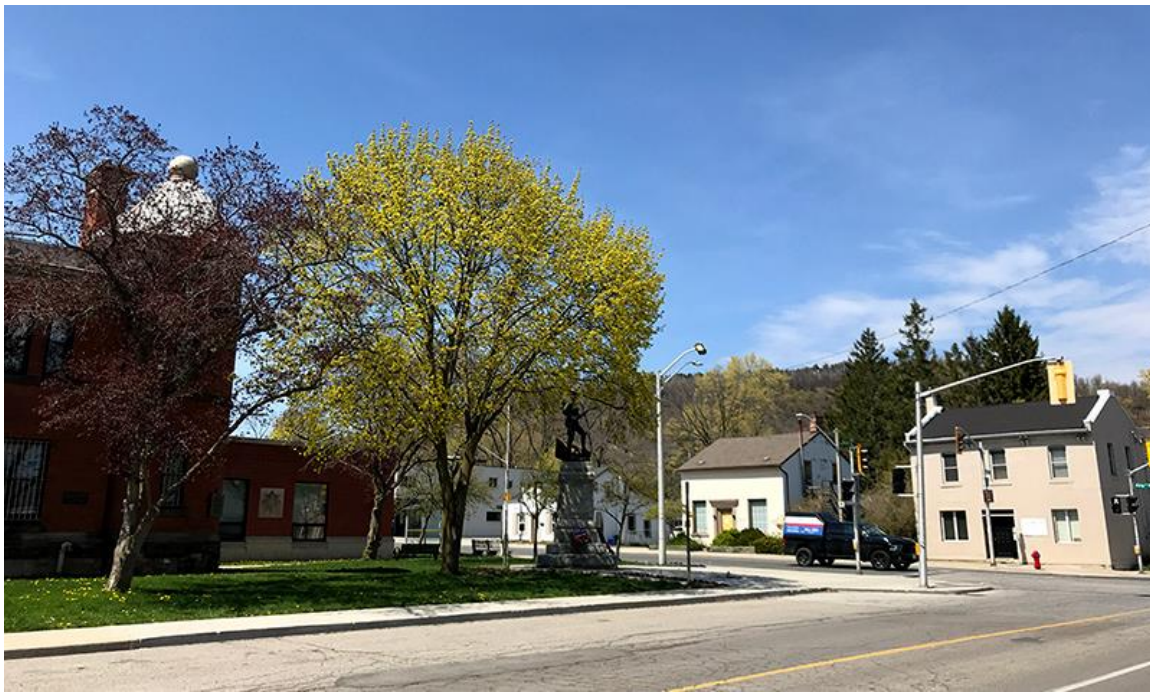
Streetscape view with the Dundas Naturopathic Centre at 211 King Street West at the corner of Market Street: a two-storey brick masonry house built after 1851 (inventoried but not listed on the Heritage Register). At the corner of Market Street South and King stands the former Armoury, renovated and enlarged several times, most recently in 2000 (designated under Part IV of the Ontario Heritage Act). Photo credit: Ann Gillespie, April 2021

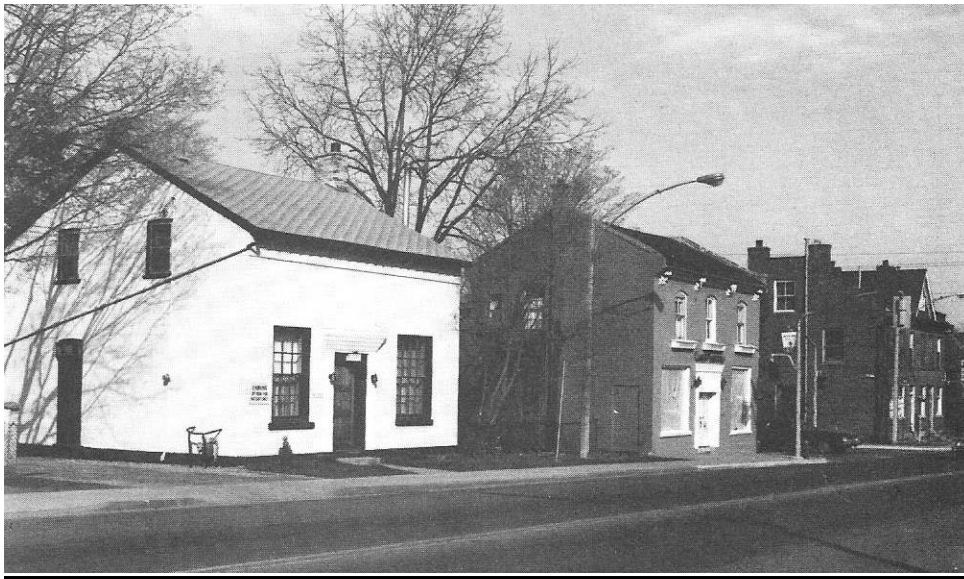
215 King Street West as it appeared in a photograph taken for the *Picturesque Dundas Update*, 1981 (Dundas Historical Society, p.168). By that time the brickwork had been painted, the existing doorway surround added (also painted white) but the side doorway had not been altered and the original windows may have been still intact.

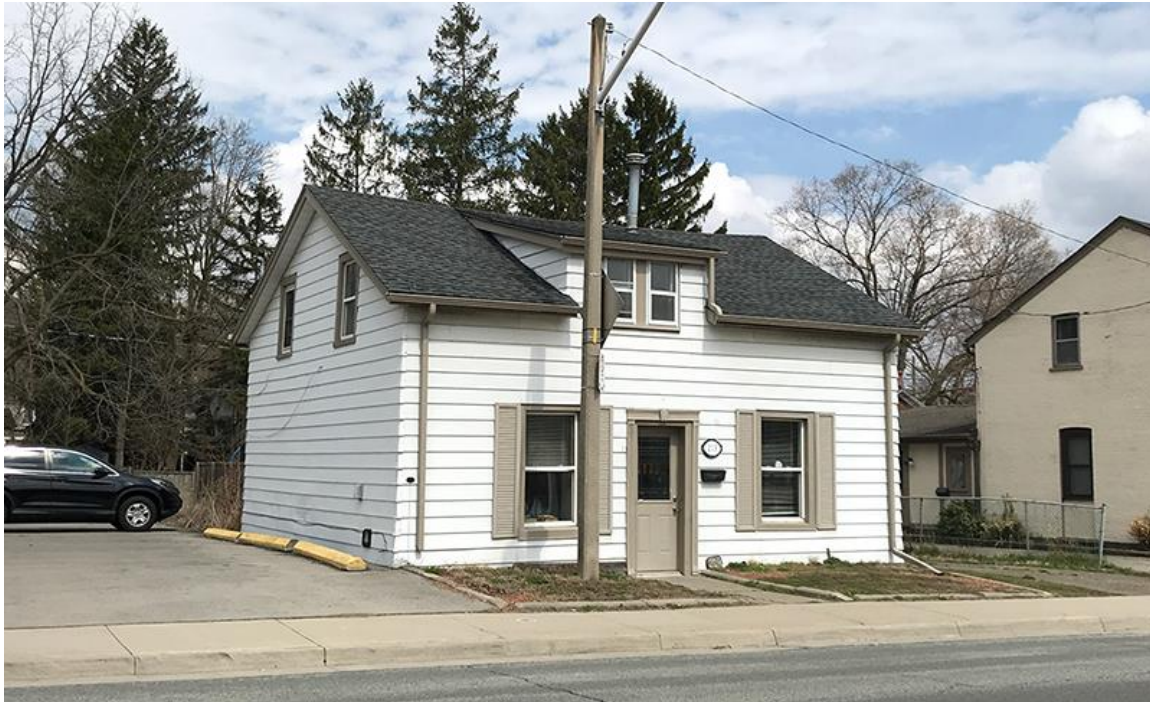
Front (south) and west facades. All traces of the original cladding and foundation have been obscured by the aluminum cladding. The shed dormer could have been added in the early to mid 20th century. March 2021

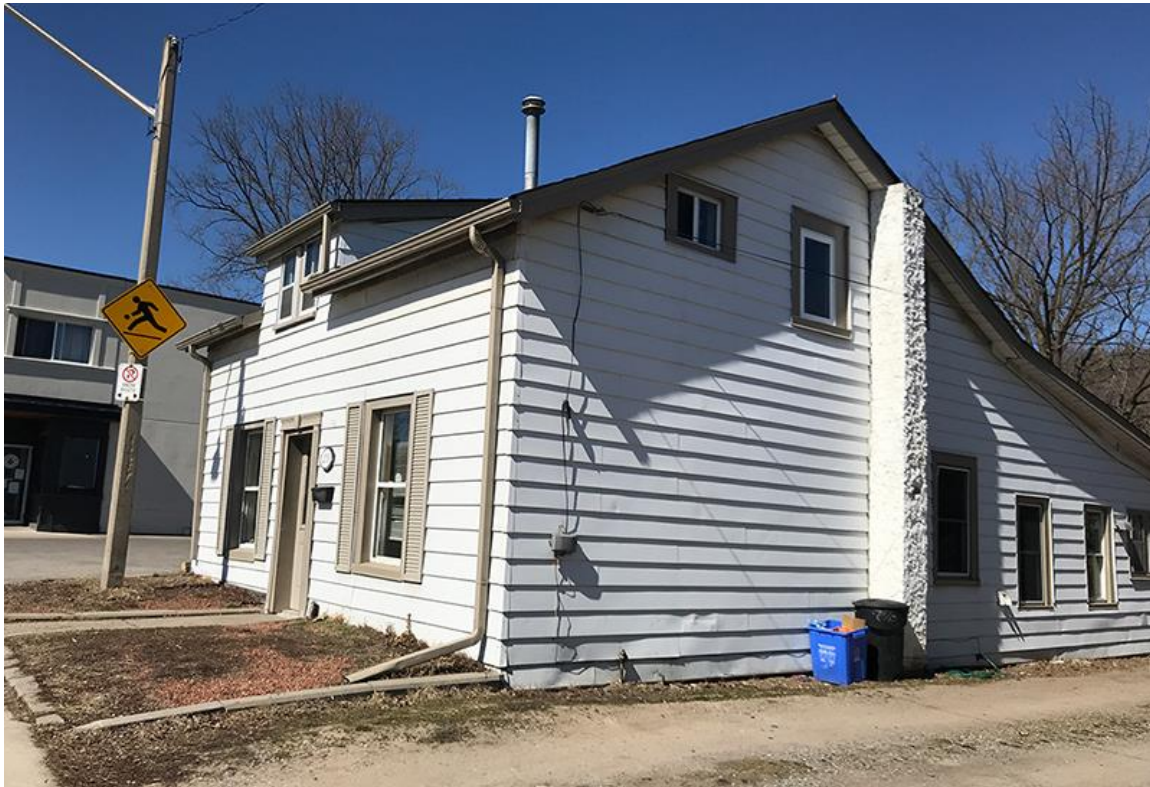
Shows the rear addition on the east side, the lowered brick chimney covered with rough stucco and an added horizontal sliding window on the second floor. March 2021

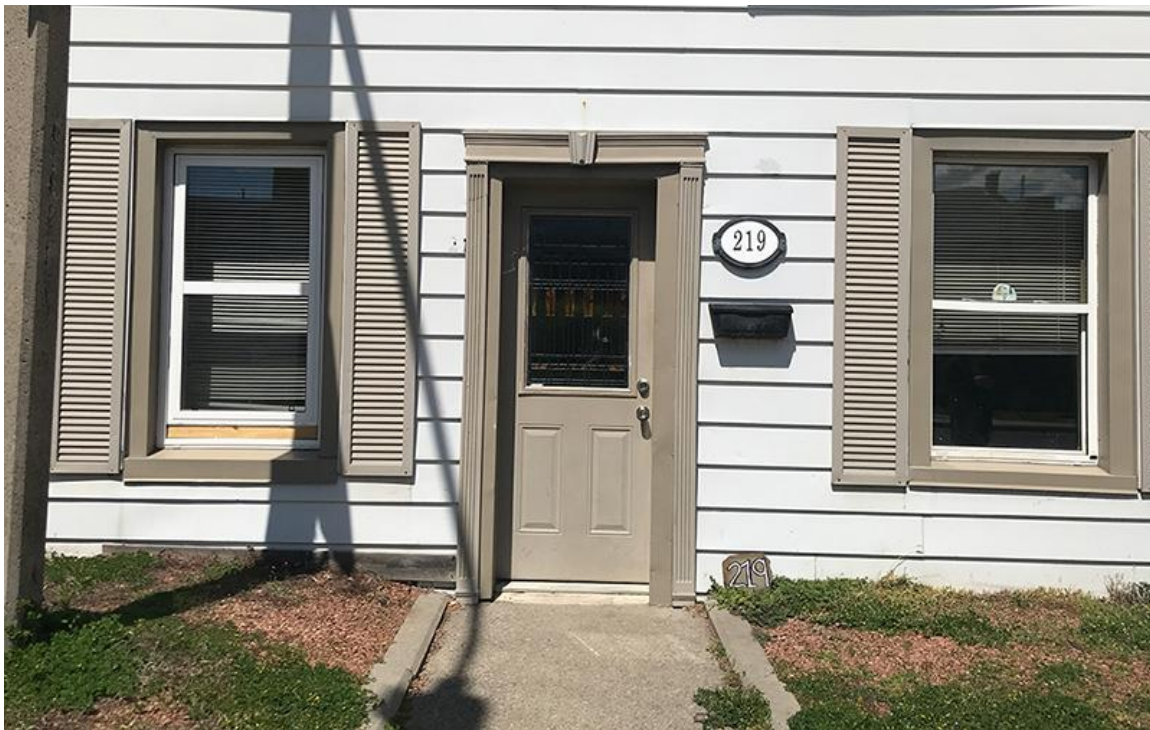
Close-up view of the front doorway and two first storey windows showing the aluminum cladding of the original wood door and window surrounds and a replacement metal door. May 2021

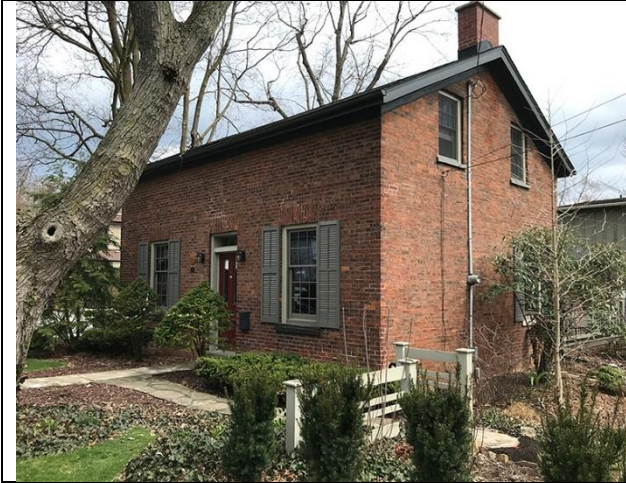
1½ storey brick masonry cottage at 31 Napier Street, constructed in 1857 by Joseph Higginson, a labourer. Very similar in form to 215 King Street West, with a tall asymmetrical façade with flat voussoir arched lintels and a transom light over the front door. Brickwork is common bond (one row of headers for every five rows of stretchers).

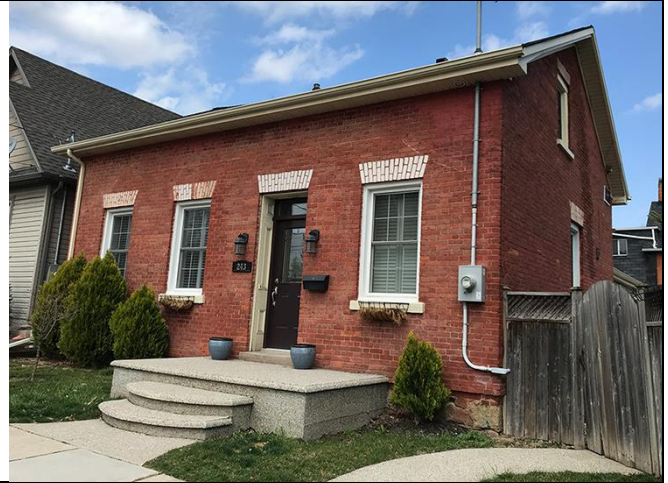
1½ brick masonry cottage at 243 Hatt Street, featuring an asymmetrical façade with three windows and a recessed doorway. Window and door sills are made of cut stone; lintels are flat voussoir arches in a contrasting yellow brick. Similarly to #215, the brickwork of the front façade is Flemish bond.

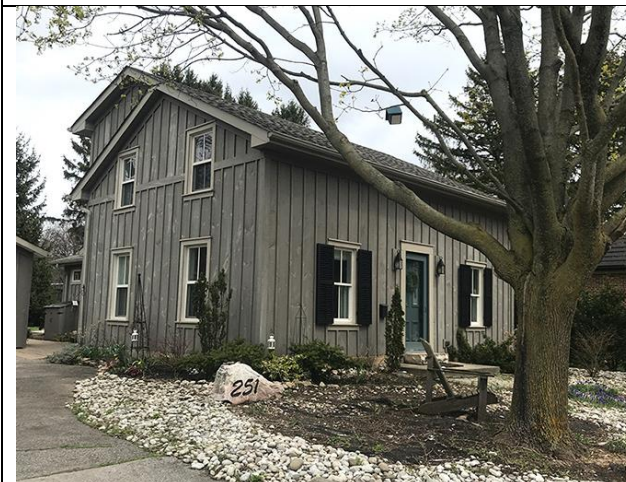
1½ storey frame cottage at 251 MacNab Street with a tall symmetrical façade featuring a simple framed doorway and two-over-two paned sash windows (probably late 19th century) with wood sills and lintels. After a two-storey rear dormer addition was built, the entire house was reclad in board-and-batten.

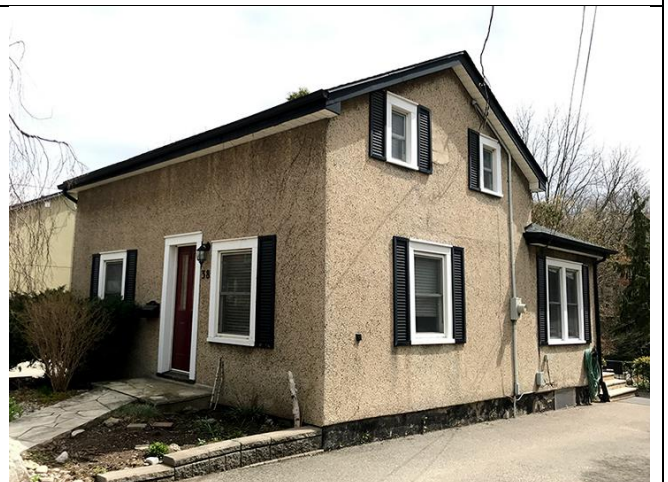
1½ storey frame cottage at 38 Dundas Street, similar in form to 219 King St. W. featuring an asymmetrical façade, a pebbledash finish and simple wood door and window surrounds.

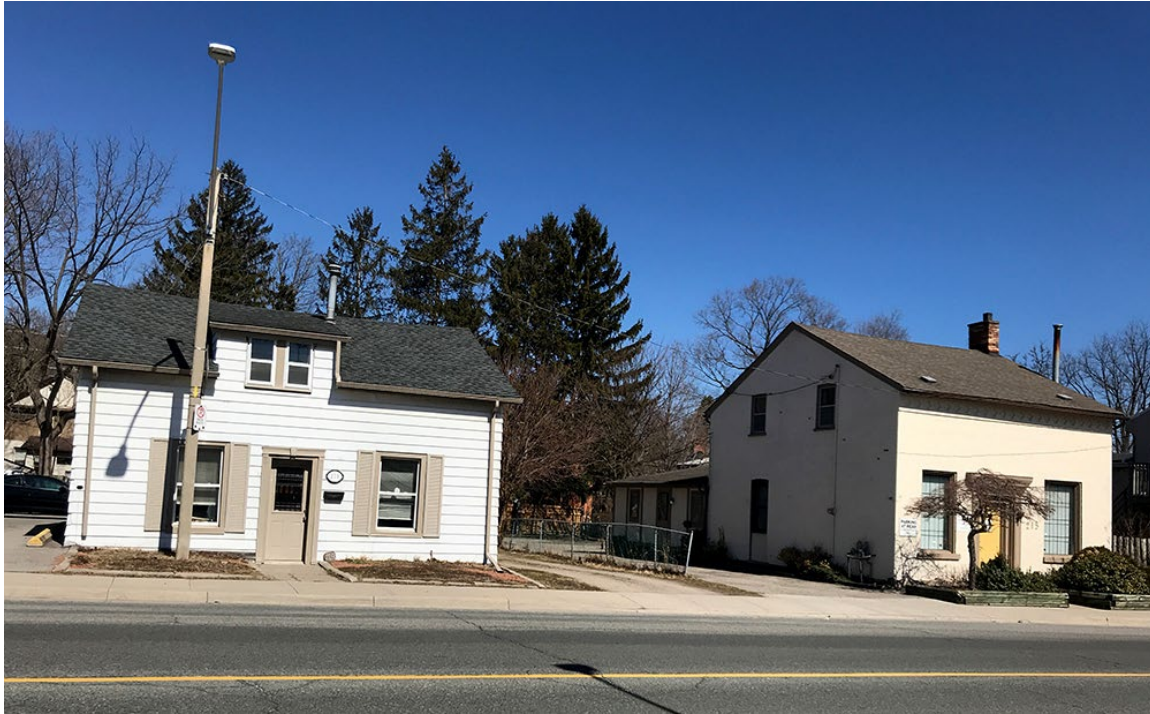
1½ storey cottages at 219 and 215 King Street West, just west of Market Street South. March 2021

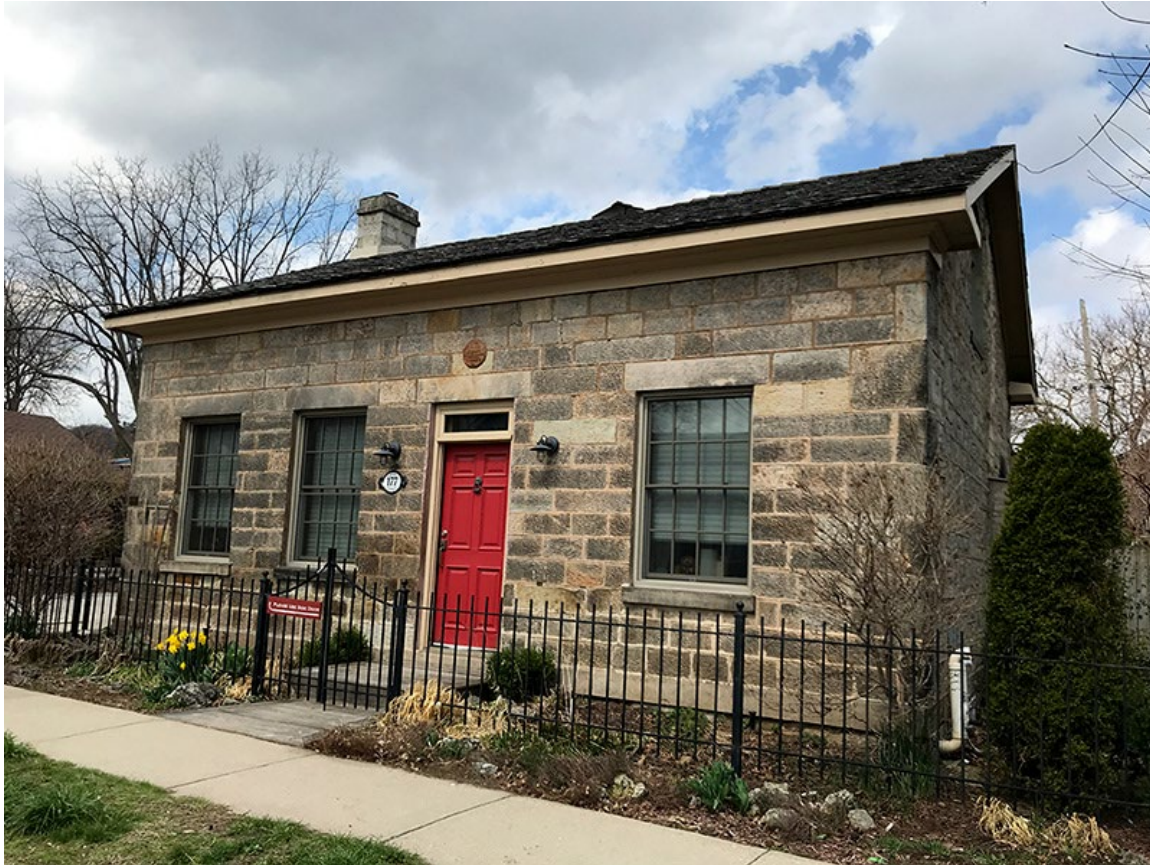
1½ storey stone cottage at 177 Hatt Street built in 838 for John Miller. Constructed of locally quarried limestone, it features an asymmetrical façade and doorway with a transom light, a stone ashlar façade with rubblestone used for the side and rear walls. OHA designated with a DHA plaque over the front doorway.

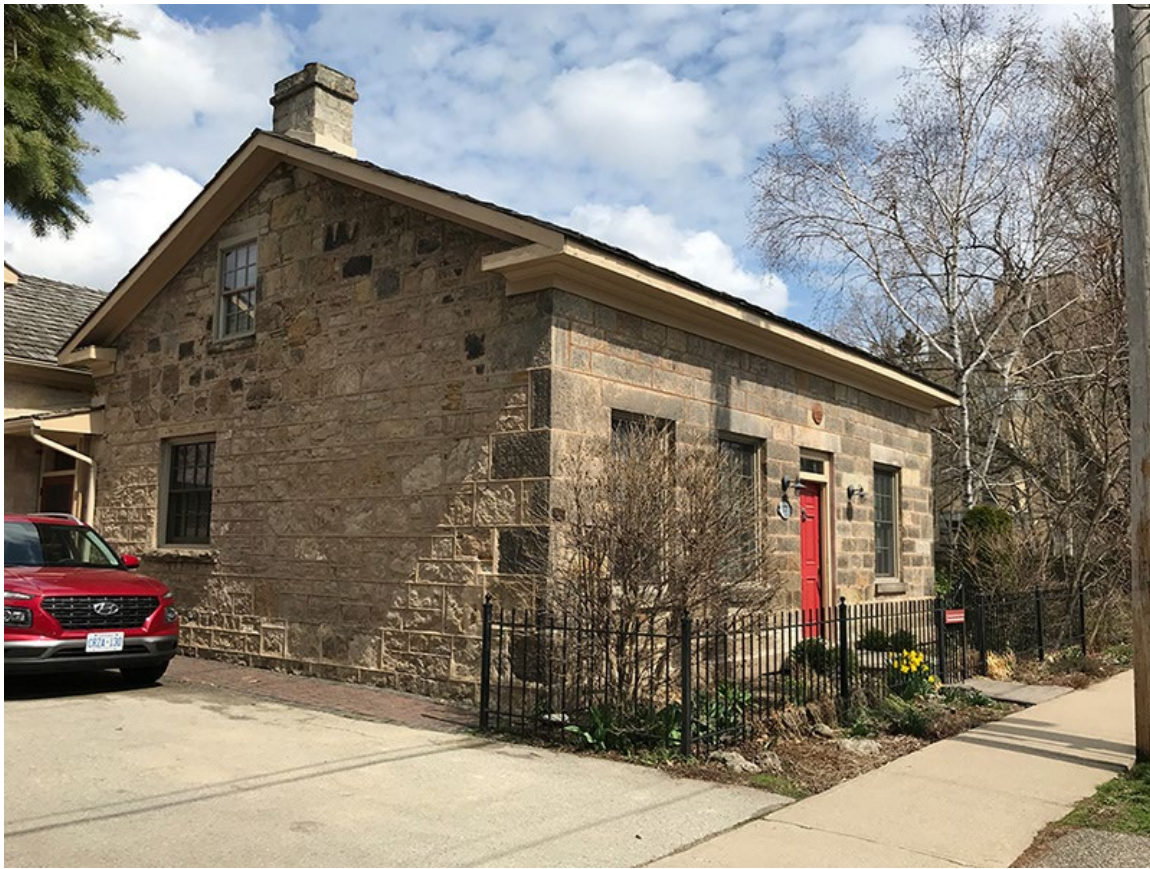
Front (south) and west facades showing the end chimney against the west wall. Also shows the large corner quoin blocks and medium-pitched side-gabled roof with returned eaves. All window and door sills and lintels are cut stone. The reproduction windows feature the original configuration of six-over-six paned sashes.

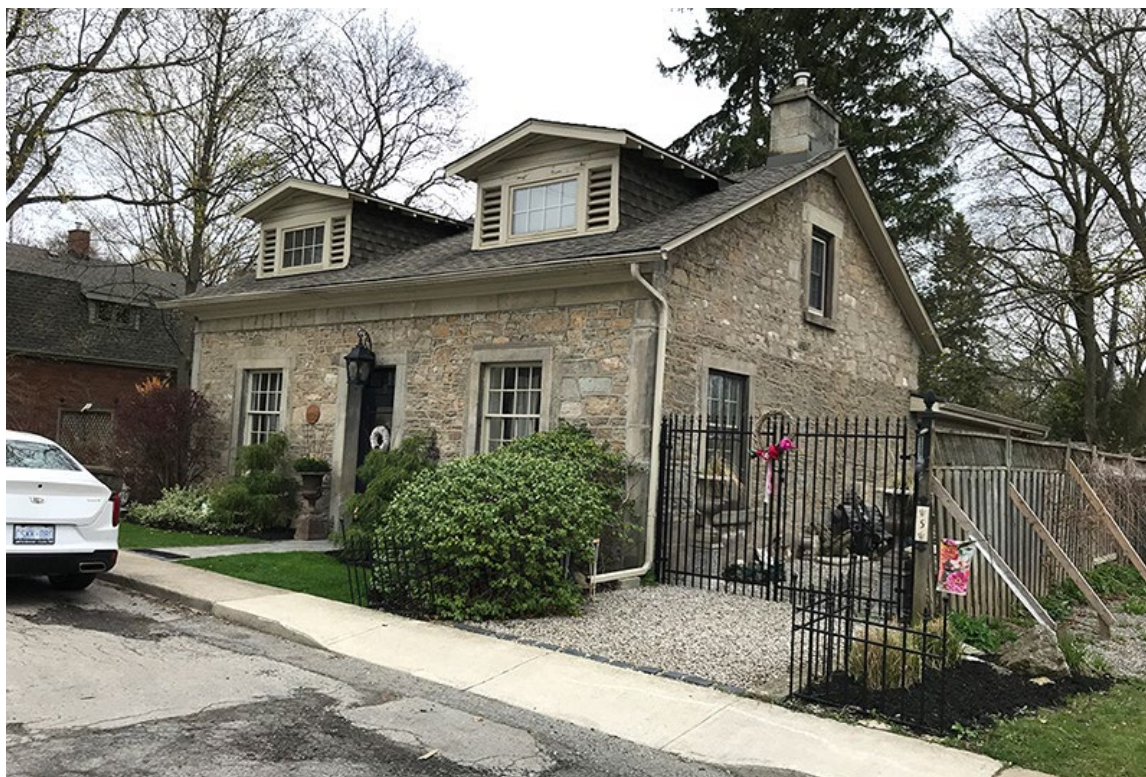
1½ storey stone cottage at 5 Brock Street North, built in 1857 by Michael Powers, a labourer. OHA designated with a designated property plaque and a DHA plaque beside the front doorway.

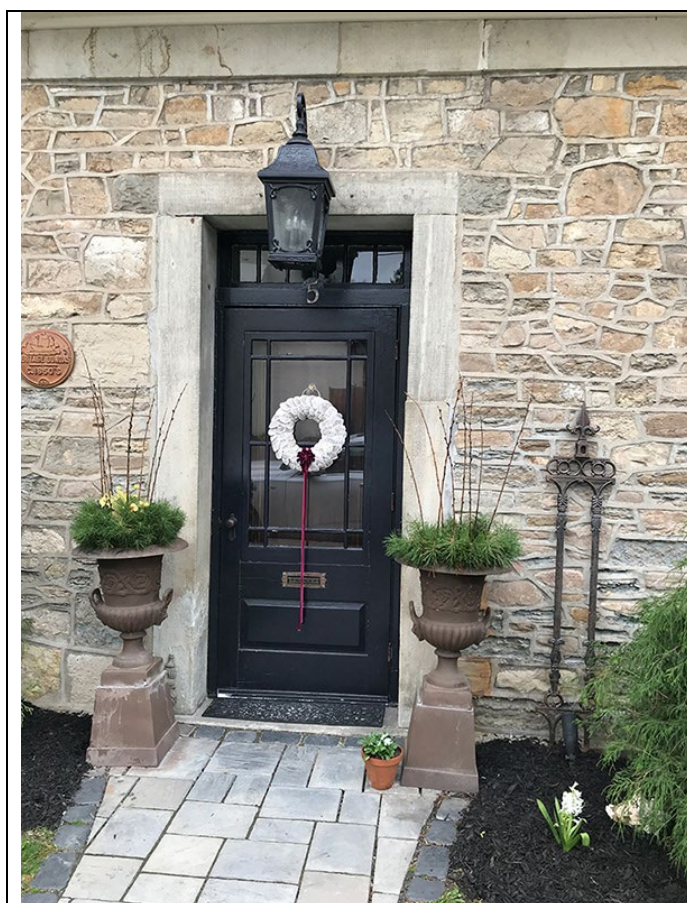
This cottage features a symmetrical façade with a central doorway flanked by two windows. Doorways and windows have cut stone frames and the fascia panel below the eaves is also made of cut stone blocks. The rubblestone masonry is tuck-pointed with raised mortar joints. The doorway features a multi-paned transom (possibly original). Windows feature an 8-over-8 paned sash configuration. Dormers are a later (possibly early 20th century) addition.

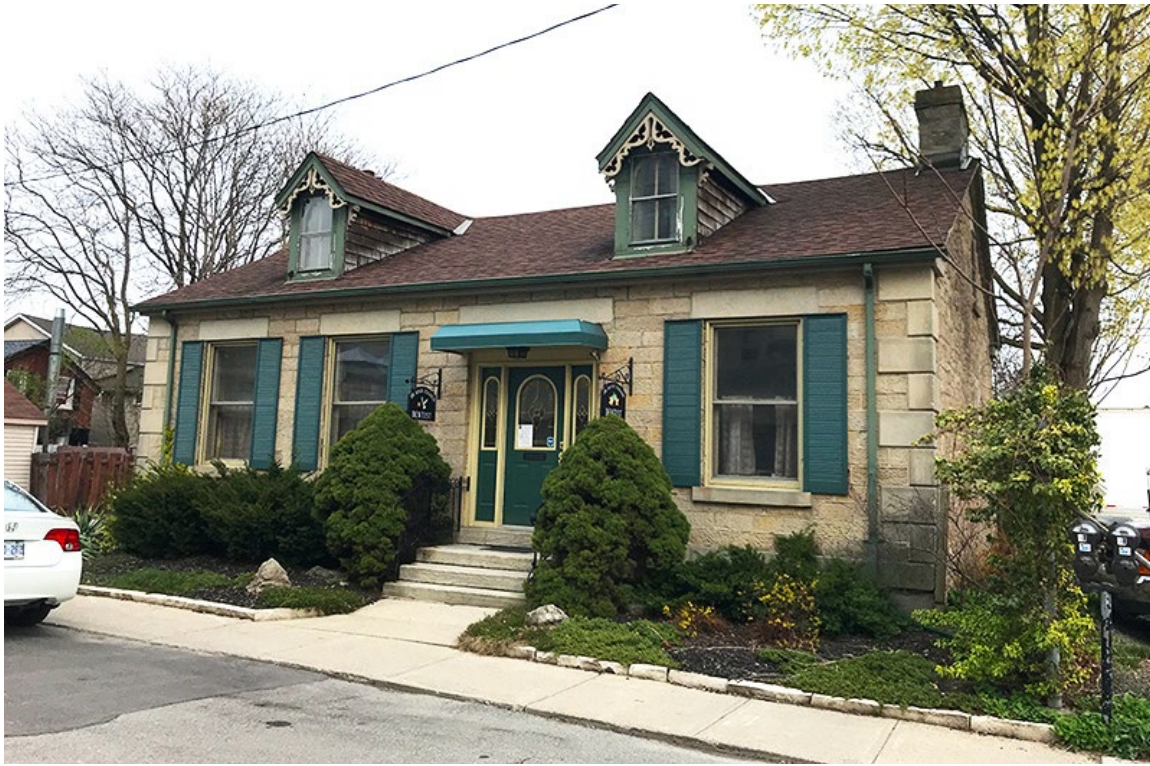
1½ storey stone cottage at 7 John Street, built circa 1840 by Dundas cabinetmaker, Huge Bennett, who passed away in 1842 at the age of 47. It features a stone ashlar façade with stone window and door sills and lintels are large corner quoin blocks. Below: north facade (end wall) showing the rubblestone construction of the end and side walls. Dormers appear to be a late 19th century addition.

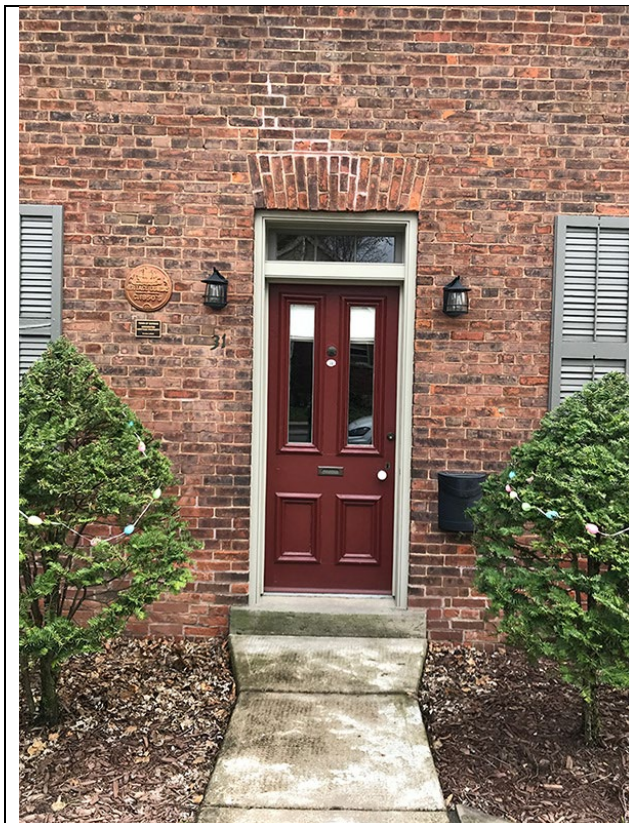
This cottage features a very tall symmetrical façade (similar to 215 King Street West) with only two windows (same configuration as 5 Brock Street North). Doorways and windows have brick voussoir lintels and stone sills. The doorway (possibly with its original door) features a transom light. The sash windows have a six-over-six paned configuration. The common bond brickwork is identified by a header course for every five stringer courses.

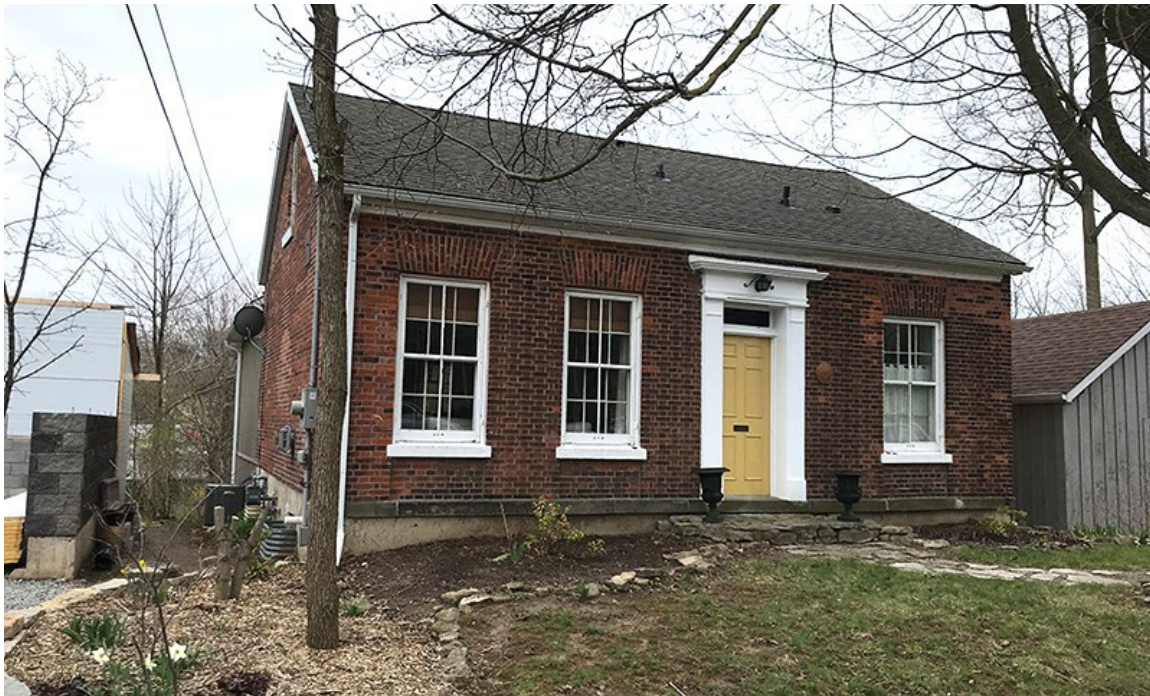
1½ storey brick masonry cottage at 320 MacNab Street. Features an asymmetrical façade with three windows and a more elaborate classical doorway with pillars and an entablature. Similarly to 215 King Street West, the bricks are laid with a Flemish bond.

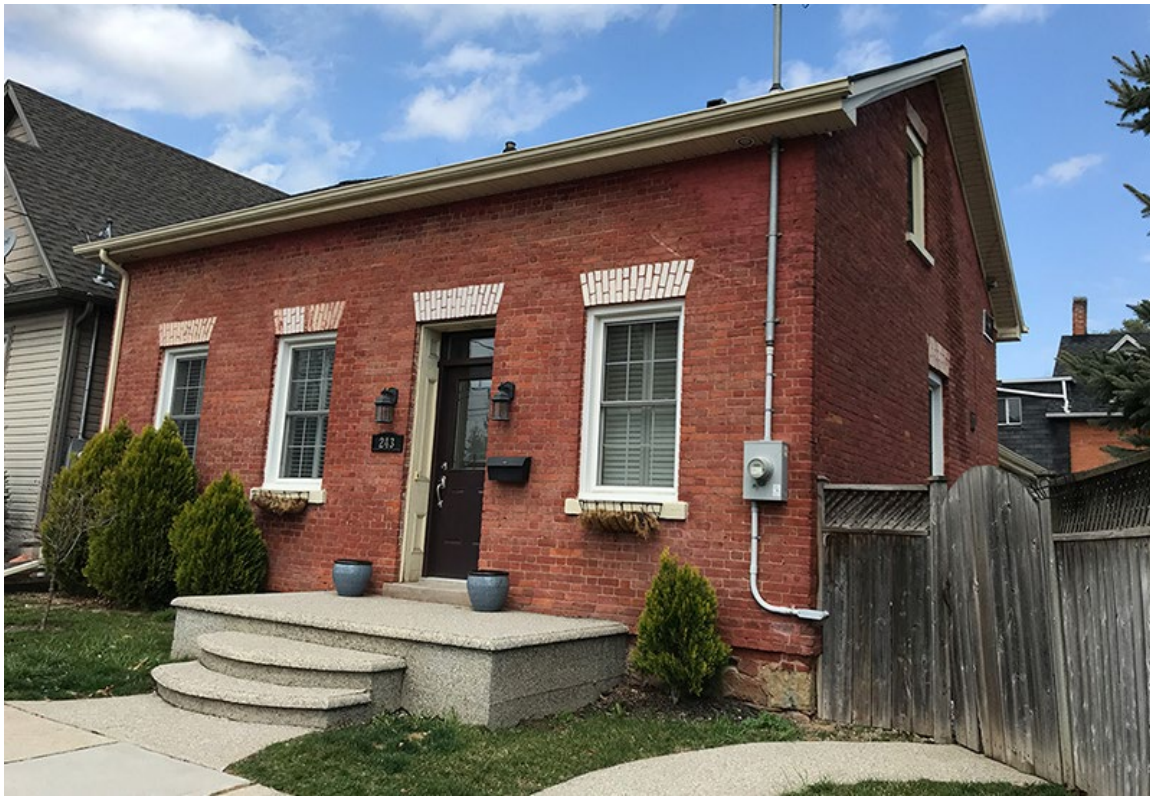
1½ brick masonry cottage at 243 Hatt Street, which features an asymmetrical façade with three windows and a recessed doorway. Window and door sills are made of cut stone; lintels are flat voussoir arches in a contrasting yellow brick. Another example of bricks laid with a Flemish bond.

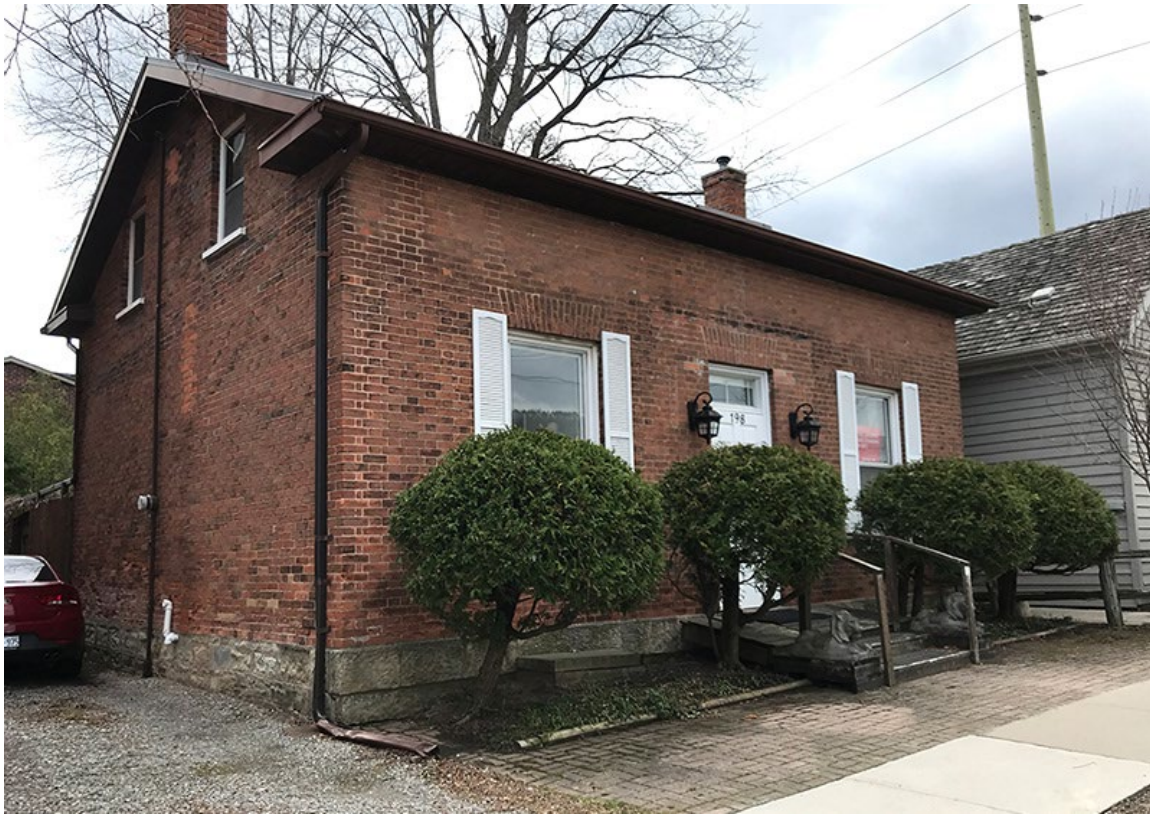
A 1½ storey brick cottage at 198 Hatt Street, with a symmetrical façade, Flemish bond brickwork and returned roof eaves.

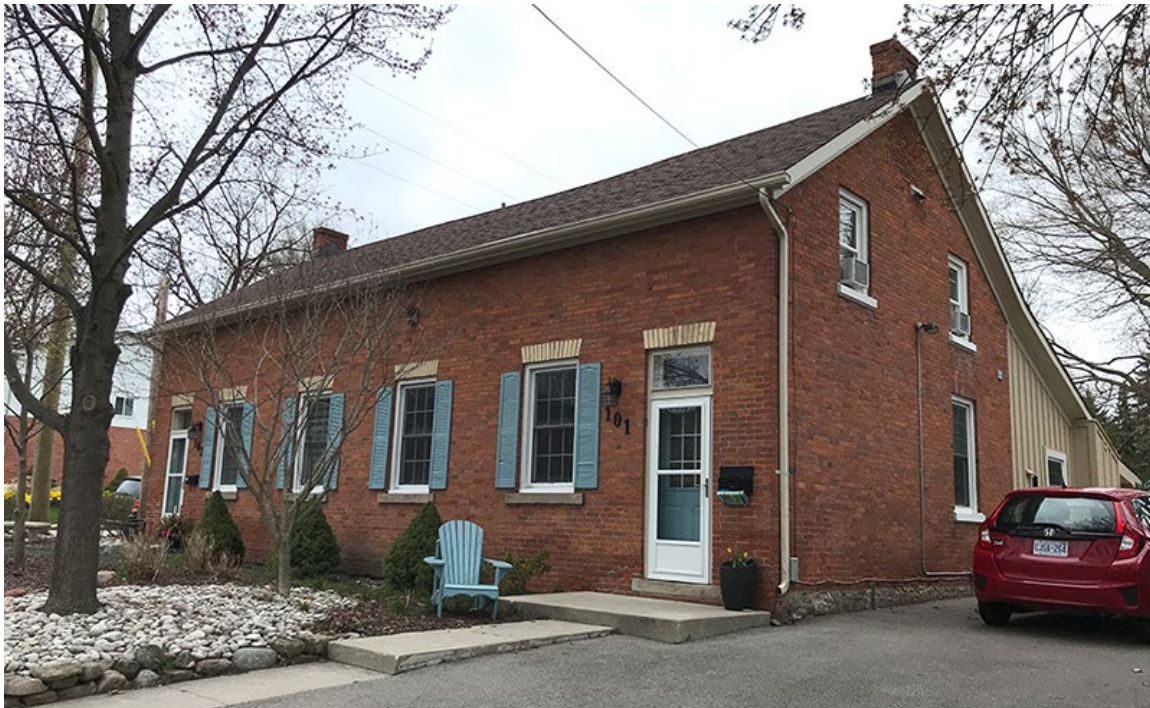
A more unusual semi-detached 1½ brick masonry storey cottage at 101 to 103 Park Street with a tall symmetrical façade and end doorways. Features flat voussoir arch window and doorway lintels in a contrasting yellow brick and stone sills. I have two more semi-detached examples to add here.

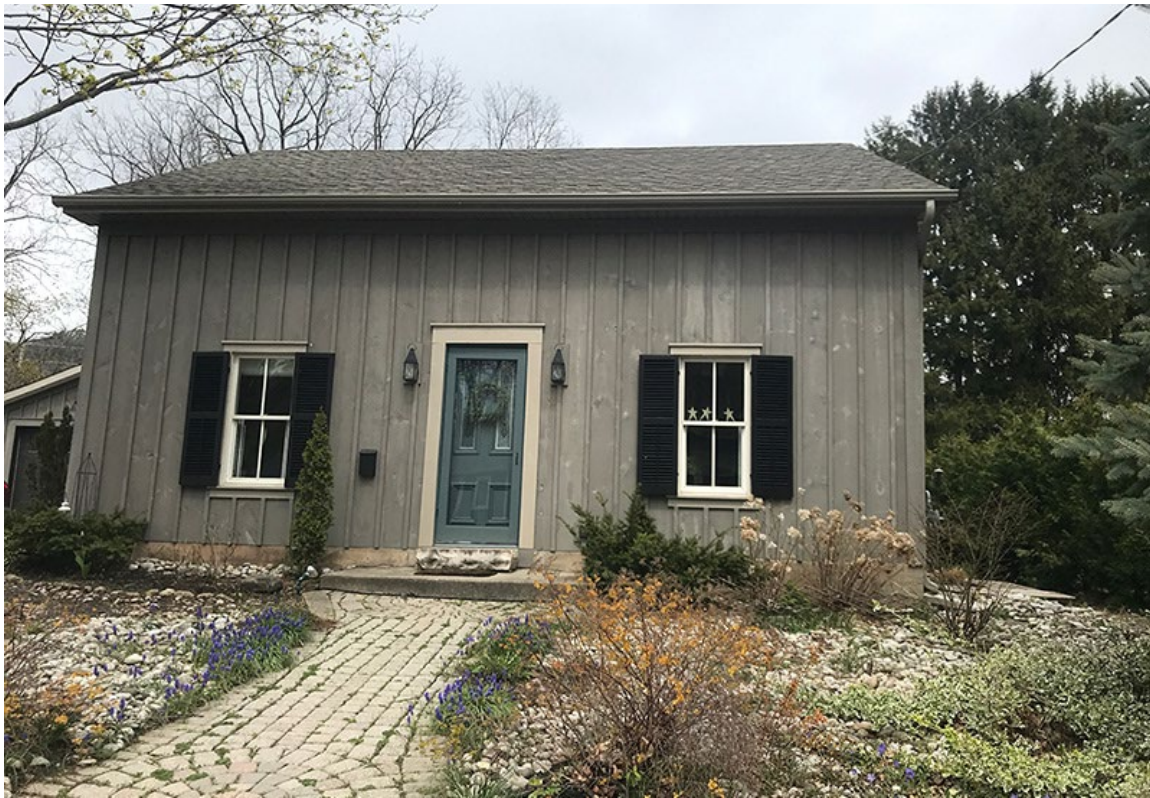
1½ storey frame cottage at 251 MacNab Street with a tall symmetrical façade featuring a simple framed doorway and two two-over-two paned sash windows with wood sills and lintels. View below shows the west side wall and the top of a two-storey rear addition. When built the entire house was reclad in board-and-batten.
