Inventory & Research Working Group (IRWG)

Meeting Notes

Monday, April 26, 2021 (6:00 pm – 8:00 pm)

APPENDIX A: 54-56 Hess Street South

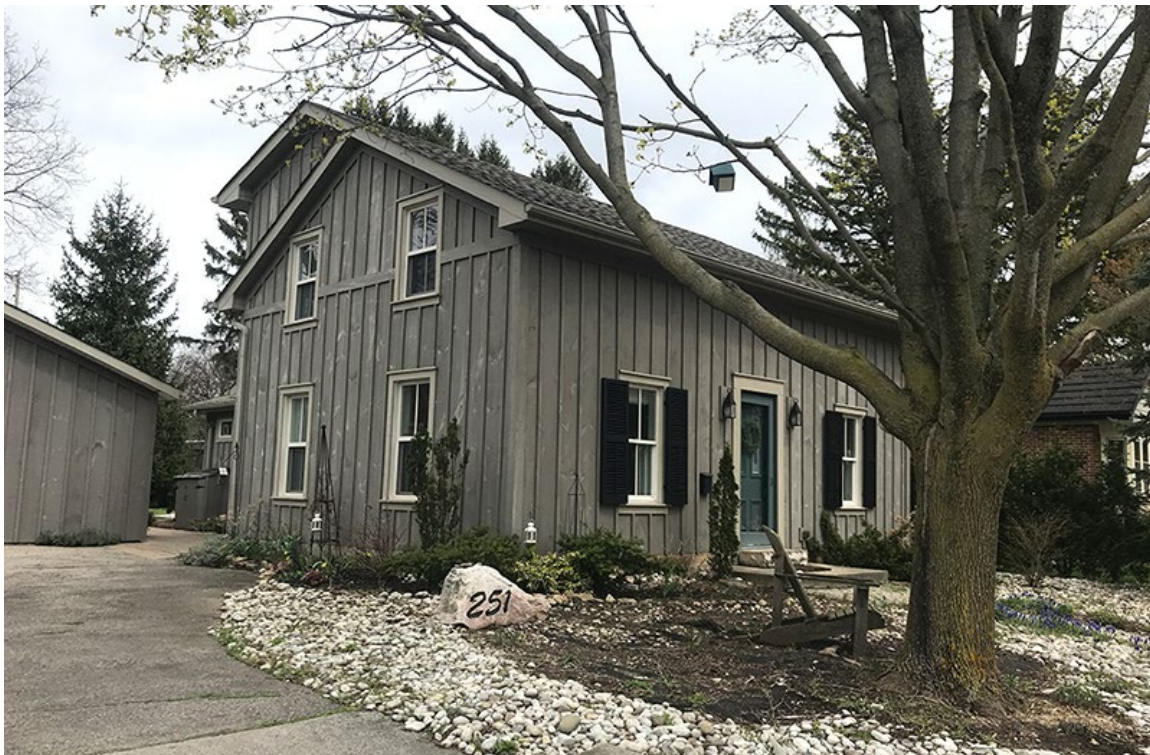
1½ storey frame cottage at 251 MacNab Street with a tall symmetrical façade featuring a simple framed doorway and two two-over-two paned sash windows with wood sills and lintels. View below shows the west side wall and the top of a two-storey rear addition. When built the entire house was reclad in board-and-batten.

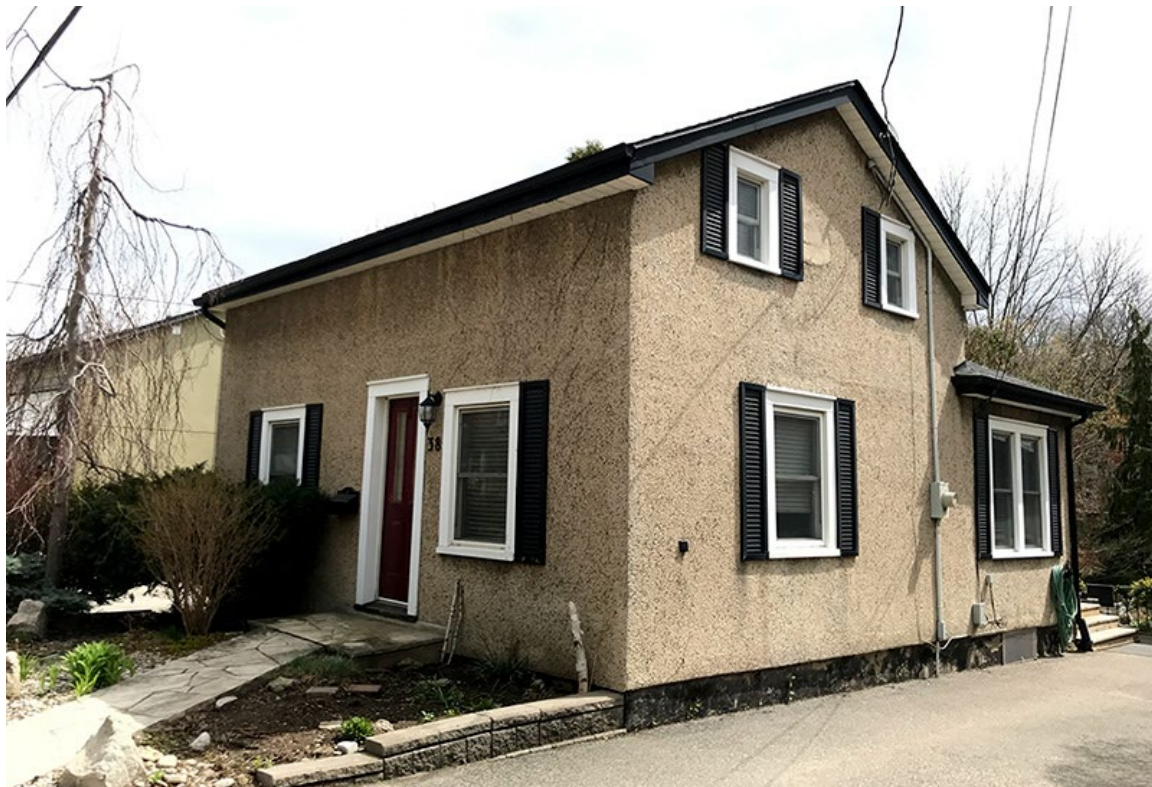
1½ storey frame cottage at 38 Dundas Street featuring a tall symmetrical façade, a pebbledash finish and simple wood door and window surrounds.

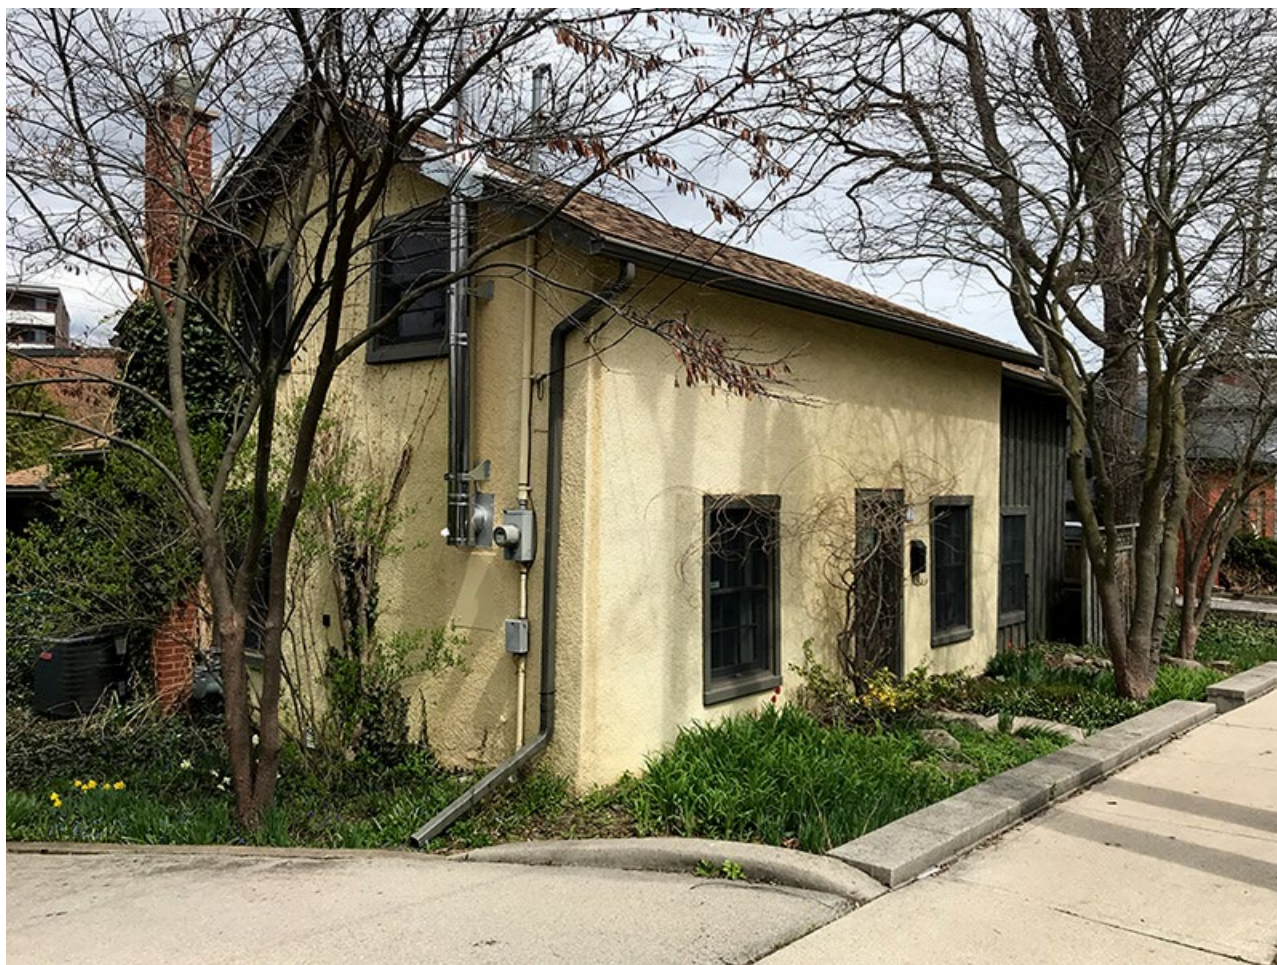
1½ storey cottage at 7 Baldwin Street with a tall symmetrical façade and a roughcast finish. Features six-over-six paned sash windows and wood-framed windows and doorway.
