Hamann Engineering
Structural Consultants Ltd.

Re: 983 Beach Blvd., Hamilton
Our Project No. 21041

We visited the above site June 2nd 2021 and met with Mr. Chris Farner. The purpose of our visit was to perform a visual inspection of the condition of the foundations in order to determine to what extent to the structural capacity has been compromised.

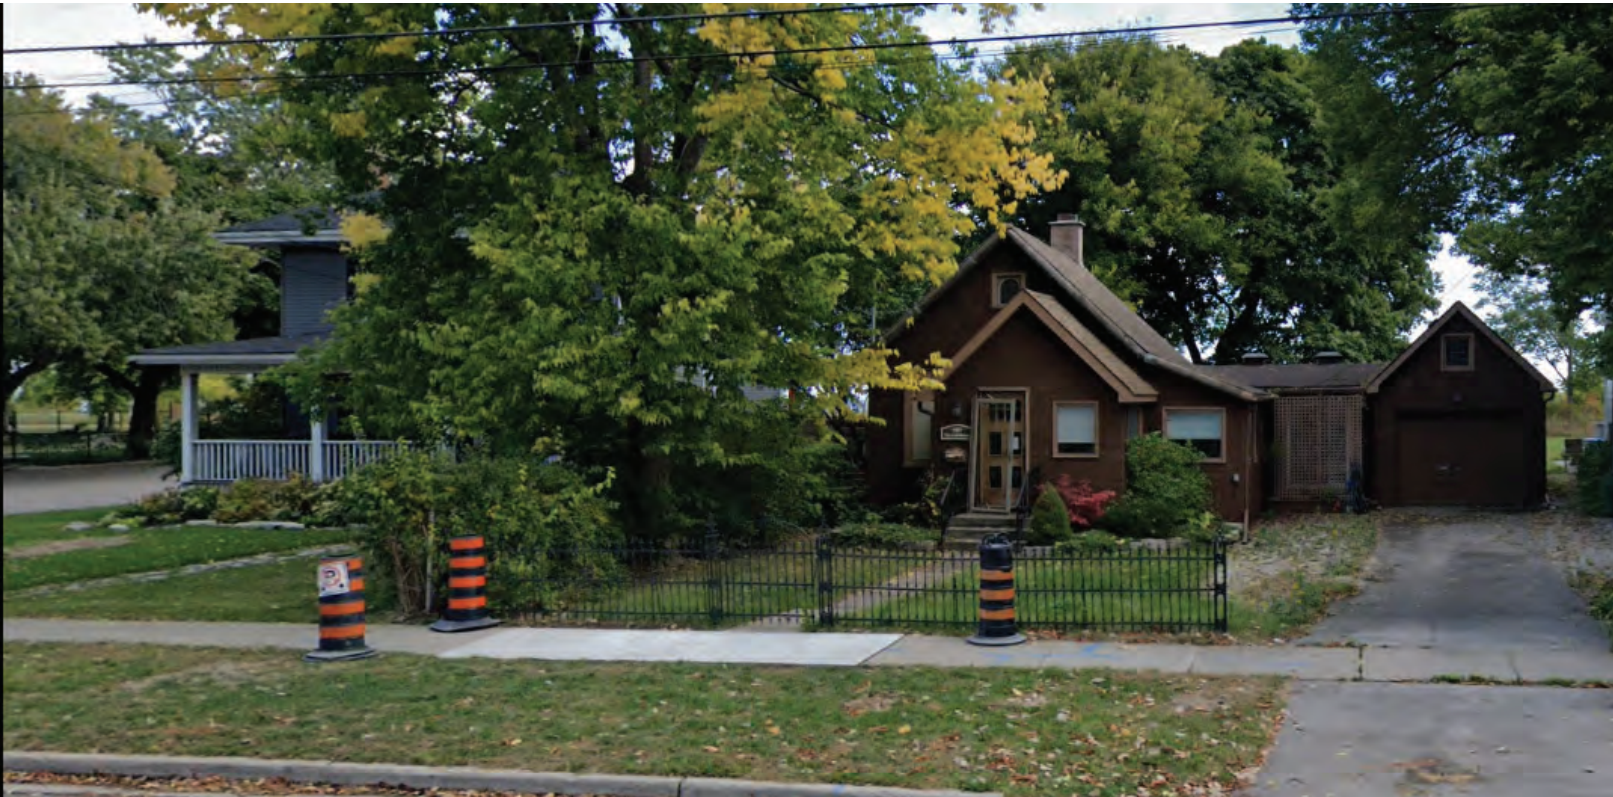
The existing house was built as a beach front cottage, approximately 75 years ago. The house consisted of a three room bungalow with what may have been an accessible attic. At some point in the history of the building a rear addition and garage were added. See attached front elevation photo.

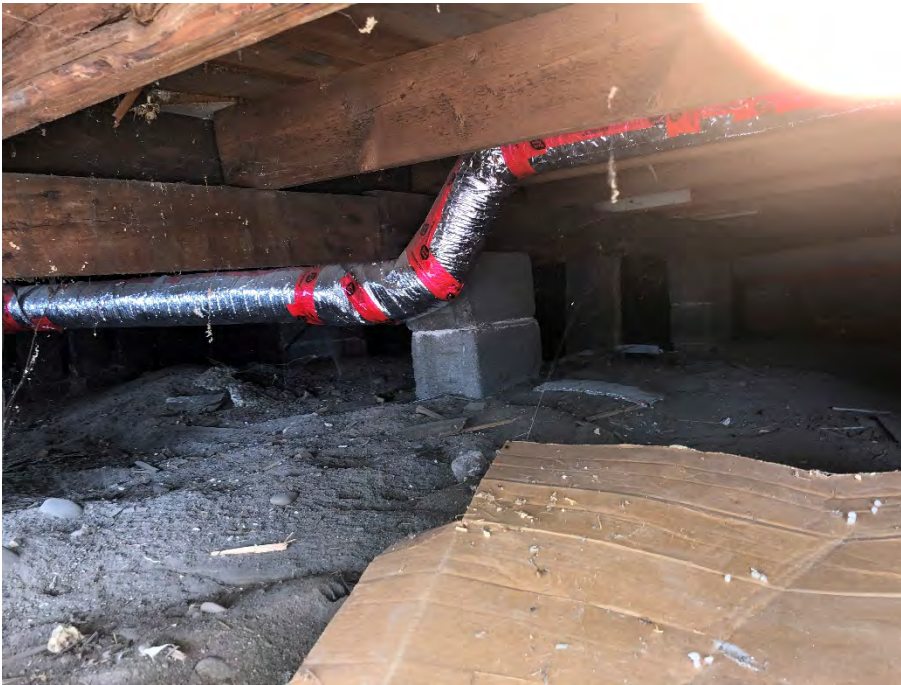
PHOTO 4448

The floor framing consists of timber joists supported on timber beams. See attached photo 4448. Foundations consisted of timber posts or log sections sitting unimbedded on the insitu beach sand subsoil. See attached photo 4454. There were no exterior foundation walls.

Beams have been left without support entirely, as shown in photo 4448.

Ground floor framing would have to be replaced to meet structural capacity requirements as well as removal of moisture damaged timber.

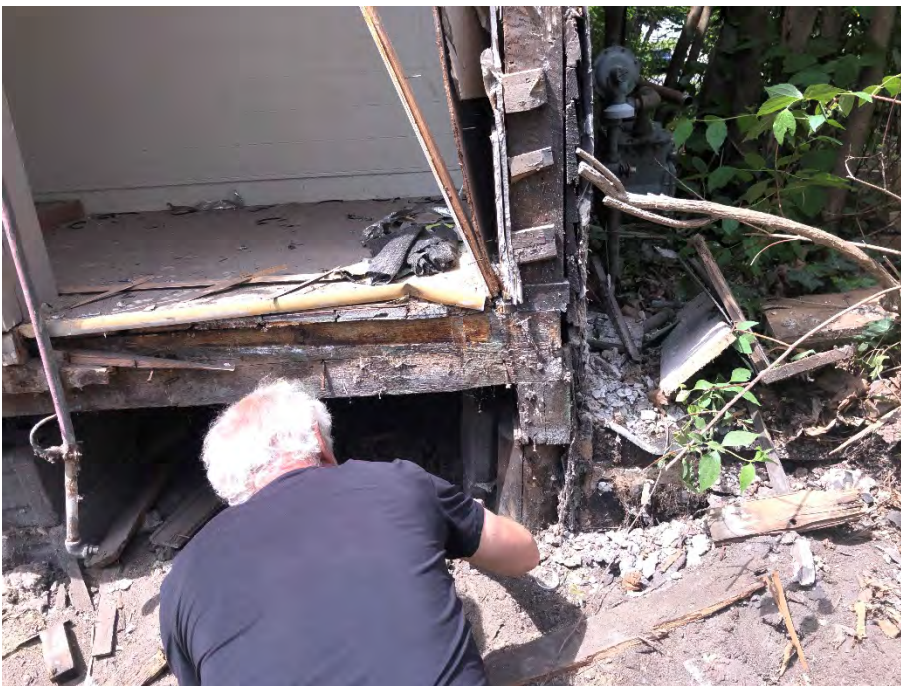
PHOTO 4454

This type of construction is consistent with unheated seasonal summer cottages, built without engineering or compliance with the Ontario Building Code of the day. The nature of the construction is prone to moisture deterioration and decay. This is exacerbated in this house as the front grade has been raised over time, leaving the floor framing buried. See attached photos 4468 & 4469.

Repair to meet the Ontario Building code would require permanent frost free foundations to replace the existing adhoc supports.

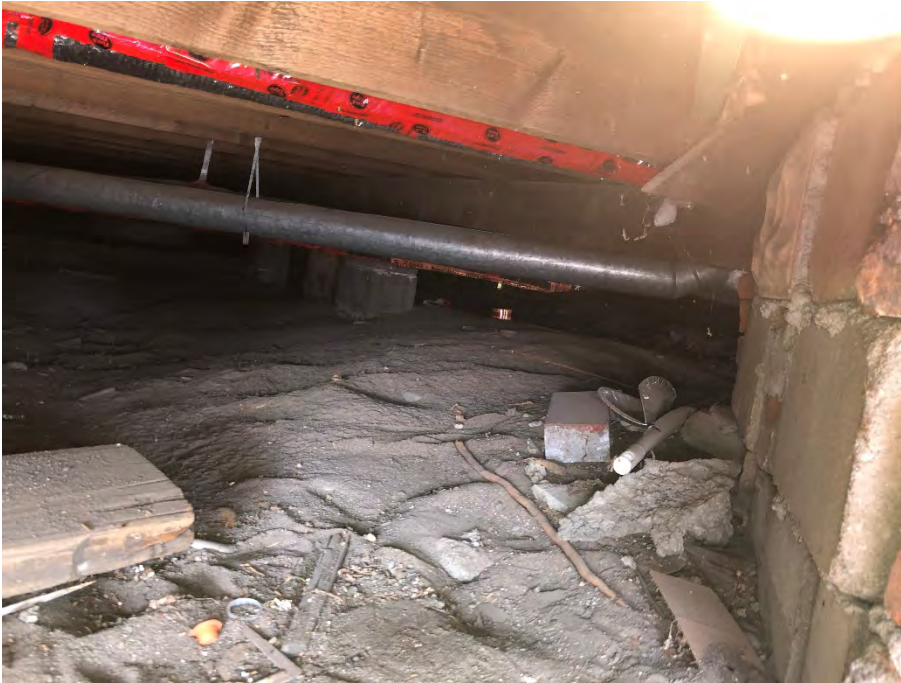
PHOTO 4447

Due to collapsing of the original timber post foundations over time, loose laid block masonry piers have been added to shore the floor framing and exterior walls. See attached photos 4447 & 4452.

The piers have been arbitrarily jammed below the framing sitting directly on the insitu beach sand. This has left the framing twisted and out of alignment.
