# City of Hamilton Property Trillium Open Space - Erosion Restoration Plan

**Presentation to Public Works Committee  
February 1, 2021**

## Trillium Open Space

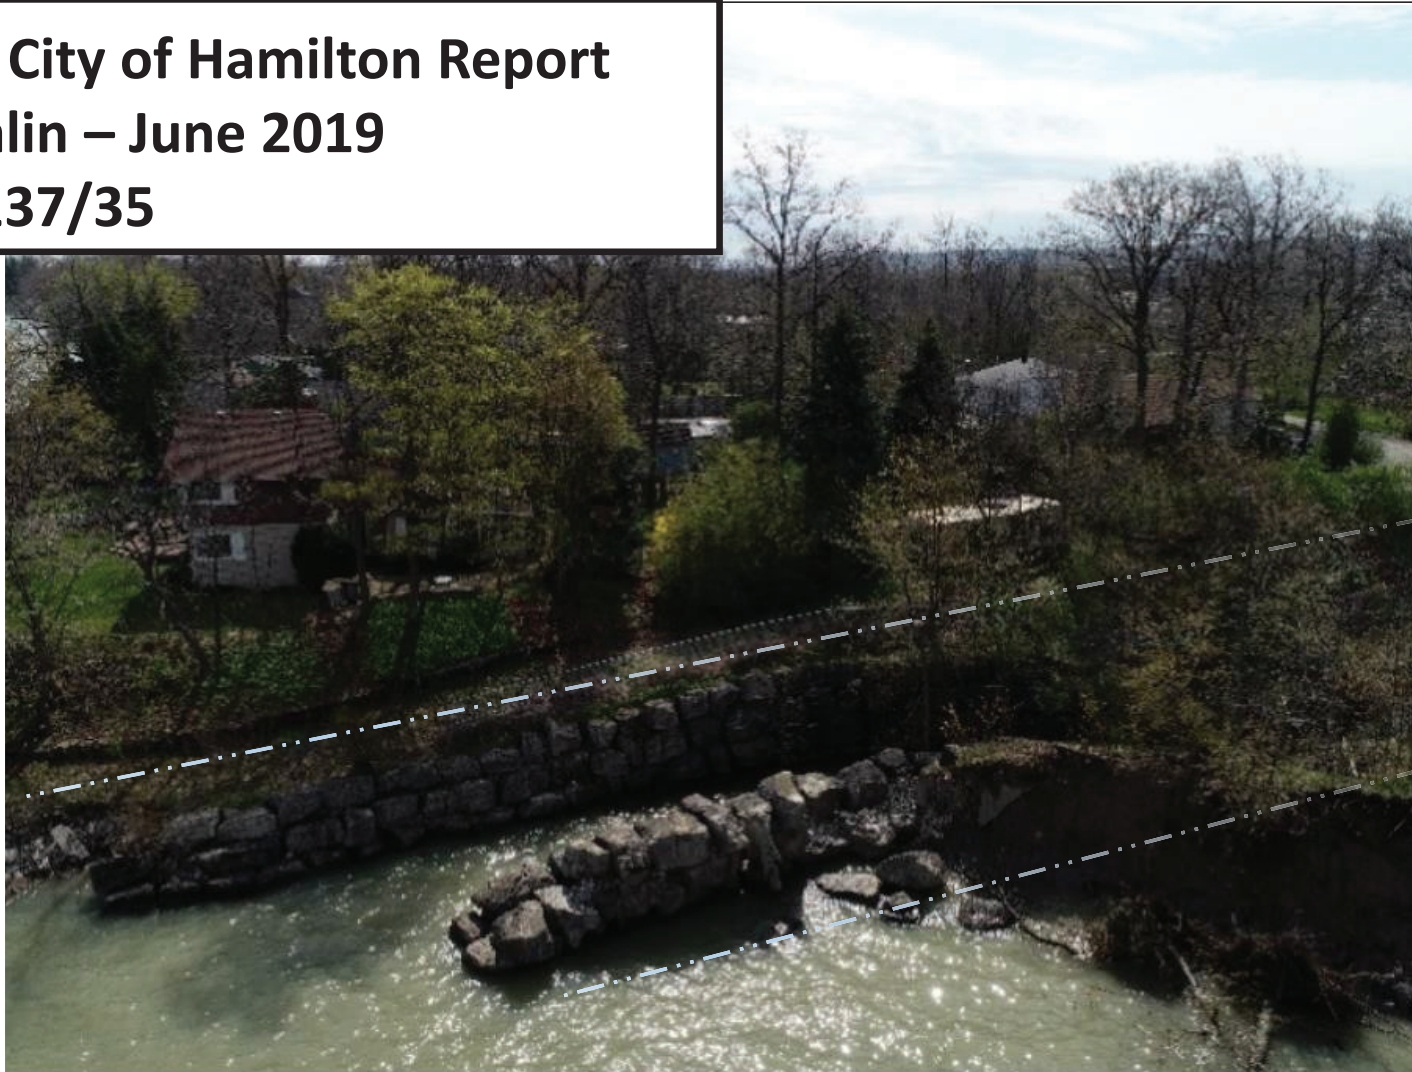
**Figure 7-4 Site 7 North Services Rd. and ~~Lewis Rd.~~ Campview**

Site 7 1137 / 35 North Services Rd Trillium	
Conditions	Poor
Crest Elevation	81.1/ 75.9 (toe) m IGLD
Solution	Replacement
Options	D

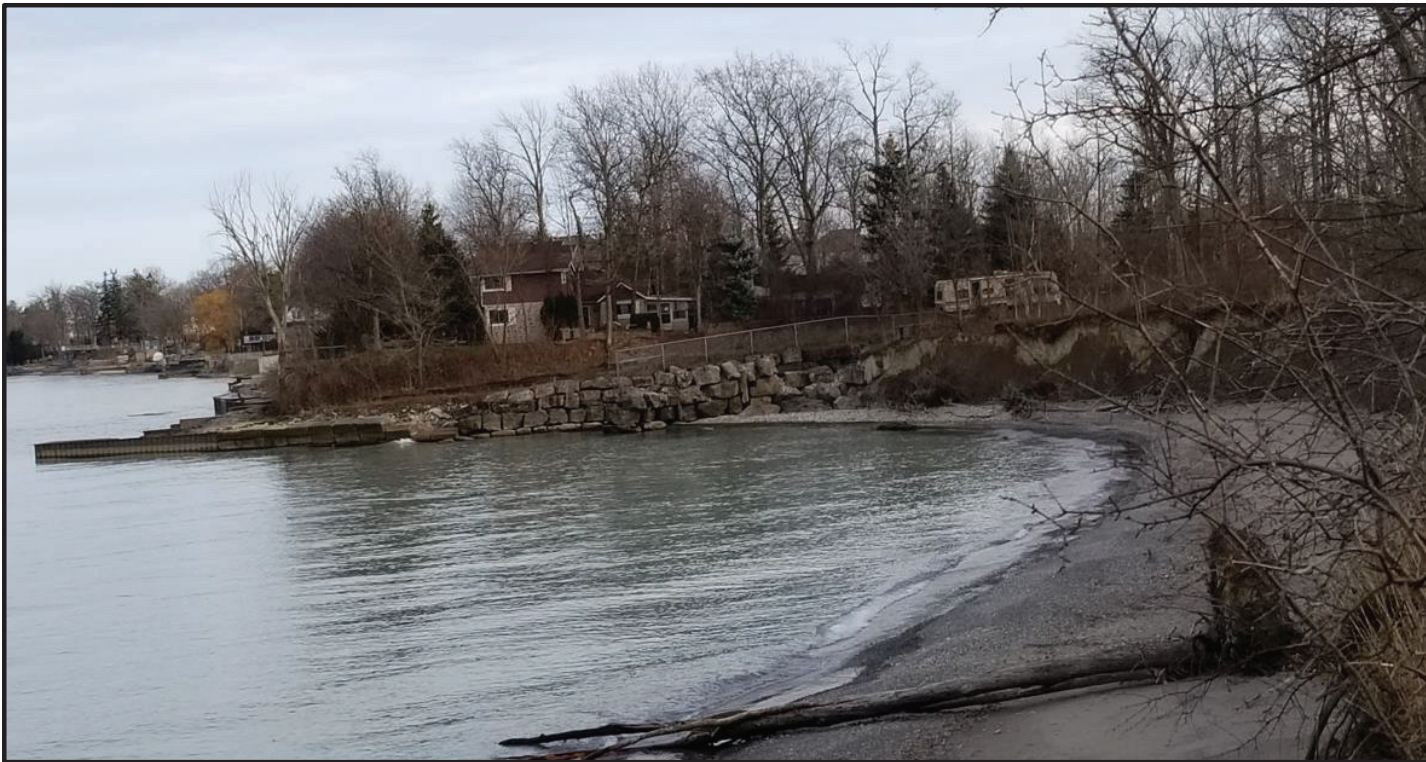
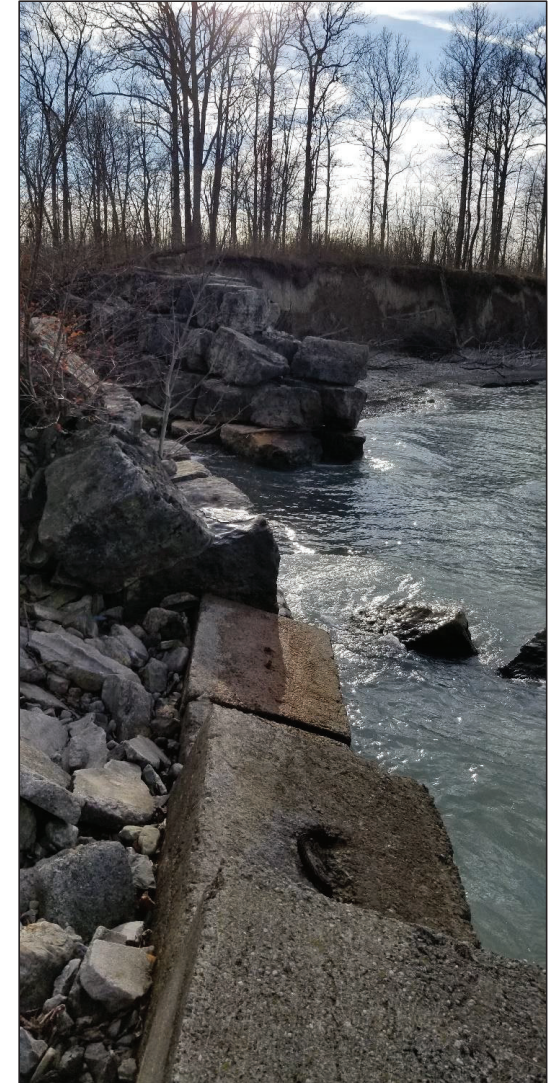
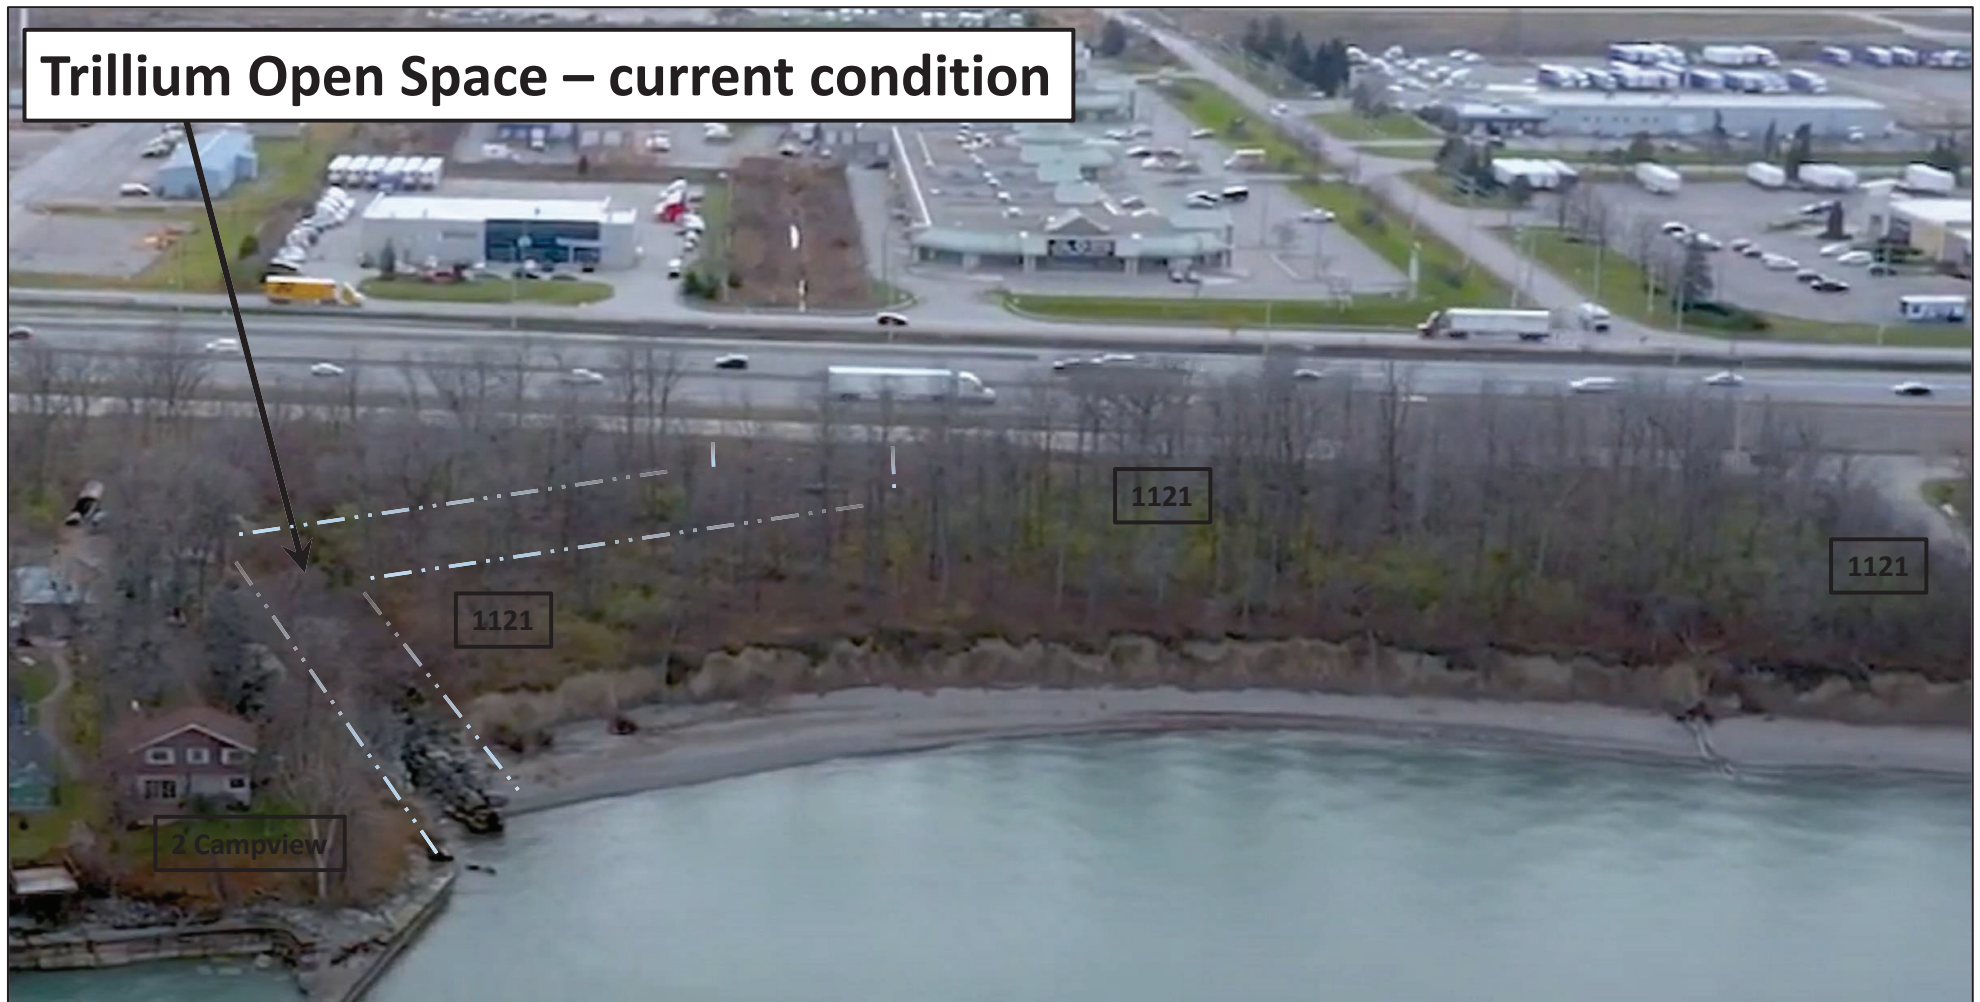
## **Trillium Open Space - current condition**

- **Property damage**
- **Collapsed armour stones**
- **Erosion and undercutting**
