<u> Artisan Metal Roofing Inspection Report</u>

159 Carlisle Road Carlisle ON

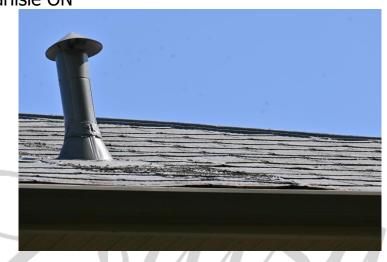
The roofing system that has been installed at 159 Carlisle Road is in poor condition. The roofing system is estimated to be over 100 years old and is showing major signs of disrepair. When the owners moved into the house the roof condition was rusting and oxidized everywhere. They have tried to refinish the roof twice but with no luck. Trying to refinish a metal roof is nearly impossible when the roof is already rusting. This is because the paint has nothing to adhere itself to other than rust and oxidation. Once rust is present in a metal roof, it will not stop.

We can also see signs of lifting. This is caused by high winds, age and the installation technique of using nails. Nails where commonly used 30+ years ago to install these types of metal roofs. Over time the nails come lose, rust out and get pulled out by high winds. The metal used on this roof was a very thin that has also become brittle over time. Allowing the nails to rip through the metal and leaves holes in the roofing materials. These lifting issues are causing heat loss, leaking and gaps in the roof that will allow creatures to entre the home.

The homeowners have also seen signs of leaking. Due to the amount of lifting and other issues this was inevitable. If this issue allows to continue there will be major damage to the structure of the roof and other parts of the home.

This roof has surpassed its lift span of 100+ years and is in need of replacing. The signs are easily seen from the ground and by doing a roof replacement it would help save the home from any further damage that can happen due to the age and condition of the roof. We recommend this roof to be replaced with a never style metal roofing shingle that will allow this homes roof to last for another 100+ years.
