**WATERDOWN COMMUNITY NODE SECONDARY PLAN
CULTURAL HERITAGE REVIEW
CITY OF HAMILTON, ONTARIO**

FINAL REPORT

ASI File 19CH-042

August 2021 (rev. September 2021)

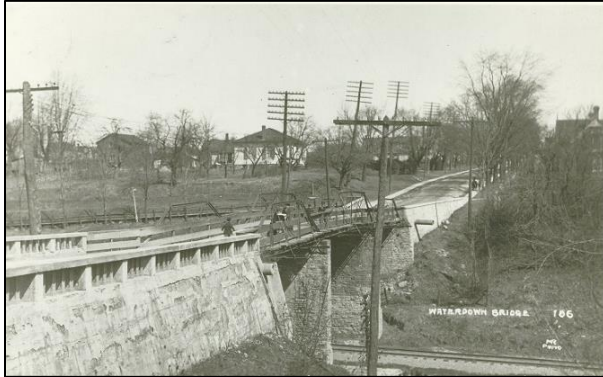
Figure 23: Waterdown: Bridge on Dundas Street, looking east up Vinegar Hill, c. 1913 (Reid 1913).

Dundas Street Bridge (Wray 1994). An analysis of early photographs of the bridge shows the evolution of the bridge construction, including the replacement of early railings with contemporary metal railings (Figure 23 through Figure 24).

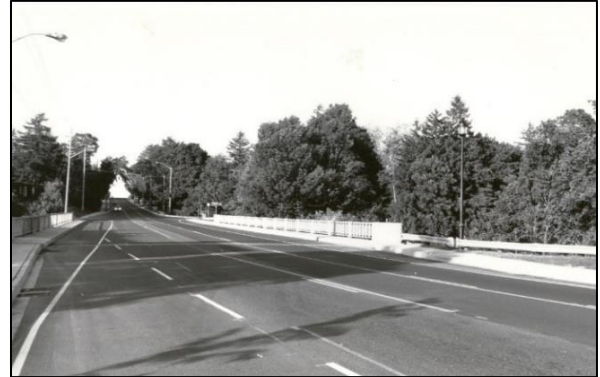
Figure 24: Looking east on Dundas Street towards the bridge and Vinegar Hill (Anon 1993).

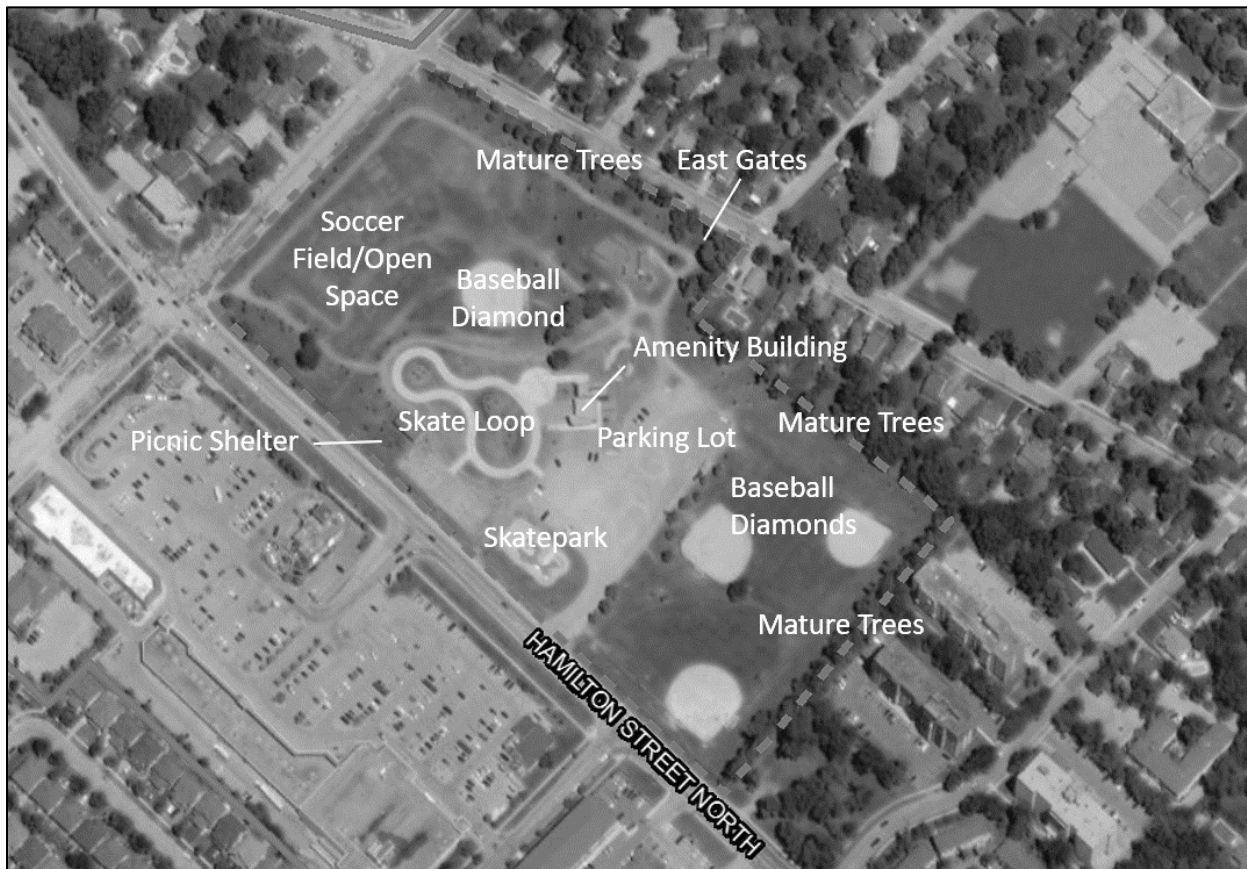
Figure 21: Annotated Aerial Photograph of Features within Waterdown Memorial Park
