Dome Project 2021/2022

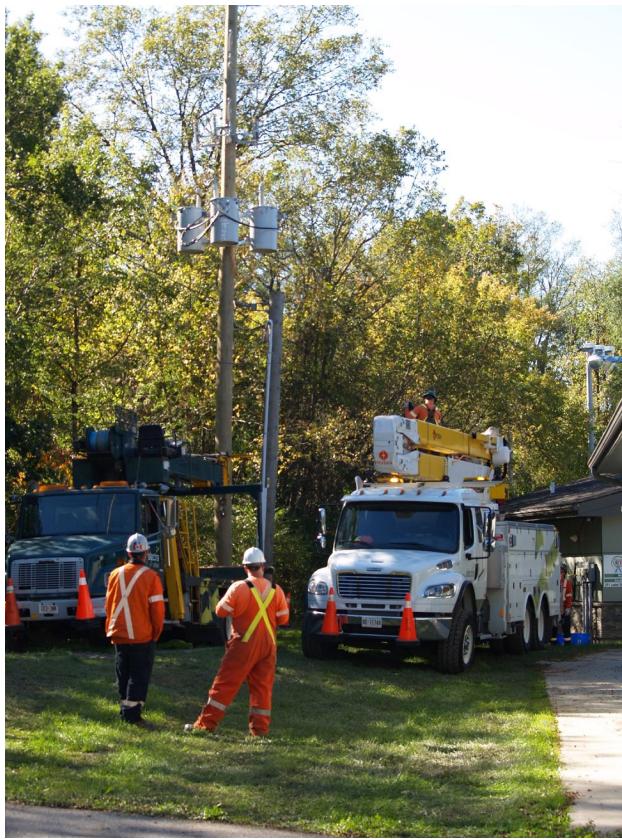
3 - Installation of the three phase transformer and additional wiring..

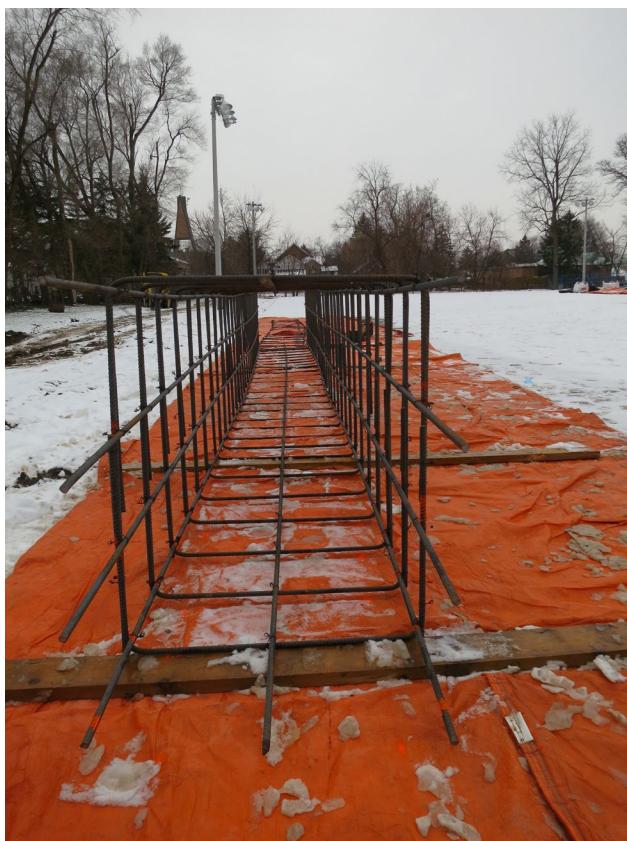
23 - Reinforcing steel cage for the grade beam.

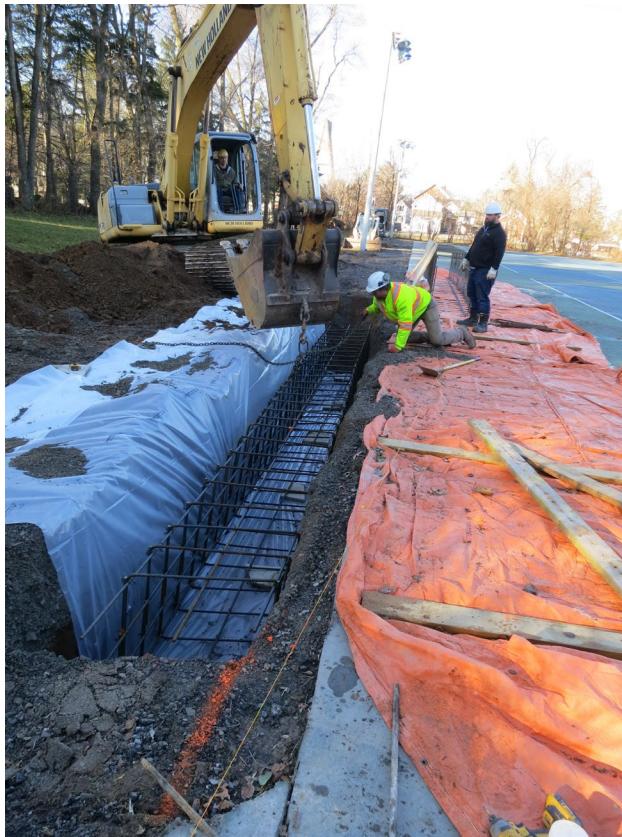
25 - Dec. 13th. Grade beam trench ready to receive concrete.

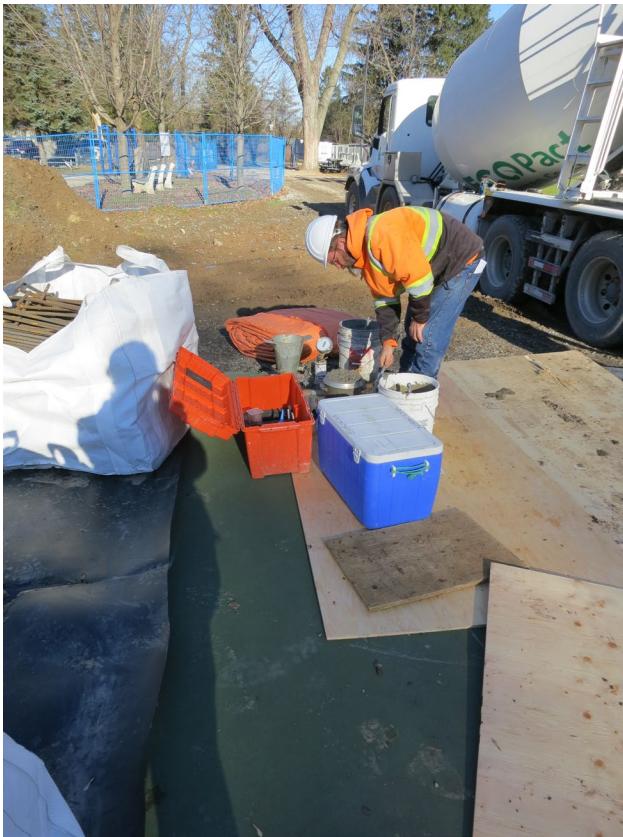
27 - Taking concrete test cylinders for compression tests. Air entrainment tests were carried out on the site.

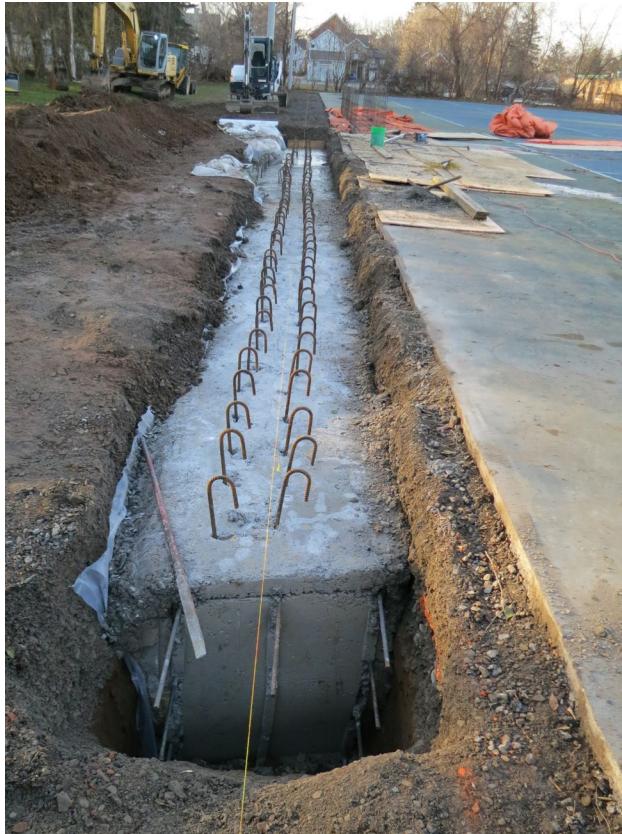
29 - Phase I of the grade beam completed. Phase II will be the concrete cap on top of Phase I, and this cap will house the aluminum rail holding the Dome fabric in place.

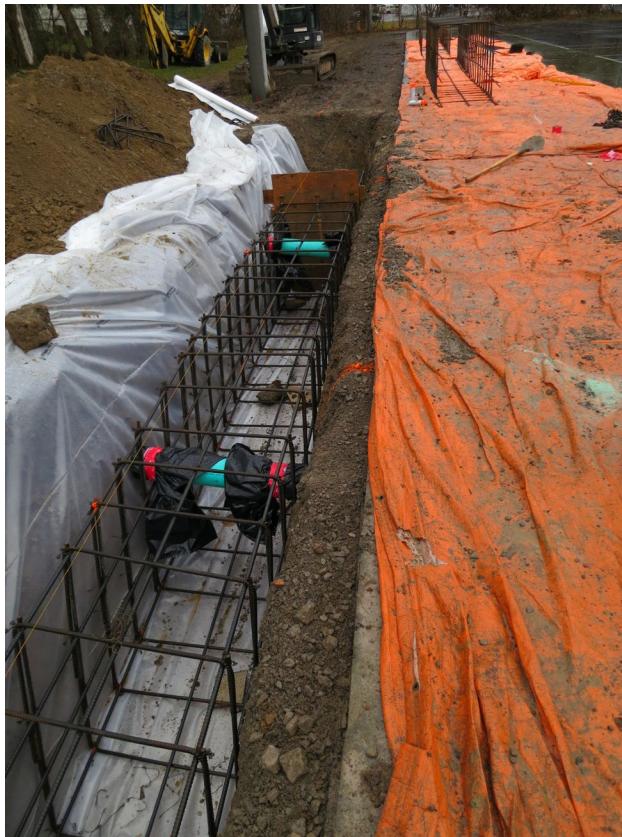
30 - Grade beam across from proposed mechanical pad. Note 6" diam. PVC pipes for electrical conduits to slip through.

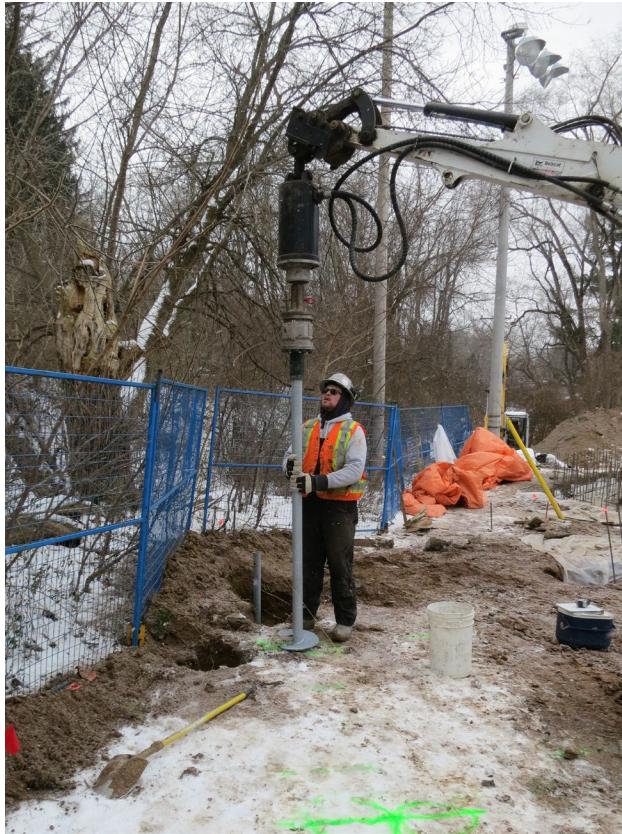
35 - Dec. 22nd. Helical Pile installation. Helical piles are a manufactured steel foundation anchor. The purpose of a helical pile is to provide foundational support for structures. In our case, required for the construction of the concrete deck and the wood deck, immediately south of the clubhouse..

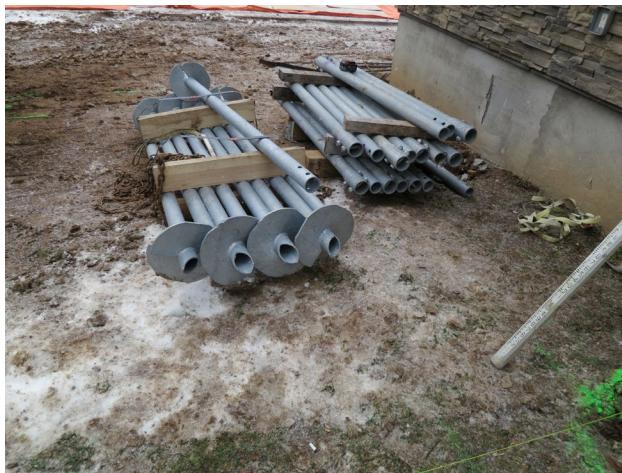
36 - Dec.22nd. A total of 11 helical piles (screw piles) were necessary on the south side of the club house. Based on the site specific ground conditions, each pile ended up approximately 21 ft. long.

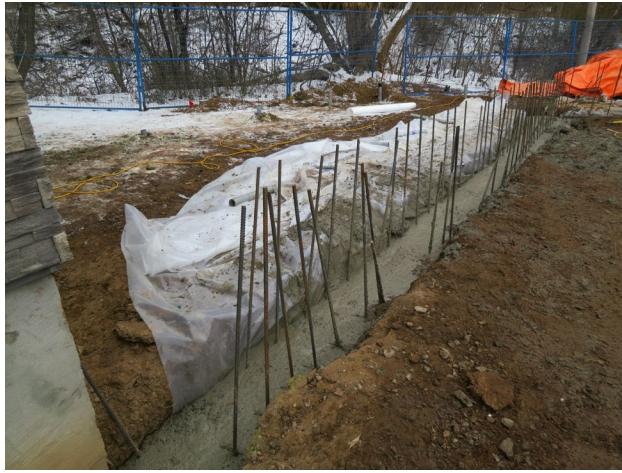
37 - Dec. 23rd. This just poured concrete foundation sits on helical piles and is for the backwall of the concrete deck, adjacent to and south of the clubhouse.

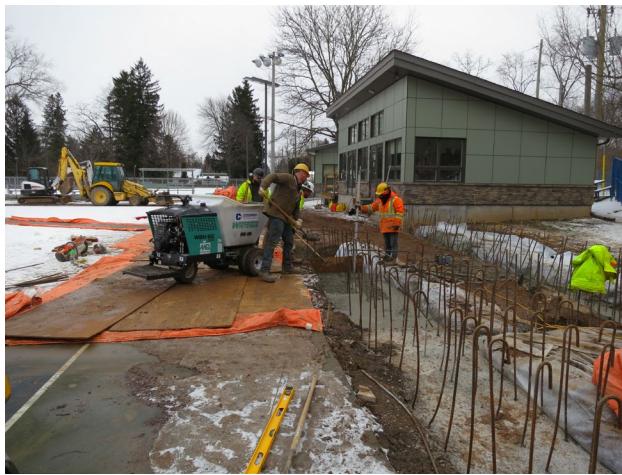
38 - Dec. 23rd. The pouring of concrete for the continuation of the foundation for the deck wall. The Dome fabric will be attached to the top of the wall . The deck will be a concrete one (fire regulation).

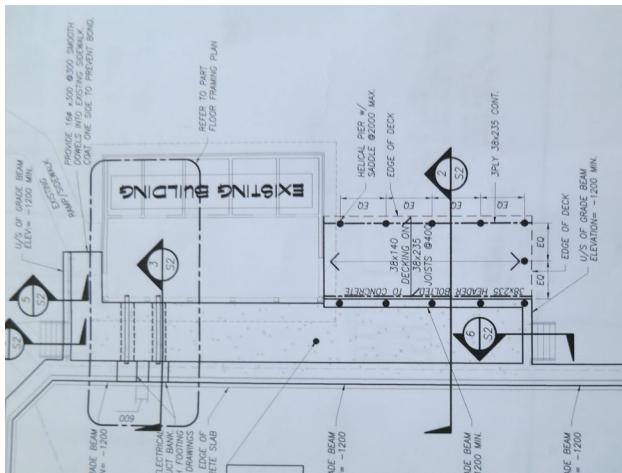
39 - This plan indicates, with black dots, the location of the eleven helical piles.

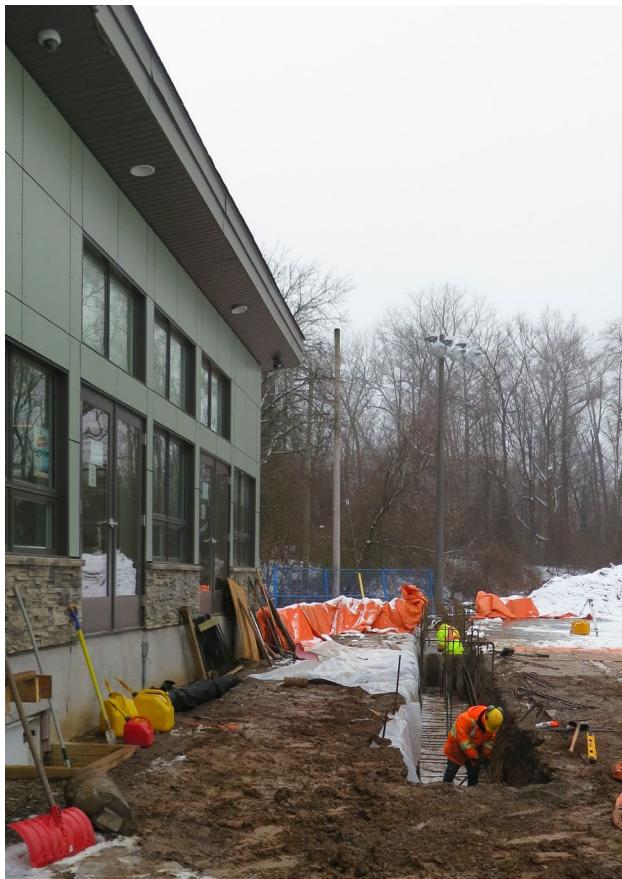
40 - Dec. 29th. Installation of the reinforcing steel for the foundation of the deck wall. Please note the polyethylene sheet. This sheet is to provide a "slip-plane" to prevent frost adhesion between the soil and the foundation wall concrete.

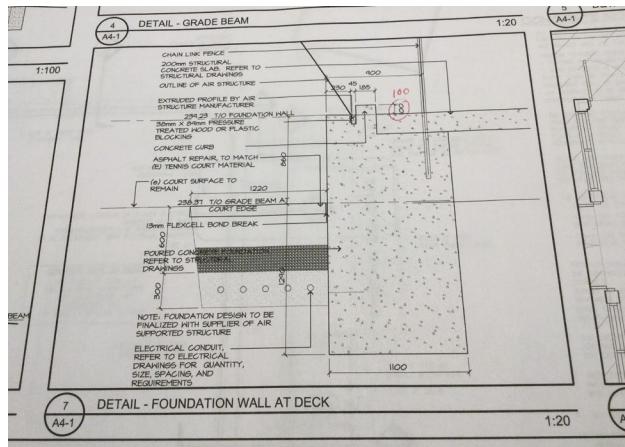
42 - Dec. 29th. Cross section of the foundation of the deck wall. The wall is 1.1m thick or 3.6 feet. The Dome fabric will be attached to the top of this deck wall (note on the drawing: "outline of air structure").

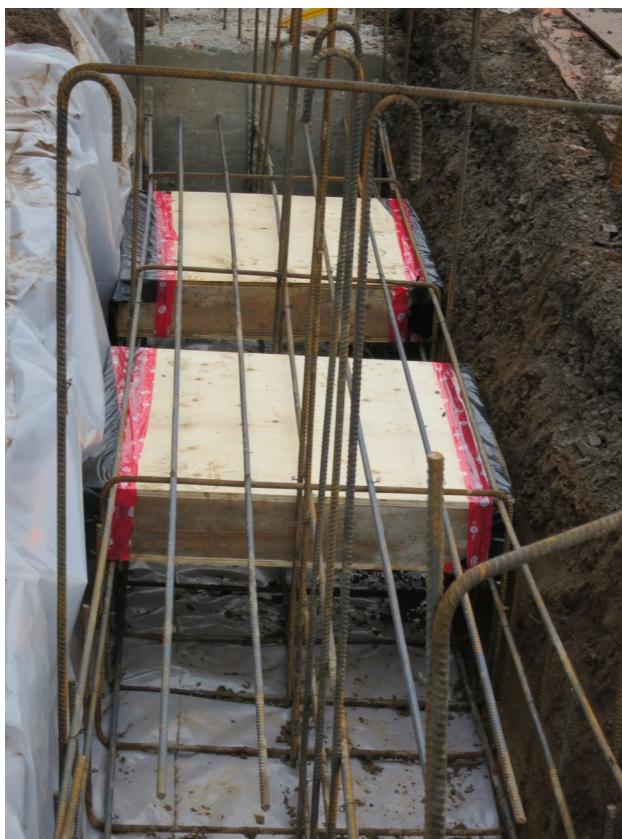
44 - Dec. 30th. Form work to create two slots, each 1 m wide X 0.2 m high, required to slip electrical conduits through.

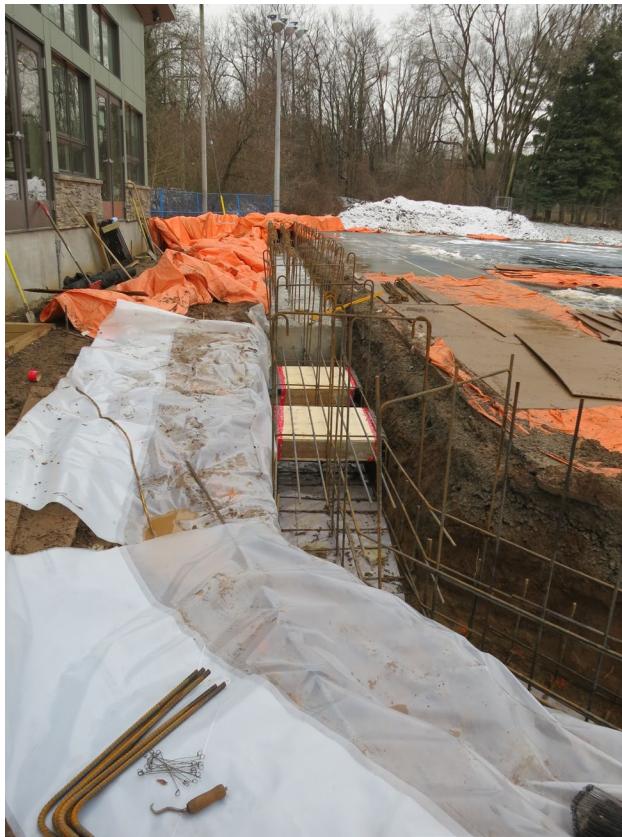
45 - Dec. 30th. This picture shows the foundation for the deck wall with the location of the form work for the two slots.

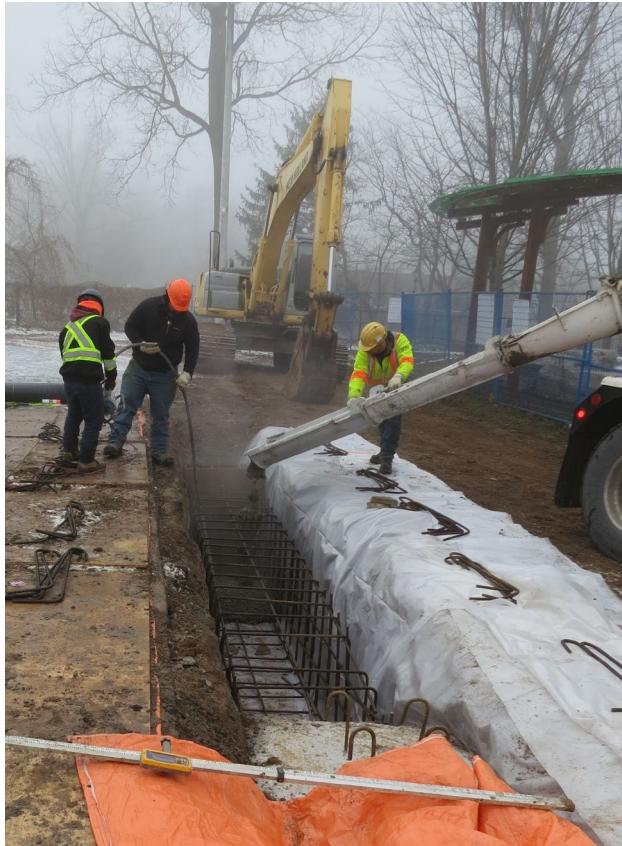
49 - Jan. 13th. Please note the steam coming off the heated concrete. In winter, most producers will try to have the concrete be between 20C - 25C when it leaves the plant.

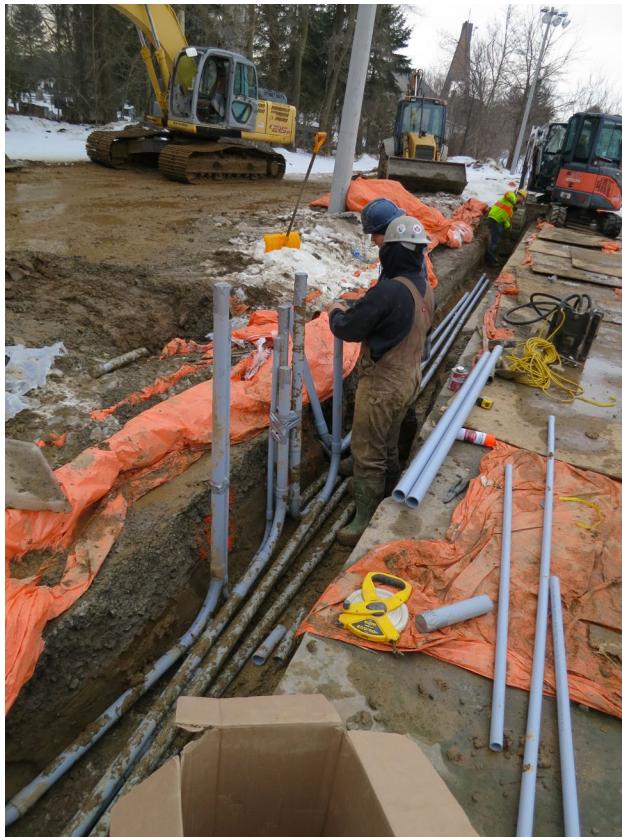
61 - March 1st. Conduit risers at the inside of the grade beam for the installation of the electrical junction boxes.

The top of these boxes will be flush with the court surface.

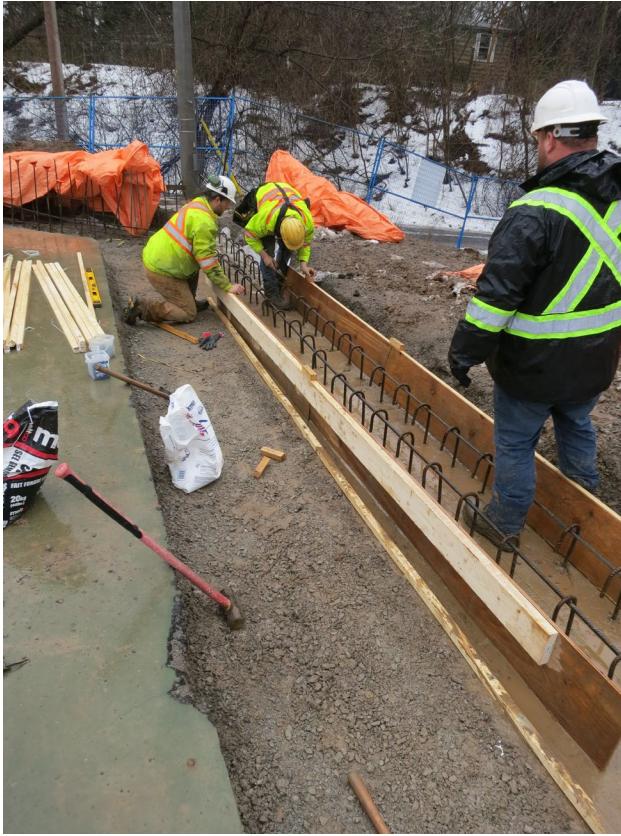
62 - March 7th. Demik started today forming the top piece of the grade beam. The extruded aluminum profile will sit in the middle of the top of the grade beam. See next slide for details.

The electrical conduits were installed in front of the grade beam and the trench was backfilled with granular "A" gravel.

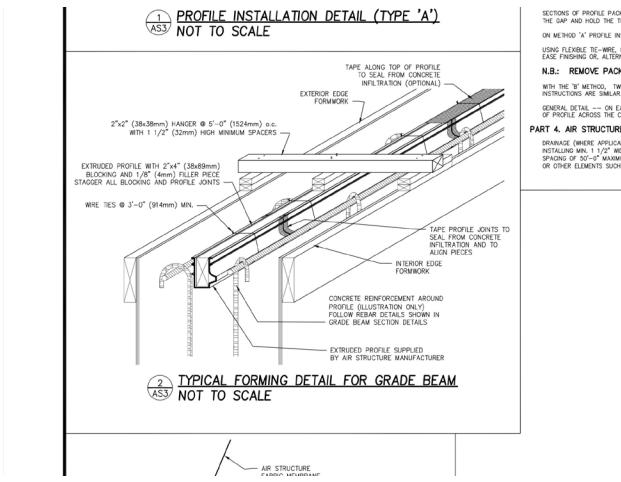
63 - March 7th. Detail of the forming of the top of the grade beam. Dome fabric to be inserted in the extruded aluminum channel

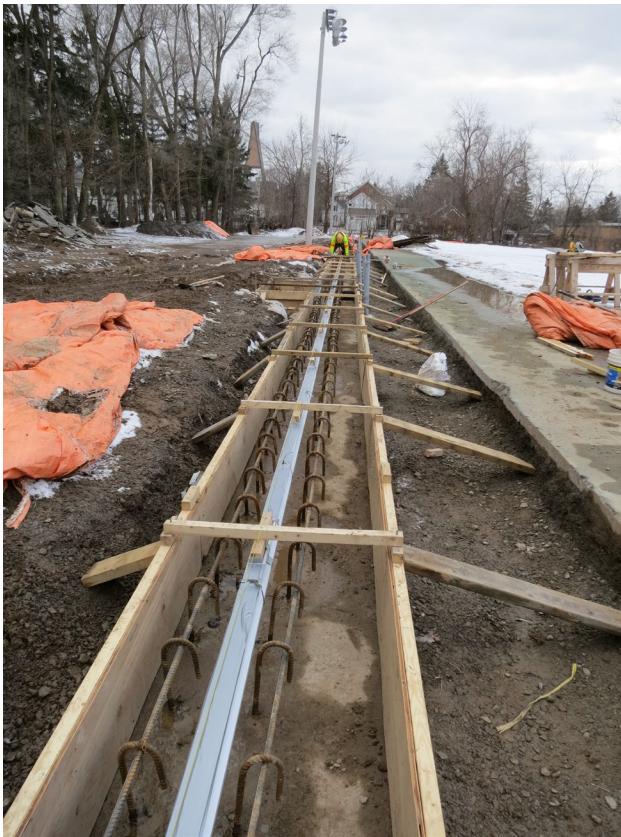
64 - March 8th. Twenty two meters of formwork for the top section of the grade beam ready for the concrete. The concrete will be poured on March 9th. Please note the aluminum channel in the middle of the form work. The bottom of the Dome fabric will be inserted in this channel.

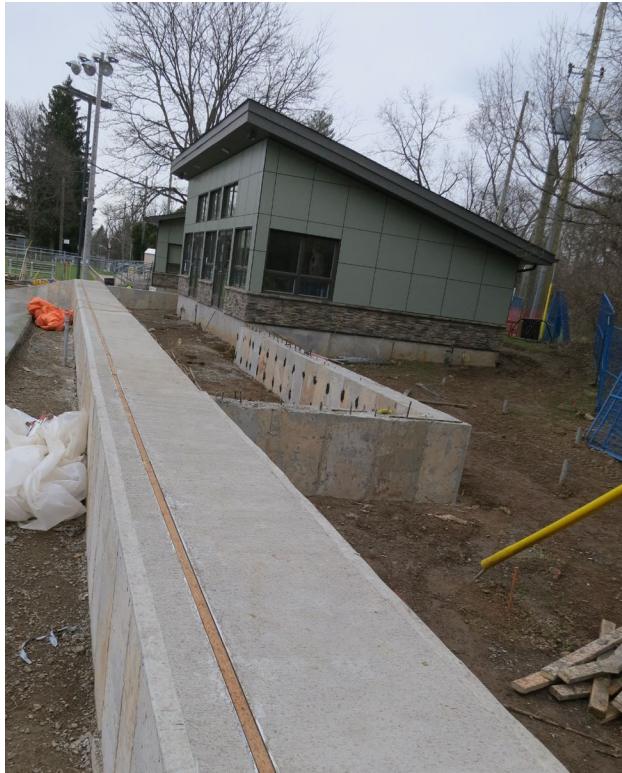
92 - April 14th. When the concrete is poured a 2x4 is inserted in the extrusion channel in which the dome is attached to. The back portion of the deck, beside the clubhouse, will be made out of wood. The posts will sit on the visible tubes (helical piles).

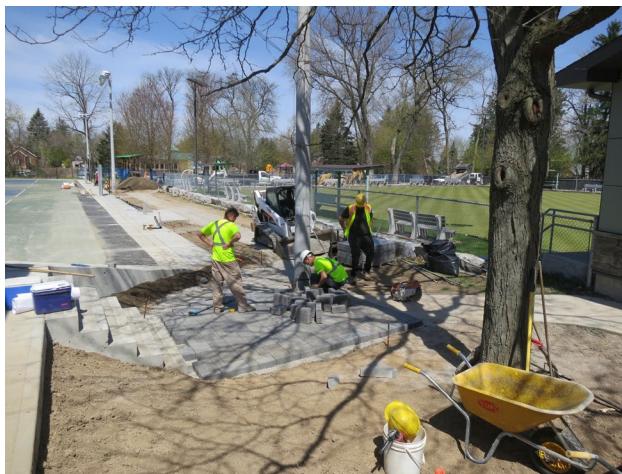
109 - May 10th. Installation of the interlocking walkway by the landscapers. Beneath the walkway is the existing infiltration system and therefore we had to use interlocking stones and not concrete.

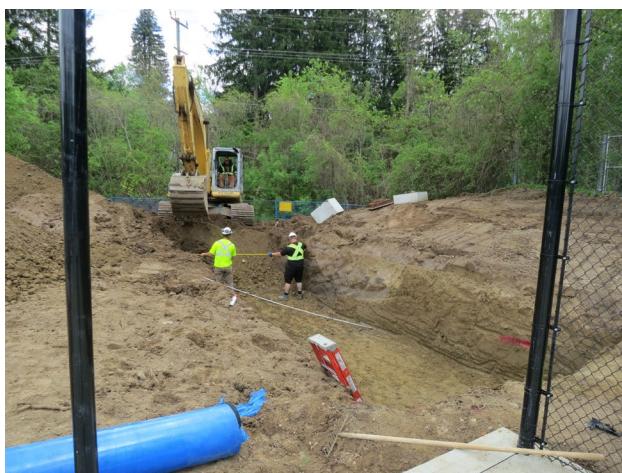
116 - May 17th. Construction of the storm water management infiltration system. This trench will be filled with 2 inch clear stone.

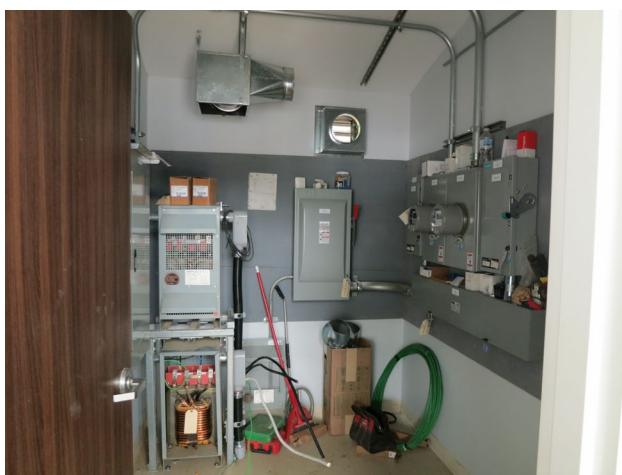
119 - May 19th. The electrical room is full of panels, switches and transformers to operate the Dome.

Note the two transformers in the left corner of the room. This room requires proper ventilation and that was being installed today.

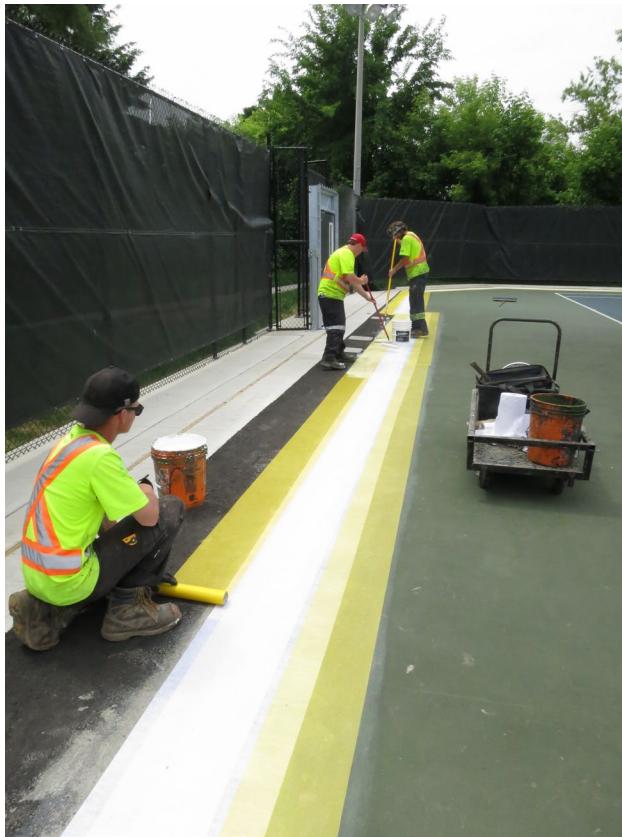
128 - June 15th. Repair of court surface by Ancaster Court Services (ACS). Laying and gluing of fiberglass screens prior to painting.
