# **Burlington Street East and Wentworth Street North Sewage Spill**

November 28, 2022

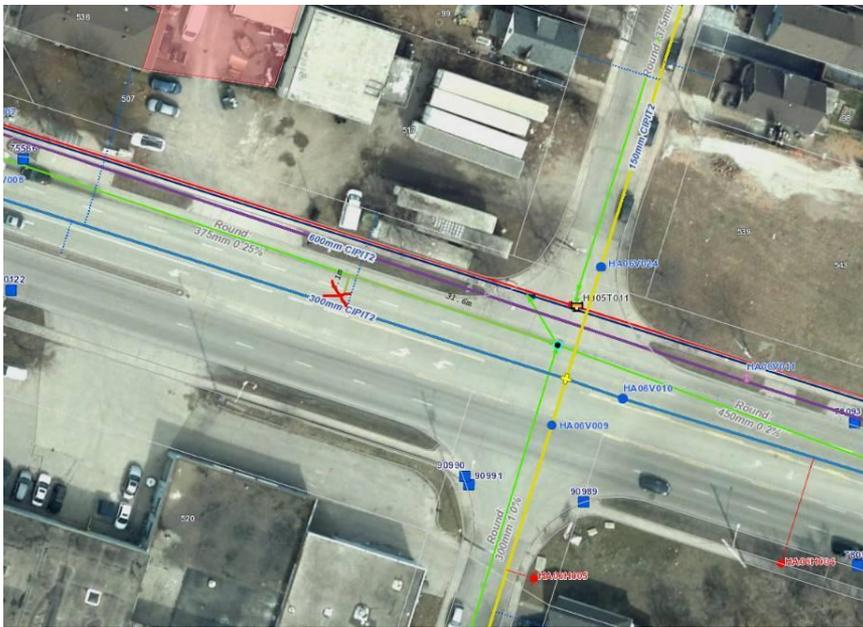
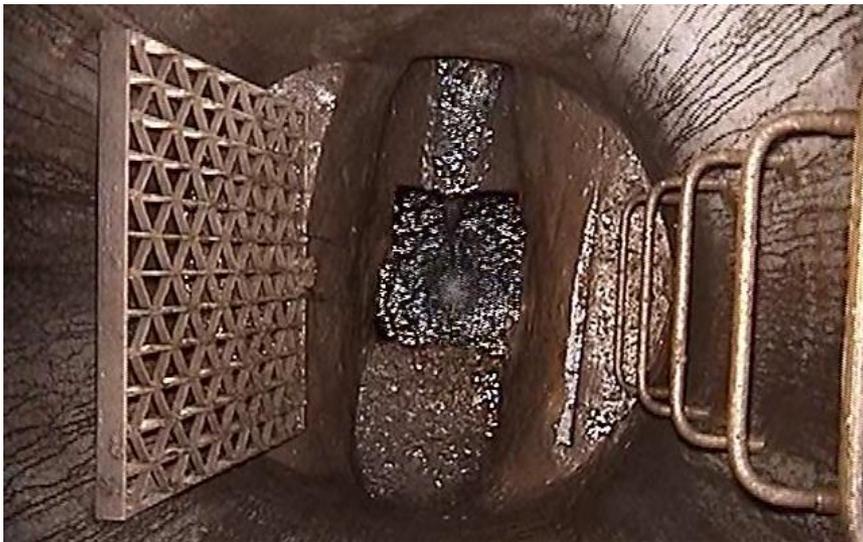
- 2019: Engineering Services completing inspections for a potential capital project
- November 2022: Hamilton Water asked to investigate a void in a sewer lateral near Burlington Street East, west of Niagara Street
- November 22, 2022: Hamilton Water reviewed a Zoom Camera inspection video made in December 2013 that didn't "look right"
- November 22, 2022: Hamilton Water completed a field investigation that identified the spill

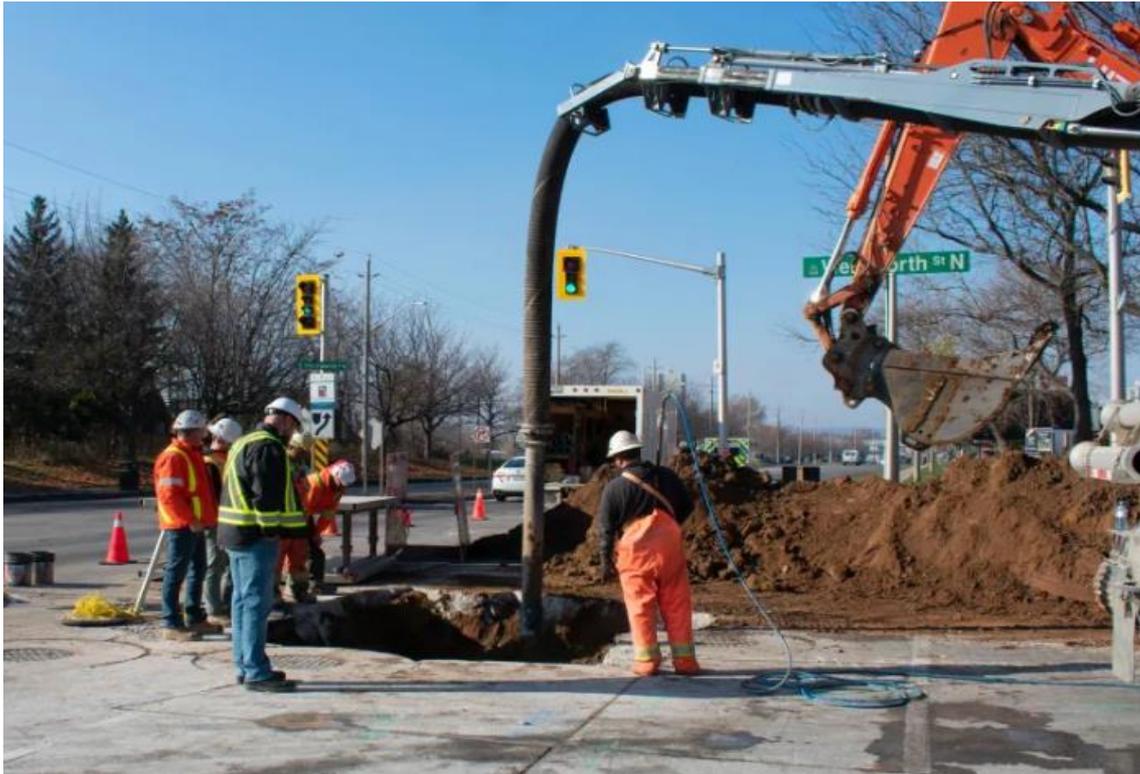
- The repair and sewer realignment started at 8:00 a.m. on November 23, 2022
- The leak was stopped at 9:32 p.m. on November 23, 2022
- The crew completed all works and was offsite at 12:30 a.m. on November 24, 2022

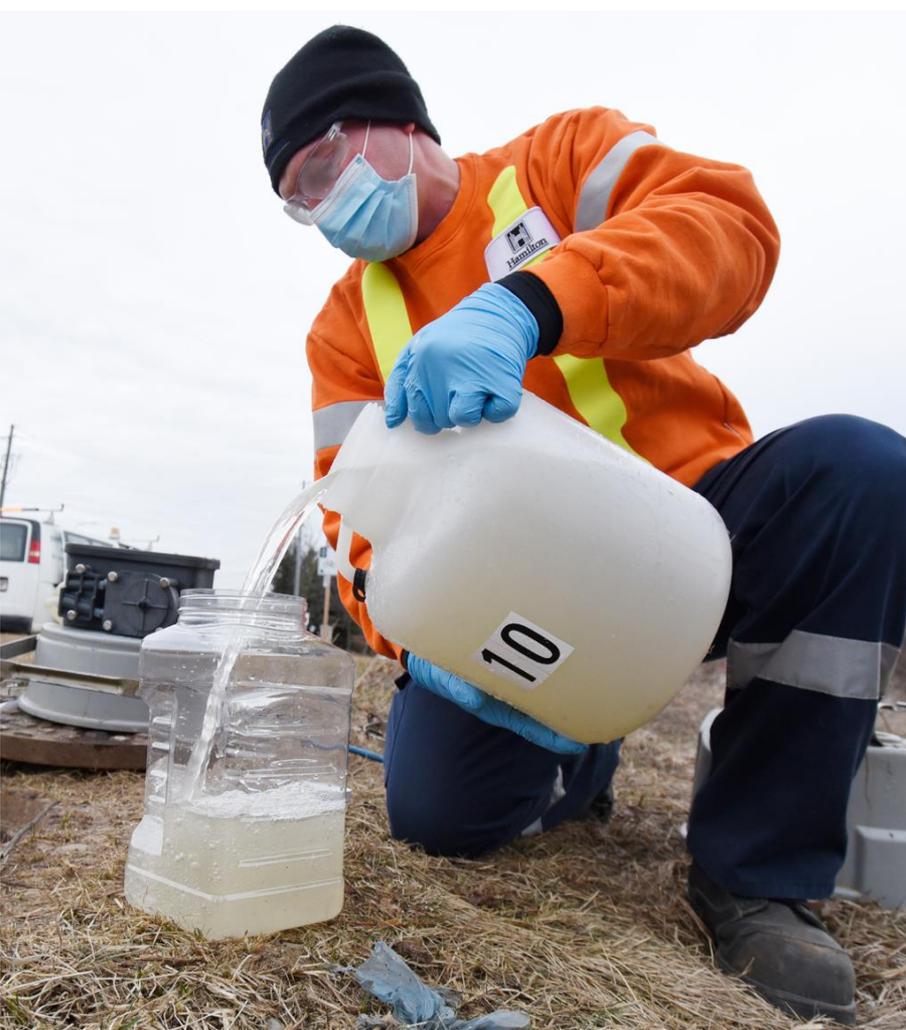
## Sampling Results

- Environmental Monitoring & Enforcement Staff completed sampling on November 22, 2022
- Samples were completed for: Escherichia coli, Conventional Parameters and Metals
- Preliminary sample results available to date show the sample is similar to residential wastewater
- Environmental Monitoring & Enforcement Staff completed post repair sampling at on November 25, 2022

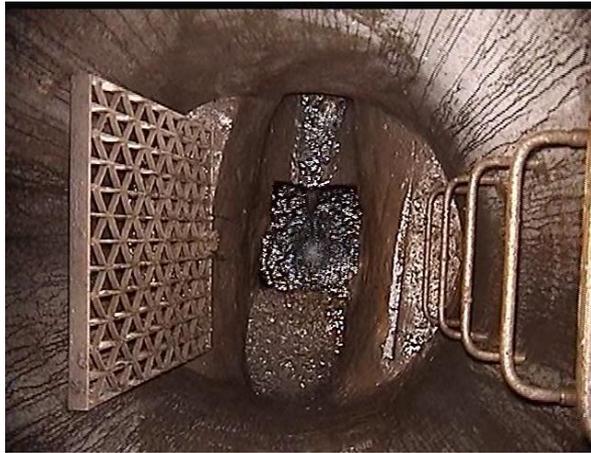
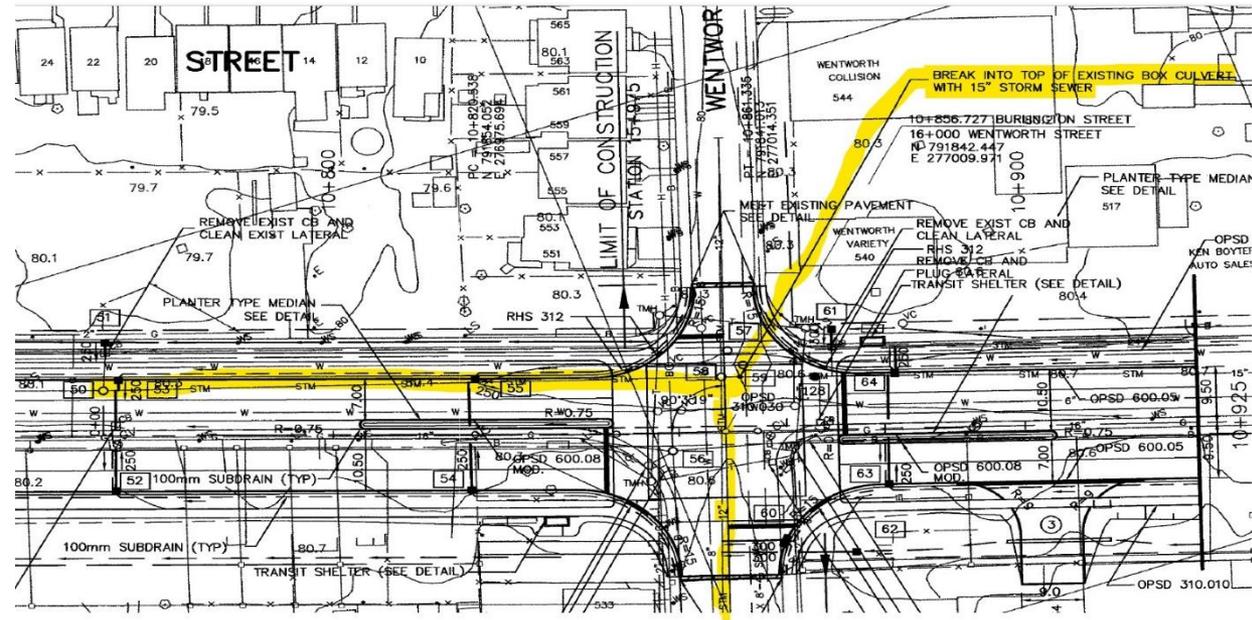
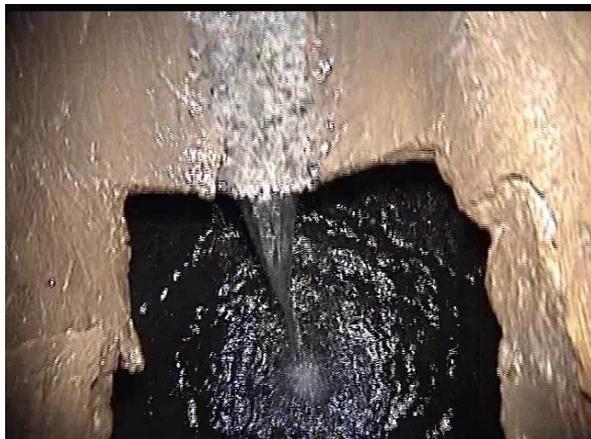
- 1996 Burlington Street Reconstruction & Widening Project
- City of Hamilton – Transportation & Environmental Services Group
- Design drawing 96-H-11\_3 has mislabeled sewers – shows a deliberate connection to the storm sewer

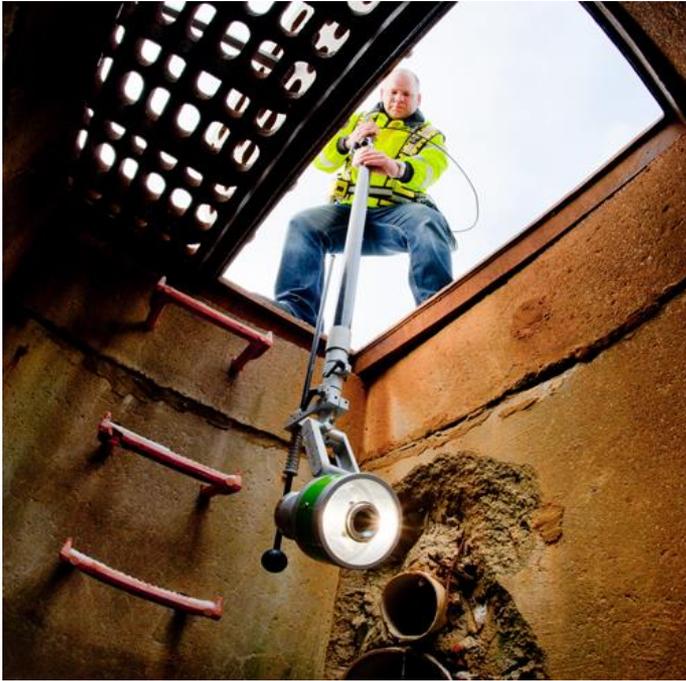
- Zoom Camera Sewer Inspection Contracts
  - C11-29-04
  - C11-86-10
  - C11-39-15
- Approximately 9,600 videos per year
- PDF Deficiency Reports Provided to City Staff
- Bulk Uploads of Videos
- Contractors not Experienced with City Sewers
- Contractors not Looking for Cross Connected Sewers

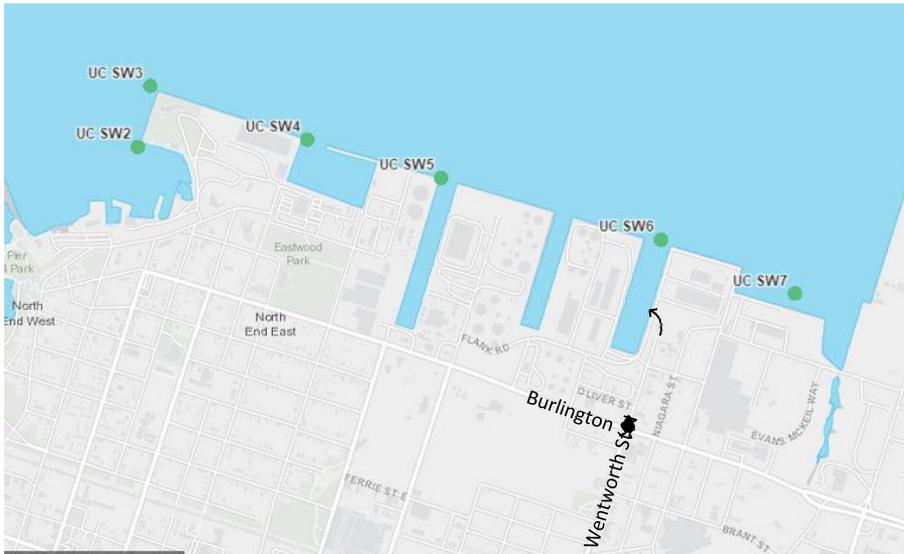
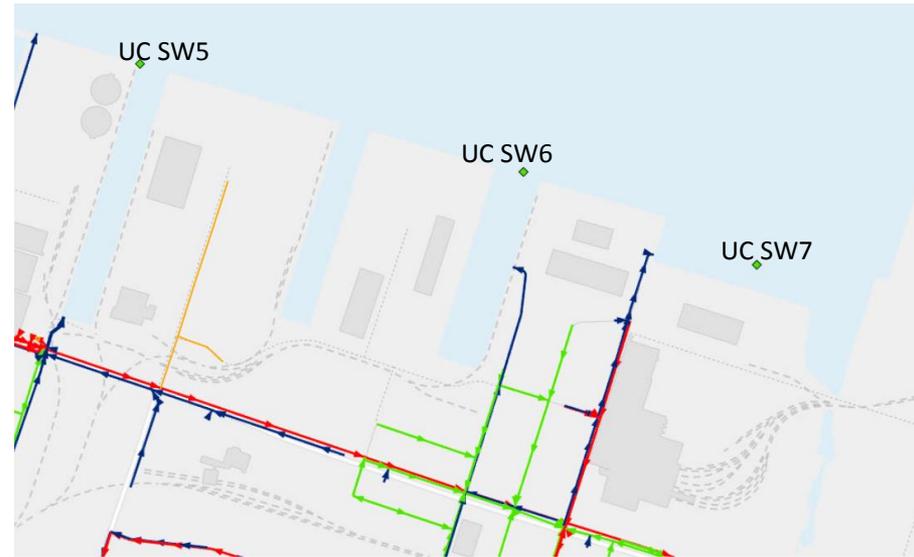
## SURFACE WATER QUALITY PROGRAM: HAMILTON HARBOUR SAMPLE LOCATIONS AT AND UP- / DOWN-STREAM TO WENTWORTH CSO

- ↪ - Wentworth CSO Outfall
- - Burlington / Wentworth Spill Location

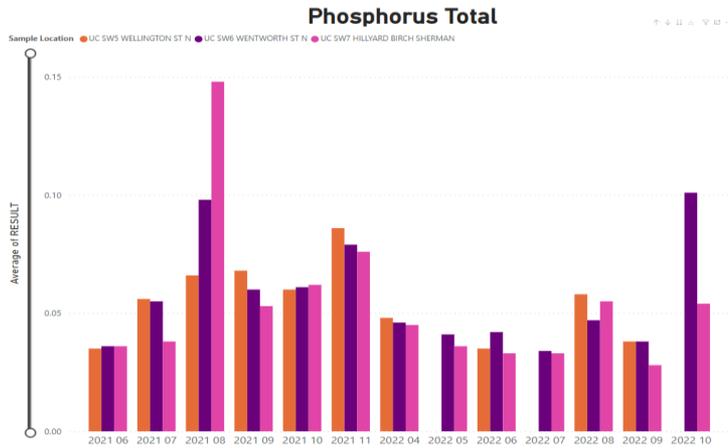
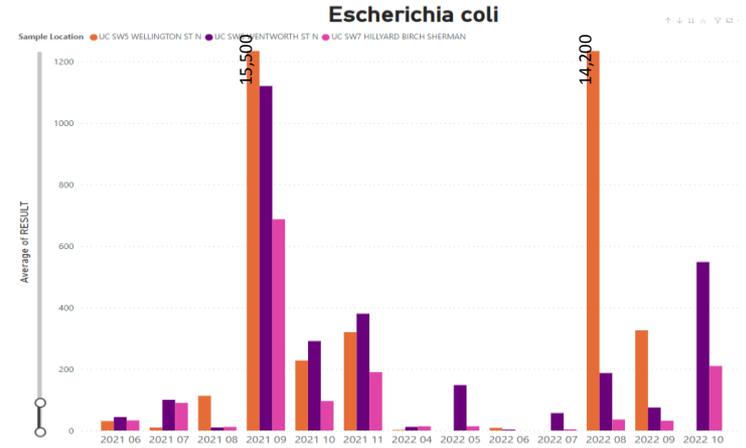
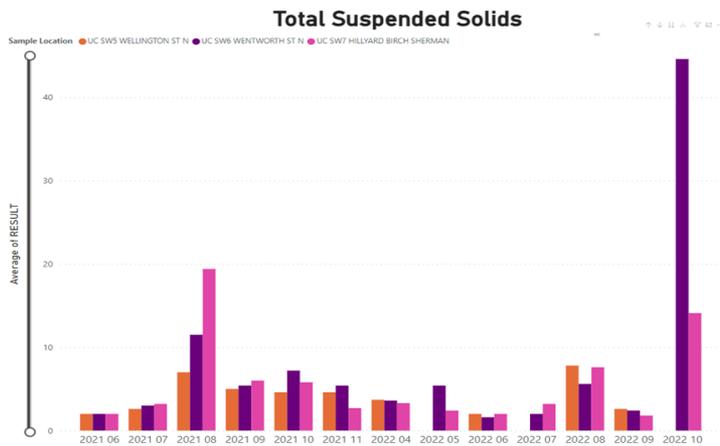
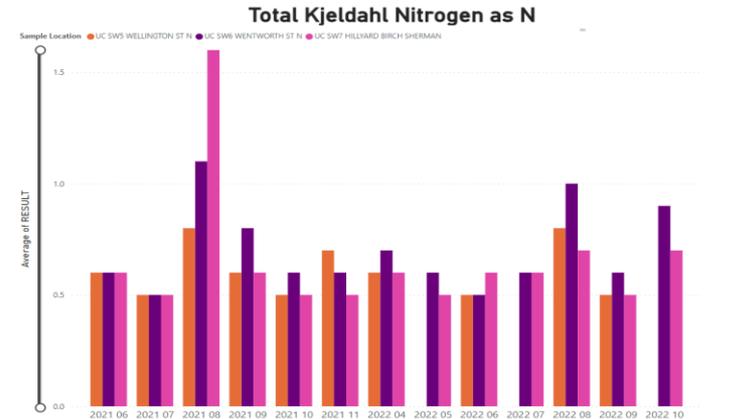
# SURFACE WATER QUALITY PROGRAM: SW6 Data

Note: During the Oct 2022 sample event, two (2) tugboats were docking a ship, working up sediment at UC SW6 location.

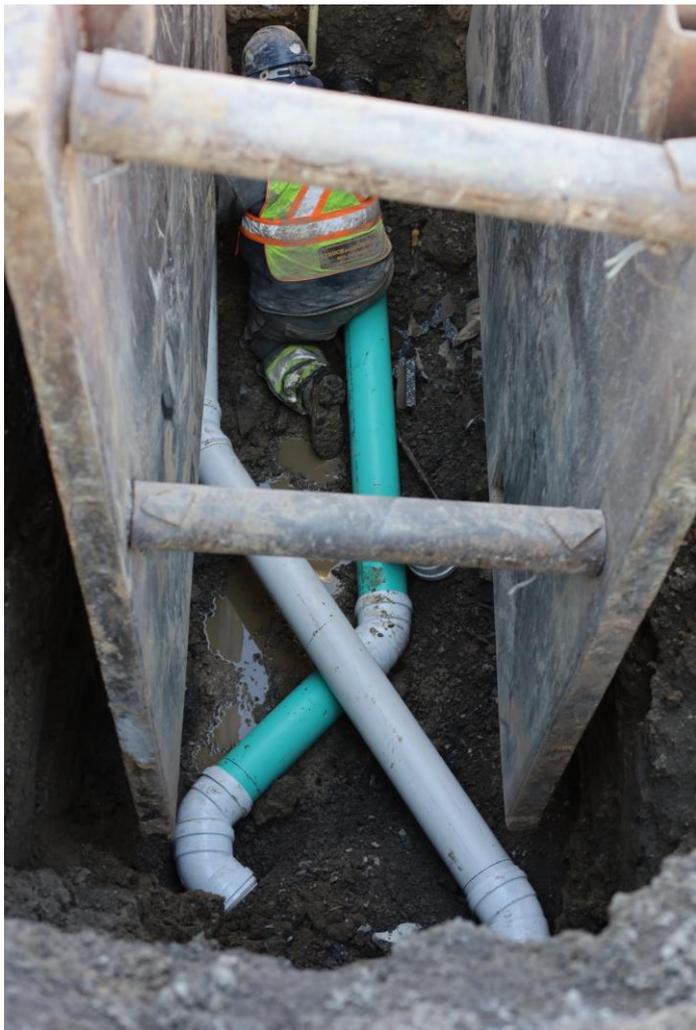
# Sewer Lateral Cross Connection Program

Sewer Lateral Cross Connection Program Activities

- 382 km Storm Sewer surveyed
- 722 Dye Test Investigations completed
- 455 Sewer Lateral Cross Connection Corrections  
= 102.5 million liters of wastewater diverted each year
