## CULTURAL HERITAGE IMPACT ASSESSMENT (CHIA)

# 115-117 George Street & 220-222 Main Street West

Hamilton, Ontario

(GBCA Project No: 20027)

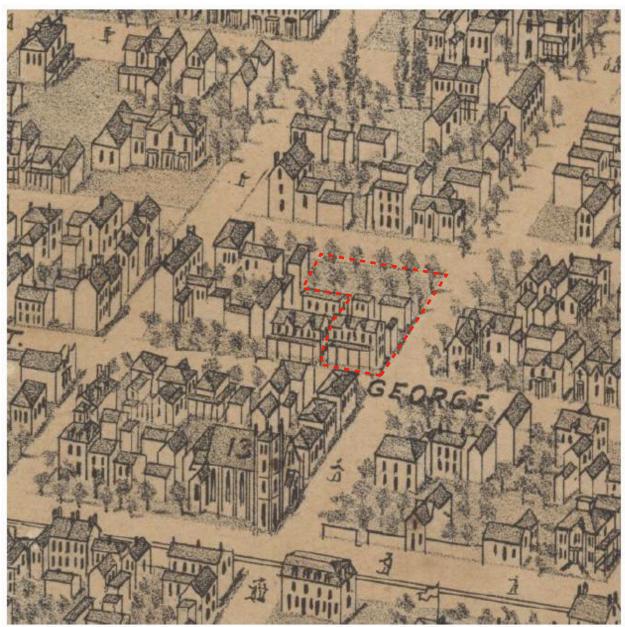
Detail from the Bird's Eye View of City of Hamilton, 1876

This bird's eye view (which is not oriented to the north, but rather looks to the south) shows the extent of the development on the subject property (highlighted in a red dashed boundary) and its block, as well as on the neighbouring blocks. The building noted as 13 is the former All Saints Episcopal Church, which has been demolished in 2016, due to structural issues.

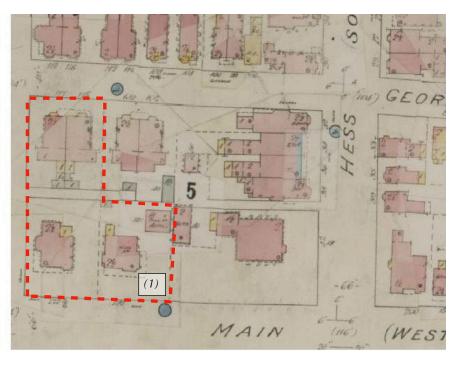
Detail of the Insurance Plan of the City of Hamilton, Charles E. Goad, 1911

At the beginning of the 20th century, the property at 220 Main Street West (1) was added, thus completing the Main Street frontage with residential buildings.

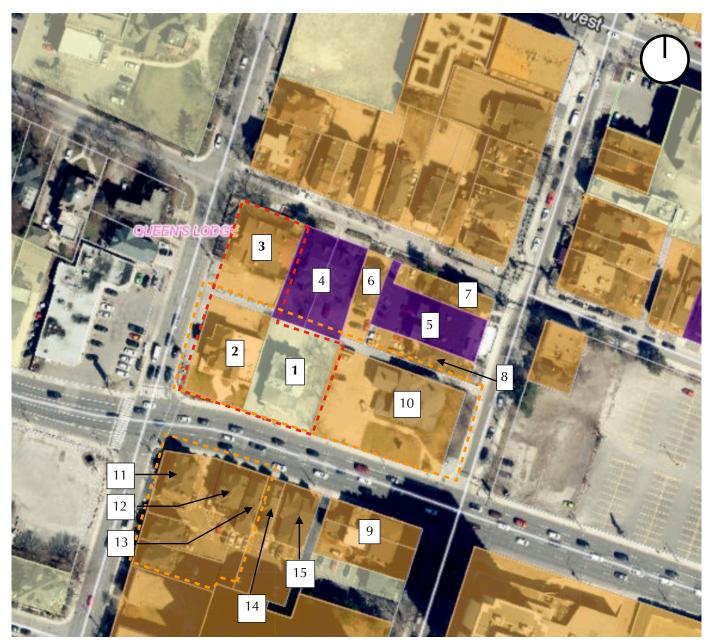
Snapshot of the City's Interactive
Heritage Property Mapping, showing
the development site (red dashed
boundary) in its context.
The orange dashed boundaries identify
the Main St. S Streetscape, identified as
a Cultural Heritage Landscape under
the Urban Hamilton Official Plan.
Properties numbered are either on the
development site (in bold) or were
identified by the City as being adjacent
to the development site.

Properties highlighted in a purple colour are Designated, those in orange are Registered and those in yellow are Inventoried. Those that have no colour have no heritage status.

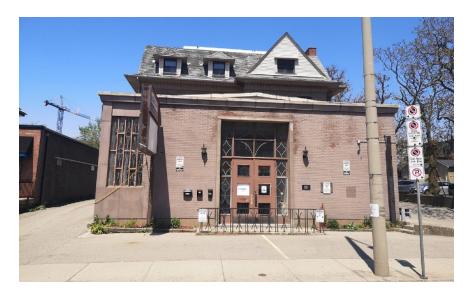
- <u>Addition of a front volume.</u> This addition supported the rehabilitation of the building for commercial usage. This addition, which is of no particular architectural interest, has significantly altered the front face of the building, where the original design can no longer be found through physical evidence.

- <u>Painting of brick facades.</u> Painting is typically done to hide deteriorated bricks or to upgrade the building with new exterior finishes. In this case, it appears that the paint is hiding spalled bricks or previously sandblasted bricks.

- Addition of new cladding materials on the roof. The roofs are clad with asphalt shingles which are in poor condition. The gables and dormers are clad with what appears to be vinyl or aluminum siding. A portion of this cladding is removed on the west-facing gable and exposes wood siding, suggesting this was the original material. The fascia bands and soffits are also clad with either vinyl or aluminum siding, and are likely hiding deteriorated materials.

- Replacement of all doors and windows with new metal units.

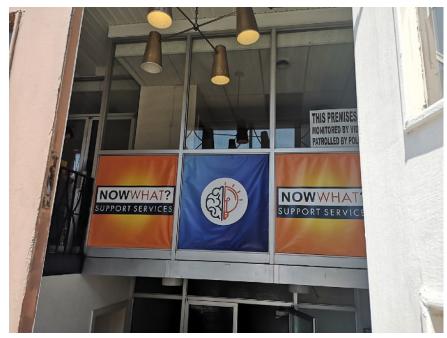
Overall interior view of 220 Main Street, taken from the main entrance of the front addition, and looking north. The space has been visibly altered and there are no signs of the original south wall of 220 Main Street. The front addition has altered the original south wall by removing the portion of the ground level and installing a supporting beam above to support the upper wall of the south elevation, visible from the exterior.

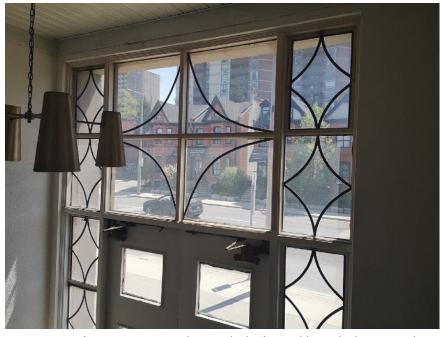
Interior view of 220 Main Street, taken inside the front addition, looking towards Main Street. and the new front entrance assembly. Windows are painted metal units with single pane glazing with lead came.

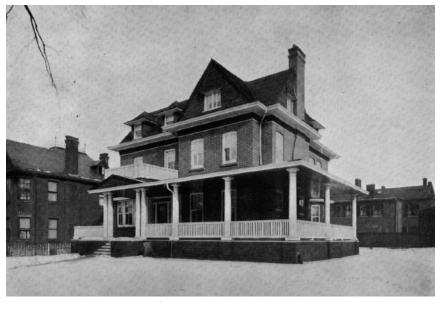
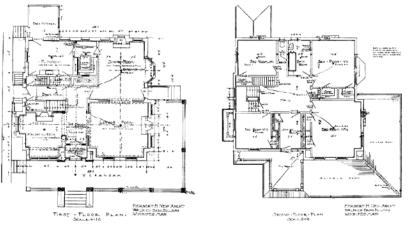
Archival photo and floor plans of Dalkeith Lodge at 222 Main Street (Canadian Architect and Builder)

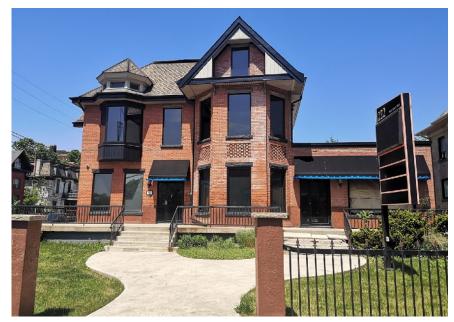
222 Main Street South in its current condition.

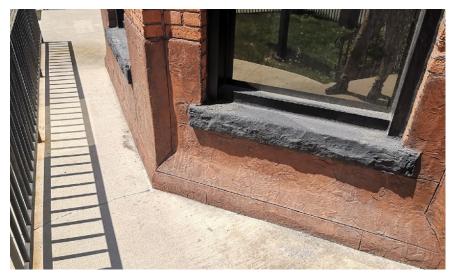
Close-up of base, showing parging over brick surface at base.

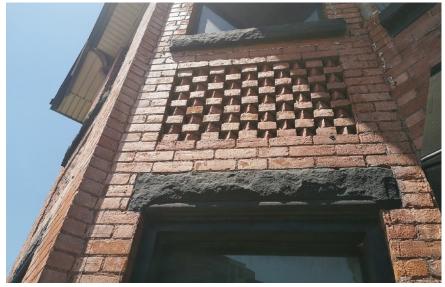
Close-up at exterior wall, showing the checkered brick pattern at the spandrel. The walls appear to have a remnant thin film over the brick surfaces. Note the modern cladding at the soffit above.

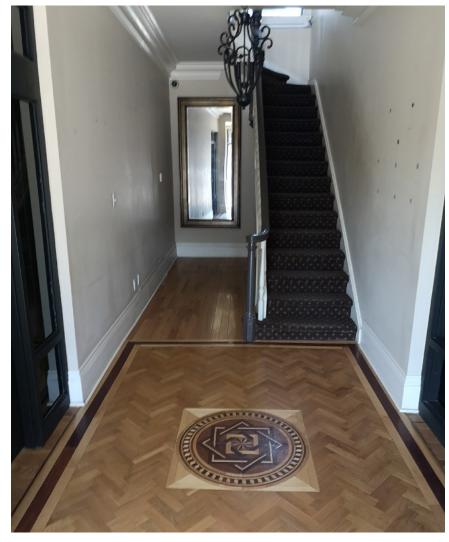
Overall interior view, from the main entrance hall. The current flooring is a modern replacement (two different flooring patterns on the ground floor as shown on the photograph). All wall finishes and trims are equally modern replacements, and trims are made to look historically accurate.

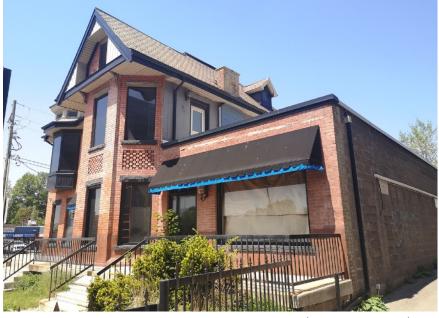
222 Main Street South in its current condition.

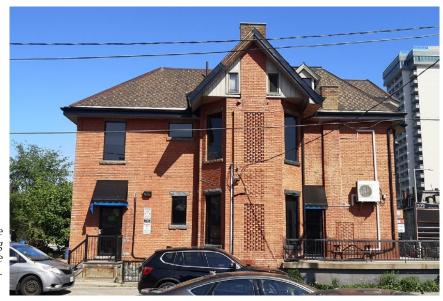
Overall west elevation. Note the checkered brick patterns on the bay wall and the additional metal cladding on the bargeboard, the soffits and on the front of the gable, hiding existing fabric. A portion of the metal cladding on the bargeboard is removed, exposing the underlaying wood trimming.

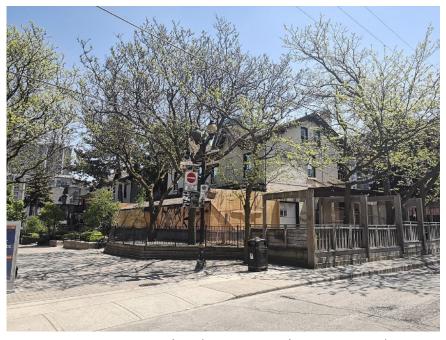
115-117 George Street as seen from the intersection of George Street and Queen Street South, which is partly obscured by trees, and later additions when the building was converted for commercial usage.

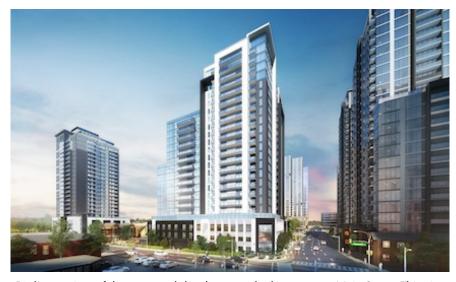
Bird's eye view of the proposed development, looking east on Main Street. This view shows the gateway towards the downtown core, starting from Queen Street (Image Via Developer / Coletara Development).

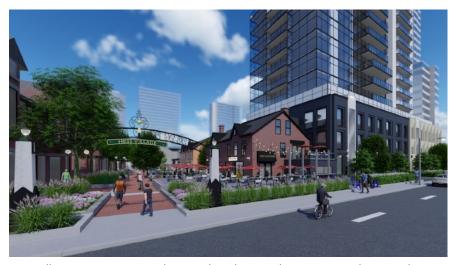
Overall George Street view, showing the John Moodie Houses in relation to the new development beyond and the George Street entrance to Hess Village. Note that some trees along George Street have been intentionally omitted in this image for clarity (Image Via Developer / Coletara Development).

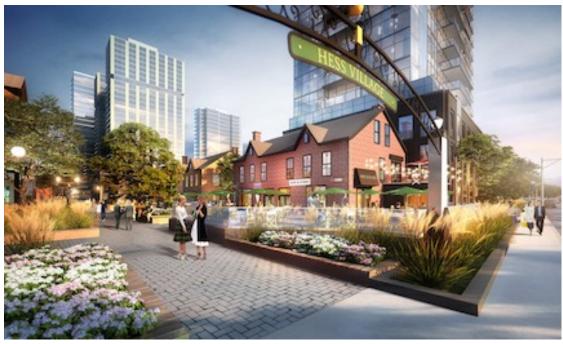
Close-up of John Moodie House in relation to the new massing behind. Note the discreetness of the link behind the roof gable. Alterations proposed and setbacks of the new massing conserve the three-dimensional quality of the heritage building. Note that some trees along George Street have been intentionally omitted in this image for clarity (Image Via Developer / Coletara Development).

The building on this property is proposed to be partially conserved by the physical retention of the main (north) facade, the side walls, the sloped roof up to the ridge (visible from George Street) and the chimneys. The front addition, dating to the second half of the 20th century, will be removed and the front facade restored. All other elements, including the interior structure, are proposed to be demolished. Further, the building will be rehabilitated to continue its commercial use and its exterior appearance will be restored to its Gothic Revival appearance.

New materials related to the new building as it links with the heritage building will be contemporary in style using contrasting materials and colours to clearly distinguish between existing and new.

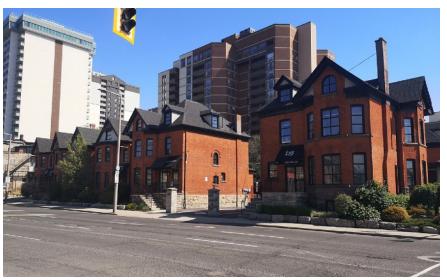
Overall view of the south side of Main Street West, across from the development site. The new development will not be visible from this view, and shadows, from the proposed development, will not be cast on these buildings. Note the current high-rise buildings in the vicinity, which do not impact the collection of brick buildings.
