Photographs

(all images taken August 30, 2023 by City of Hamilton, unless otherwise stated)

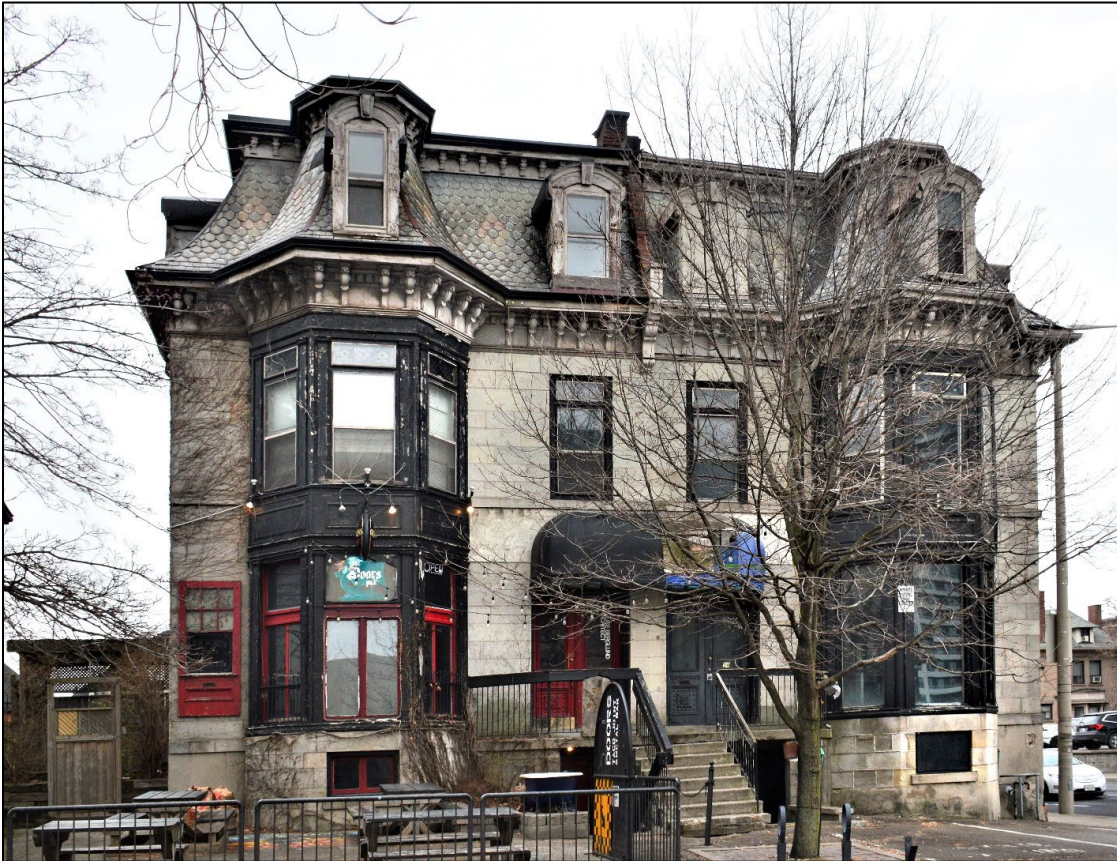
54 and 56 Hess Street South, front (east) elevation (2021)

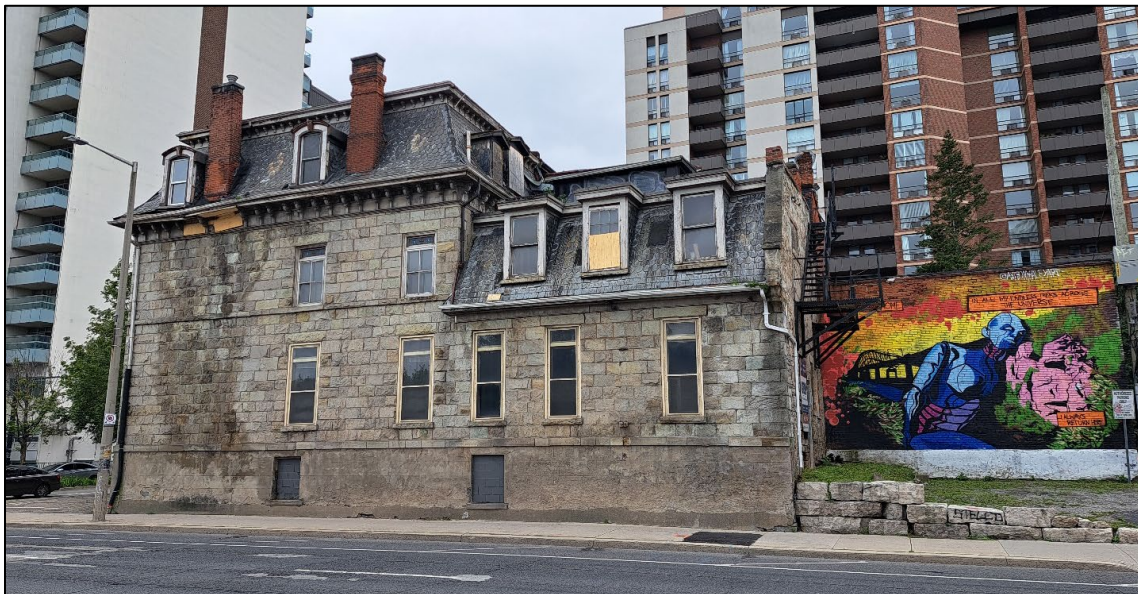
Side (north) elevation

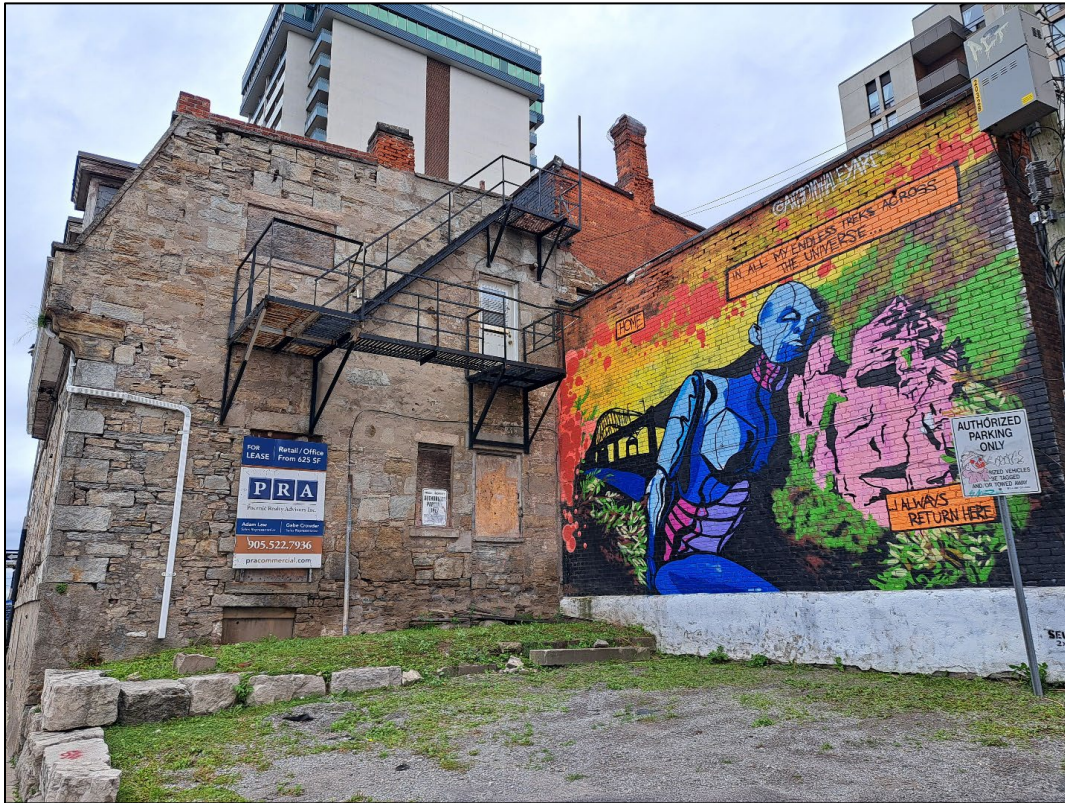
Rear (west) elevation of 54 Hess Street South (left) and north elevation of the painted rear brick wing of 56 Hess Street South (right)

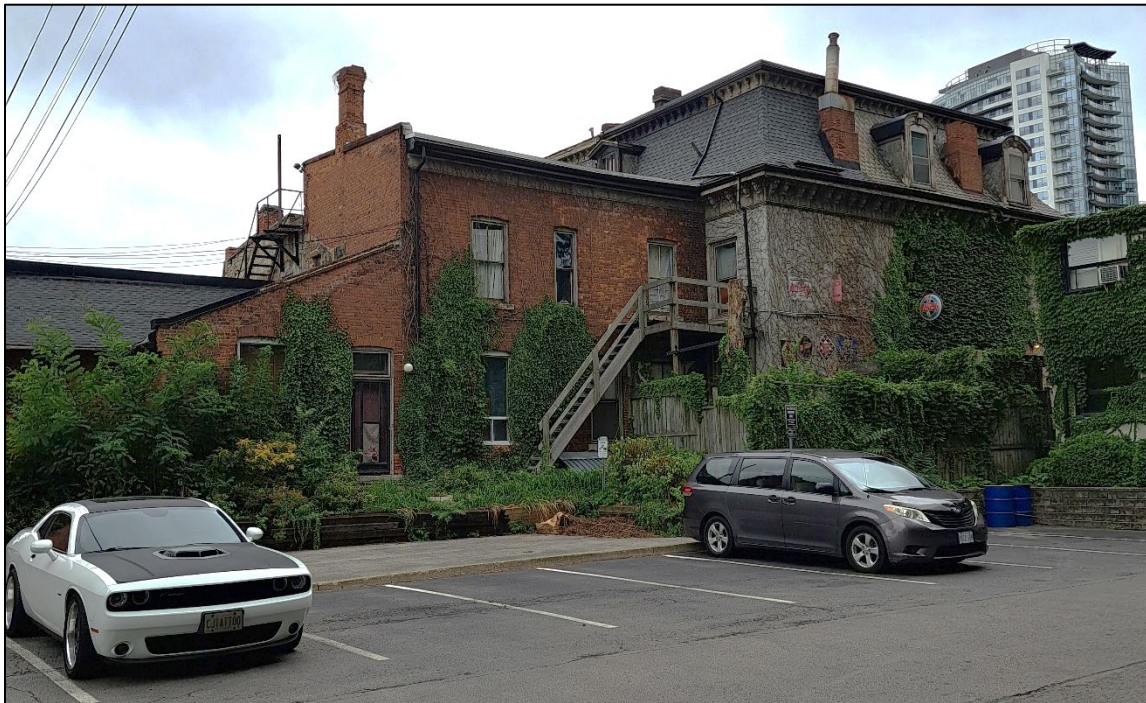
Side (south) elevation of 56 Hess Street South

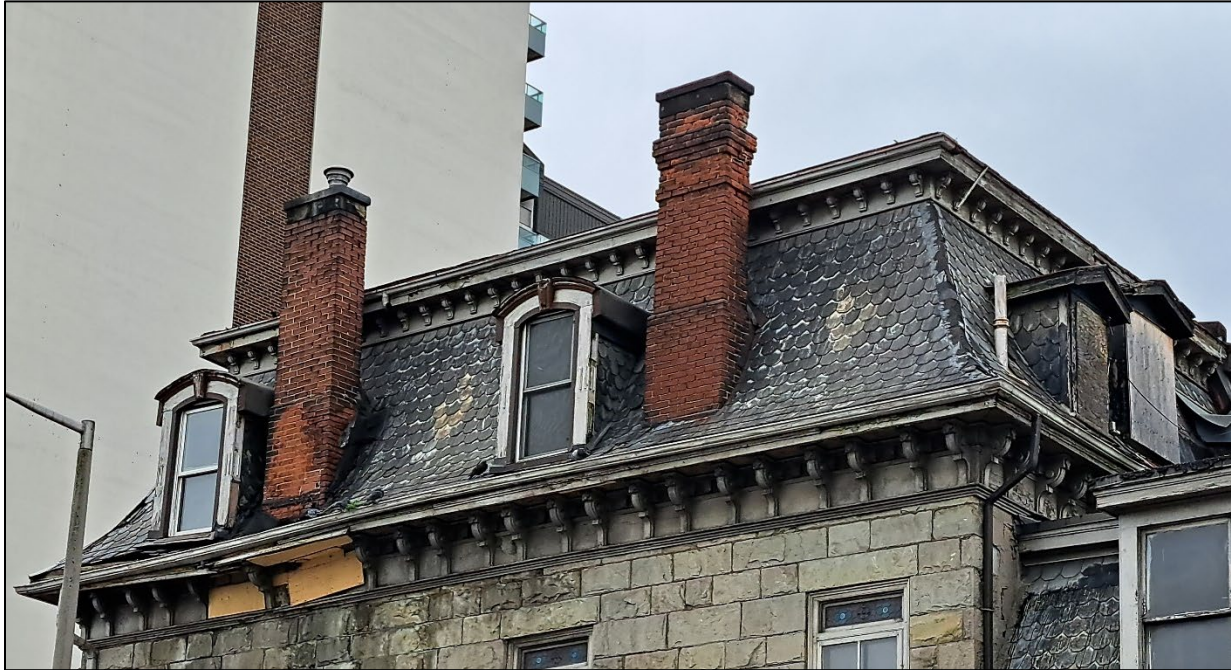
Closeup of Mansard roof with slate shingles, brick chimneys and dormers

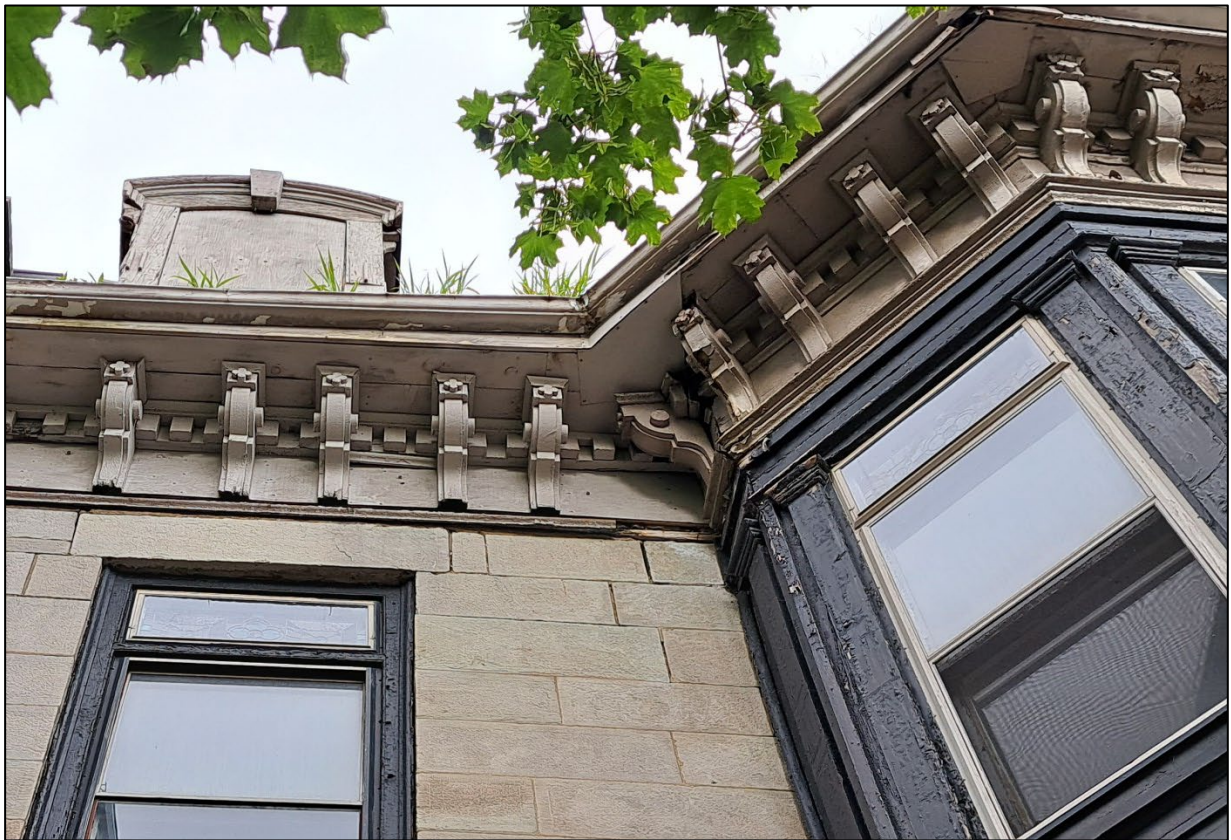
Closeup of wood cornices with dentils, decorative brackets and moulded frieze

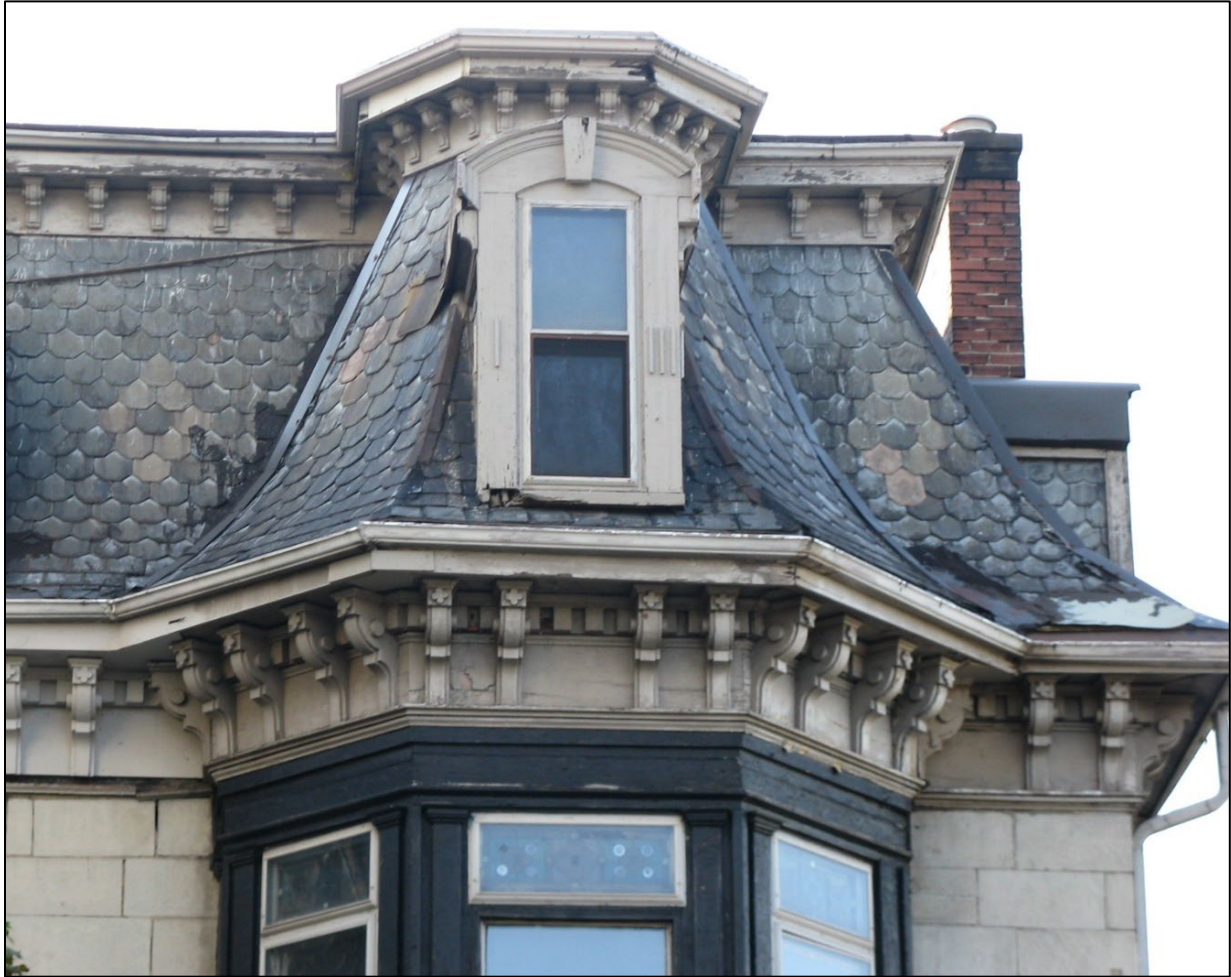
Closeup of second-storey front bay (2011)

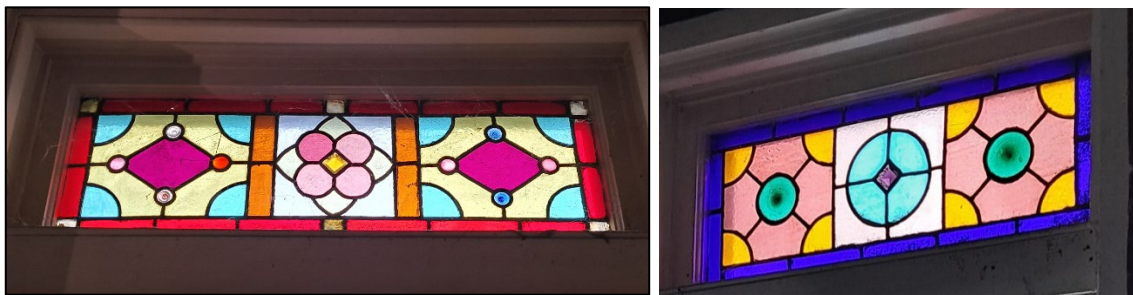
Examples of stained glass transoms

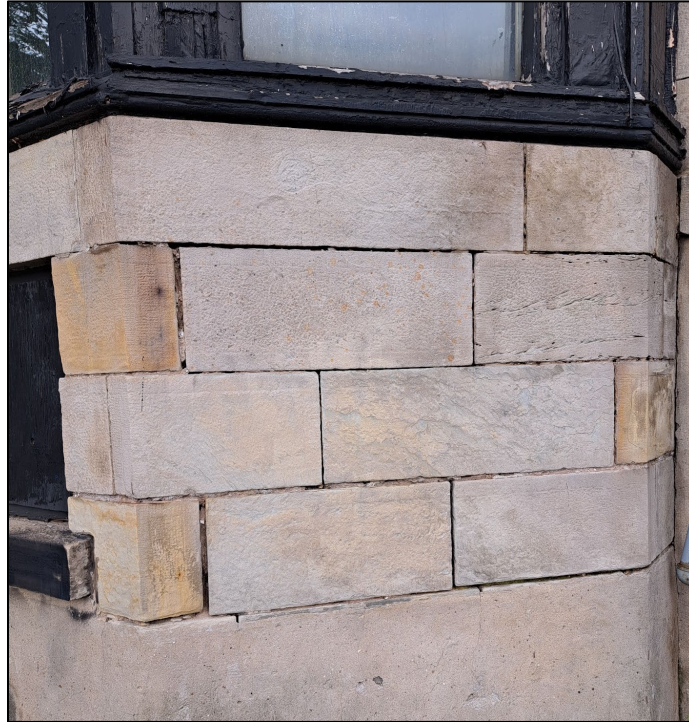
Closeup of cut-stone even course façade

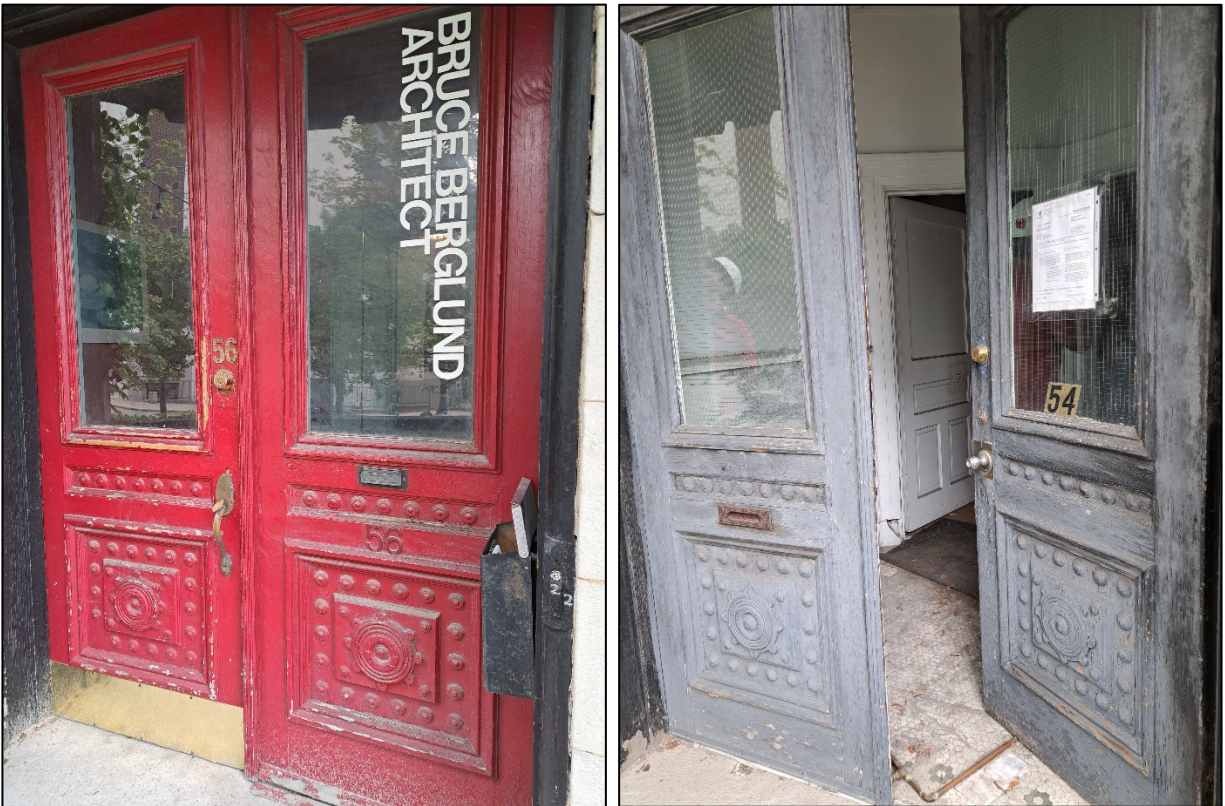
Closeups of decorative paired wooded doors, no. 54 (right) and no. 56 (left)
