TO:	Mayor and Members Board of Health
DATE:	September 15, 2023
SUBJECT:	Air Monitoring On-Site Assessment at Green for Life Stoney Creek Regional Facility (City Wide)
WARD(S) AFFECTED:	Ward 9
SUBMITTED BY:	Dr. Elizabeth Richardson, MD, MHSc, FRCPC Medical Officer of Health Public Health Services
SIGNATURE:

RE: **GFL Environmental August 2023 Air Monitoring On-Site
Assessment Survey, Stoney Creek, Ontario**

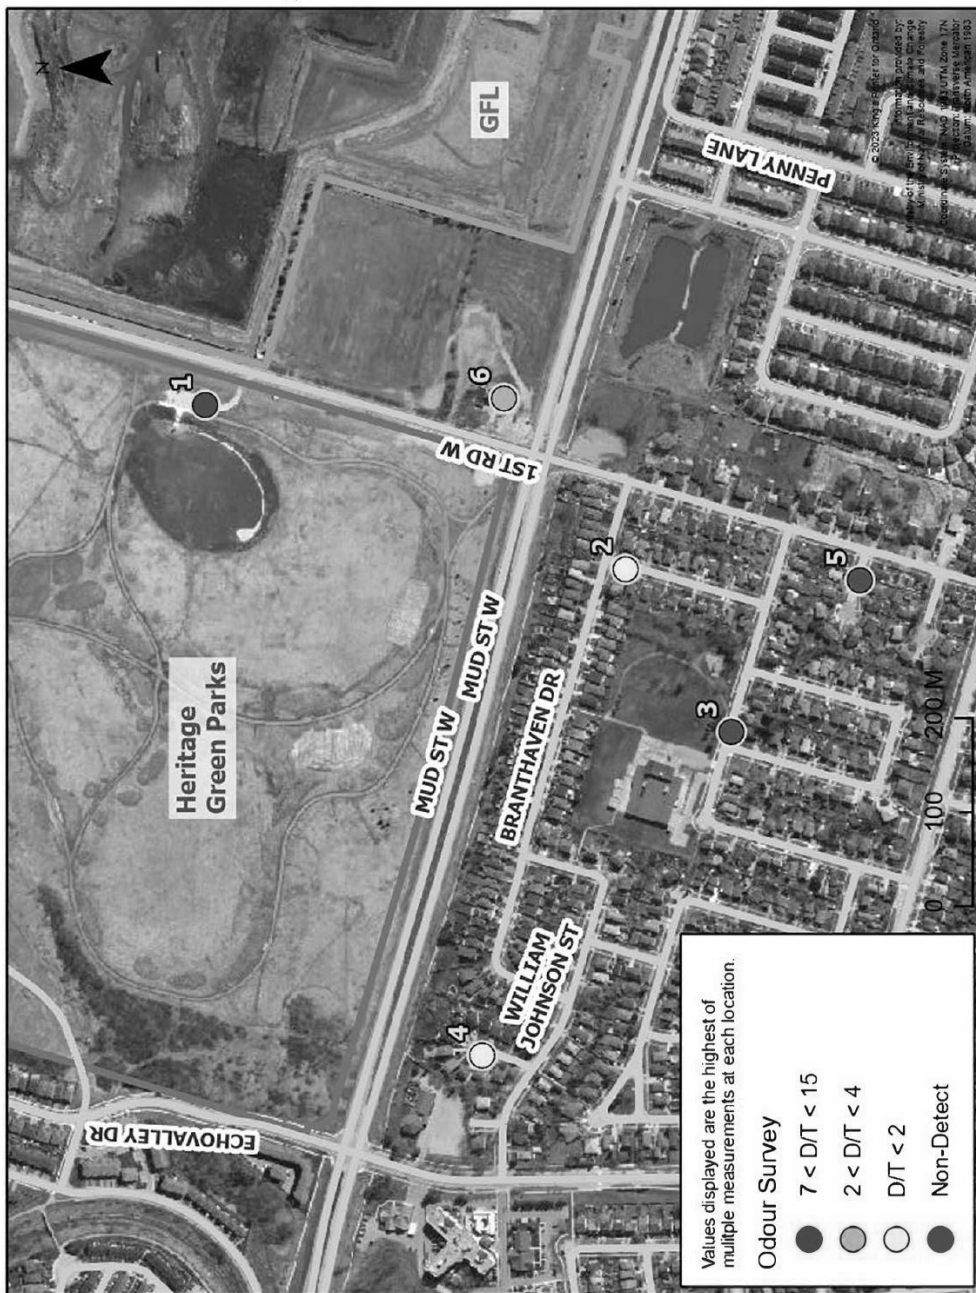
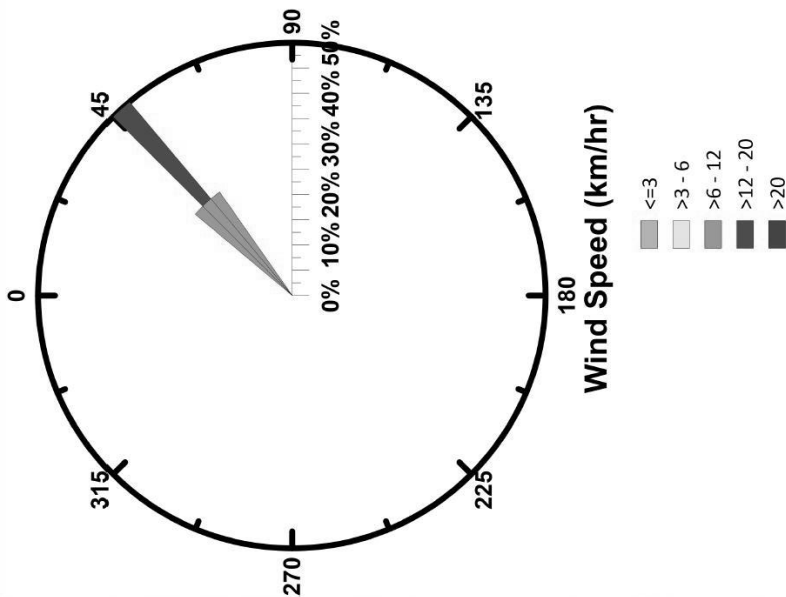
Figure 10 - GFL Environmental August 2023
Air Monitoring On-Site Assessment Survey - Aug 28, 2023

- Location 1 (dog park) - D/T ratios as high as $7 < D/T < 15$ were observed with odours that can be described as garbage, leachate, sweet, sour and sulphur smelling.
- Location 2 (Mellenby St.) – D/T ratios < 2 were observed with odours that can be described as garbage, leachate, sour and sulphur smelling
- Location 4 (Lemonyne Pl.) - D/T ratios < 2 were observed with odours that can be described as garbage and sour smelling
- Location 6 (Model Home Parking Lot) - D/T ratios up to $2 < D/T < 4$ were detected with odours that can be described as garbage, sour, leachate smelling.

Detectable concentrations of toluene, 1,3-dimethylbenzene and hydrogen sulphide were measured from approximately 12:30 to 13:15 at Location 1 (dog park). Table 2 below summarizes the measured concentrations and compares against Emergency Screening Values (ESV) used during emergency response, worker safety standards and Ontario Ambient Air Quality Criteria (AAQC). Measured concentrations of toluene and 1,3-dimethylbenzene were well below all the standards they were compared against.

A hydrogen sulphide (H_2S) concentration of 0.0084ppm or $11.61 \mu g/m^3$ was measured. This was well below the worker safety standards and was close to (but still below) the 10-min (odour-based) AAQC of $13 \mu g/m^3$. Total reduced sulphur (TRS) measured a maximum 10-min average of 5ppb, or $12 \mu g/m^3$ (assuming an equal mixture of the sulphur compounds listed under the AAQC) which was below the 10-min (odour-based) AAQC of $13 \mu g/m^3$. The concentrations of both hydrogen sulphide and TRS were below their respective odour-based AAQCs. Since they are measured continuously, both H_2S and TRS can be compared directly to the 10-min criteria.

Date	Time (Location)	Name	HAPSITE Comments:	Other compounds (PM, H ₂ S, Nox, CO or SO ₂)	Odours observations	General Comments
28-Aug-23	12:33	1	Toluene: 8.7 ug/m3 1-3-dimethylbenzene: 3.6 ug/m3	Slightly elevated H2S	Yes	Odour Survey Conducted. Odours detected
	12:55		No Compounds Detected	Measured H2S concentrations as high as 8.4 ppb	Yes	
	13:12		No Compounds Detected			
	13:28	2	No Compounds Detected		No	
	13:47	3	No Compounds Detected		Yes	
	14:05	4	No Compounds Detected		No	
14:22	5	No Compounds Detected		Yes		
14:47	6	No Compounds Detected		No		
15:03			No Compounds Detected		Yes

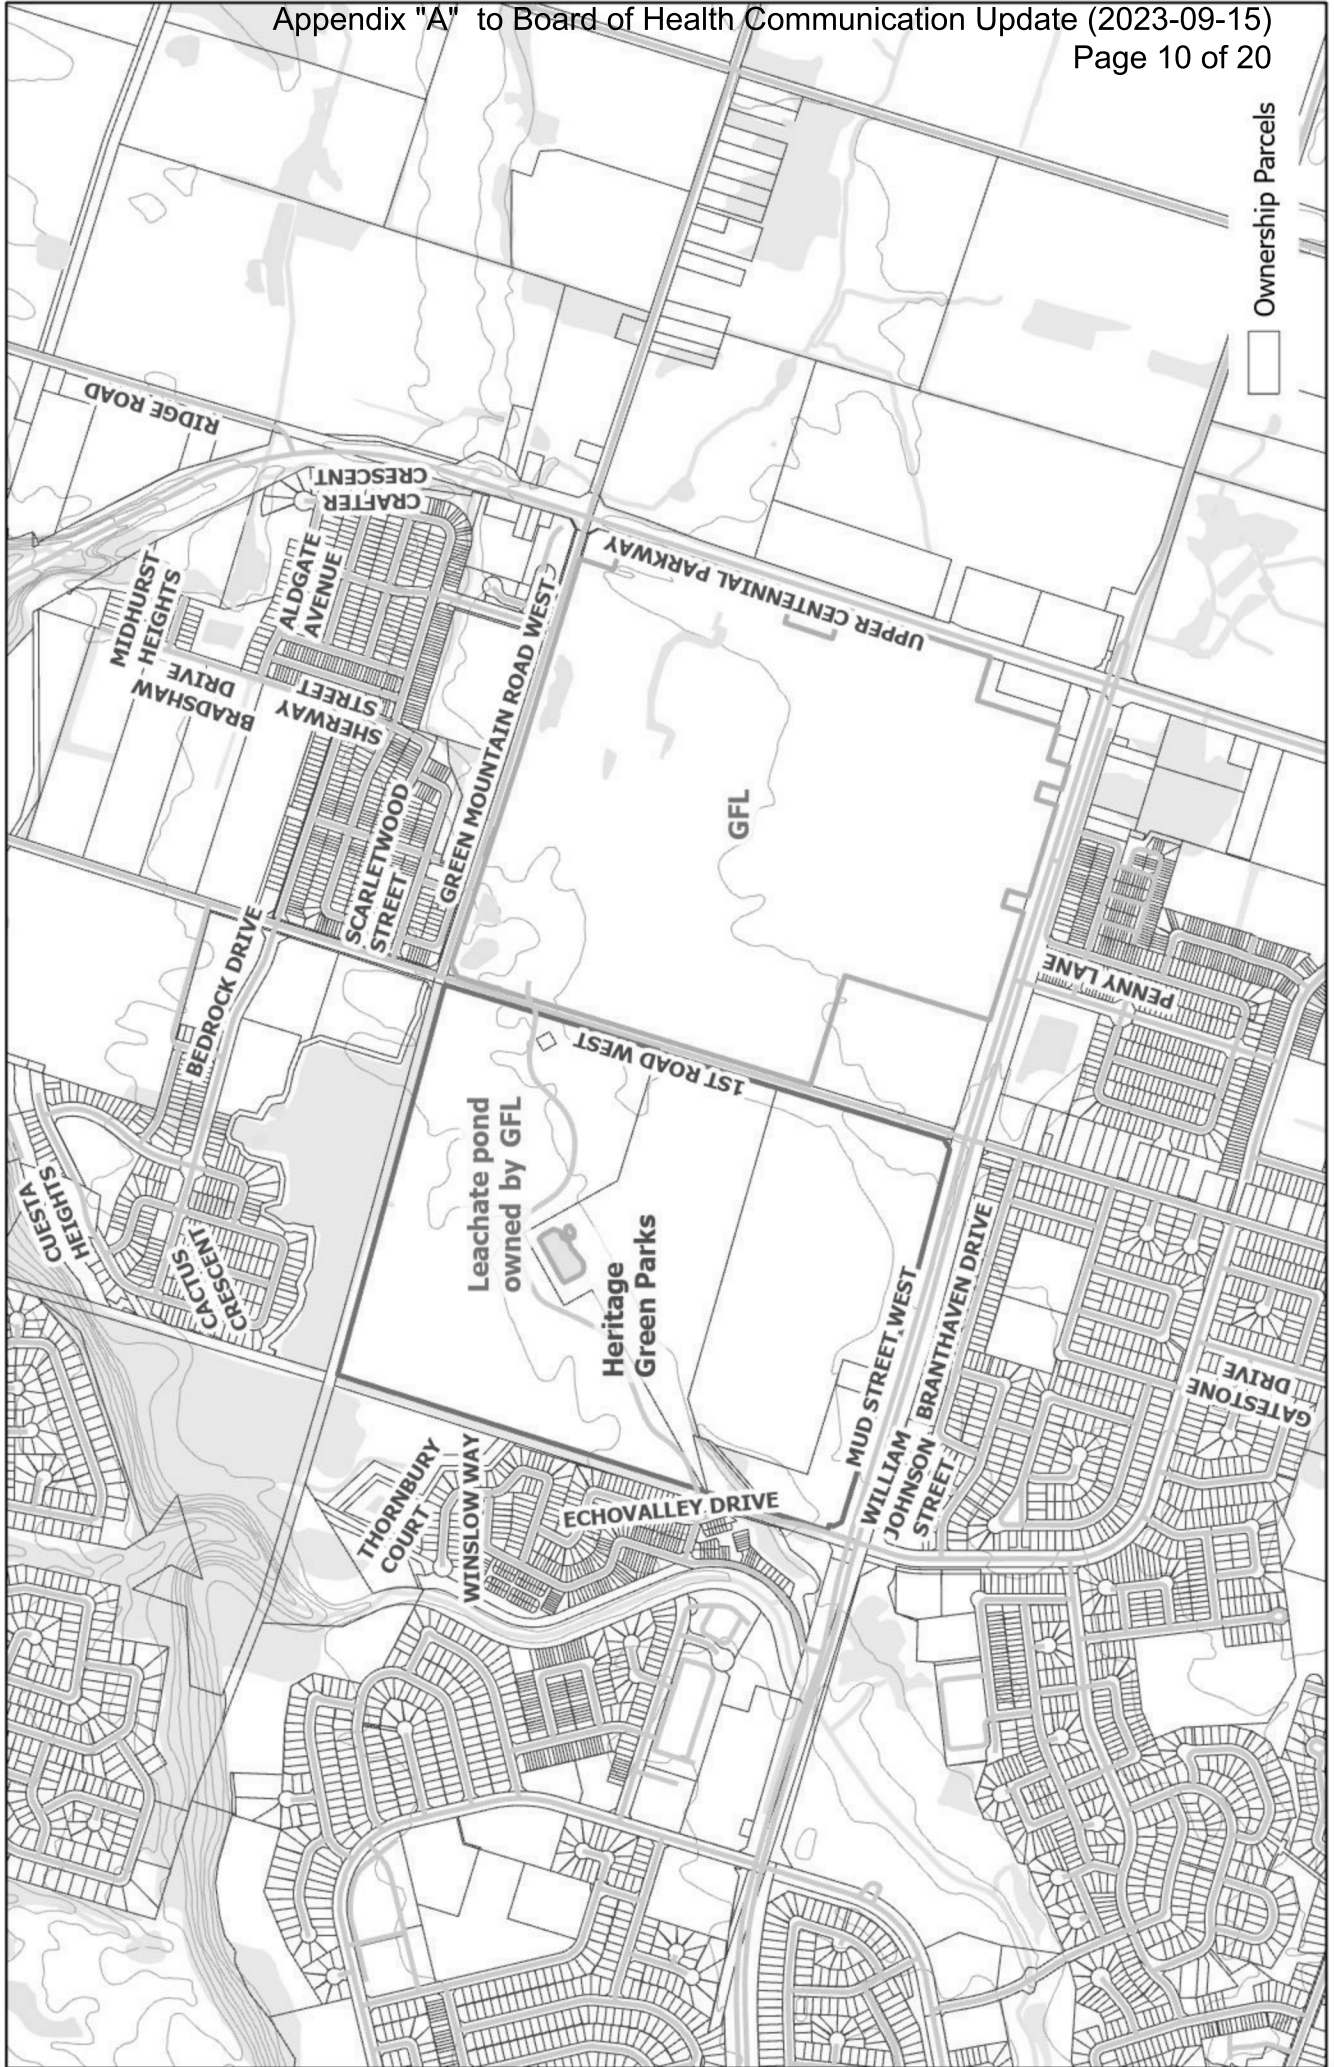
The GFL Facility and surrounding area are shown in Figure 1.

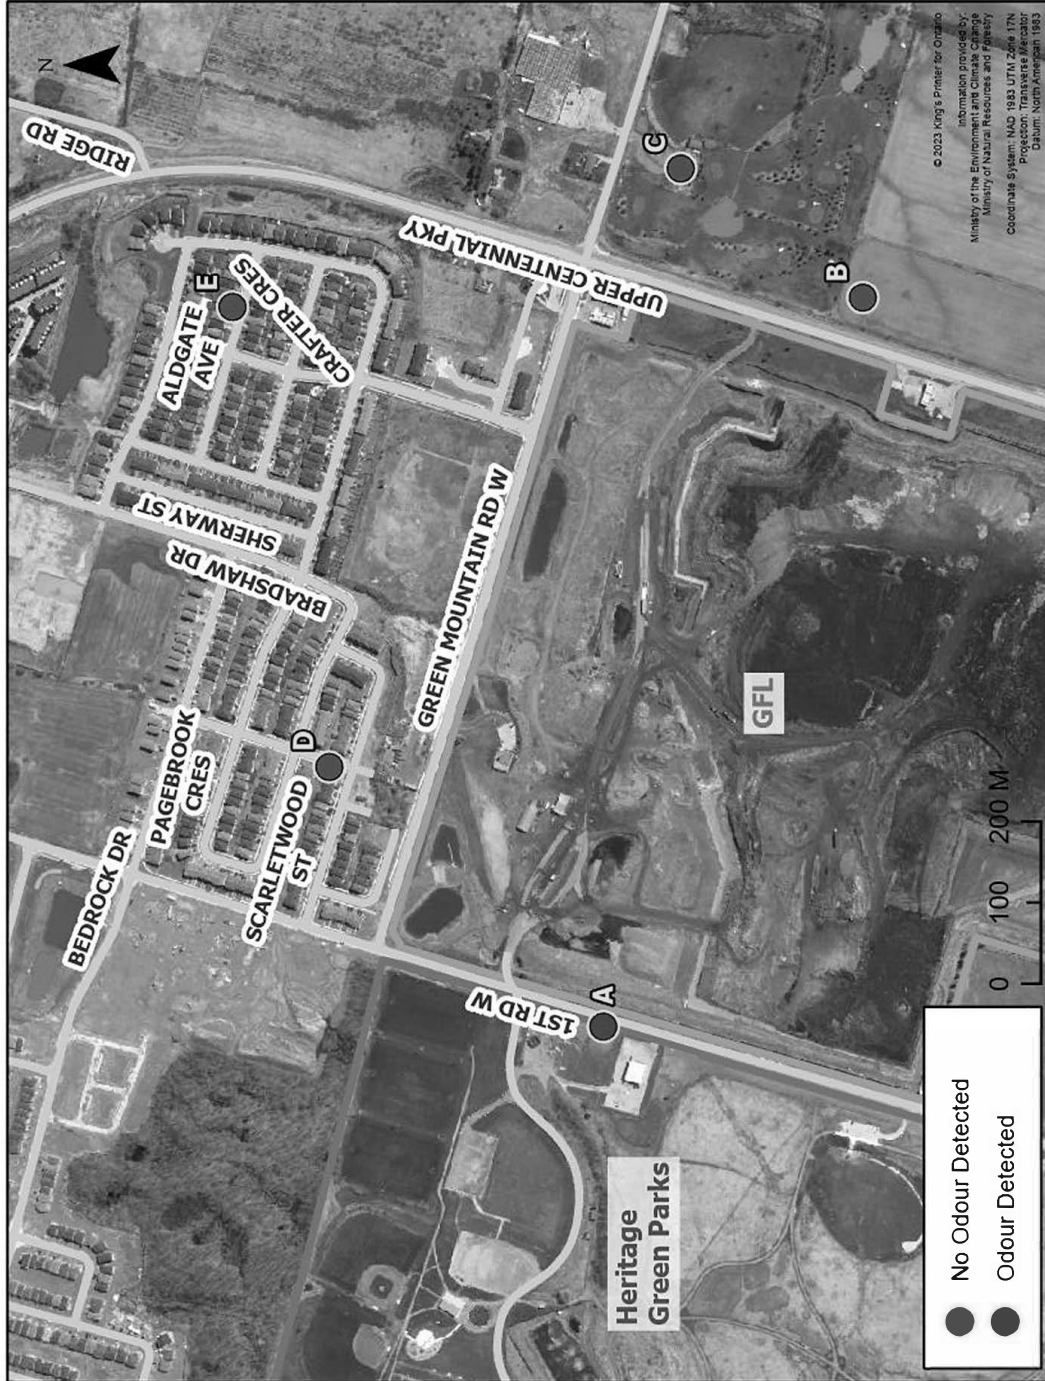
Figure 2 - GFL Environmental August 2023 Air Monitoring On-Site Assessment Survey - Aug 8, 2023

HAPSITE compounds and other compounds were not detected on this sampling day. The technician detected a slight odour at 15:30 but could not be quantified using the nasal ranger (D/T<2). Winds were also blowing from the west where the leachate pond was upwind and a probable source. The technician did not detect odours from other sampling locations including those downwind of the GFL Facility.

Date	Time (Location)	Name	HAPSITE Comments:	Other compounds (PM, H ₂ S, Nox, CO or SO ₂)	Odours observations	General Comments
08-Aug-23	15:15	A	No Compounds Detected		There was a slight odour coming from the leachate ponds at 15:30	
	15:30					
	15:48					
	16:05	B				
	16:21					
	16:38	C				
	16:54					
	17:15					
	17:30	D				
	17:30	E

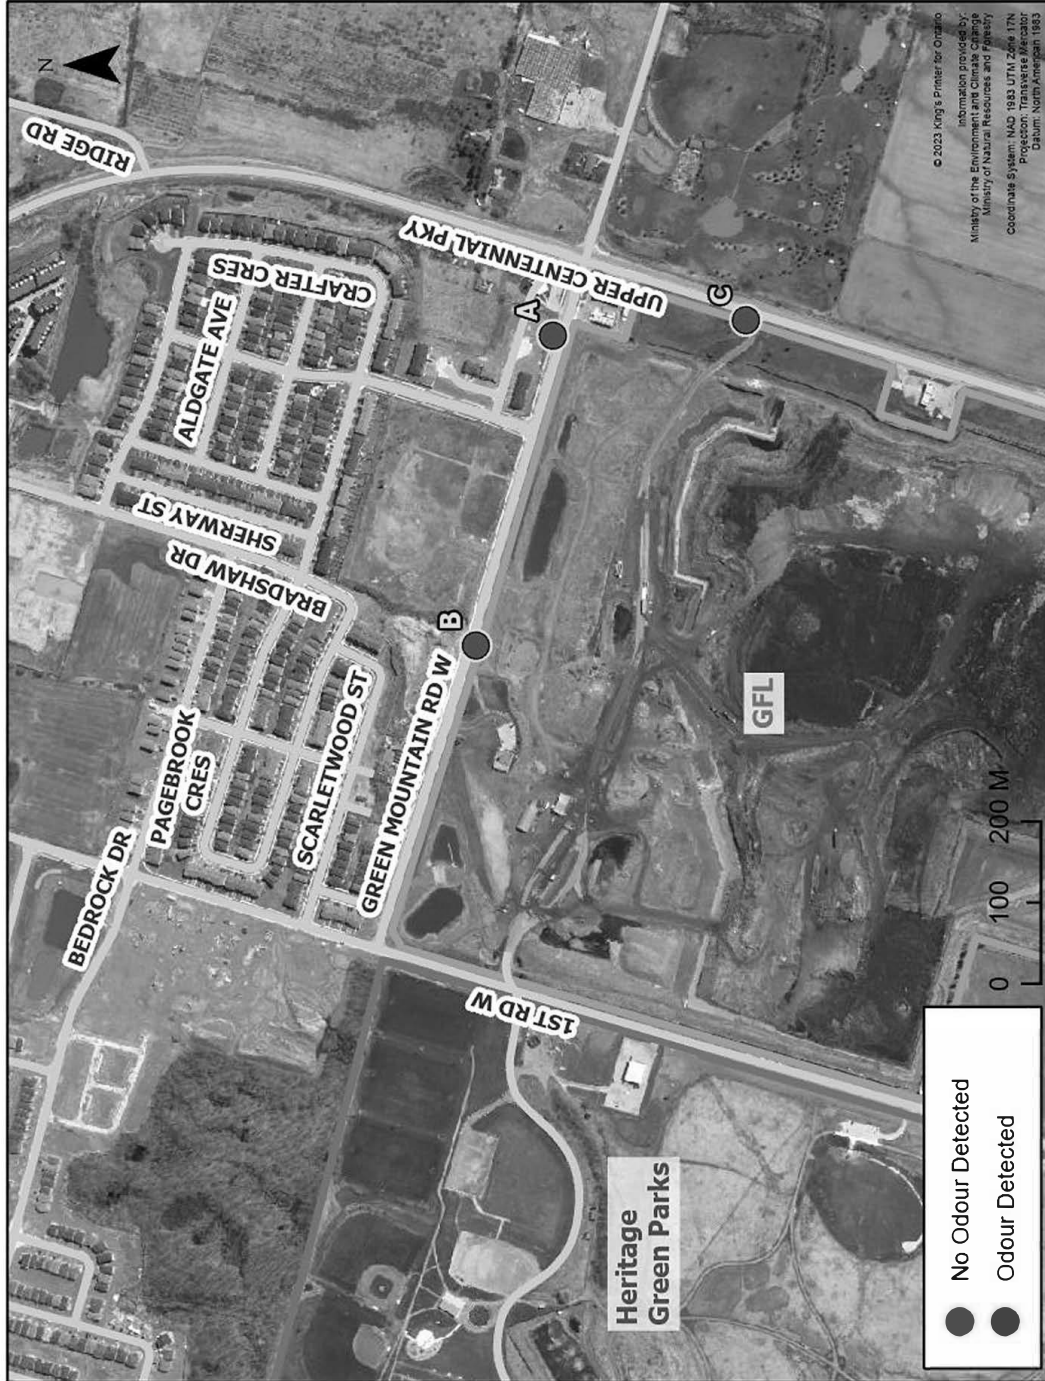
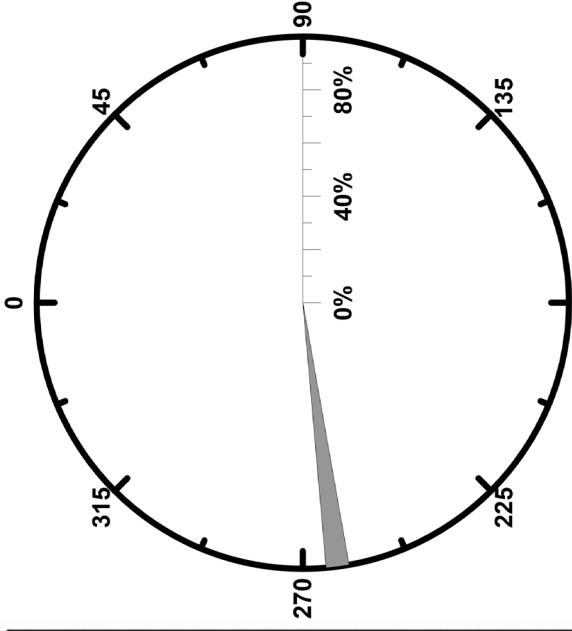
Figure 3 - GFL Environmental August 2023 Air Monitoring On-Site Assessment Survey - Aug 9, 2023

HAPSITE compounds and other compounds were not detected on this sampling day. No odours were detected by the technician. Winds were blowing from the west where the GFL Facility was upwind of one sampling location.

Date	Time (Location)	Name	HAPSITE Comments:	Other compounds (PM, H ₂ S, Nox, CO or SO ₂)	Odours observations	General Comments
09-Aug-23	9:00	A	No compounds detected	-	No offensive odours	-
	9:20					
	9:30	B				
	9:45					
	10:00	C

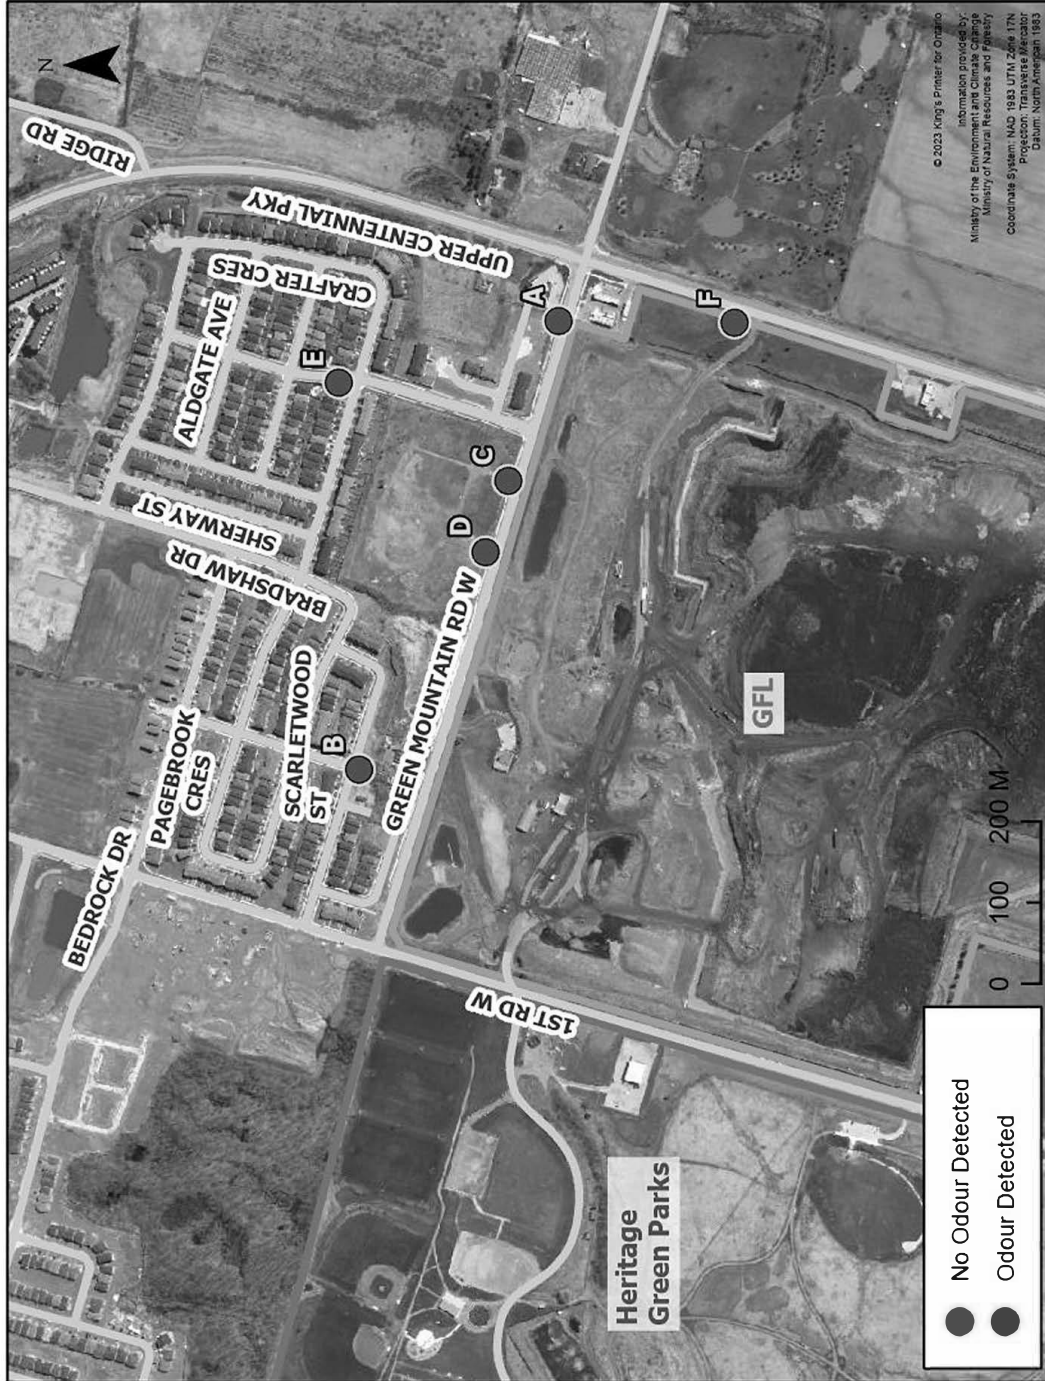
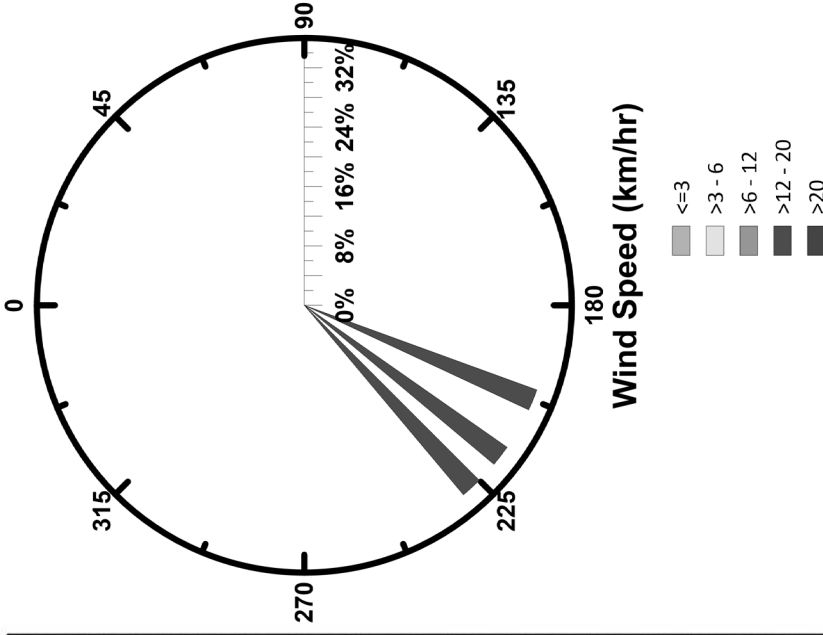
Figure 4 - GFL Environmental August 2023 Air Monitoring On-Site Assessment Survey - Aug 10, 2023

HAPSITE compounds and other compounds were not detected on this sampling day. No odours were detected by the technician. Winds were blowing from the south to southwest where the Facility was upwind of most sampling locations.

Date	Time (Location)	Name	HAPSITE Comments:	Other compounds (PM, H ₂ S, Nox, CO or SO ₂)	Odours observations	General Comments
10-Aug-23	8:45	A	No compounds detected	-	No offensive odours	-
	9:00	B				
	9:20	C				
	9:40	D				
	10:00	E				
	10:15	F

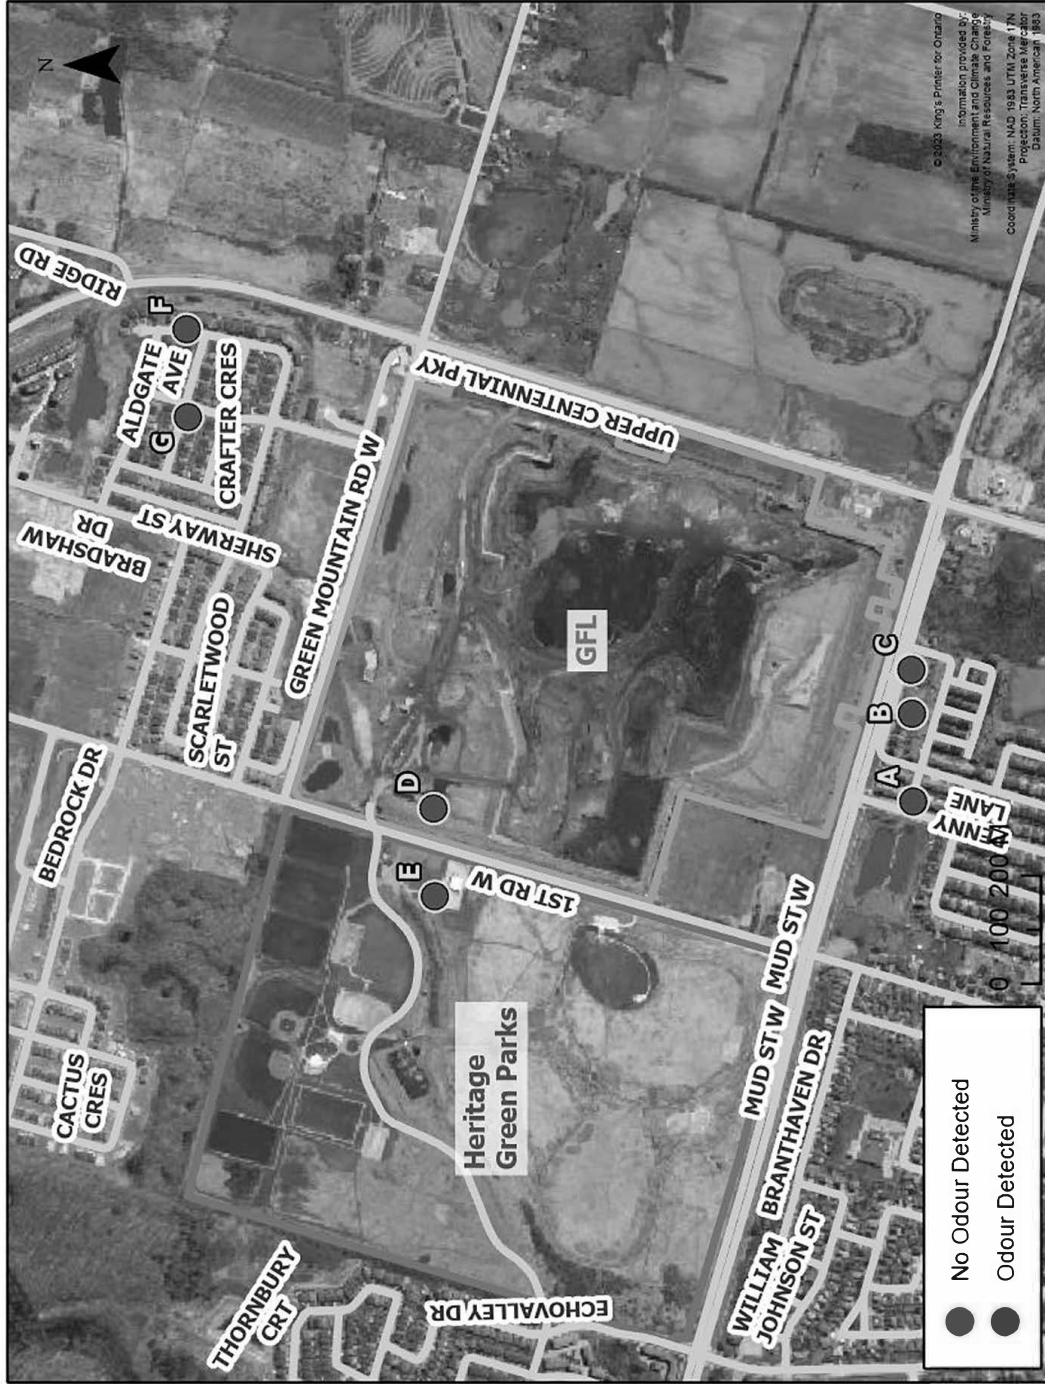
HAPSITE compounds and other compounds were not detected on this sampling day. No odours were detected by the technician. Winds were generally blowing from the southwest where the Facility was upwind of a few sampling locations.

Date	Time (Location)	Name	HAPSITE Comments:	Other compounds (PM, H ₂ S, Nox, CO or SO ₂)	Odours observations	General Comments
16-Aug-23	13:42	A	No compounds detected			
	13:58	B				
	14:21	C				
	14:38	D				
	14:54	E				
	15:12	F				
	15:30	G				
16:02						
16:49

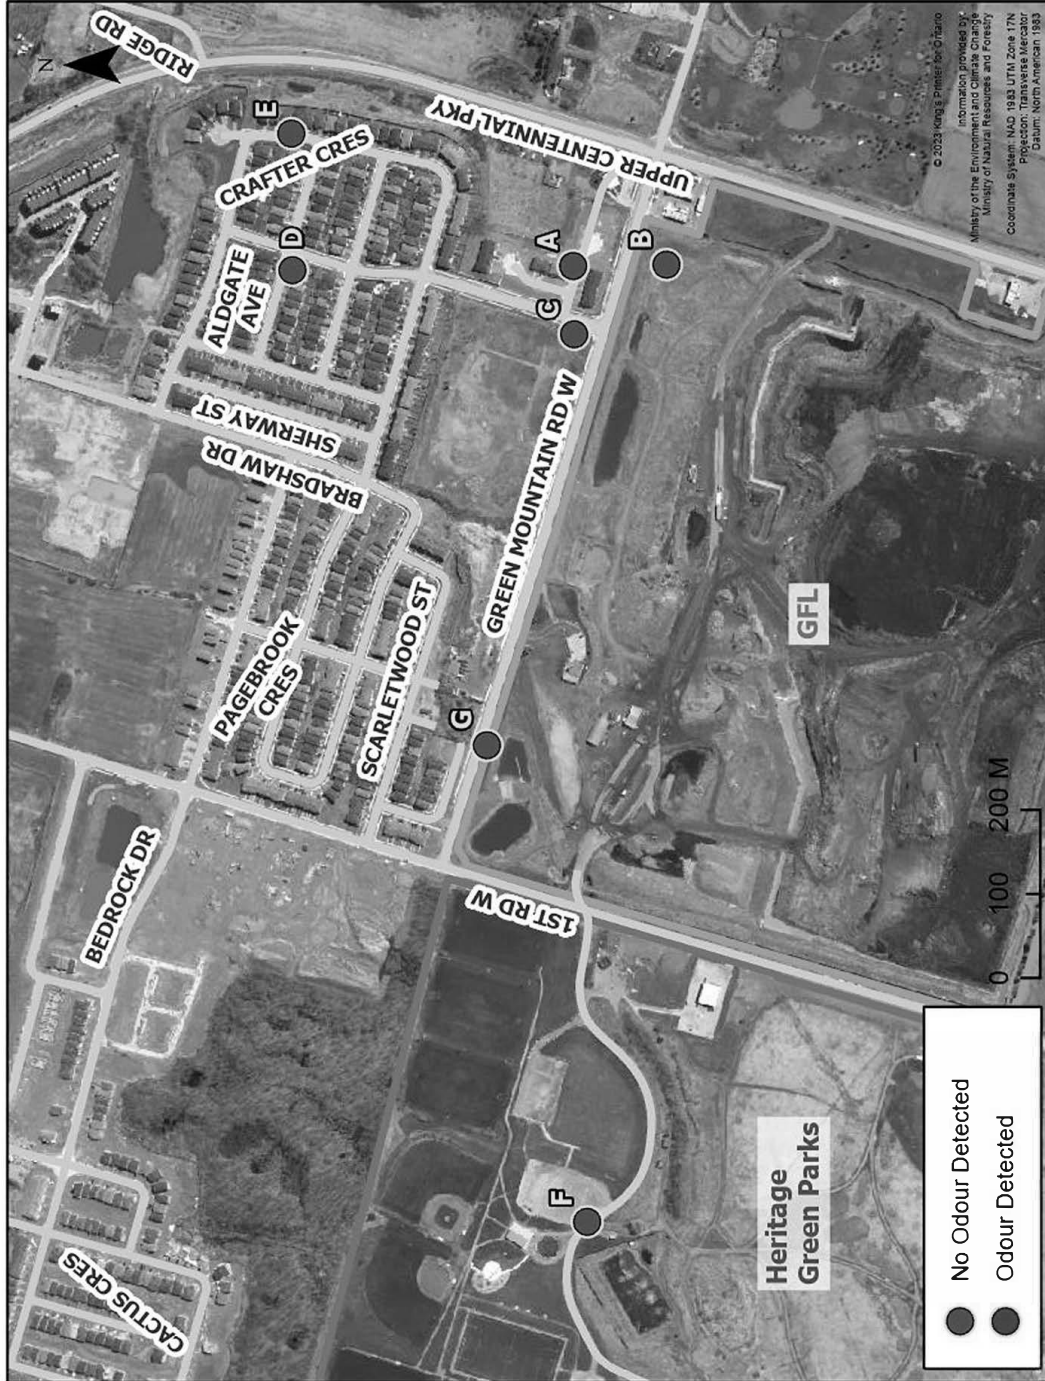
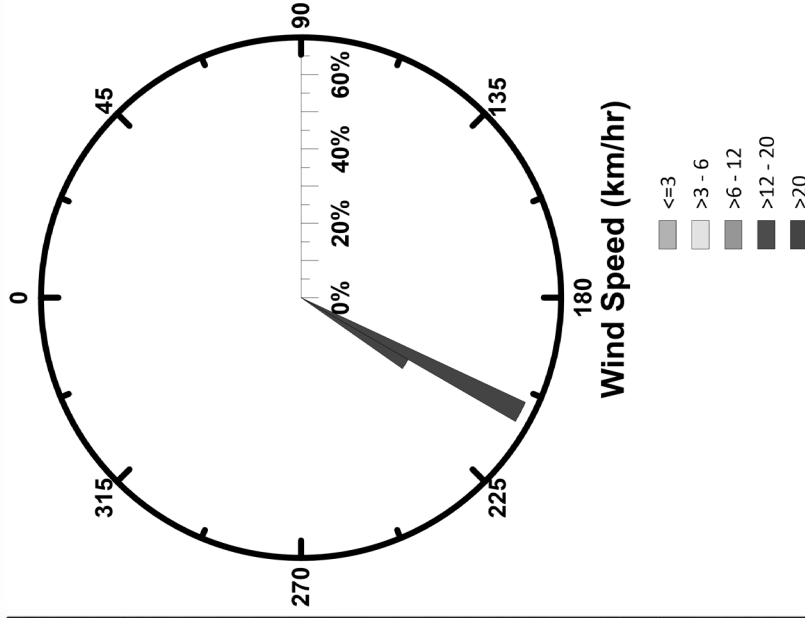
Figure 6 - GFL Environmental August 2023 Air Monitoring On-Site Assessment Survey - Aug 17, 2023

HAPSITE compounds and other compounds were not detected on this sampling day. No odours were detected by the technician. Winds were generally blowing from the south-southwest where the Facility and leachate pond was upwind of most sampling locations.

Date	Time (Location)	Name	HAPSITE Comments:	Other compounds (PM, H ₂ S, Nox, CO or SO ₂)	Odours observations	General Comments
17-Aug-23	14:00	A	No compounds detected	-	-	-
	14:20	B				
	14:40	C				
	14:58	D				
	15:15	E				
	15:30	F				
	15:48	F				
16:05	G					
16:21	G

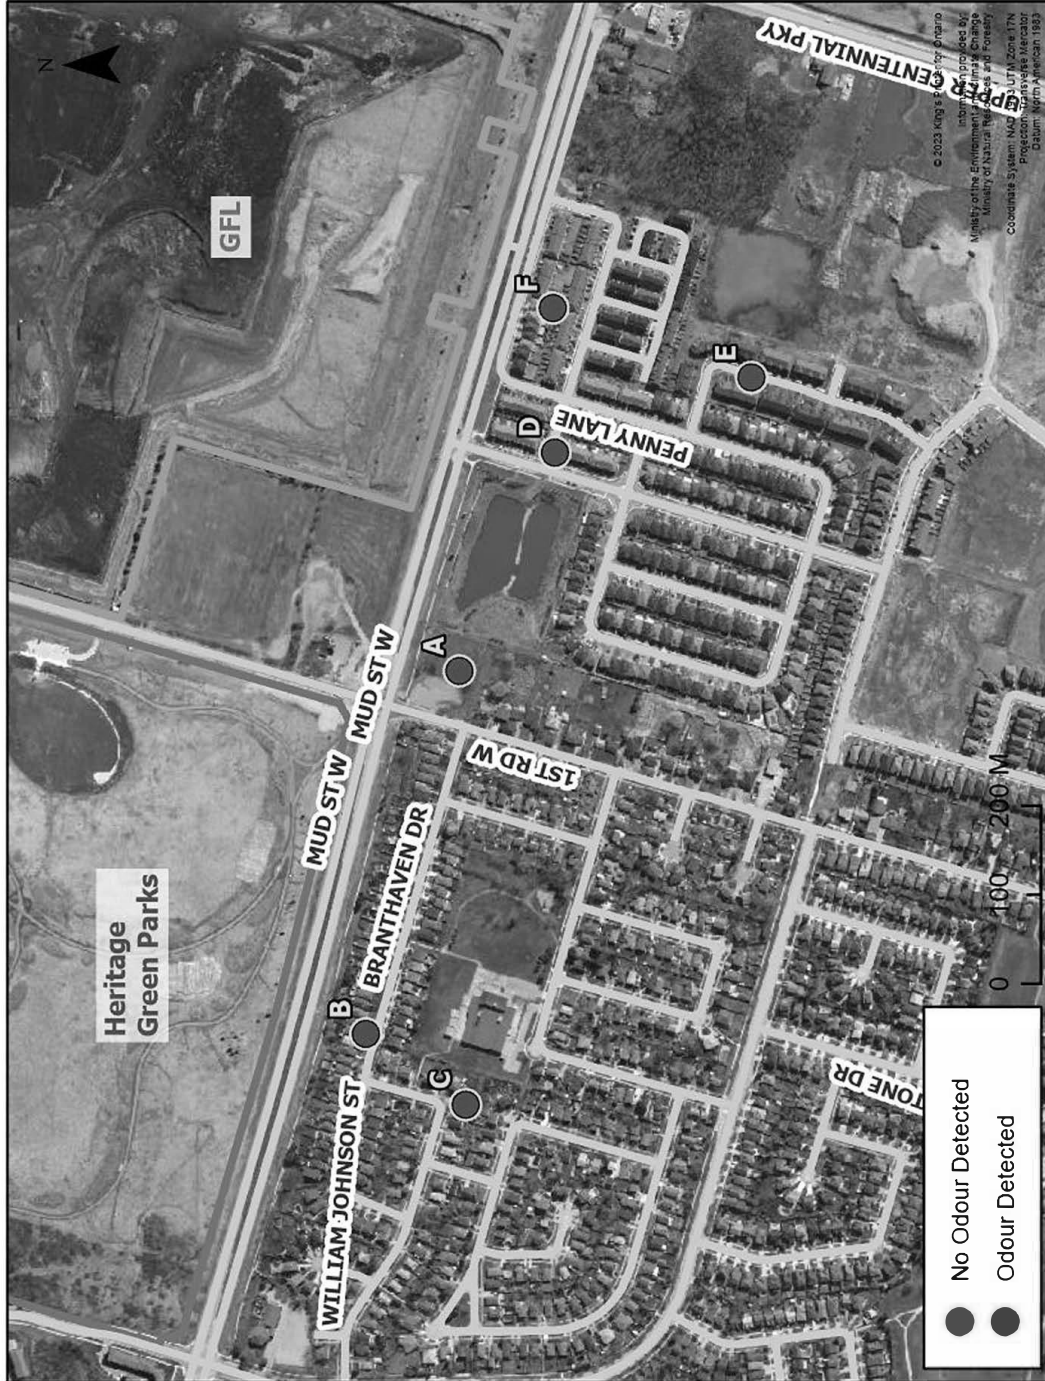
Figure 7 - GFL Environmental August 2023 Air Monitoring On-Site Assessment Survey - Aug 21, 2023

HAPSITE compounds and other compounds were not detected on this sampling day. No odours were detected by the technician. Winds were generally blowing from the northeast where the Facility was upwind.

Date	Time (Location)	Name	HAPSITE Comments:	Other compounds (PM, H ₂ S, Nox, CO or SO ₂)	Odours observations	General Comments	
21-Aug-23	12:30	A	No compounds detected	-	-	-	
	12:50						
	13:08						
	13:24	B					
	13:45						C
	14:00						
14:18	D						
14:35		E					
14:55	F

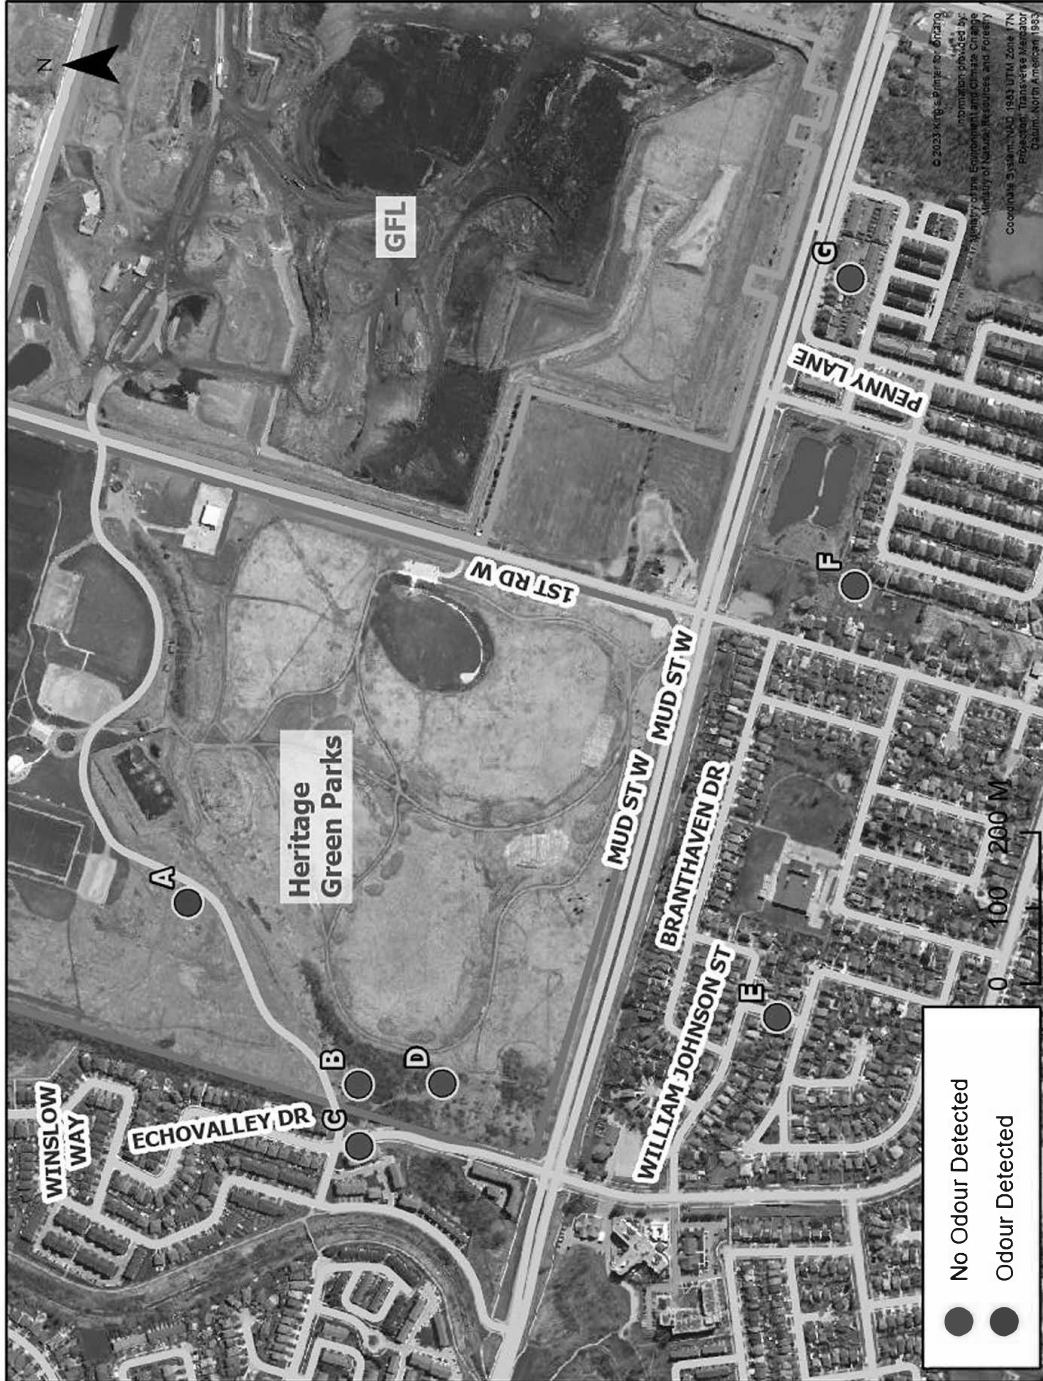
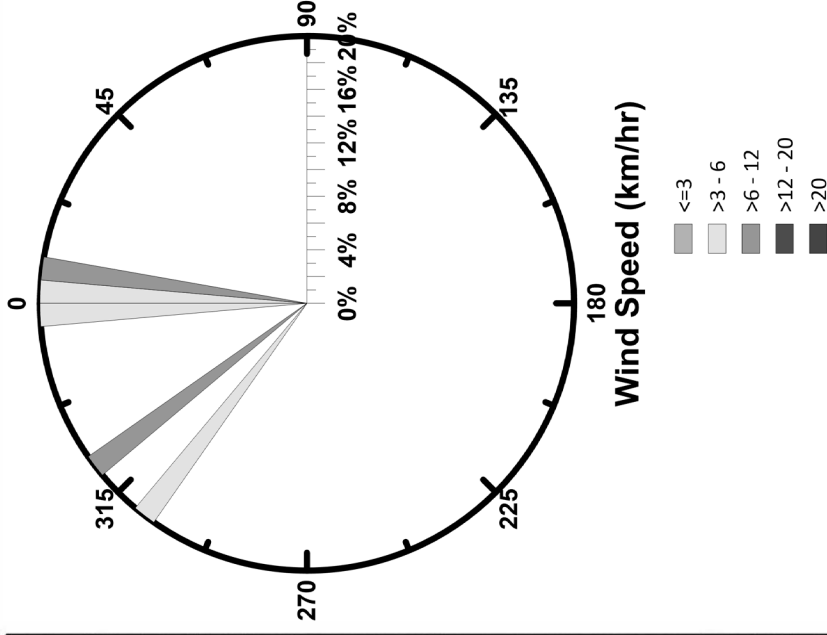
Figure 8 - GFL Environmental August 2023 Air Monitoring On-Site Assessment Survey - Aug 24, 2023

HAPSITE compounds and other compounds were not detected on this sampling day. The technician detected a wet diaper/ urine/ portable toilet odour at a sampling location somewhat downwind of the leachate pond which may have been an odour source. The odour could not be quantified using the nasal ranger (D/T<2). Winds were generally blowing from the northwest to north where the sampling points were downwind of residential, the leachate pond and the GFL Facility.

Date	Time (Location)	Name	HAPSITE Comments:	Other compounds (PM, H ₂ S, NOx, CO or SO ₂)	Odours observations	General Comments
24-Aug-23	11:30	A	No Compounds Detected	-	Yes	Wet diaper, urine/ porta potty odour
	11:45	A				
	12:05	A				
	12:18	A	No Compounds Detected	-	No	-
	12:35	B				
	12:53	B	No Compounds Detected	-	No	-
	13:10	C				
	13:28	C	No Compounds Detected	-	Yes	Wet diaper, urine/ porta potty odour
	13:45	D				
	14:04	E				
	14:20	F	No Compounds Detected	-	Yes	Wet diaper, urine/ porta potty odour
	14:40	G				
	15:00	A	No Compounds Detected	-	Yes	Wet diaper, urine/ porta potty odour
	15:18	A

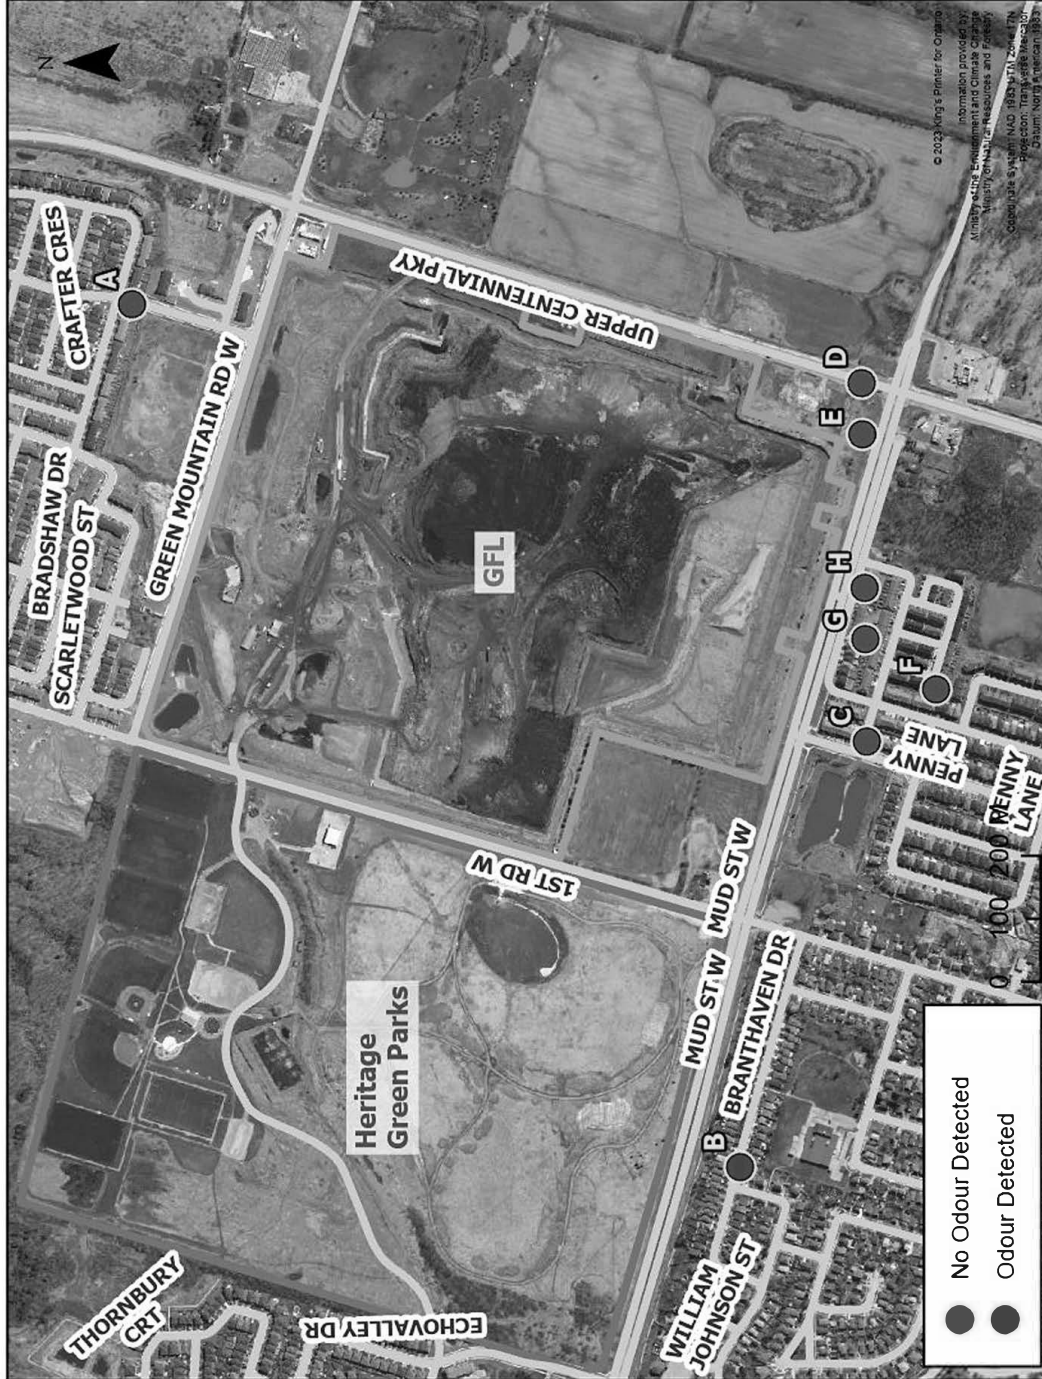
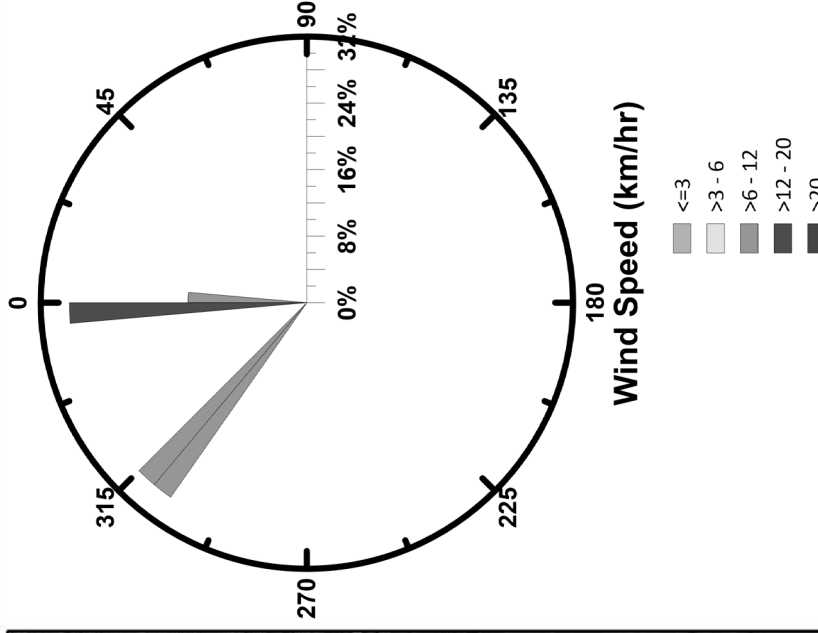
HAPSITE compounds and other compounds were not detected on this sampling day. Garbage, leachate, musty and natural gas odours were detected by the technician at a single location south where the leachate pond was upwind and a probable source. The odour could not be quantified using the nasal ranger ($D/T < 2$). Odours were not detected at other samples south of the GFL Facility. Winds were generally blowing from the north and northwest where the Facility was upwind.

Date	Time (Location)	Name	HAPSITE Comments:	Other compounds (PM, H ₂ S, Nox, CO or SO ₂)	Odours observations	General Comments
	10:38	A	No Compounds Detected	-	No	-
	10:50	A	No Compounds Detected	-	Yes	Garbage, Leachate, Musty, Natural Gas Odour. Overcast / muggy conditions with moderate wind speeds. 24C
25-Aug-23	11:13	B	No Compounds Detected	-	No	-
	11:26	B	No Compounds Detected	-	No	-
	14:26	C	No Compounds Detected	-	No	-
	14:42	D	No Compounds Detected	-	No	-
	14:59	E	No Compounds Detected	-	No	-
	15:16	F	No Compounds Detected	-	No	-
	15:43	G	No Compounds Detected	-	No	-
	15:49	H	No Compounds Detected	-	No	-

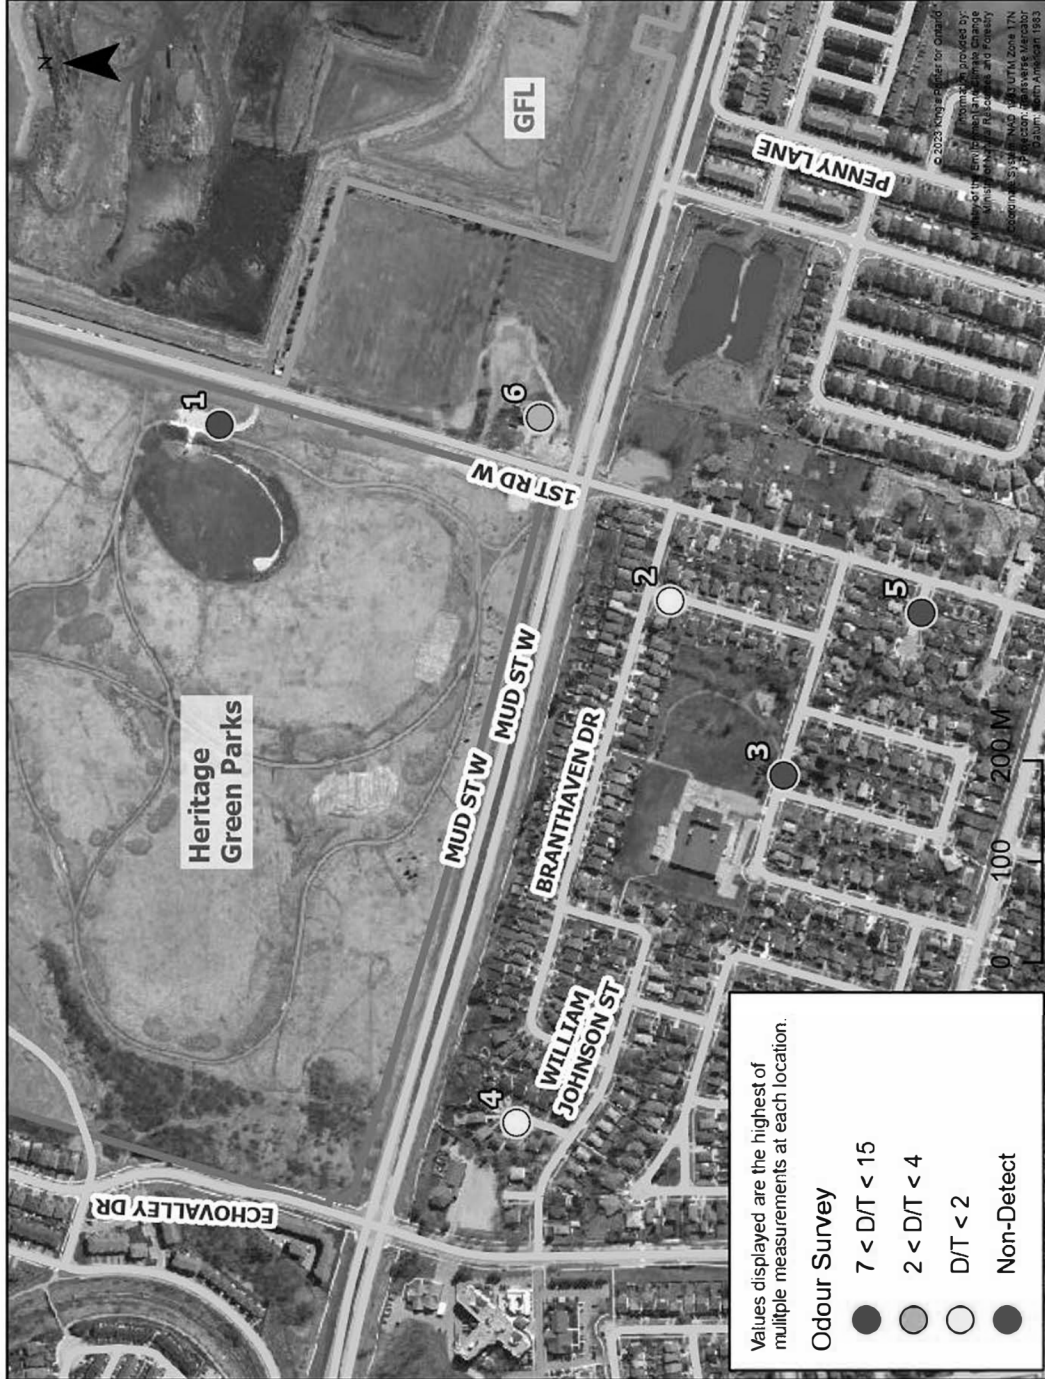
Figure 10 - GFL Environmental August 2023 Air Monitoring On-Site Assessment Survey - Aug 28, 2023

Date	Time (Location)	Name	HAPSITE Comments:	Other compounds (PM, H ₂ S, Nox, CO or SO ₂)	Odours observations	General Comments
28-Aug-23	12:33	1	Toluene: 8.7 ug/m3	Slightly elevated H2S	Yes	Odour Survey Conducted. Odours detected
	12:55		1-3-dimethylbenzene: 3.6 ug/m3		Yes	
	13:12		No Compounds Detected		Yes	
	13:28	2	No Compounds Detected	-	No	
	13:47		No Compounds Detected	-	Yes	
	14:05		No Compounds Detected	-	No	
14:22	3	No Compounds Detected	-	No		
14:47		No Compounds Detected	-	No		
15:03		No Compounds Detected	-	Yes
