TO:	Mayor and Members Board of Health
DATE:	September 15, 2023
SUBJECT:	Air Monitoring On-Site Assessment at Green for Life Stoney Creek Regional Facility (City Wide)
WARD(S) AFFECTED:	Ward 9
SUBMITTED BY:	Dr. Elizabeth Richardson, MD, MHSc, FRCPC Medical Officer of Health Public Health Services
SIGNATURE:

RE: **GFL Environmental August 2023 Air Monitoring On-Site
Assessment Survey, Stoney Creek, Ontario**

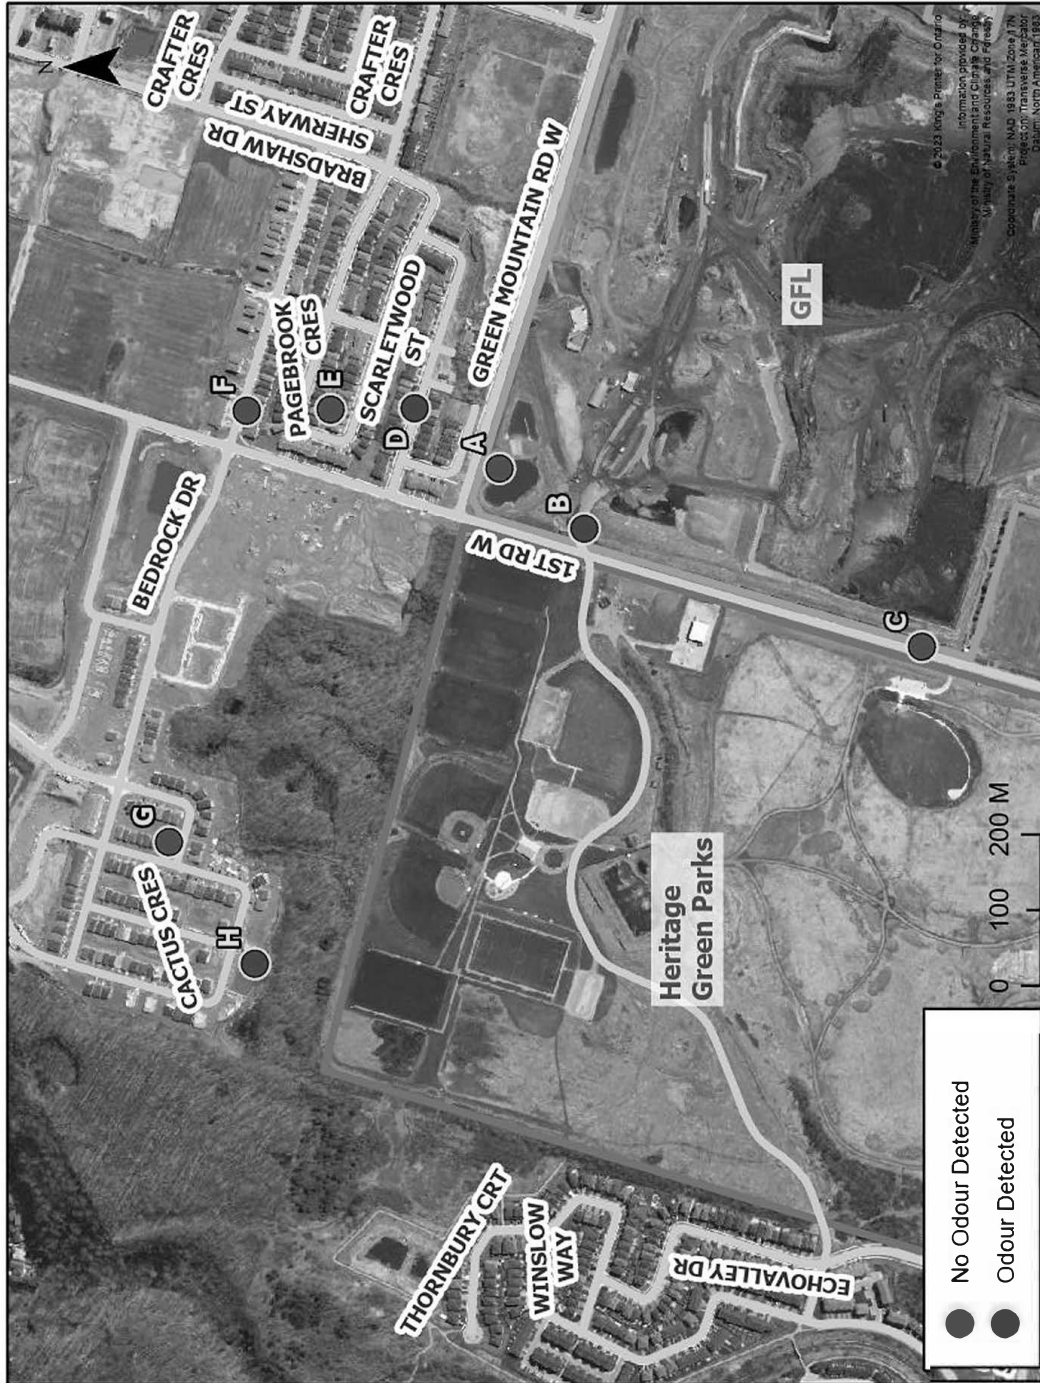
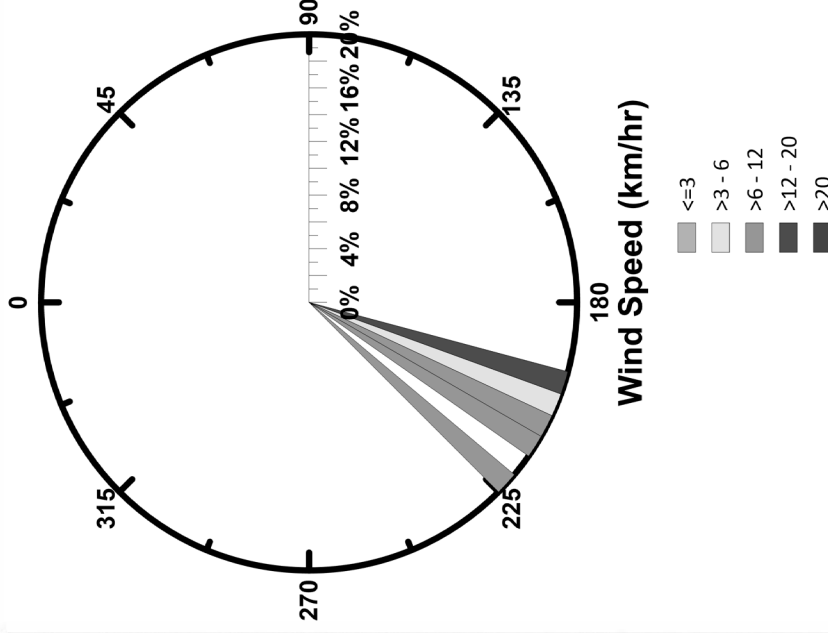
Figure 11 - GFL Environmental August 2023 Air Monitoring On-Site Assessment Survey - Aug 29, 2023

HAPSITE compounds and other compounds were not detected on this sampling day. Sweet, sour and garbage odours were detected by the technician while onsite from various locations. The odours could not be quantified using the nasal ranger ($D/T < 2$). Winds were generally blowing from the southwest where the leachate pond was somewhat upwind and a potential odour source.

Date	Time (Location)	Name	HAPSITE Comments:	Other compounds (PM, H ₂ S, Nox, CO or SO ₂)	Odours observations	General Comments
29-Aug-23	11:40	A	No Compounds Detected	-	No	-
	12:00	B	No Compounds Detected	-	Yes	Sweet & Sour
	12:15	C	No Compounds Detected	-	No	-
	12:30	D	No Compounds Detected	-	Yes	Sweet & Sour
	12:50	E	No Compounds Detected	-	No	-
	13:15	F	No Compounds Detected	-	No	-
	13:40	G	No Compounds Detected	-	No	-
	13:57	H	No Compounds Detected	-	Yes	Garbage
	14:13					
	14:30
