**98 Sydenham Street, Dundas**  
Constructed circa 1904

**Preliminary Evaluation of Cultural Heritage Value or Interest:**

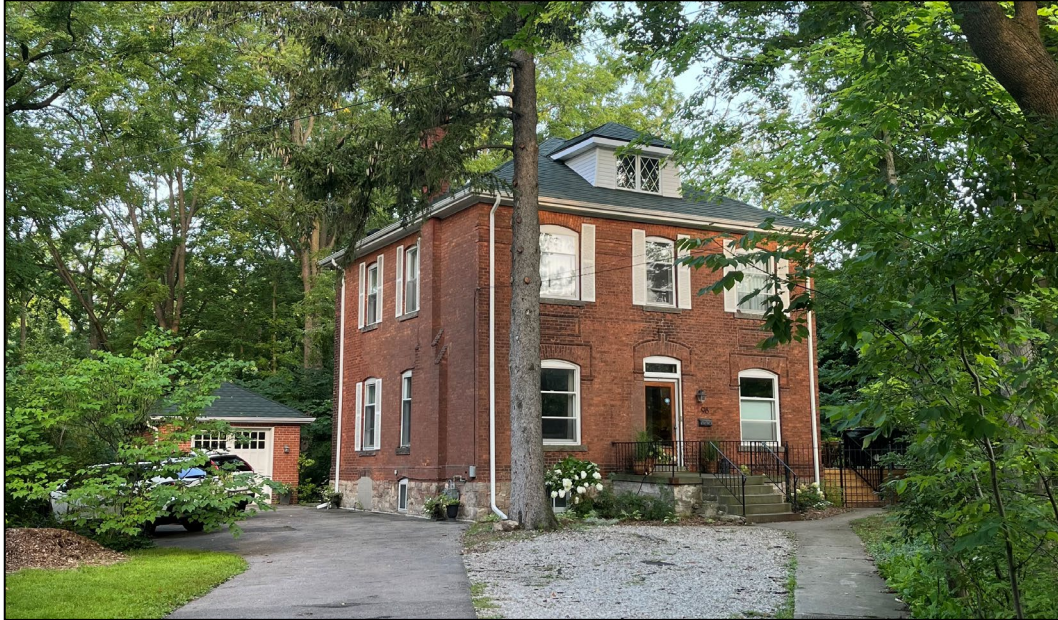
1. The property is representative of an early-twentieth century vernacular two-storey brick dwelling. Notable features of the building include its: symmetrical three-bay front façade with central ground-floor entrance; , hip roof with flanking chimneys; segmentally-arched window openings with decorative brick voussoirs with raised trim and stone lug sills, and decorative brick paneling between the storeys.
2. The property does not appear to demonstrate a high degree of craftsmanship.
3. The property does not appear to demonstrate a high degree of technical or scientific achievement.
