CULTURAL HERITAGE IMPACT ASSESSMENT

309 JAMES STREET NORTH, CITY OF HAMILTON

AUGUST 31, 2023 FINAL REPORT

PROJECT NO.: CA0006154.3202

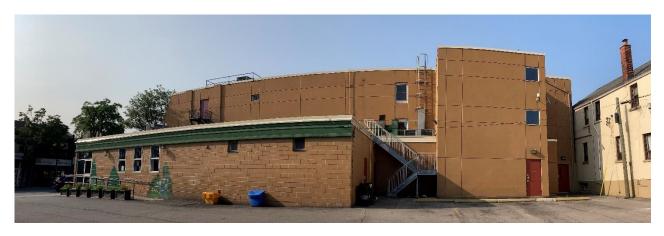
Image 23: North elevation of subject property

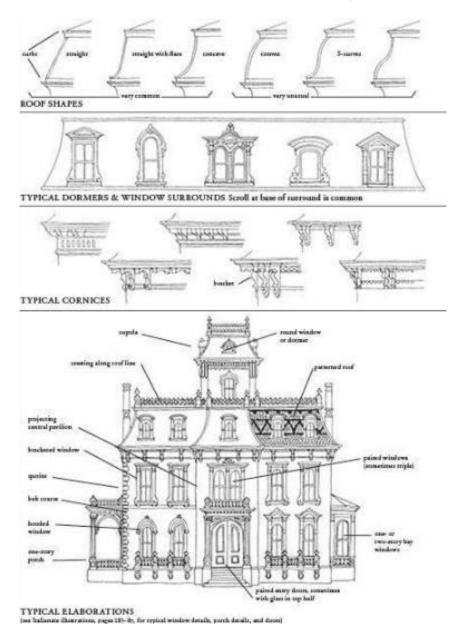
Plate 6: Line drawing of typical Second Empire architectural features (Knopf n.d.)

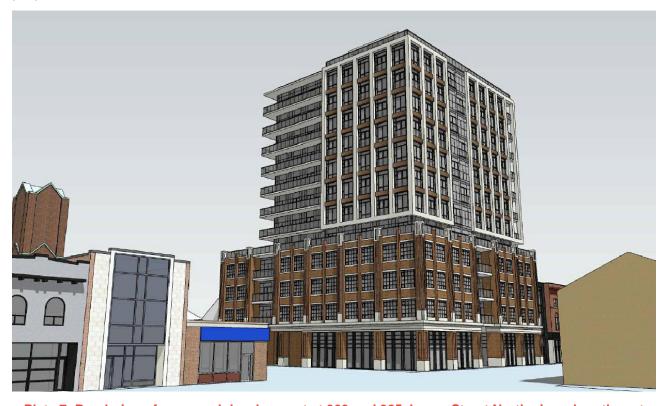
Plate 7: Rendering of proposed development at 309 and 325 James Street North viewed northwest from James Street North (Lintack Architects 2023)

The Client has worked with the City of Hamilton to revise the concept plans to propose a new structure that is sympathetic to and distinguishable from the surrounding built heritage resources. The ground floor of the development is designed for commercial use with a combined area of 2,838 sq. ft., while the remaining floors will consist of 129 residential units. In keeping with the surrounding streetscape, the building footprint has been maximized on the site and is positioned close to the front lot line in-keeping with the existing James Street North and Barton Street West building set-backs. The eight-storey podium transition has a setback on the west side from the front and a cantilevered design to minimize shadows and respect the adjacent properties to the west. The step-back above the podium has also been refined to break up the vertical massing of the tower.

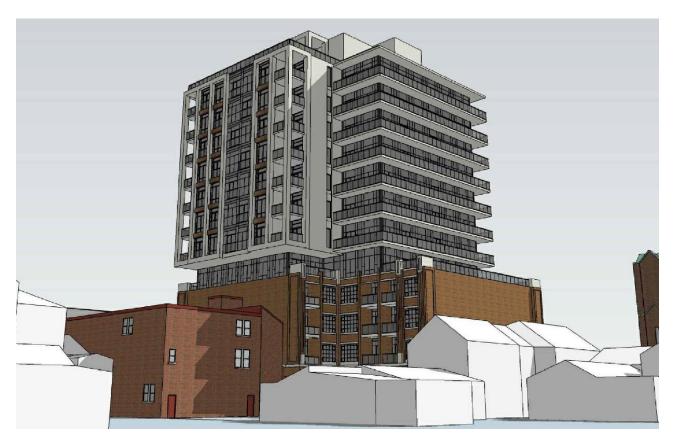
Plate 8: Rendering of proposed development looking southeast (Lintack Architects 2023)

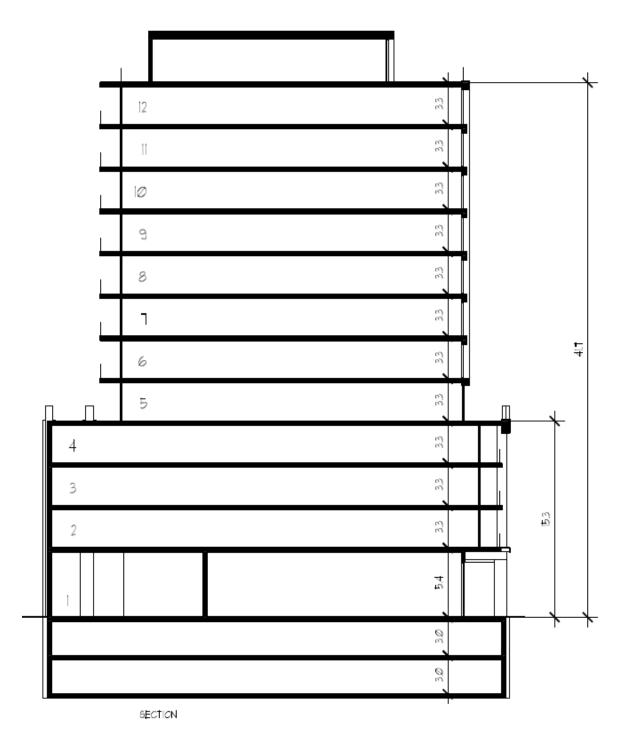
Plate 9: Building section of proposed development (Lintack Architects 2023)

The podium will be composed of a traditional brick facade with corbeled columns for texture, and sash windows, vertically book-ended with stone accents. The upper eight-storey volume is stepped and setback from the podium to minimize the impact at neighbourhood level and will be clad with glazing, mullions, horizontal and vertical concrete bands, and balconies all tied together with a continuous glass curtain wall and materials that connect both volumes in the same design language.

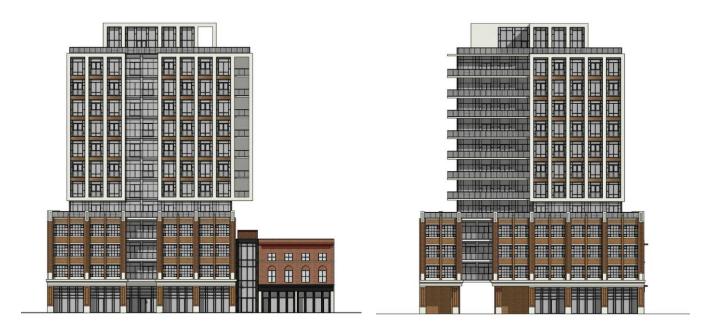
Plate 10: East and south elevations of proposed development (Lintack Architects 2023)

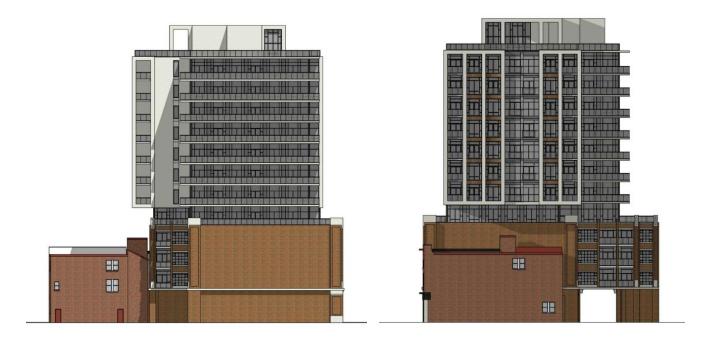
Plate 11: West and north elevations of proposed development (Lintack Architects 2023)

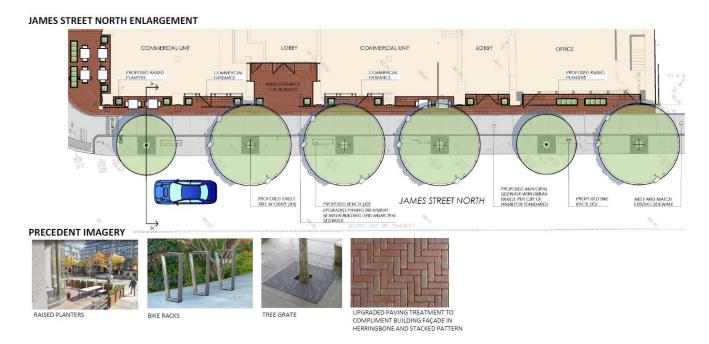
Plate 15: James Street North landscape design of proposed development (Lintack Architects 2023)

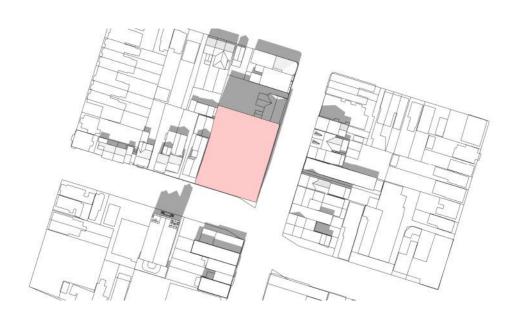
Mar.21 @ 1:27pm Solar Noon

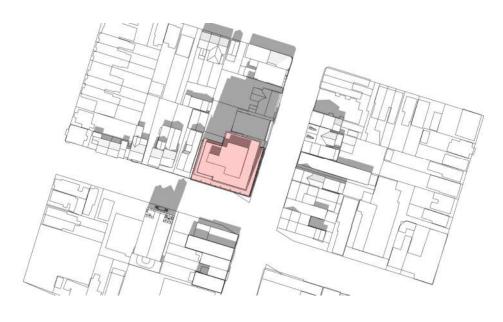
Mar.21 @ 1:27pm Solar Noon
