CPTED PROPERTY AUDIT

**Chedoke Stairs
Hamilton Ontario**

Audit prepared by: Hamilton Police Service - Crime Prevention Branch

Date of Audit: 2020-06-06 - Daylight Hours

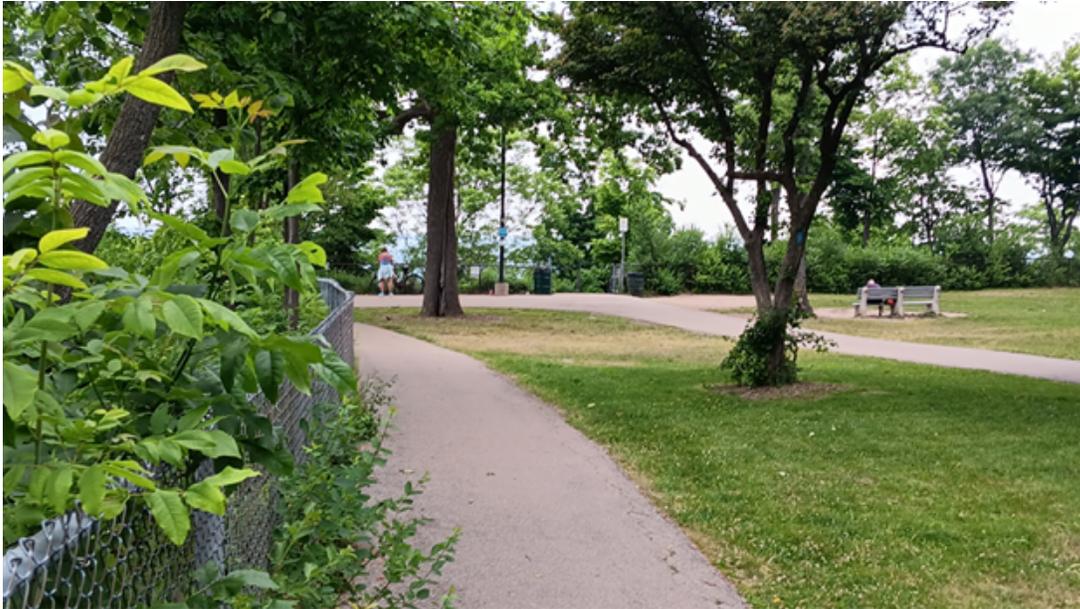
Recommendation: all bushes or hedges that line a chain-linked fence at the upper entrance are removed, such as seen in the image below. As they are right now, they prohibit Police or any witnesses from having clear sight lines into that area of the property. Thus, they are creating an environment conducive for criminal activities and trespassers.

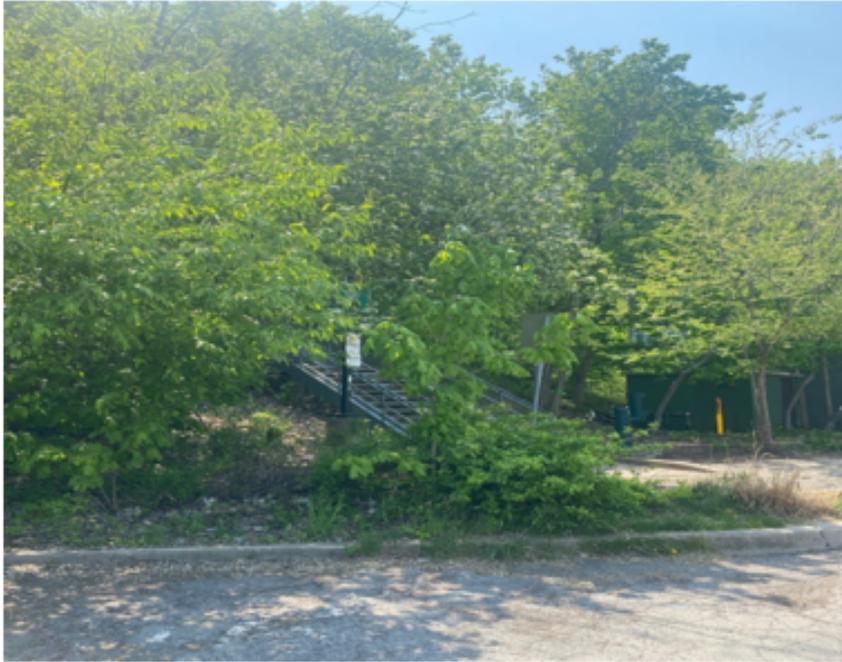
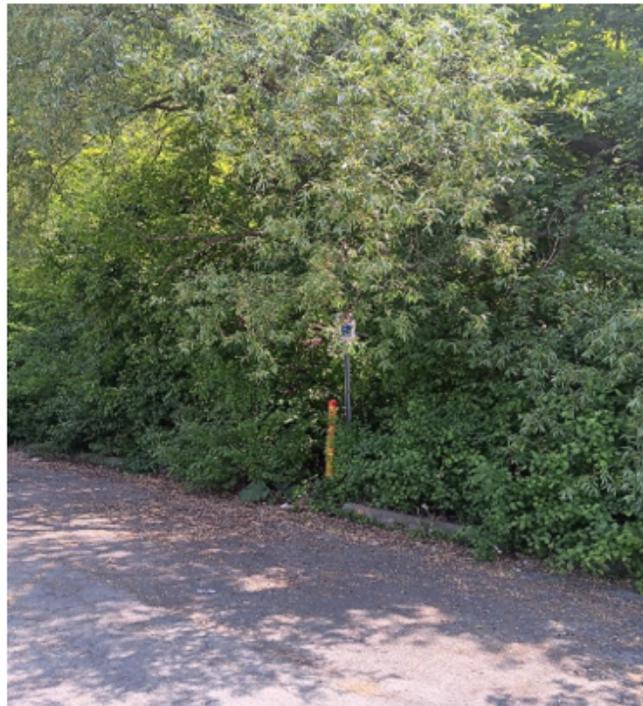
The approach to the lower entrance to the stairs is not visible from the parking lot due to overgrowth of trees and shrubs. These should be trimmed back. The area around the parking lot should be trimmed back into the slope at least 8' in order to improve sight lines and prevent foliage from covering parking signage. There is a Manitoba maple currently leaning over the parking lot. This should be removed.

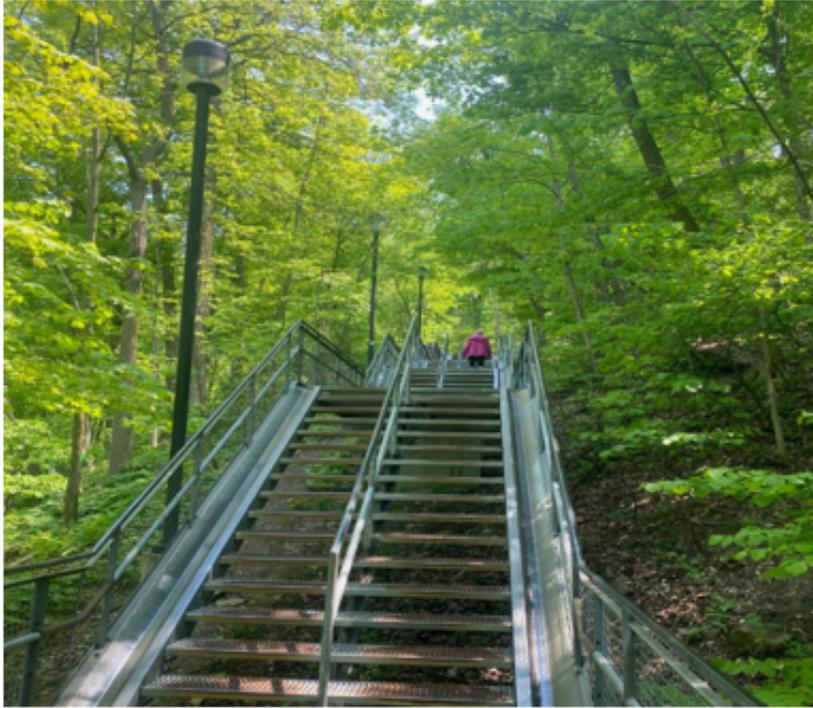
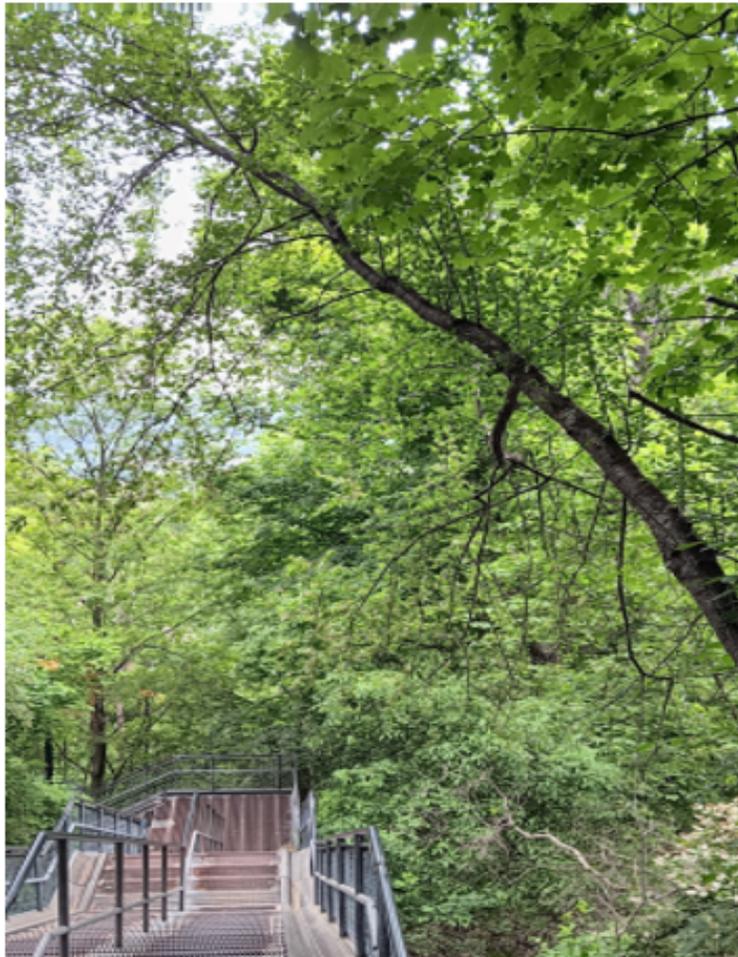
Trees need to be trimmed that are growing over the stairs and handrails.

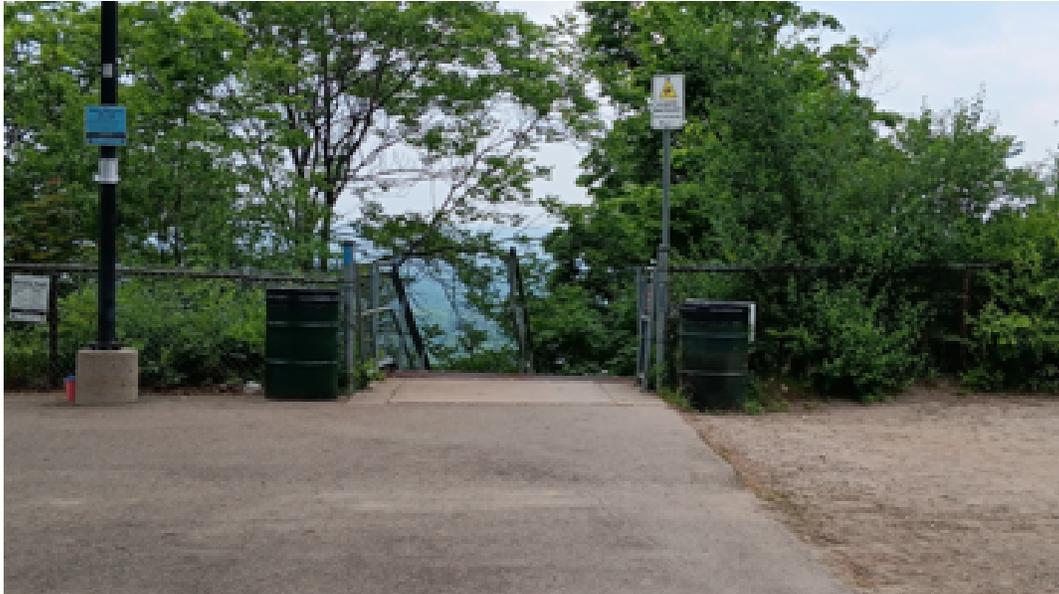
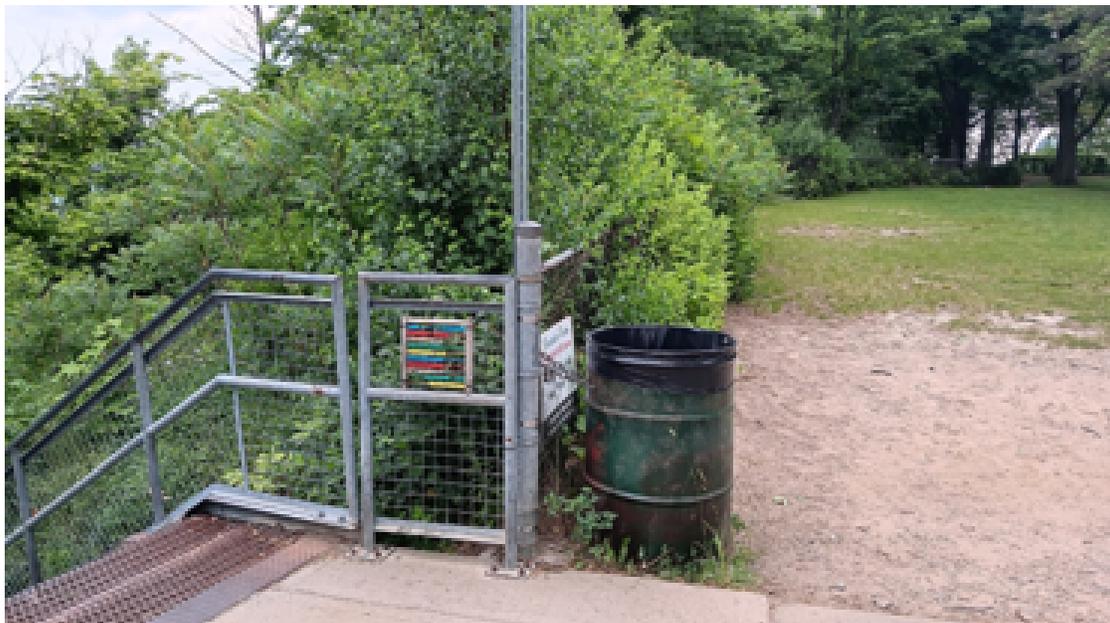
The approach to the upper entrance to the stairs has good sight lines. There is some vegetation growing through the chain-link fence. This can be pruned back. The garbage cans should be relocated further from the stairs. This will eliminate a potential concealment area.

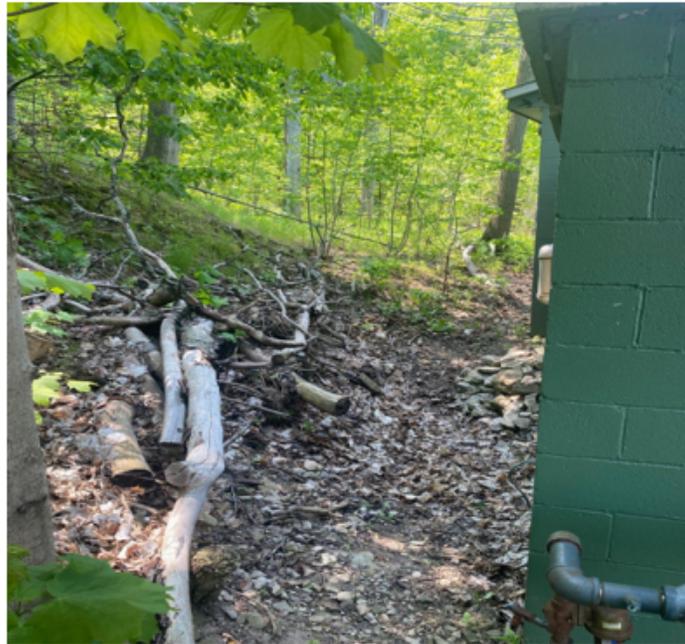
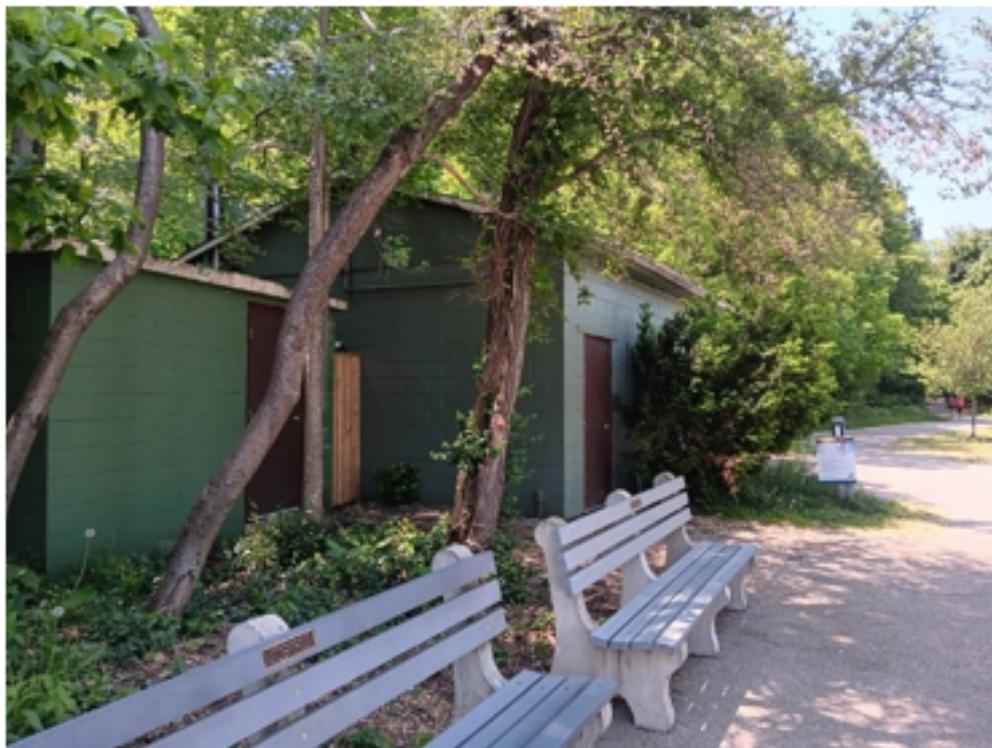
Buildings: There is a lot of debris around the maintenance building. Dead wood and standing dead trees should be removed and disposed.

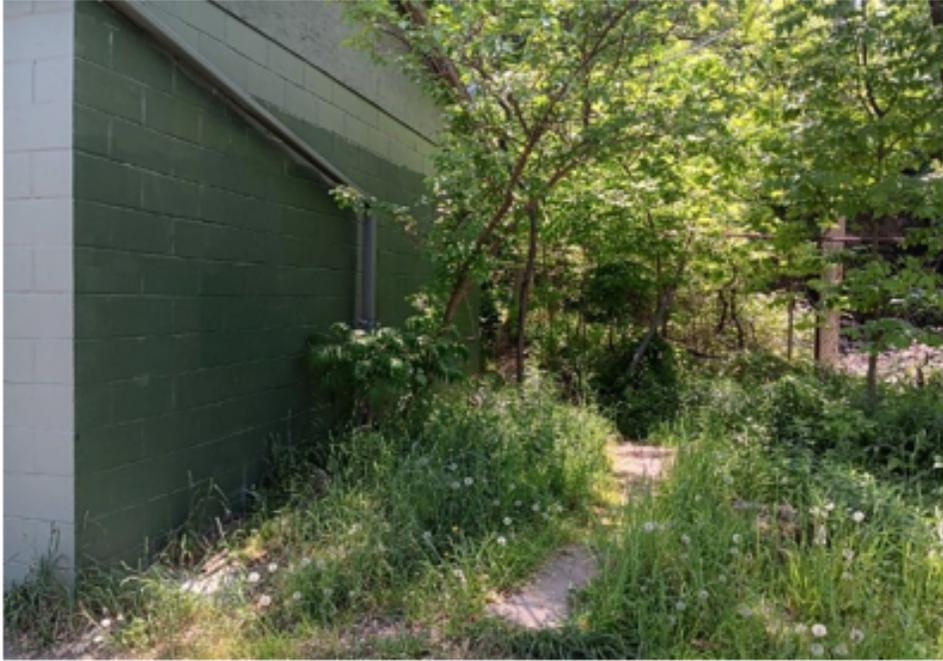
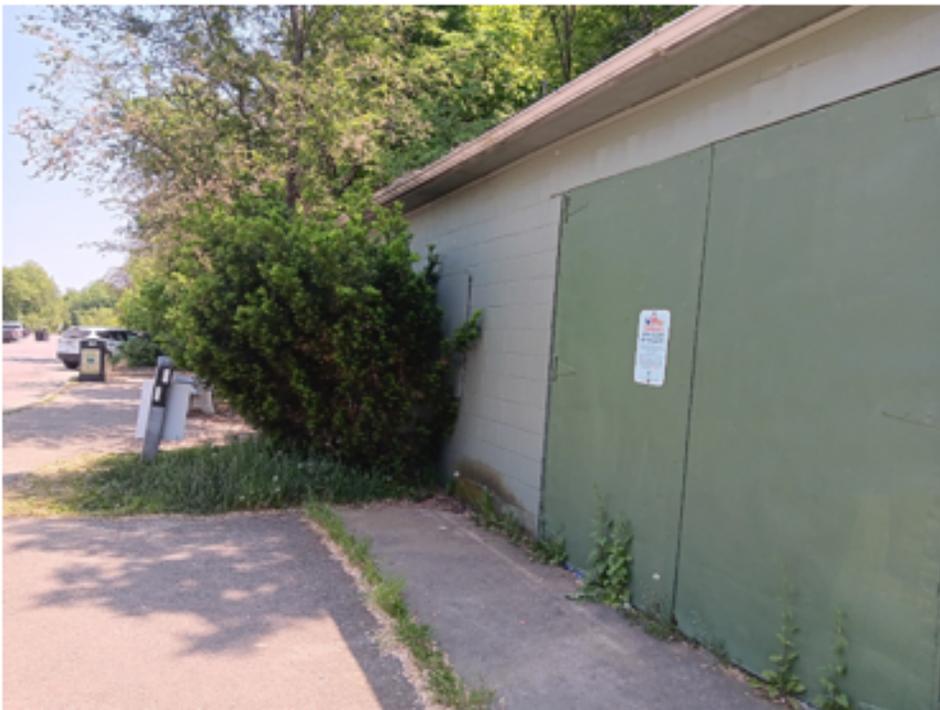
Buildings: There are areas of concealment around the maintenance building. Overgrown shrubs should be trimmed or removed to improve sight lines.

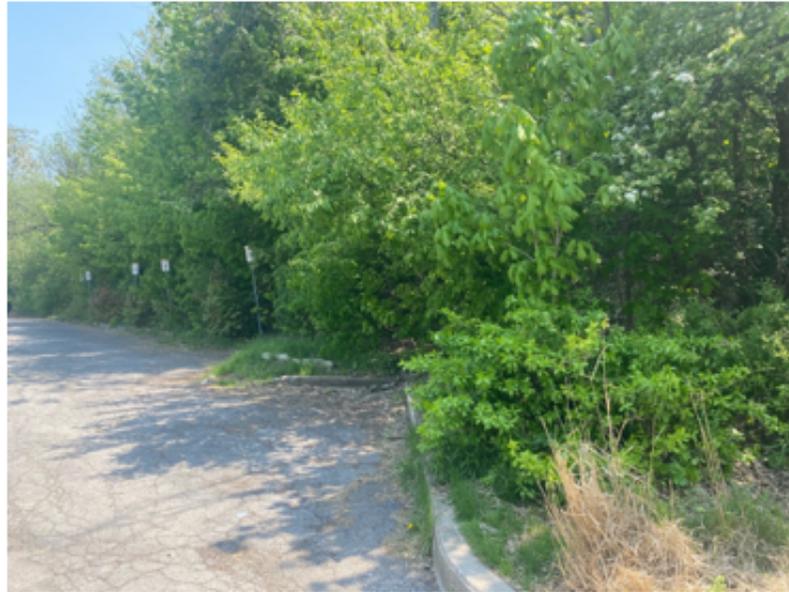
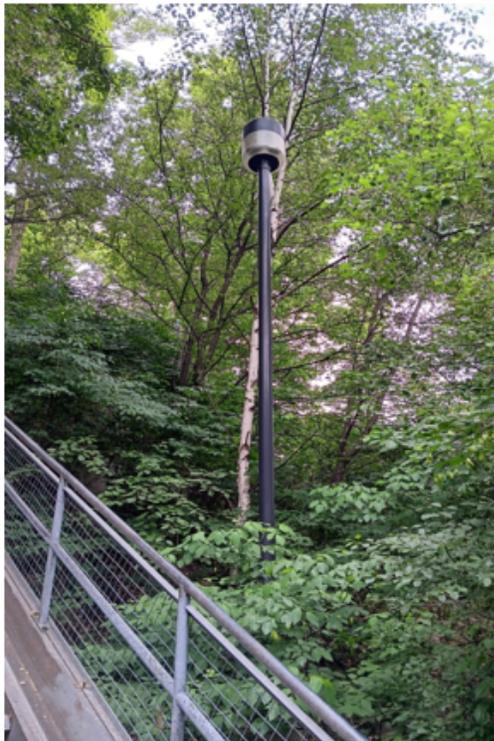
Signage: Signage can help establish territory and can clearly distinguish private from public property. With signs being properly displayed throughout the property, this helps to eliminate the “I did not know” excuse for trespassers and loiterers alike. The signs currently posted in the lower access parking lot are being covered by vegetation.

Recommendation to clear vegetation overgrowth.
