CPTED PROPERTY AUDIT

**Wentworth Stairs
Hamilton Ontario**

Audit prepared by: Hamilton Police Service - Crime Prevention Branch

Date of Audit: 2023-06-06 - Daylight Hours

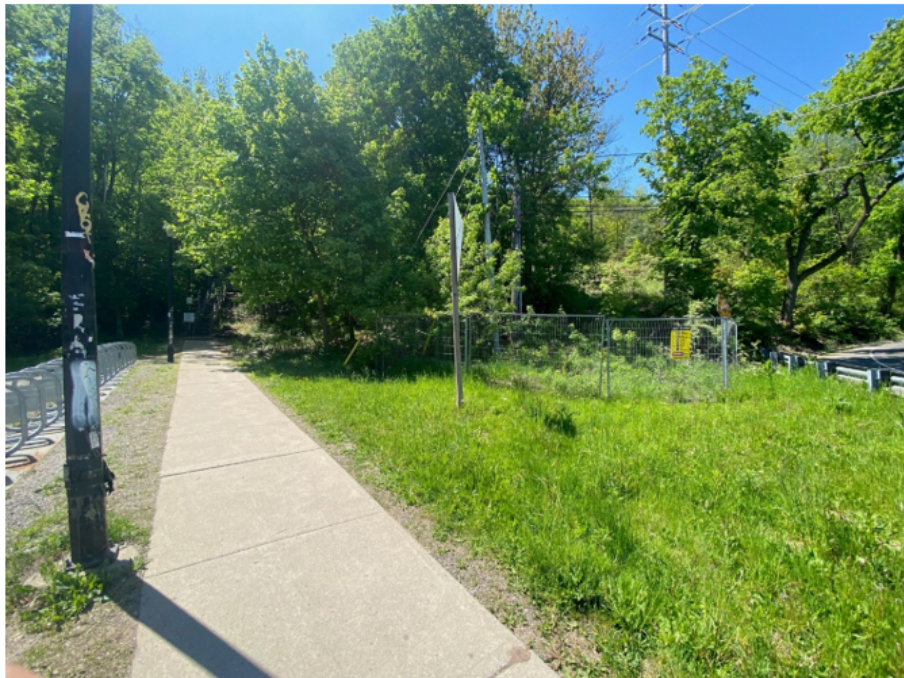
Image taken on June 6 at the bottom of the Wentworth Stairs.

All trees in the open space around the stairs should be trimmed up 7 feet from the ground to allow for clear sight lines. Any foliage overhanging the stairs and handrails should be pruned. Shrubbery adjacent to the stairs should be trimmed to a maximum of 3 feet high to prevent people from hiding behind them. When new trees and shrubs are added to increase the overall canopy across the City, plant material should be carefully selected as to not create more hidden hazards. Some examples of this include trees that grow tall and narrow with minimal low hanging branches and low growing shrubs that don't affect sight line issues.

Recommendation: the Manitoba Maple located at the base of the stairs is overhanging the approach area should be removed, such as seen in the image below. As it is right now, it prohibits Police or any witnesses from having clear sight lines into that area of the property. Thus, it is creating an environment conducive for criminal activities and trespassers.

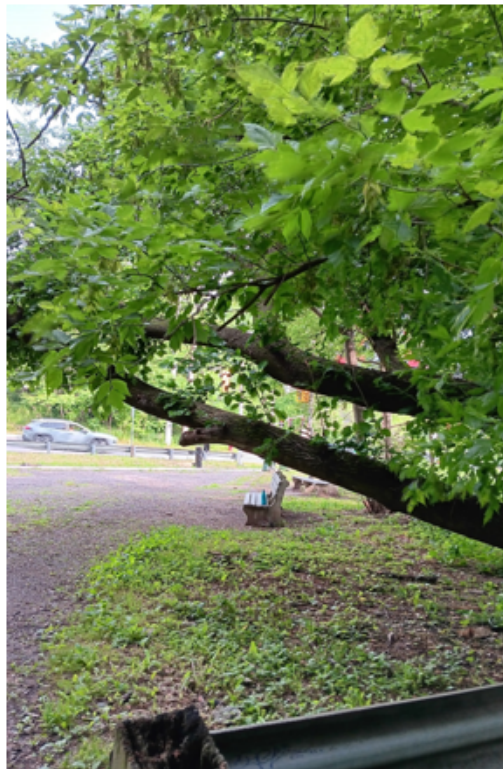
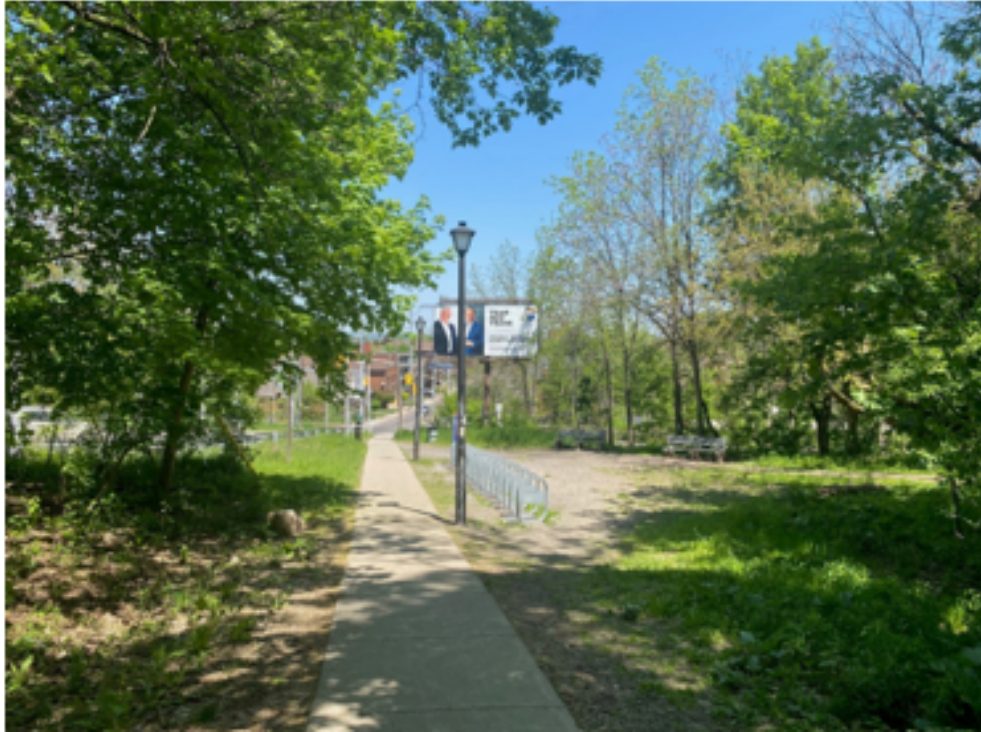
Regular maintenance should be completed at this site. The base of the stairs present a shadowed area due to extreme tree cover (above). Thinning of the trees would allow natural light into the area. As seen below, the vegetation at the top of the stairs will need to be pruned to allow for a 180° visibility at the top of the stairs.

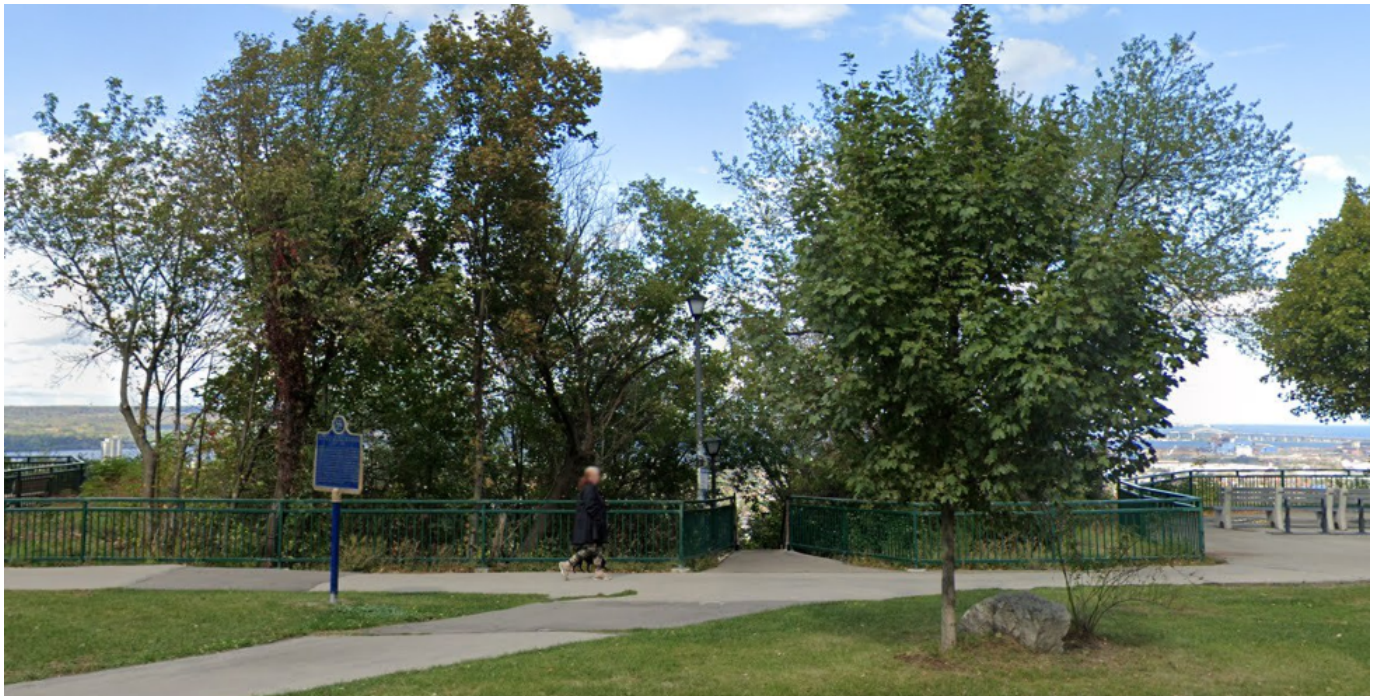
Image from Google Street view.

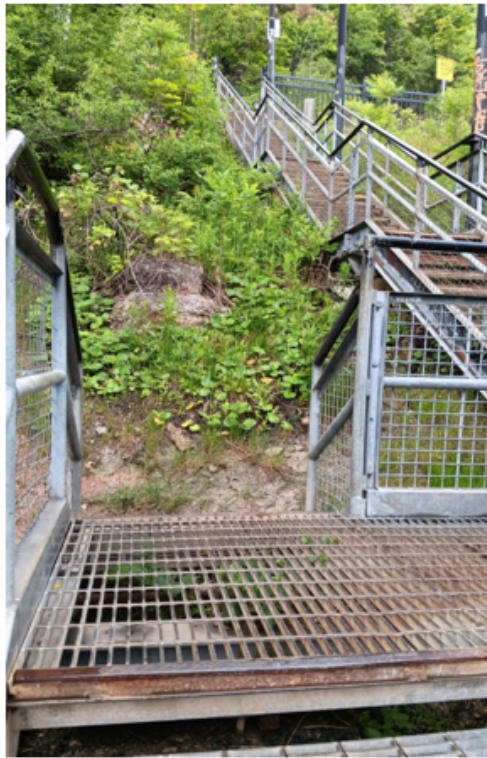
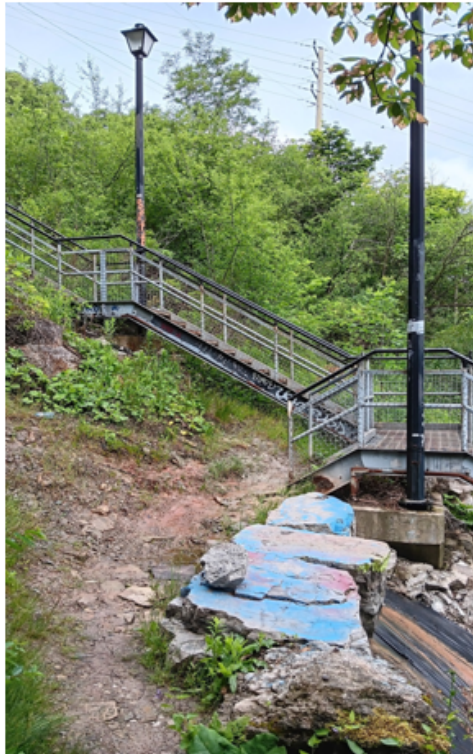
Alternate Access Points: About 3/4 of the way up the lower staircase is an access point for the Bruce Trail to connect with the Wentworth stairs. This access point is a concern as this can be a concealment area and it leads to a forest path.

Recommendation: Install additional lighting to allow for more illumination in hidden areas.

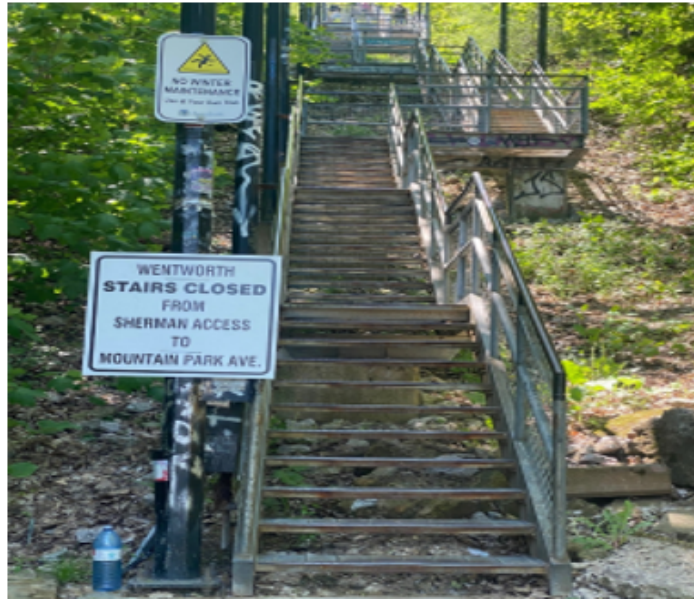
Signage: Signage can help establish territory and can clearly distinguish private from public property. With signs being properly displayed throughout the property, this helps to eliminate the “I did not know” excuse for trespassers and loiterers alike. The sign (above) was displaying incorrect information. As seen below, the stairs were open.

Recommendation: Post clear, concise messaging for those who are using the stairs. When repair work is completed, remove signage.

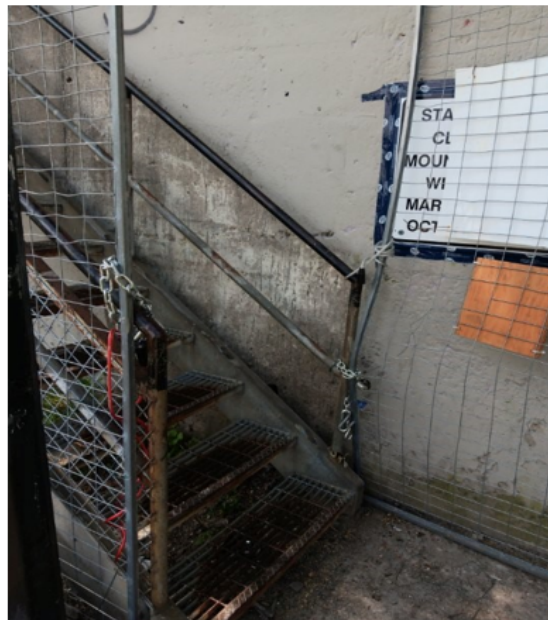
Graffiti – Graffiti is a common issue in many major cities. This is not only a cost to the city, it also takes away from the clean image which the City is attempting to portray in its parks. The light standards have become a target for graffiti. Regular maintenance and inspections should be completed to clean up graffiti.

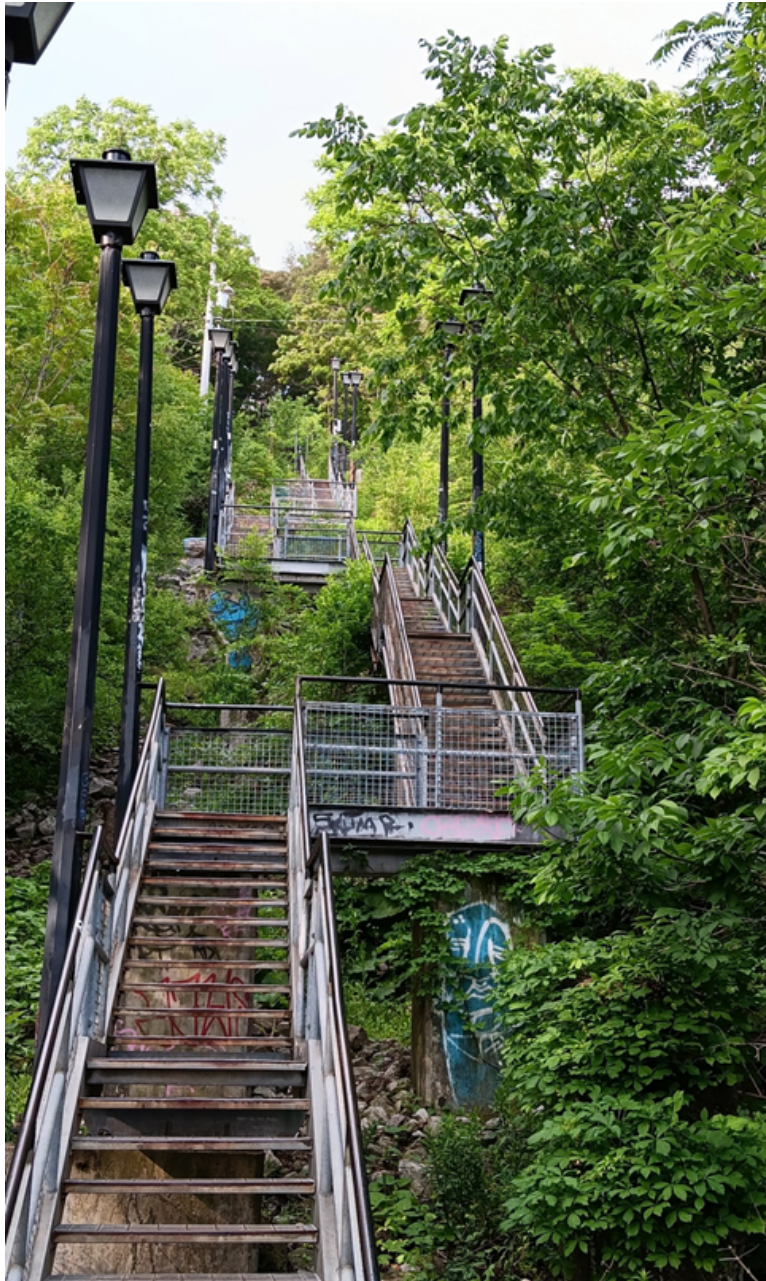
Lighting: One of the most important components of CPTED is lighting. Effective lighting allows for natural surveillance by providing the ability for people to see. It can also generate witness potential by giving people a reason to look. There are many different types of lighting available and the goal is to select a light type that is appropriate for the area. The area should be well illuminated without creating a visual nuisance for onlookers. It should also be placed along the stairs so that all hidden areas are illuminated to reduce people hiding and to provide a secure environment for those climbing. The spacing of the lights should be that there are no blind spots or shaded areas along buildings and paths. To reduce cost motion activated lights can be installed in some areas that only come on when there is motion or people walking through the area. Maintenance is also a consideration with a good lighting plan to replace broken lights and burned out bulbs on a regular schedule. All lighting should be installed to light from the inside out and with protection to stop vandals and damage; deterring crime. When an area is well-lit, people who wish to engage in illegal activities will tend to move to darker more discrete areas. Studies have shown that graffiti and other activities happen more often in dark unlit areas.

Recommendation: Have an official lighting audit conducted for the Bruce Trail access to the stairs. Install LED lights to further illuminate the area if necessary and possibly put these lights on a sensor so they only operate while people are walking in the area to minimize the impact of lighting on the natural area. Ensure that foliage is pruned to allow for increased visibility (previous page).
