# **CPTED PROPERTY AUDIT**

## **Dundurn Stairs**

## **Hamilton Ontario**

Date of Audit: 2023-06-06 - Daylight Hours

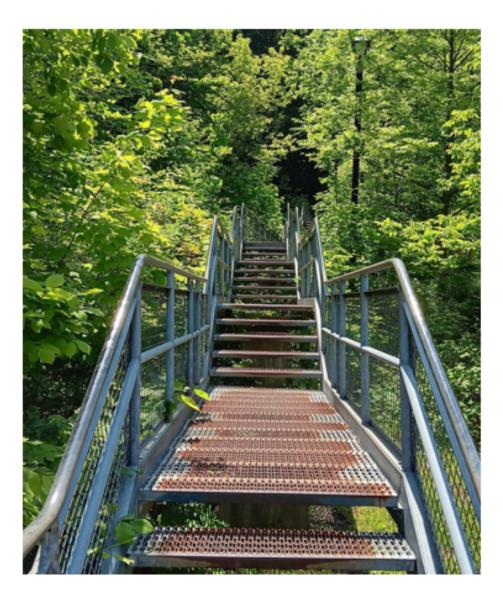
All trees in the open space around the stairs should be trimmed up 7 feet from the ground to allow for clear sight lines. Any foliage overhanging the stairs and handrails should be pruned. Shrubbery adjacent to the stairs should be trimmed to a maximum of 3 feet high to prevent people from hiding behind them. When new trees and shrubs are added to increase the overall canopy across the City, plant material should be carefully selected as to not create more hidden hazards. Some examples of this include trees that grow tall and narrow with minimal low hanging branches and low growing shrubs that don't affect sight line issues.

Recommendation: Vegetation could be thinned to improve visibility.

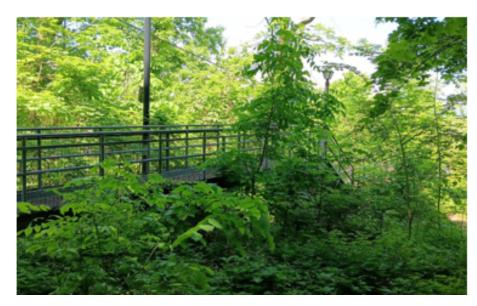
Regular maintenance should be completed at this site. There is a lot of vegetation along the side of the stairs that will need to be thinned, as seen above. Vegetation at the top of the stairs (below) is overhanging the wall. This can be a location for hiding. This should be pruned to allow for ample walking space.

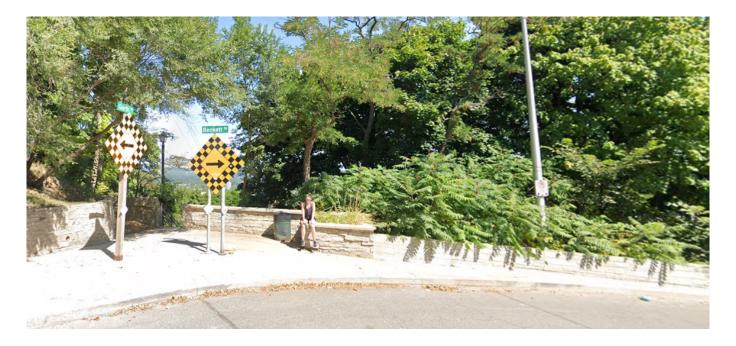
Google Street view at the top of the Dundurn Stairs.

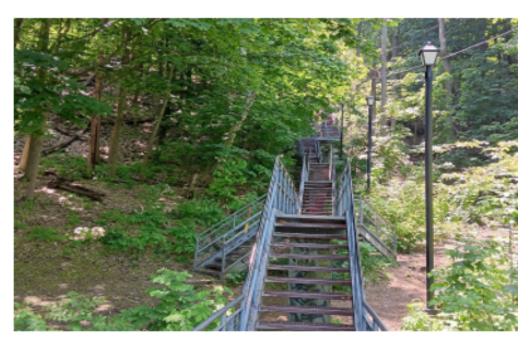
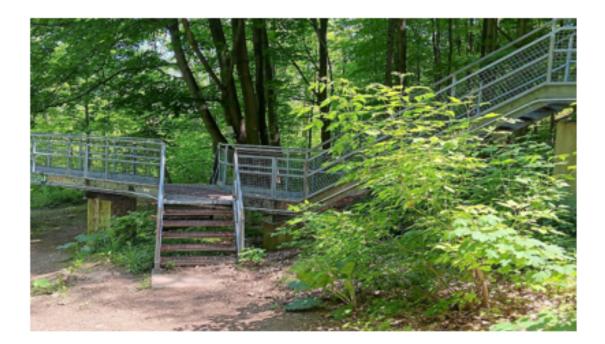
Alternate Access Point: About halfway up there is an access point for the Bruce Trail to cross the Dundurn Stairs. This access point is a concern as this can be a concealment area and it leads to a forest path.

Recommendation: Install additional lighting to allow for more illumination in hidden areas.

Recommendation: Have an official lighting audit conducted for the Bruce Trail access to the stairs. Install LED lights to further illuminate the area if necessary and possibly put these lights on a sensor so they only operate while people are walking in the area to minimize the impact of lighting on the natural area. Ensure that foliage is pruned to allow for increased visibility (bottom of previous page).

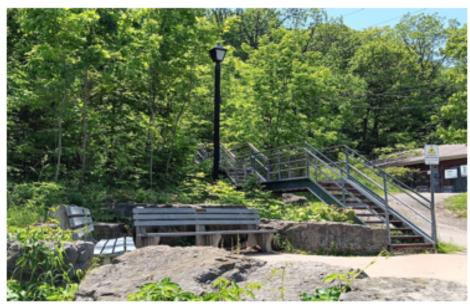
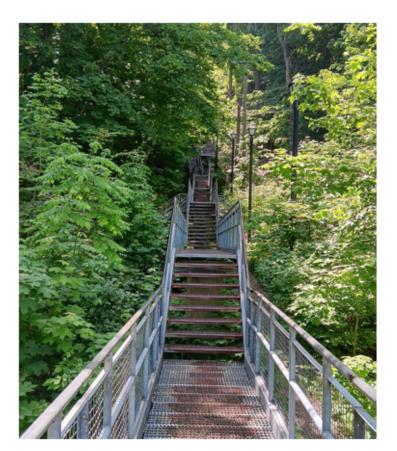
Graffiti – Graffiti is a common issue in many major cities. This is not only a cost to the city, it also takes away from the clean image which the City is attempting to portray in its parks. The light standards have become a target for graffiti. Regular maintenance and inspections should be completed to clean up graffiti.
