Cultural Heritage Impact Assessment Report

Royal Hamilton Yacht Club
555 Bay Street North

Date:
September 2023

RHYC Jr. Sail Building Structural Assessment (DRAFT)

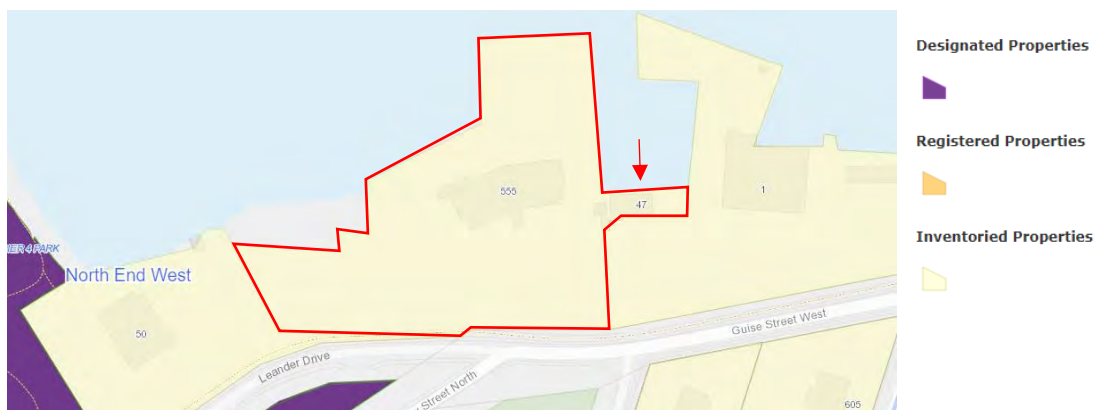
Figure 3: Aerial map of the subject lands (outlined in red), included as an **"Inventoried Property"** on the City of Hamilton Interactive Map. Approximate location of the existing sailing school facility noted with red arrow. (Source: City of Hamilton Interactive Map, accessed 2023)

The inventory identifies the RHYC sailing school facility as the potential heritage resource, estimated to have been built in 1920 as noted in the Class EA report dated 2013.

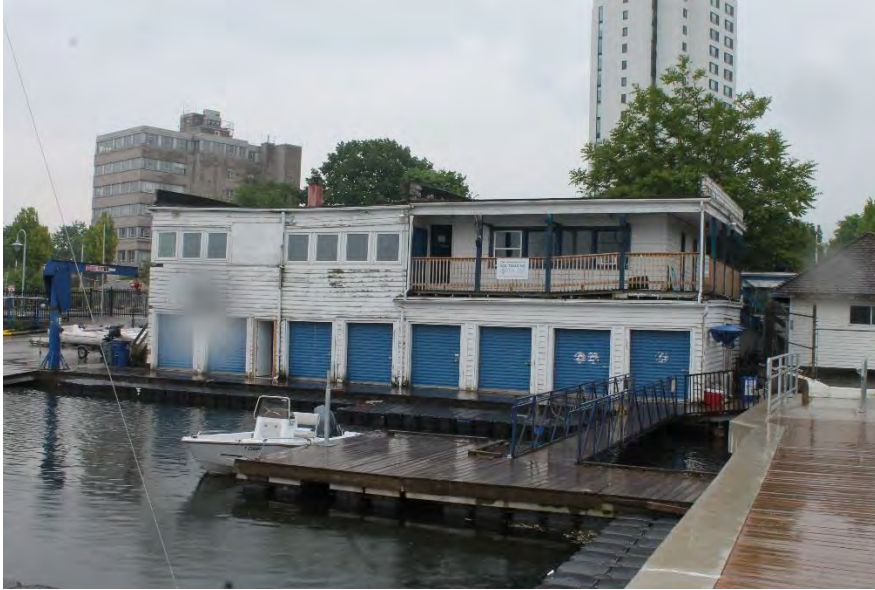
Figure 4: View of the north elevation of the sailing school facility, looking south
(Source: MHBC, 2023)

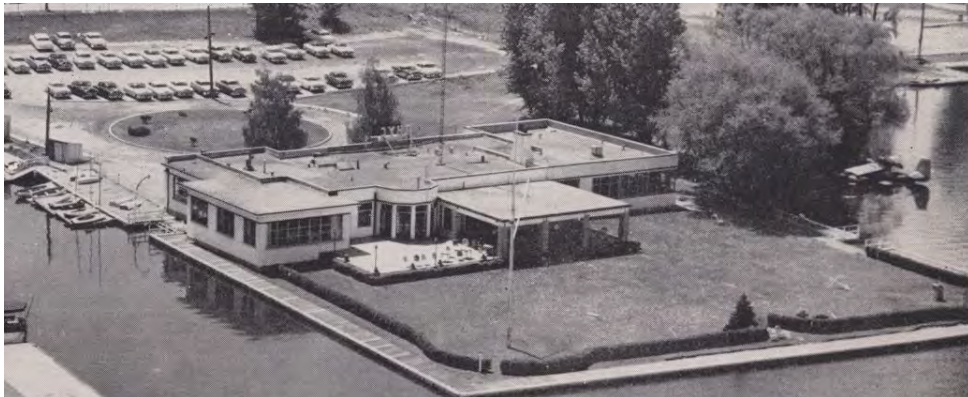
In 1911 the federal government established the Hamilton Harbour Commission for the management of the lands adjacent to the harbour (Unterman McPhail Cuming Associates, 1995). This was a joint agency with both federal and municipal members, with ownership of the lands being fully transferred to the City of Hamilton. In 1937, the RHYC negotiated the long-term lease of the current lands from the Commission, in addition to the rebuilding of the docking facilities. One year later in 1938, the RHYC built a clubhouse in the Art Deco architectural style on the subject property. This building was removed in the 1980s (See Figure 11).

Figure 11: Image of the 1938 Art Deco style Club House (since removed) (Robert Mazza c.1955)

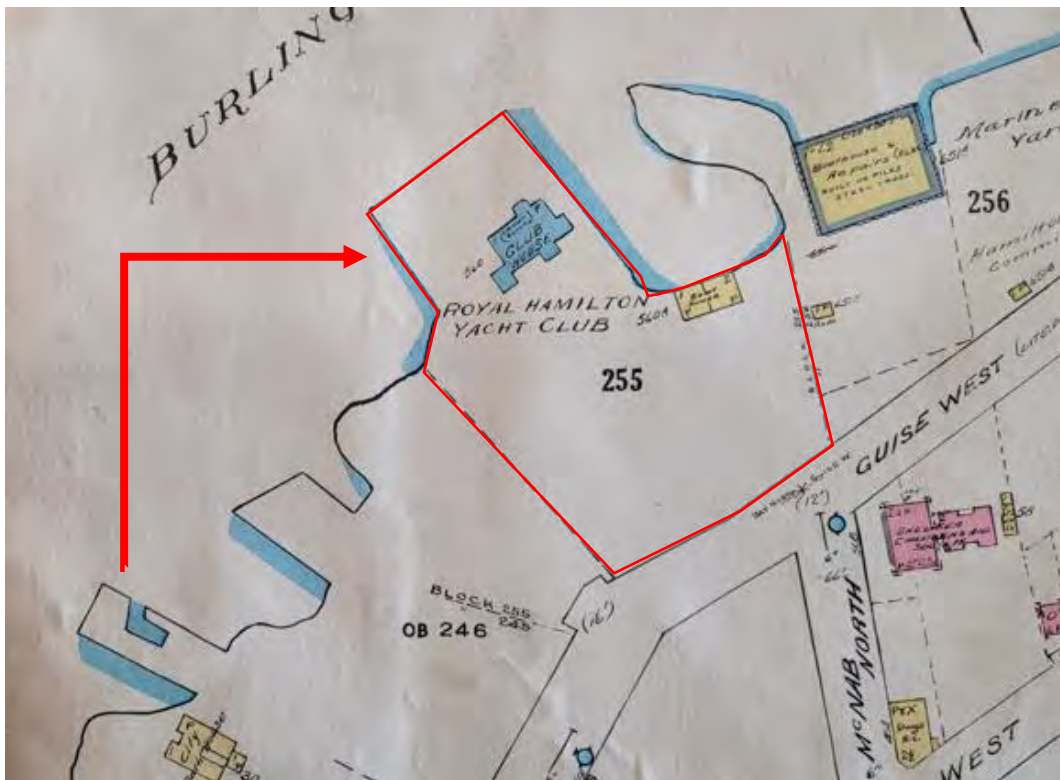
The 1947 Fire Insurance Plan indicates the 1938 club house located at the terminus of McNab Street North (See Figure 12).

Figure 12: 1947 Fire Insurance Plan. Property at what is now 555 Bay Street outlined in red. (Source: Courtesy of the Hamilton Public Library)

The sailing school facility was constructed in 1944 and can be described as a 2 storey wood frame structure. The original purpose of the structure was to provide lockers/storage areas ancillary to the main clubhouse (Penny, 1988). In 1946, the boat house was enlarged to add additional lockers and a kitchen area at the first storey. This resulted in the construction of a second storey. This structure appears on the 1947 Fire Insurance Plan and can be described as a wood frame building (See Figure 12).

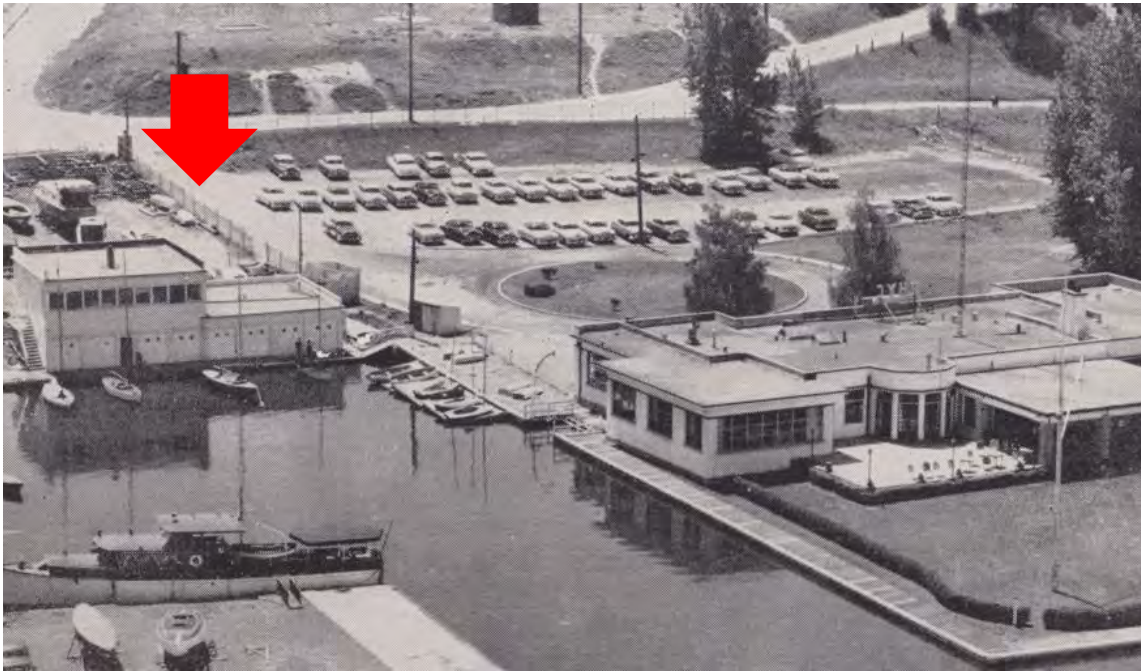
formal program was developed for junior members by the late 1950s, which resulted in the creation of a professional sailing school (Penny, 1988). In 1962 the top floor of the sailing school facility was expanded to accommodate a meeting area, office and washrooms for the junior sailors (See Figure 13).

Figure 13: Aerial photograph of the subject property. Location of the sailing school facility noted in red. Note that the third addition to the clubhouse had not yet been constructed (Robert Mazza c.1955)

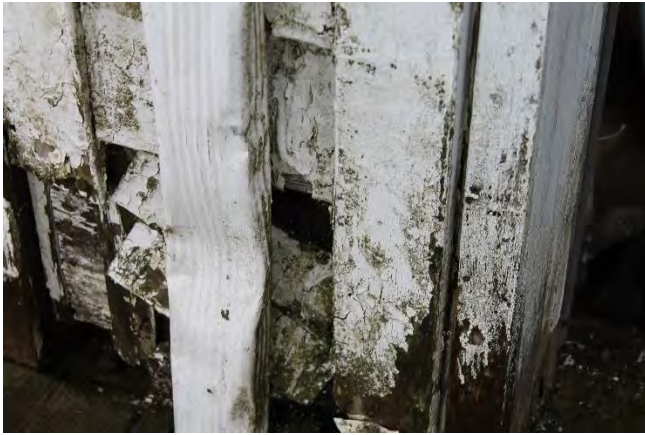
North elevation damage to exterior wood framing. Framing is rotting.

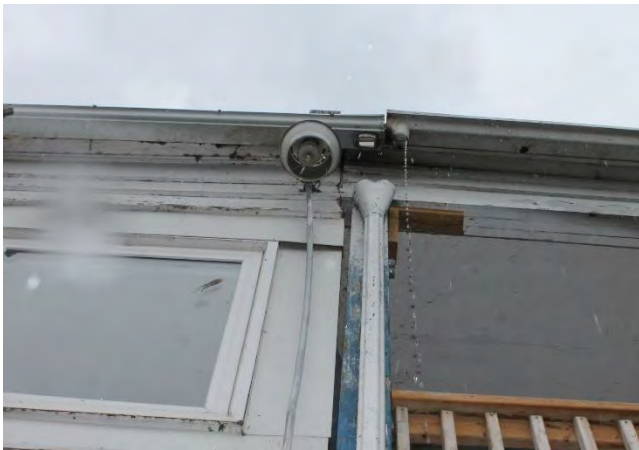
North elevation roof gutter leaking.

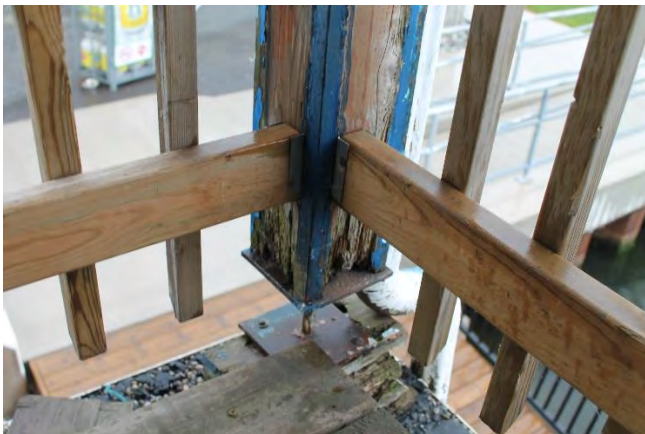
Compromised balcony post and support. Bottom of post is rotting.

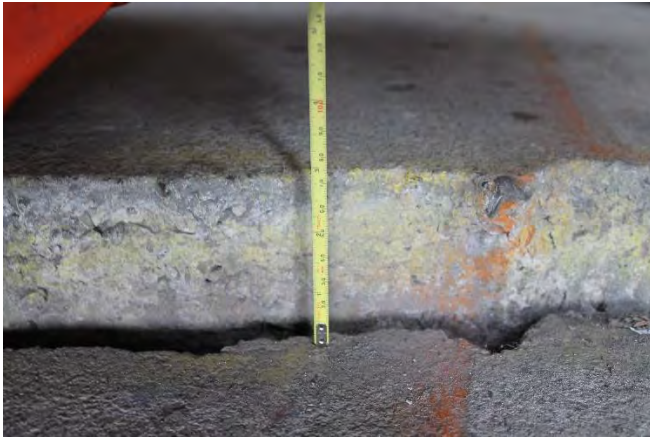
Three inch heave in concrete floor.

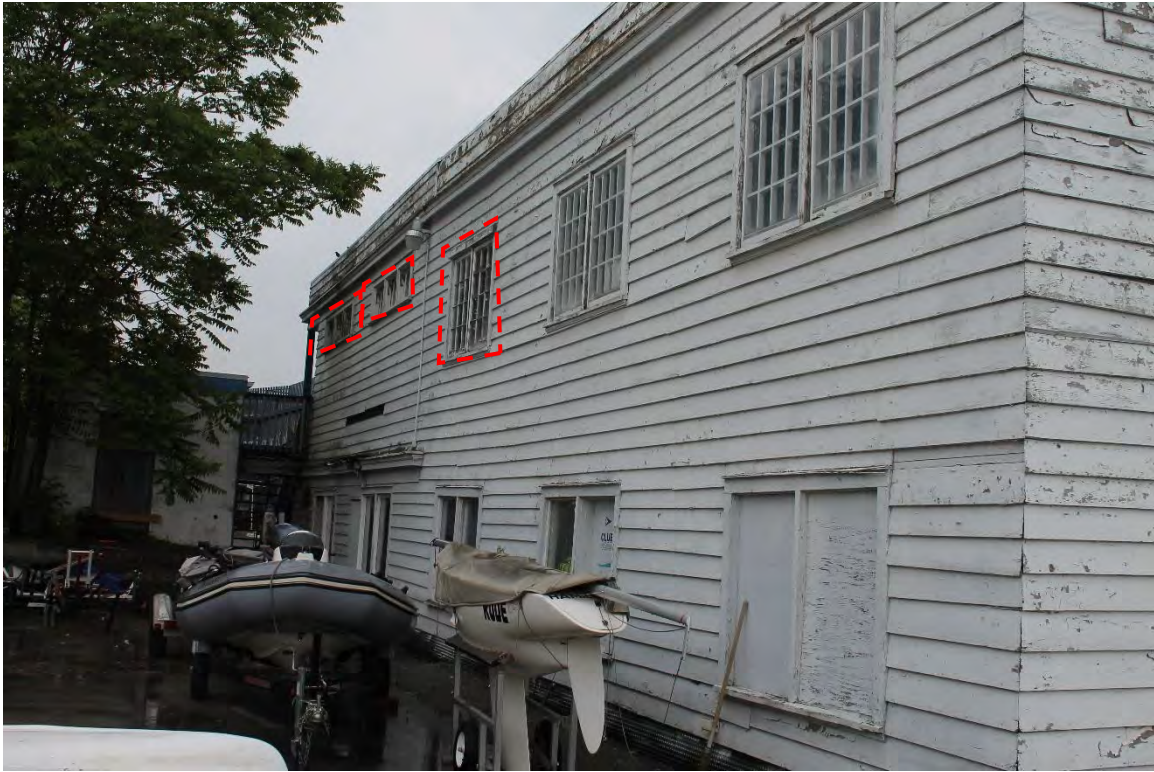
Figure 19: View of south façade of the Sailing School Facility noting the location of mid. 19th century wood windows which may be candidates for salvage provided that they are in good condition (Source: MHBC, 2023).

features which may be considered for salvage are mid. 20th century windows located on the south façade of the building (See Figure 17). These windows could be set aside from landfill materials during the demolition process and adaptively re-used for other projects within the City.

It is recommended that the property and building be documented with photographs, as provided in this report. Two windows at the south elevation of the sailing school facility may be salvaged, provided that they are in good condition and can either be used on-site or be donated to the public. Provided that any new facility continues to support the existing uses of the RHYC, no additional Heritage Impact Assessment is recommended any new building.

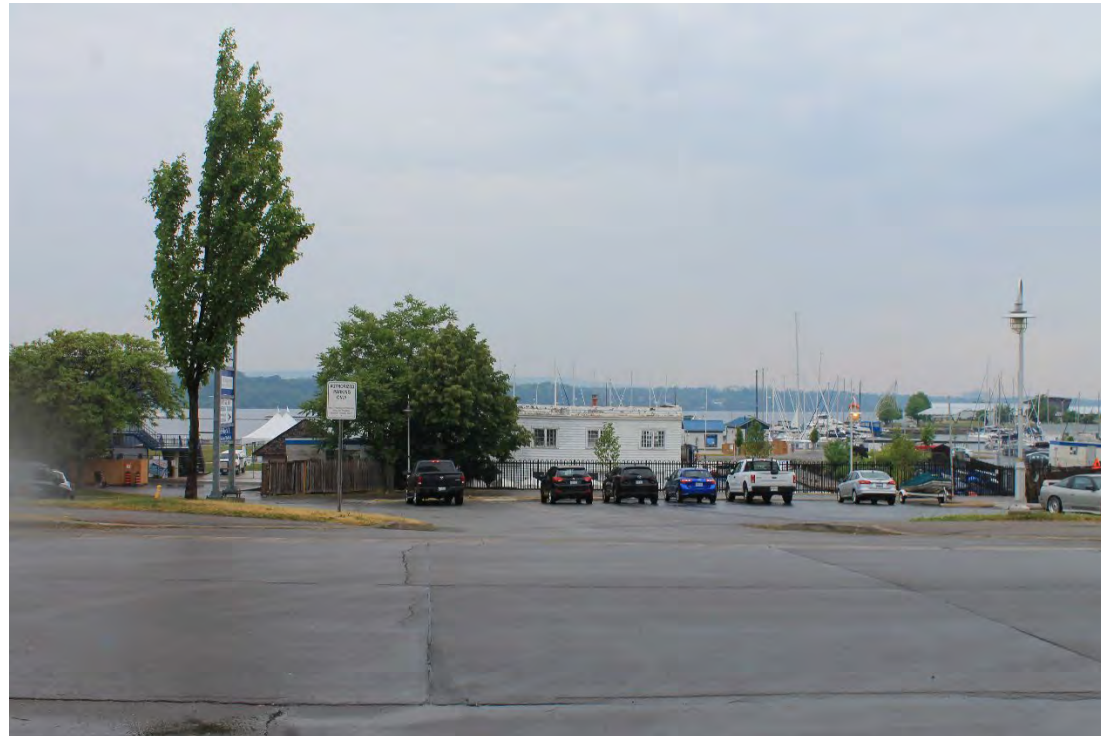
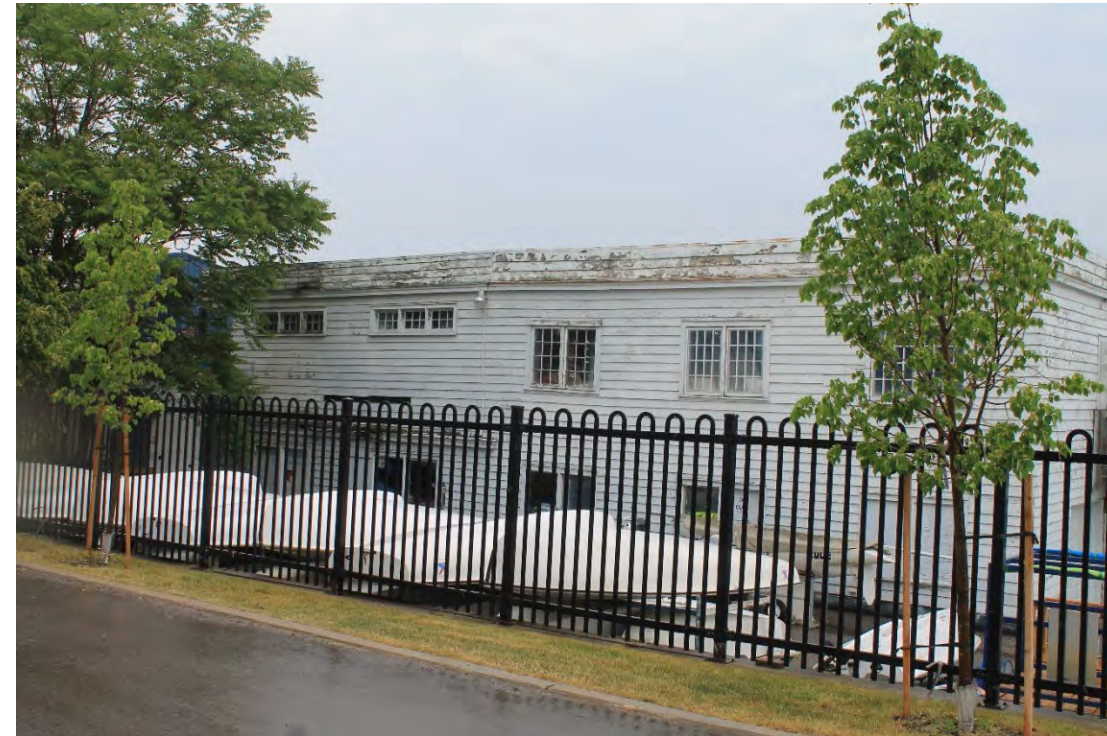
Photos 1 & 2: (left) View of rear (south) elevation of the sailing school/locker facility, looking north, (right) Detail view of the south elevation of the sailing school/locker facility (Source: MHBC, 2023)

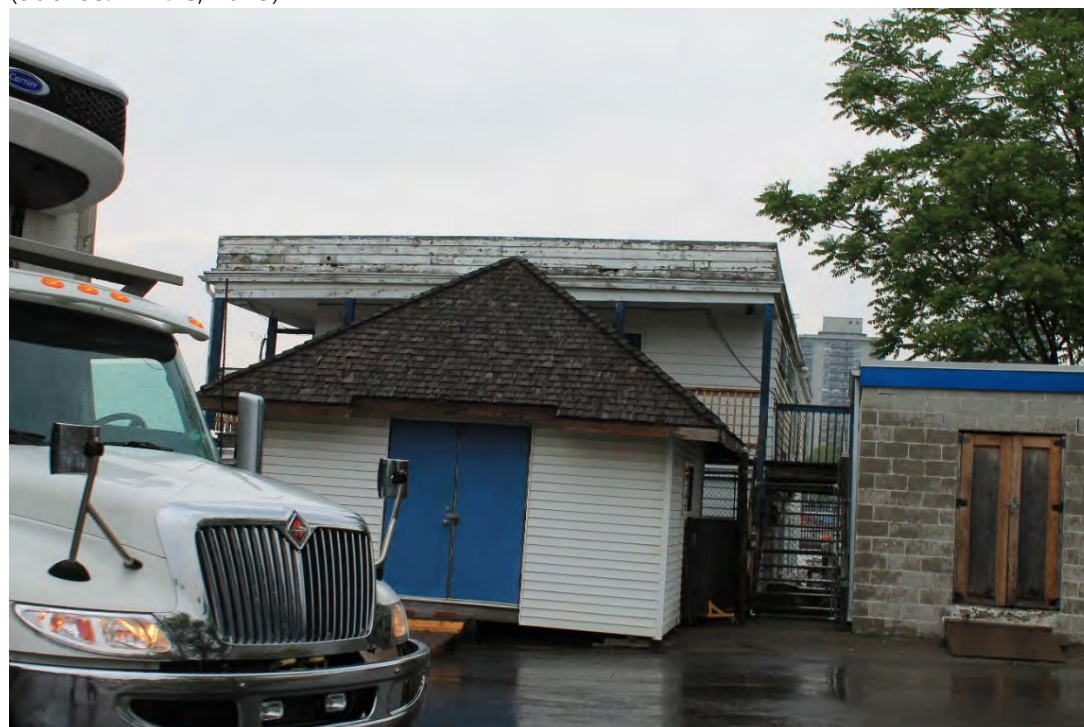
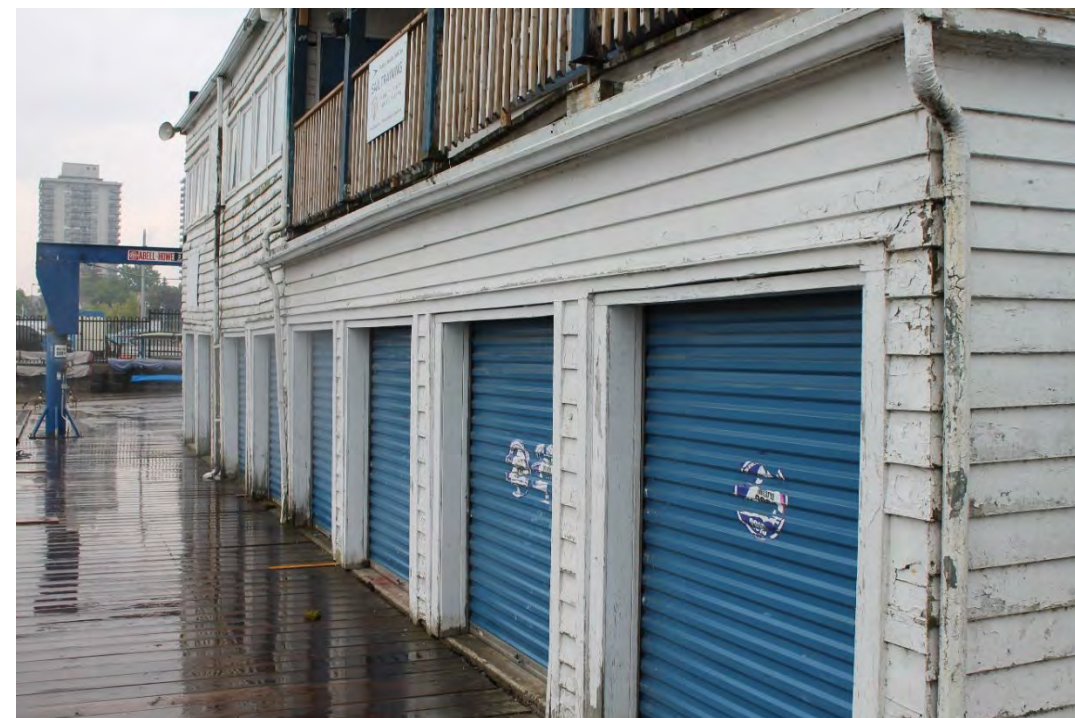
Photos 3 & 4: (left) View of the west elevation of the sailing school/locker facility looking east (note small outbuilding in the foreground) (right) View of north elevation of the sailing school/locker facility, looking east along lockers (Source: MHBC, 2023)

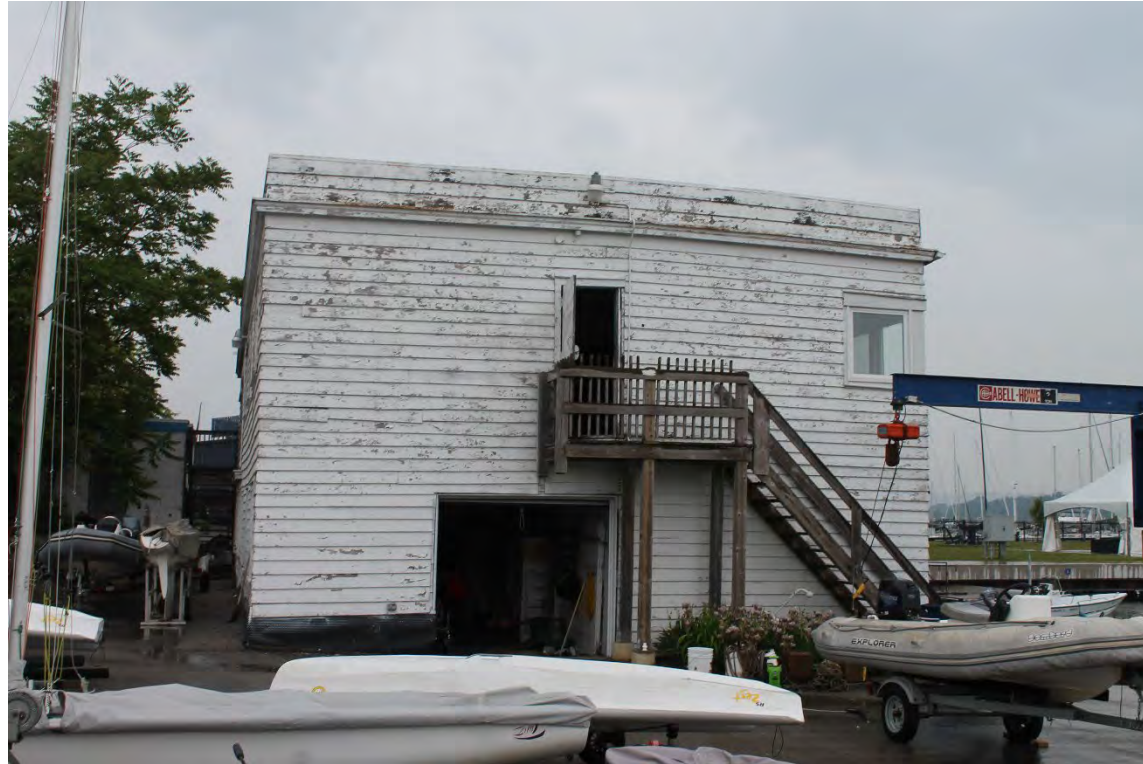
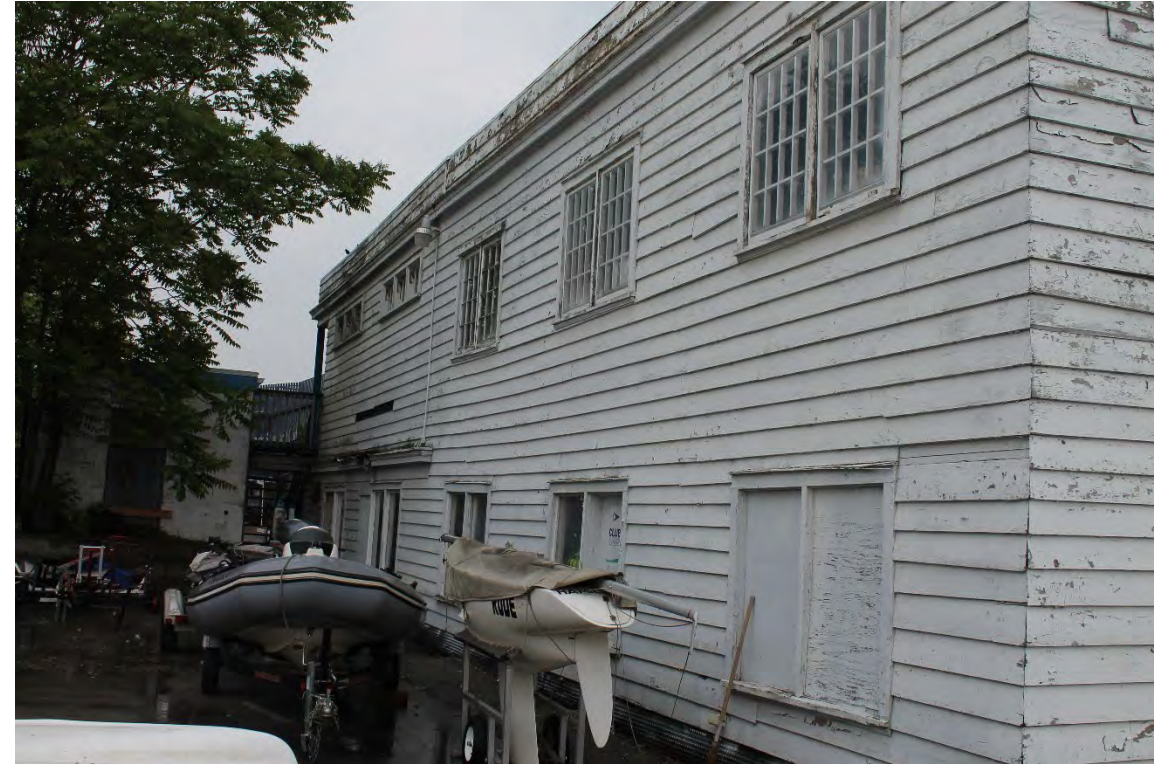
Photos 5 & 6: (left) View of east elevation of the sailing school/locker facility, (right) View of south elevation of sailing school/locker facility (Source: MHBC, 2023)

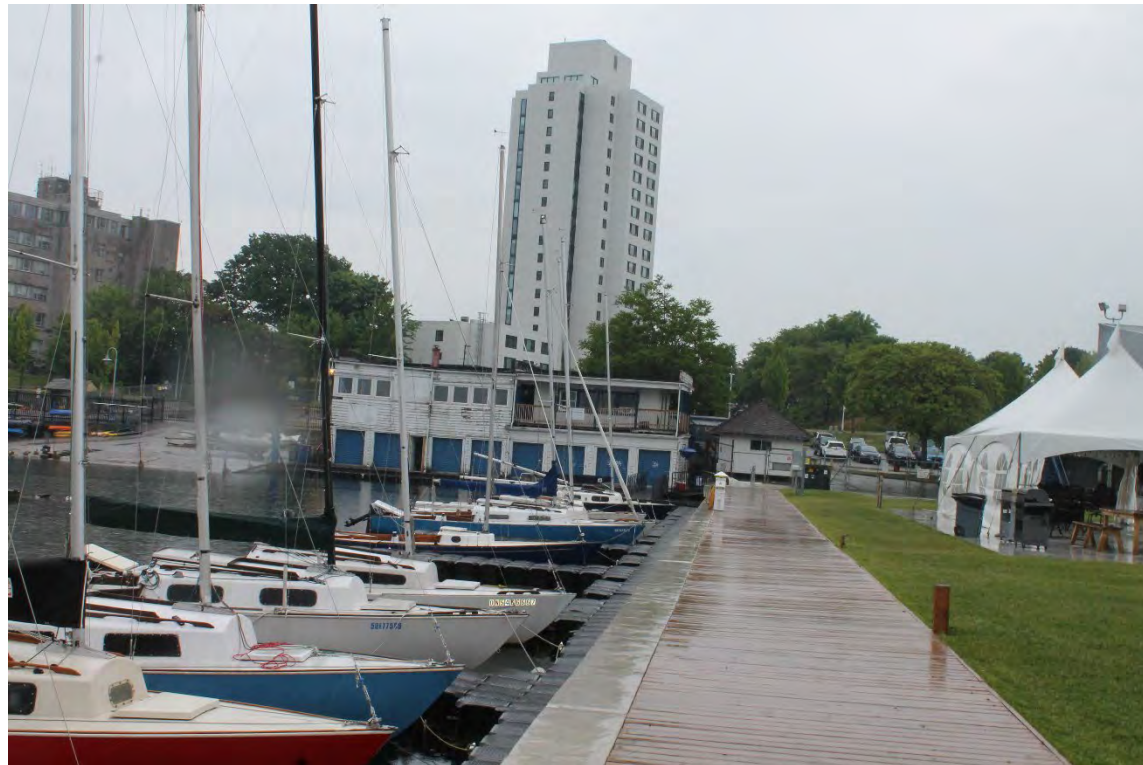
Photos 9 & 10: (left) View of front (north) elevation of sailing school, looking south from the boardwalk (right) View of the boardwalk looking west towards the RHYC Marina, (Source: MHBC, 2023)

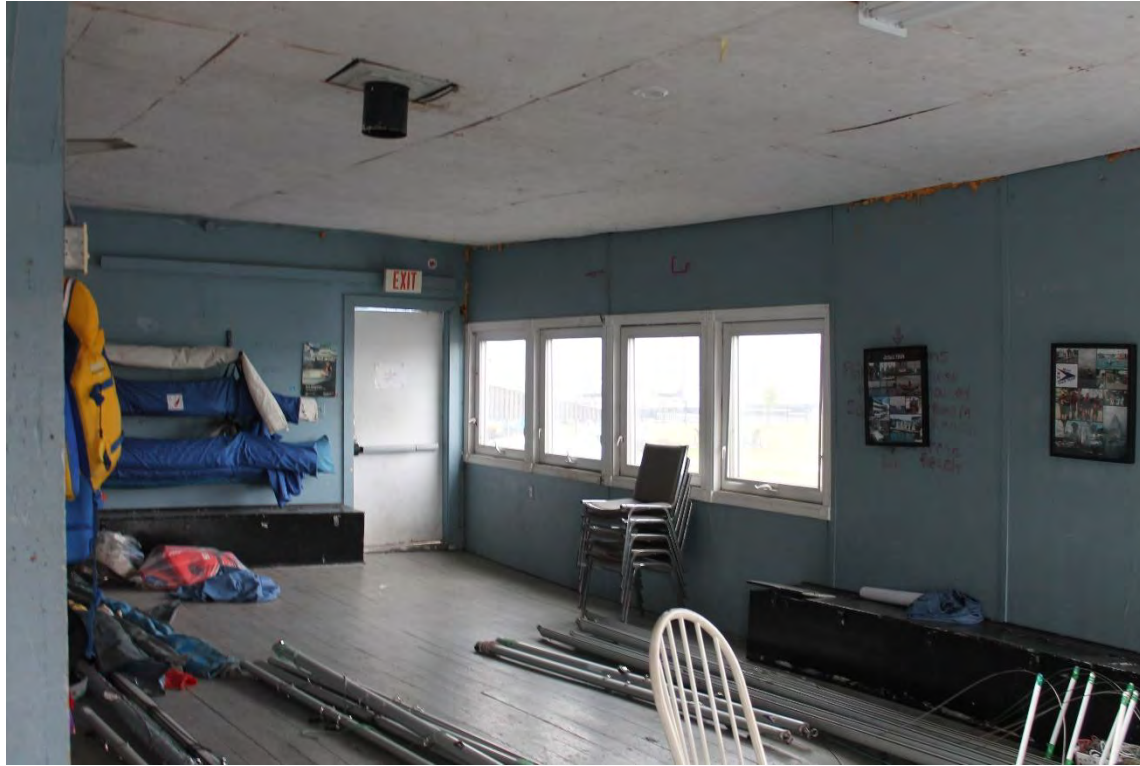
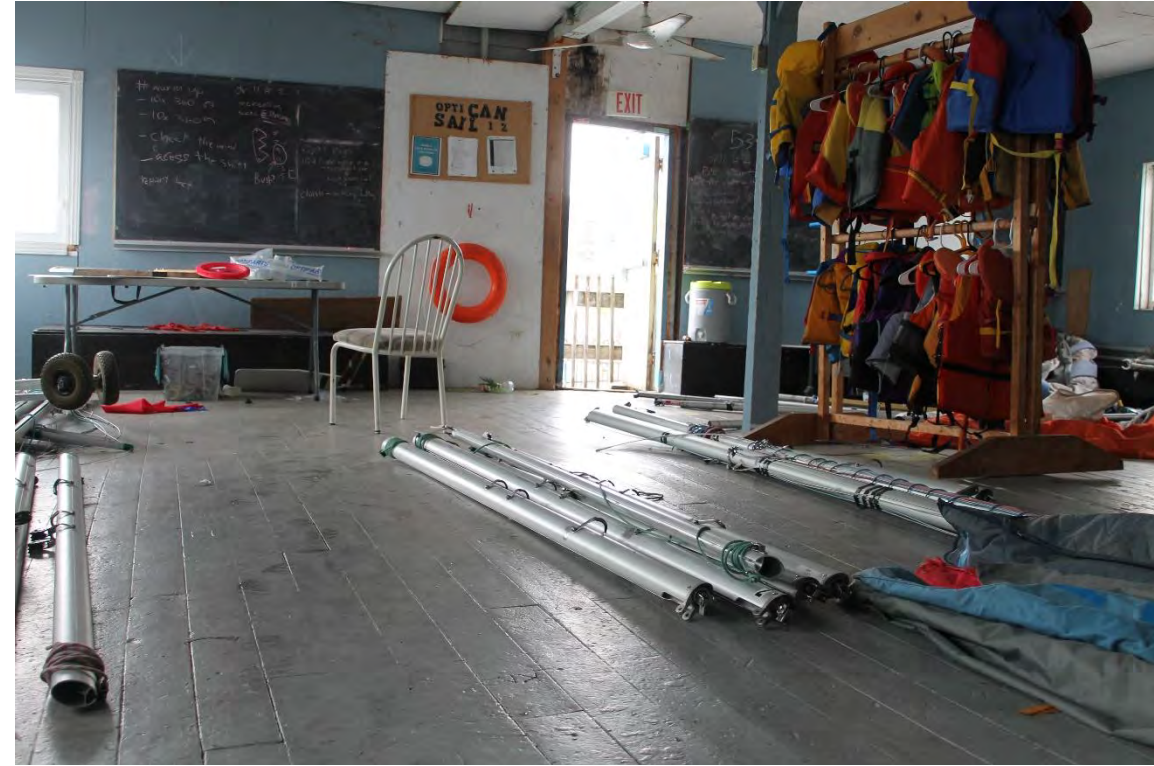
Photos 1 & 2: (left) View of second storey sailing school facility area, looking west, (right) View sailing school facility (second floor) looking east *note warped flooring (Source: MHBC, 2023)

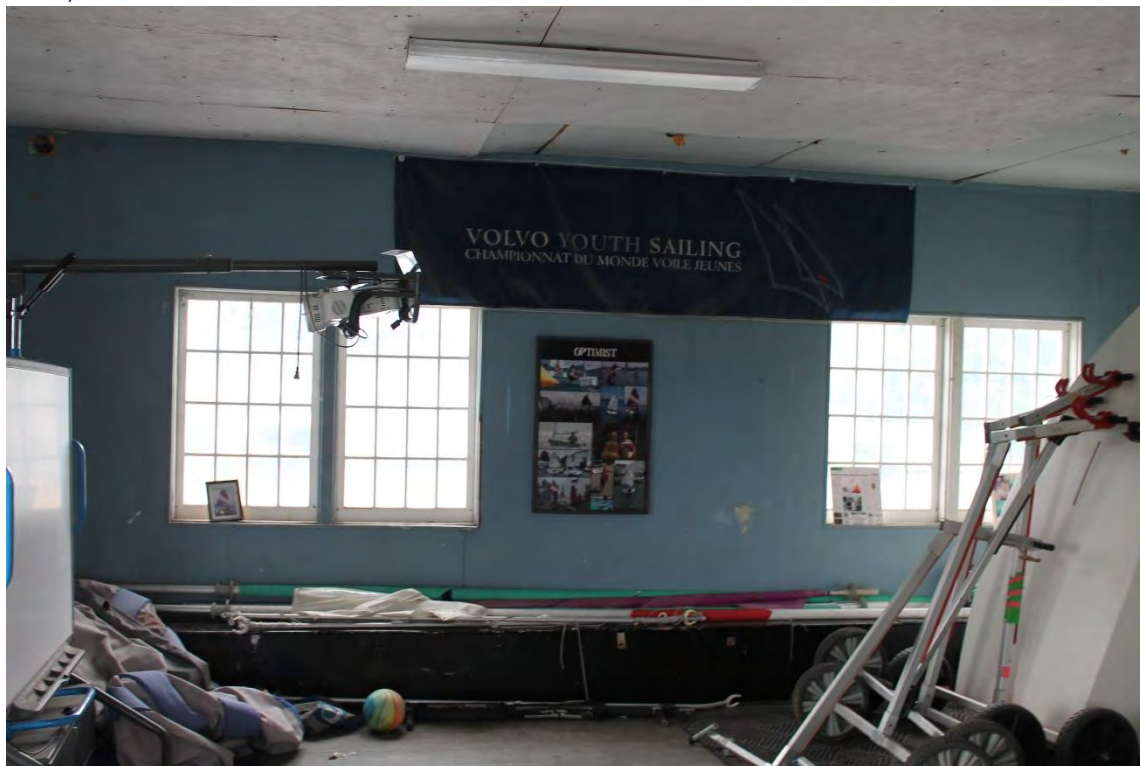
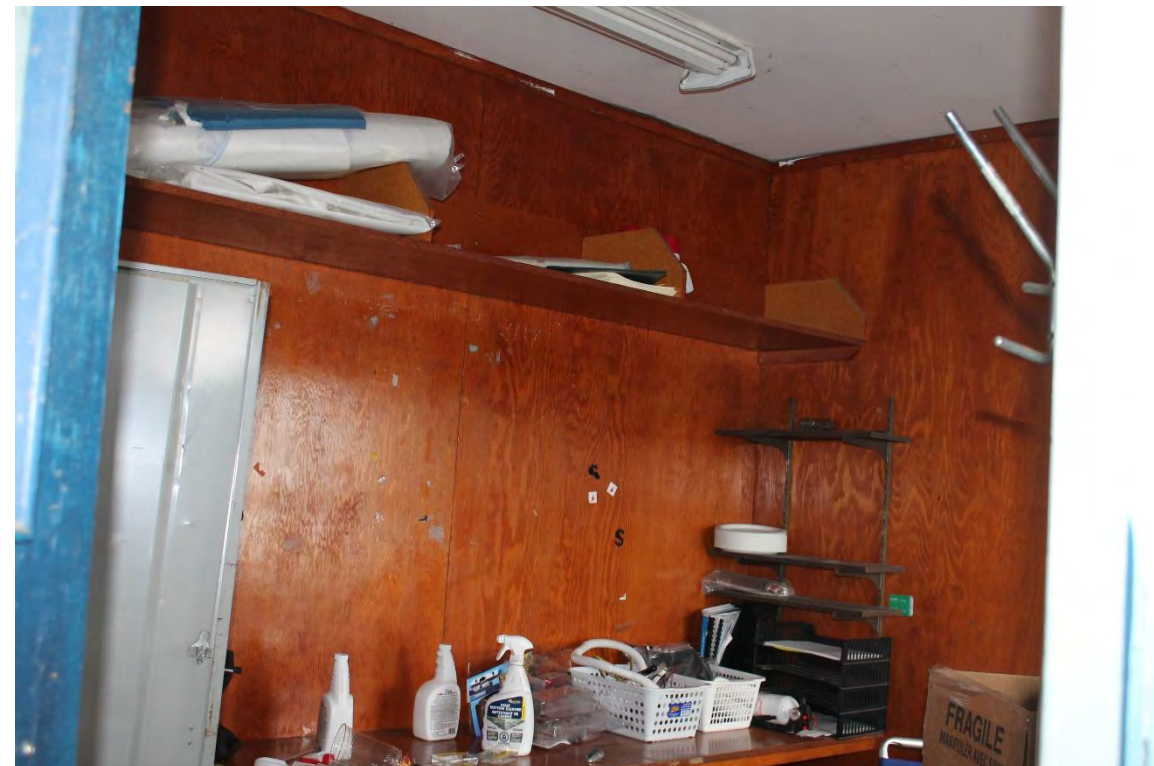
Photos 3 & 4: (left) View of south elevation, looking south from inside sailing school facility, (right) View of office area, looking south-west, (Source: MHBC, 2023)

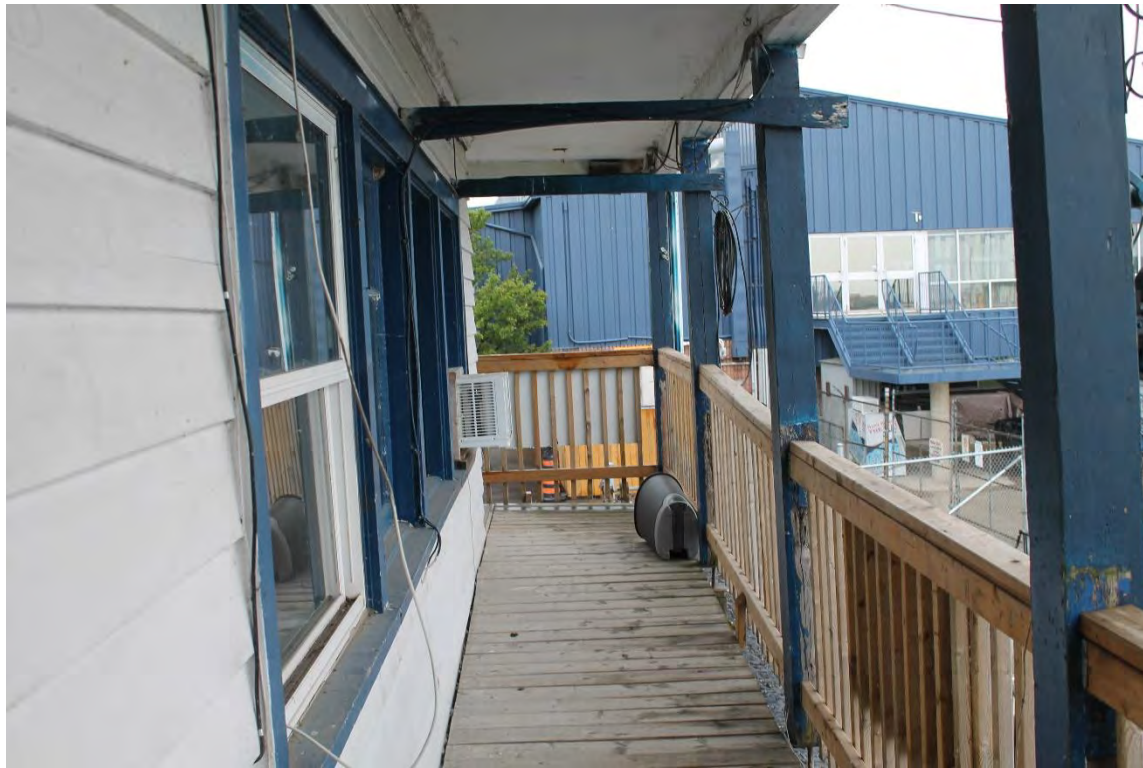
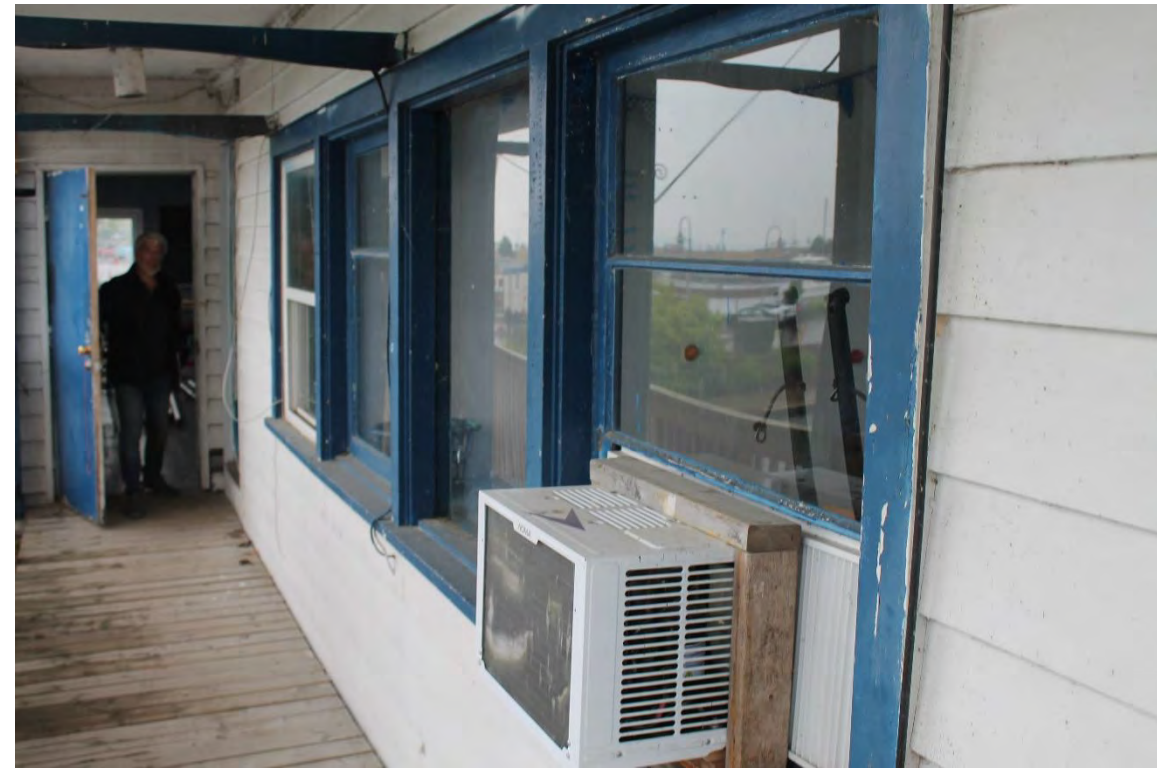
Photos 5 & 6: (left) View of exterior access (second storey) looking west along north elevation, (right) View exterior access (second storey), looking east along north elevation, (Source: MHBC: 2023)

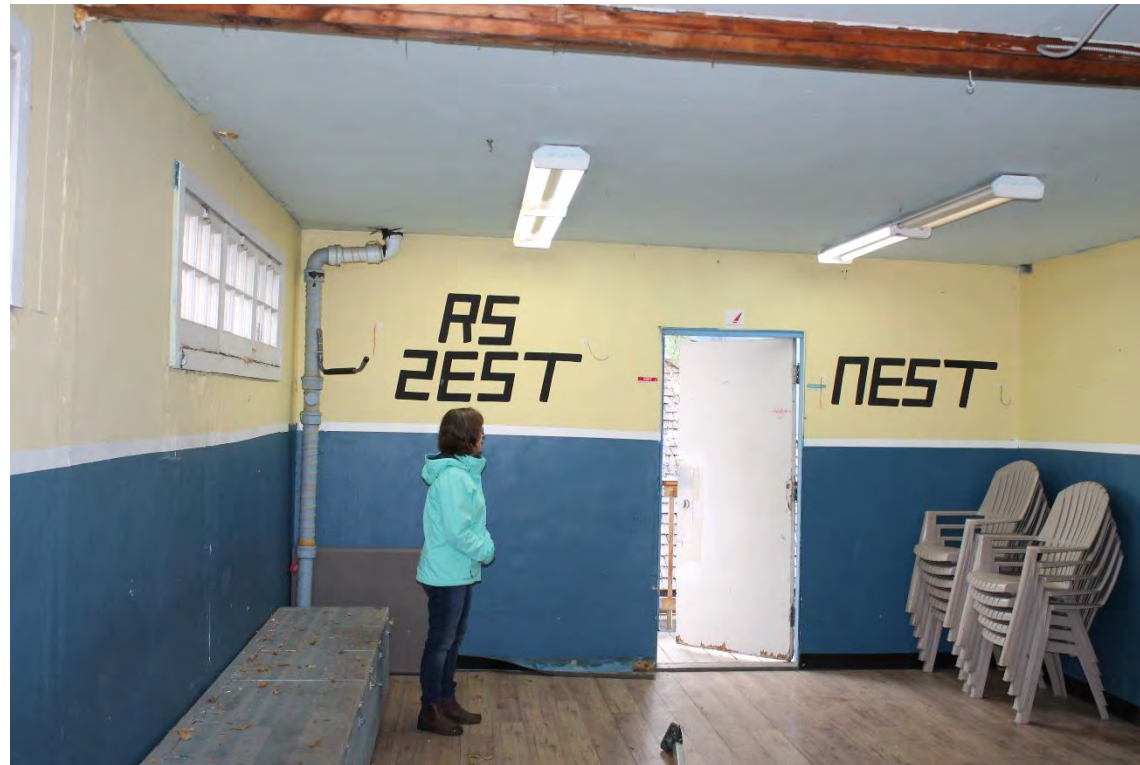
Photo 9: (left) View of classroom, looking west(Source: MHBC: 2023)

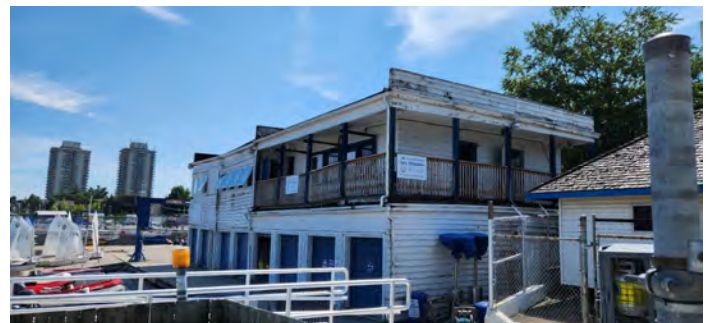
Photo 2: Exterior View of the Second Floor Balcony

In photograph 2, the roof line is visibly sagging down at the lakeside (left of the photo). The balcony post bases are resting on wood shims that appear to be rotting and will need some remediation.

As the building currently stands, it does have severe serviceability issues with the warping of the second floor, cracked slabs, balcony post bases as outlined above will need to be remediated. The major issues and cause of the tilting of the RHYC Junior Sail Building appears to be from the founding material below the footing structure being washed out. If not corrected, the condition will worsen to the point where the building is no longer serviceable. It is in our opinion to correct this issue; deep foundation system will need to be implemented. The cost of the installing such a system can be high due to its location, access and keeping the existing building intact. It is recommended to reach out to a geotechnical engineer to explore possible design solutions and feasibility of undertaking the repair.

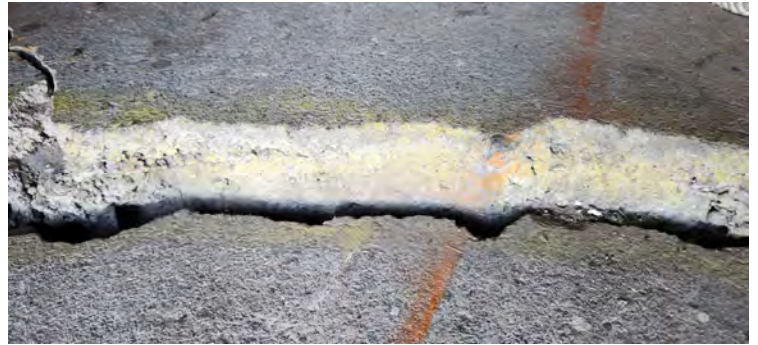
Photo 3: Close Up View of the Cracked Slab Inside the Lockers

The slab supporting the structure cracked and separated completely as shown in Photo 3. This photograph was taken in the open storage locker shown in Photo 2. This condition is consistent all along the lake side of the building.

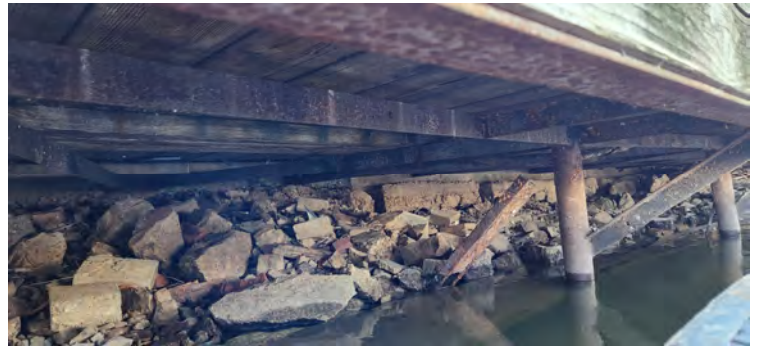
Photo 4: View Below the Deck Which Show the Exposed Foundation

MTE was able to view the foundation below the lockers from the underside of the deck. As can be seen from the right side of the photograph, large footings that were placed below the existing slab. This was a temporary remediation for the same issue done years prior.

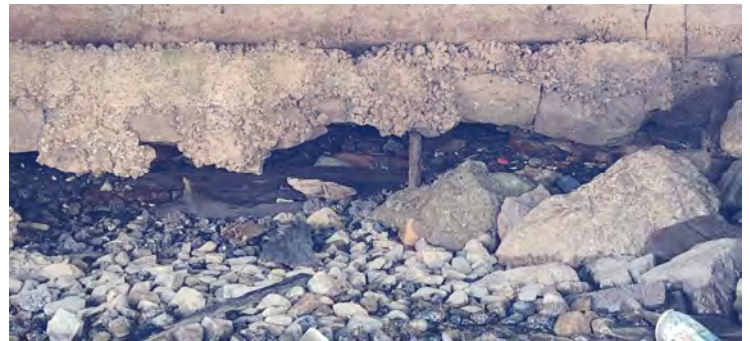
Photo 5: Close-up View of the Building Foundation

Photograph 5 is a close-up of the foundation. There is a large void below the footing and bearing material. It is believed that the founding soil is being washed out over time causing the building to tilt towards the lake.

The issues related to the footing structure of the building is an issue where, "If not corrected, the condition will worsen to the point where the building is no longer serviceable." In order to correct the issue, a deep foundation system would need to be implemented.
