FINAL REPORT FOR CHEDOKE CREEK WORK PLAN IMPLEMENTATION

CITY OF HAMILTON
71 MAIN STREET WEST, HAMILTON, ONTARIO L8P 4Y5

FINAL REPORT

DATE: JULY 12, 2024

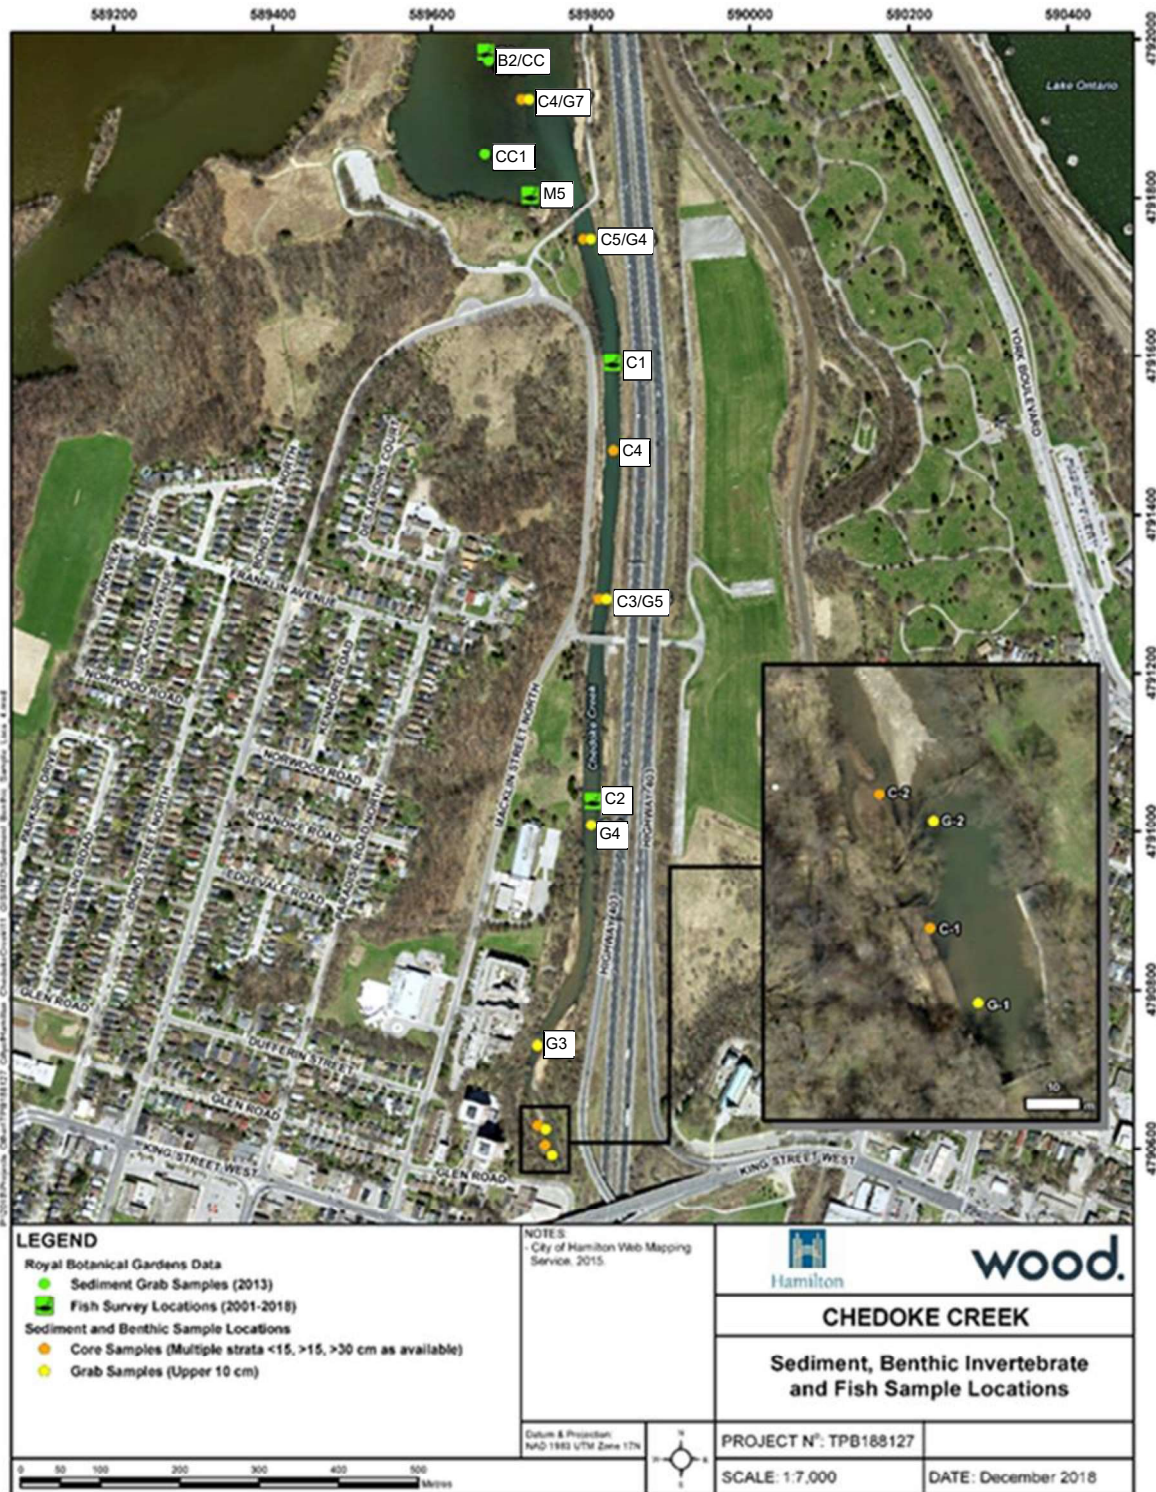
Figure 1.2: Sediment, Benthic Invertebrate and Fish Sampling Locations

Aquatic invertebrates were sampled in 2018 at the locations identified in **Figure 1.2**. Invertebrate abundance and diversity generally decreased from upstream to downstream, reflecting the reduction in habitat quality, as defined by sediment condition. The overall benthic community was dominated by pollutant-tolerant organisms typically found in

Fish data collected by the Royal Botanical Garden (RBG) from 2001 through August 2018 were evaluated, along with fish sampling data collected by WSP, from areas shown in **Figure 1.2** as part of the 2018 *Chedoke Creek Natural Environment and Sediment Quality Assessment and Remediation* Report. Data were normalized to catch per unit area. Fish abundance was variable over the period of record, but was, on average, highest at station C1, located about 250 m upstream of the outflow to Cootes Paradise. Fish abundance was also high at station M5, west of the Chedoke Creek discharge to Cootes Paradise. The greatest number of species, on average, was also found at C1.

Sediment quality nutrients of interest included ammonia+ammonium, total phosphorus (TP) and total Kjeldahl nitrogen (TKN), all of which were found in the highest concentration within the surface strata (0 to 15 cm) at the C-3/G-5 sample transect, specifically the C-3C sample location (**Figure 1.2**).

Previous sediment quality studies conducted by the RBG in 2006 and 2013 documented nutrient parameters at two locations (CC-1 and CC-2) positioned further northwest from the 2018 C-6/G-7 sample location (**Figure 1.2**). Pre-spill RBG data suggest that TKN enrichment had already occurred downstream in Cootes Paradise. Similarly, TP enrichment was found to have occurred downstream in Cootes Paradise prior to the event. The means and timeframe of TKN and TP enrichment remain unclear.

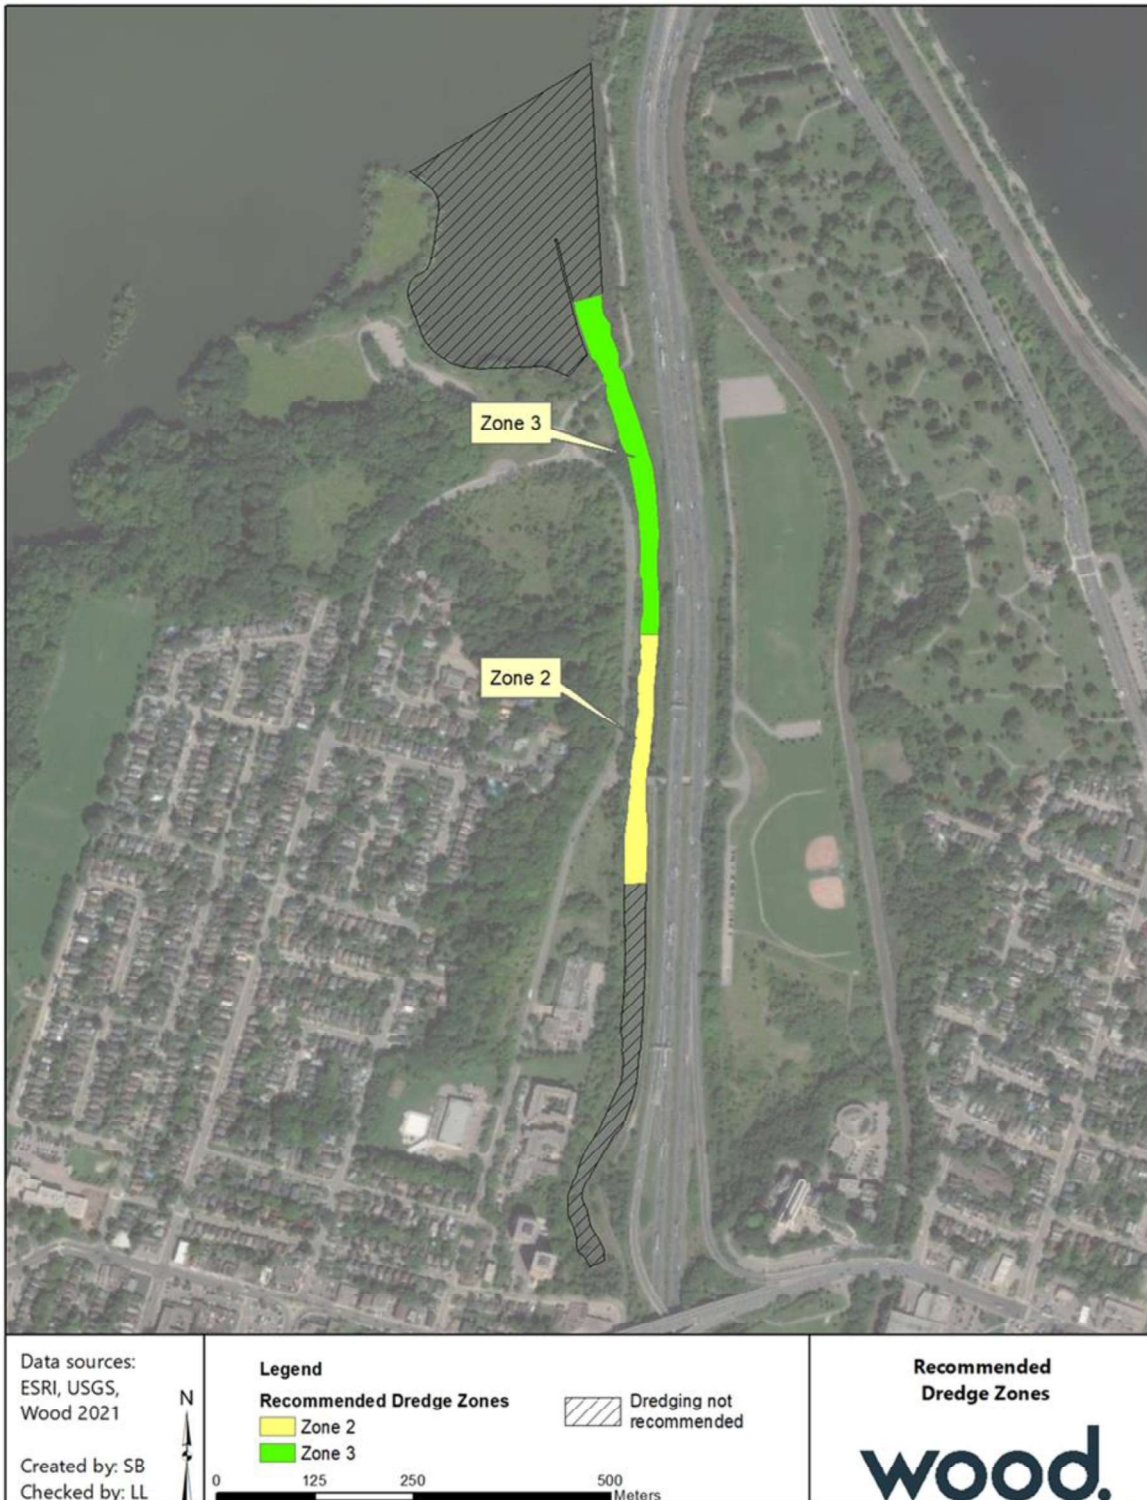
Figure 2.3: Recommended Dredge Zones 2 and 3.

WSP provided updated load reduction estimates for Zones 2 and 3 as shown in **Table 2.1** and updated target dredge elevations to 73.7 m IGLD (International Great Lakes Datum) in Zone 2 (average removal of ~ 0.5 m) and 73.4 m IGLD in Zone 3 (average removal of ~ 0.6 m). An estimated 10,674 m³ of material, comprised of 29 tonnes of TKN and 23 tonnes of TP, were estimated to be available for removal at the time of the assessment. After reviewing additional sediment chemistry data collected during Phase 2, WSP subsequently recommended a revised dredge target elevation of 73.5 m IGLD in Zone 2 (average removal of ~ 0.5 m) and a dredge target elevation of 73.0 m in Zone 3 (average removal of ~ 0.9 m) and a revised estimated total in-situ removal volume of 11,300 m³. The revised target dredge depths provided for additional TKN and TP mass removal while maintaining suitable quality of the remaining exposed sediment. Because the revised dredge volume estimate was similar to the previously determined volume estimate, the estimated TKN and TP mass removal was not revised pending the actual dredge volume removal following construction. WSP prepared several technical memoranda detailing the sediment chemistry and rationale for establishing the final dredge limits (**ref. Appendix C**), which were subsequently posted to the City's Chedoke Creek webpage (hamilton.ca/chedokecreek) and included the following:

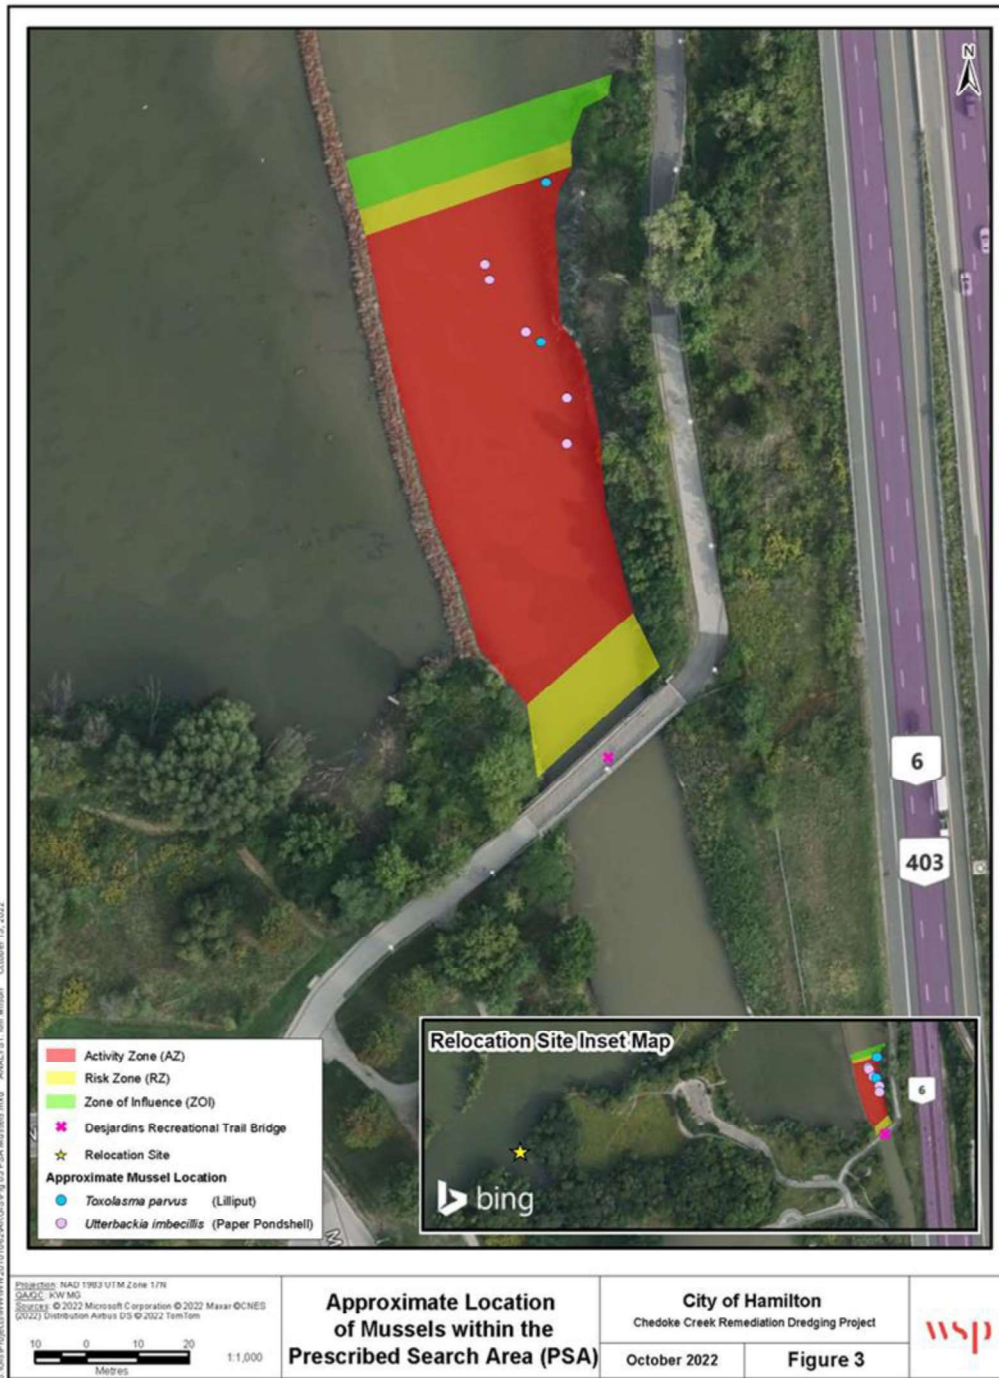
Figure 3.1: Mussel Search and Restoration Map.

WSP biologists initiated the mussel search and relocation project on June 6, 2022, starting at the downstream extent of the PSA (see **Figure 3.1**) by placing metal fence posts within the substrate and running floating line between them to delineate the search area. Initially (June 6 to 10, 2022), a team of two biologists worked from opposing banks, searching towards the middle by 1 m² grids placed upon the substrate. When a line was completely searched, the fence posts were moved upstream 1 m and the search was continued in the same fashion. A total of 20 lines, or approximately 720 of the 4,203 m² search area was completed within week one. During the search, one dead/relic Lilliput and two live Paper Pondshell (*Utterbackia imbecillis*) mussels were found with the live mussels relocated to the area identified within **Figure 3.1**.

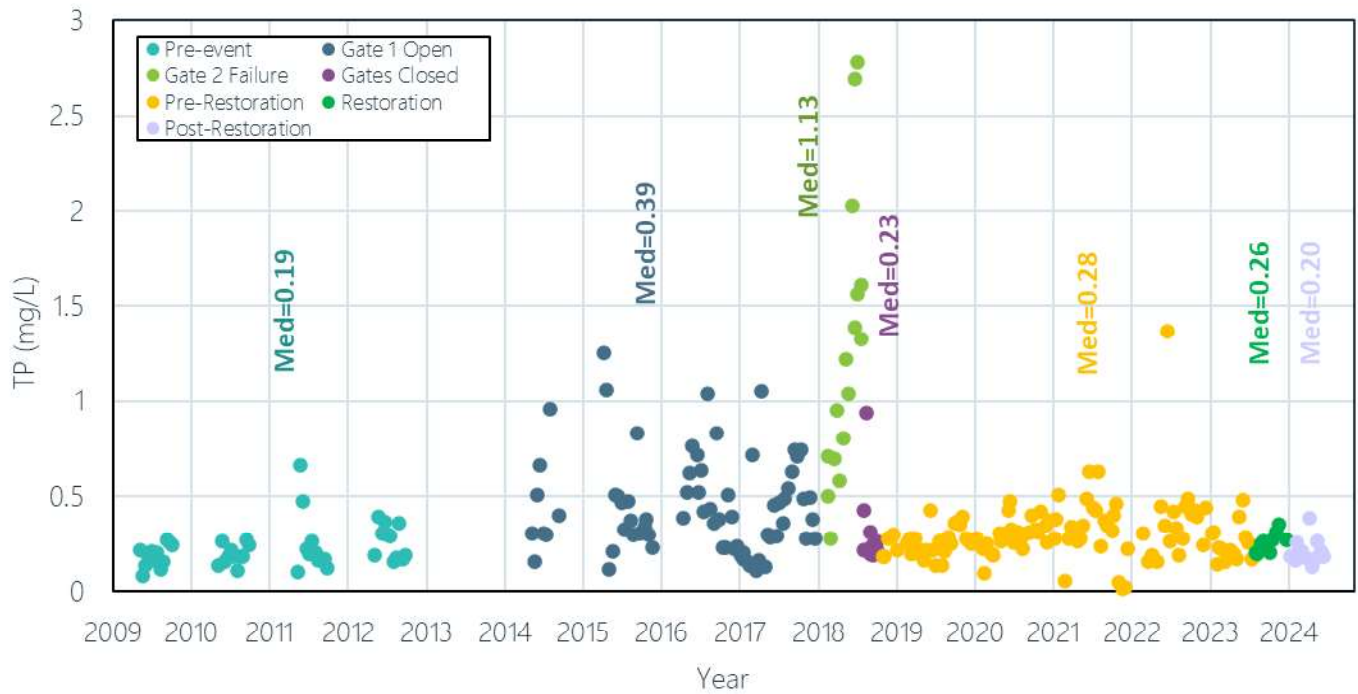
Figure 4.2: Chedoke Creek at CC-SW2/CP-11 TP Concentrations (2009 through 2024)

Total phosphorus data shown in **Figure 4.2** suggests TP concentrations at CC-SW2/CP-11 have continued to decrease through the pre-restoration, restoration, and post-restoration phases. The post-restoration TP median concentration of 0.20 mg/L is similar to the pre-event concentration of 0.19 mg/L and is less than 18% of TP median during the Gate 2 failure period.

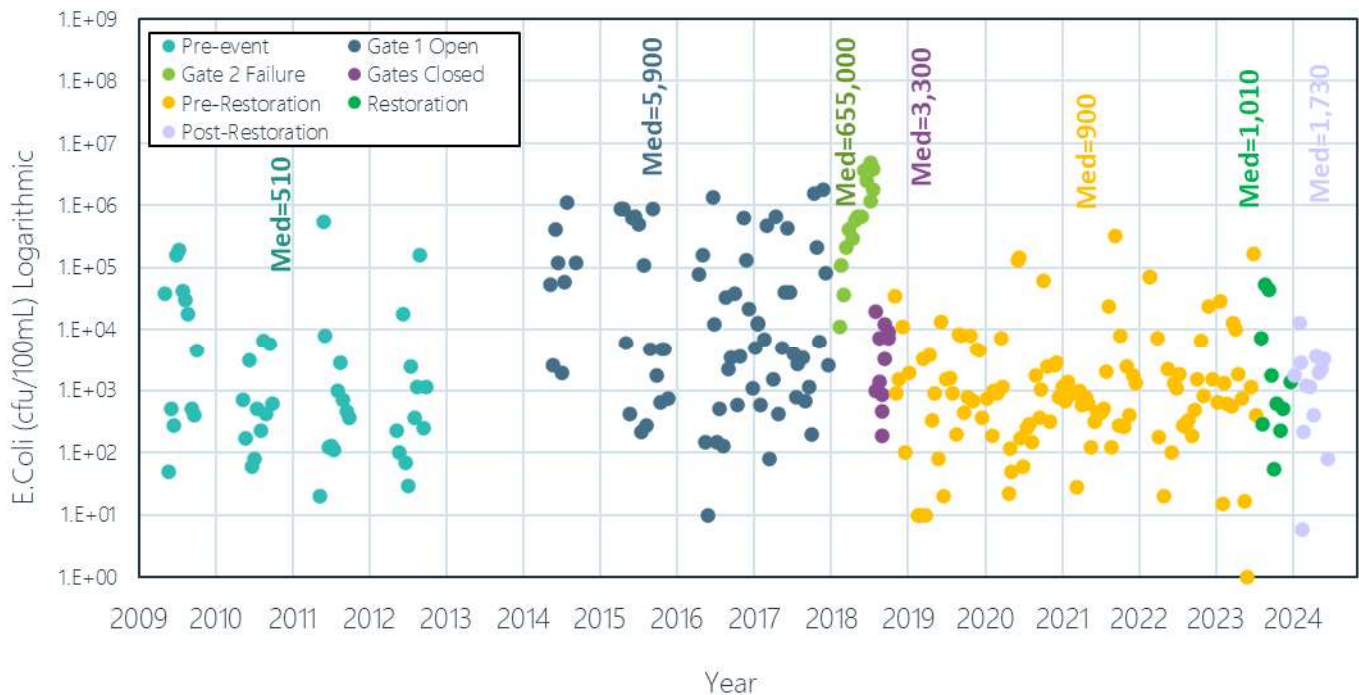
Figure 4.3: Chedoke Creek at CC-SW2/CP-11 E. coli Counts (2009 through 2024)

Median *E. coli* concentrations at CC-SW2/CP-11 shown in **Figure 4.3** suggest that *E. coli* counts returned to pre-event conditions following gate closure and have remained several orders of magnitude below the peak median concentration of 665,000 cfu/100 mL which occurred during the Gate 2 failure period.

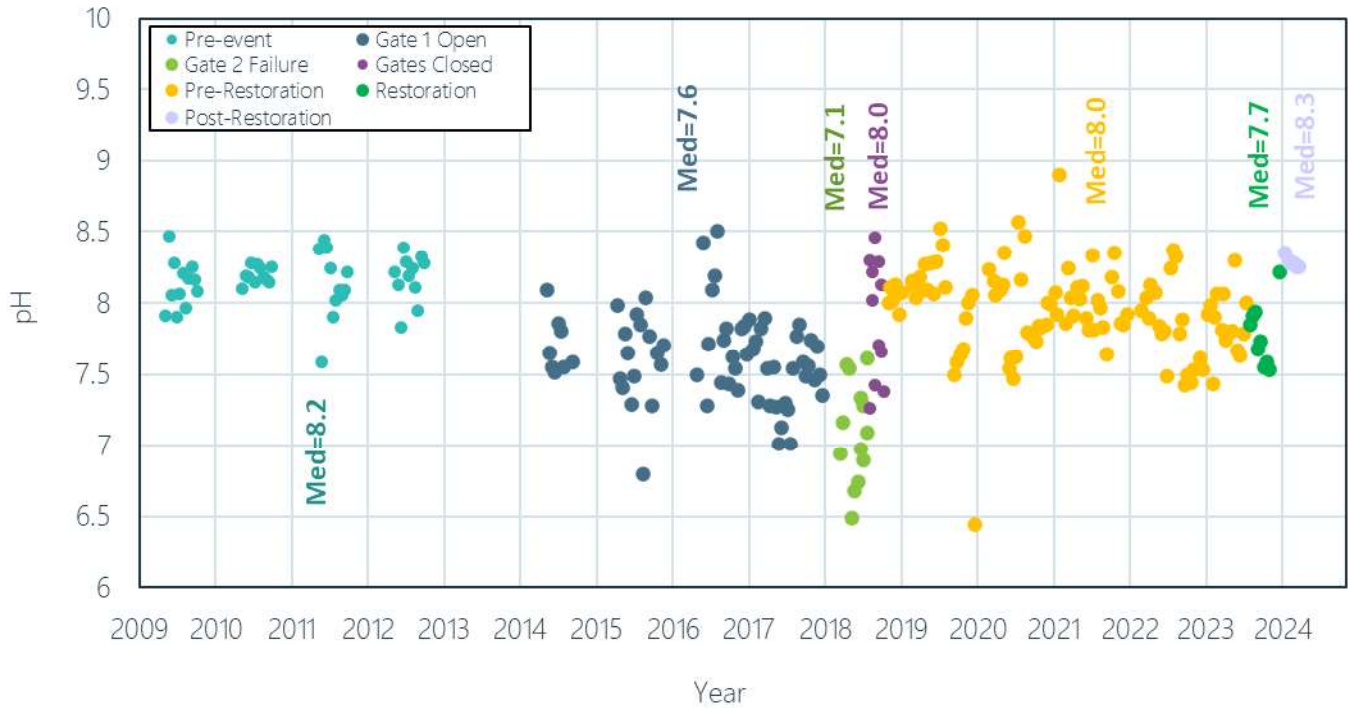
Figure 4.4: Chedoke Creek at CC-SW2/CP-11 pH (2009 through 2024)

Median pH values at CC-SW2/CP-11 shown in **Figure 4.5** indicate that pH returned to pre-spill conditions once the gates were closed. During the Gate 2 failure event, the median pH decreased to 7.1 which was likely a result of high carbon dioxide concentrations associated with wastewater loading. The post-restoration median pH of 8.3 is similar to the pre-spill median pH of 8.2.

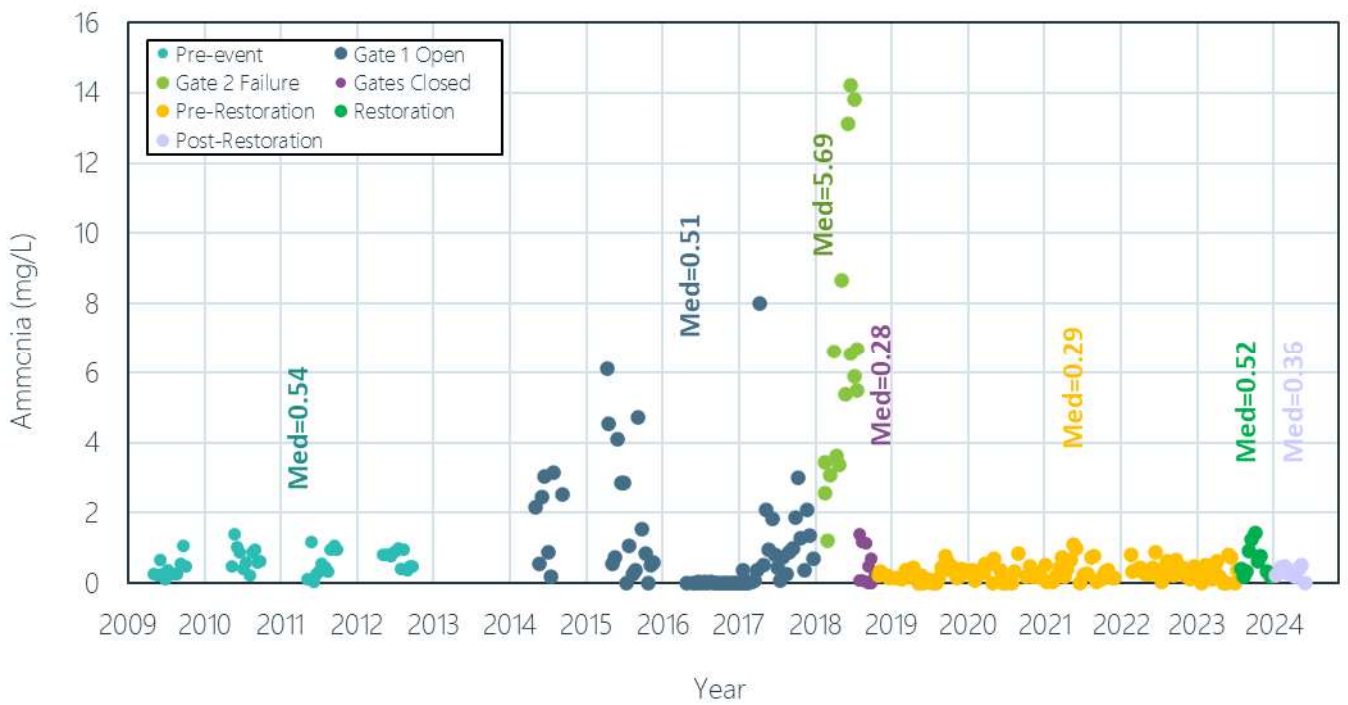
Figure 4.5: Chedoke Creek at CC-SW2/CP-11 Ammonia Concentrations (2009 through 2024)

Median ammonia concentrations at CC-SW2/CP-11 shown in **Figure 4.5** indicate water quality conditions following gate closure may be better than the pre-spill conditions. The median post-restoration ammonia concentration of 0.36 mg/L is only 67% of the pre-spill median concentration of 0.54 mg/L.

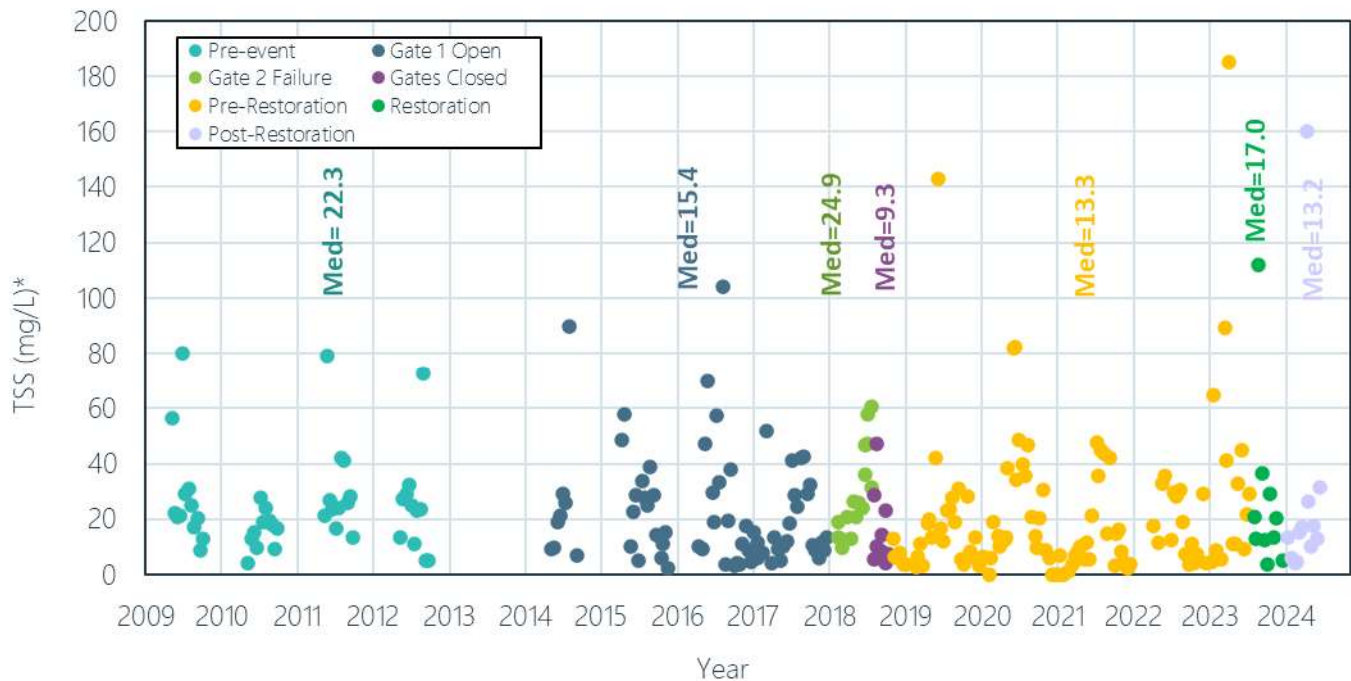
Figure 4.7: Chedoke Creek at CC-SW2/CP-11 TSS Concentrations (2009 through 2024)

Median TSS concentrations at CC-SW2/CP-11 are shown in **Figure 4.7**. Chedoke Creek is an urban drainage conveyance which typically has elevated and variable TSS concentrations depending on a variety of factors including rainfall duration and intensity, snowmelt, and others as discussed above. Median TSS concentrations were similar throughout the period of record and ranged from 9.3 mg/L to 24.9 mg/L. The median TSS concentrations for the pre-restoration (13.3 mg/L), restoration (17.0 mg/L) and post-restoration (13.2 mg/L) periods are all below the pre-event period TSS concentration of 22.3 mg/L.

*A TSS value of 1,020 mg/L measured on 6/15/2022 is not shown on the graph.
