Photographs

All images taken by City of Hamilton staff in July 2019 unless otherwise noted.

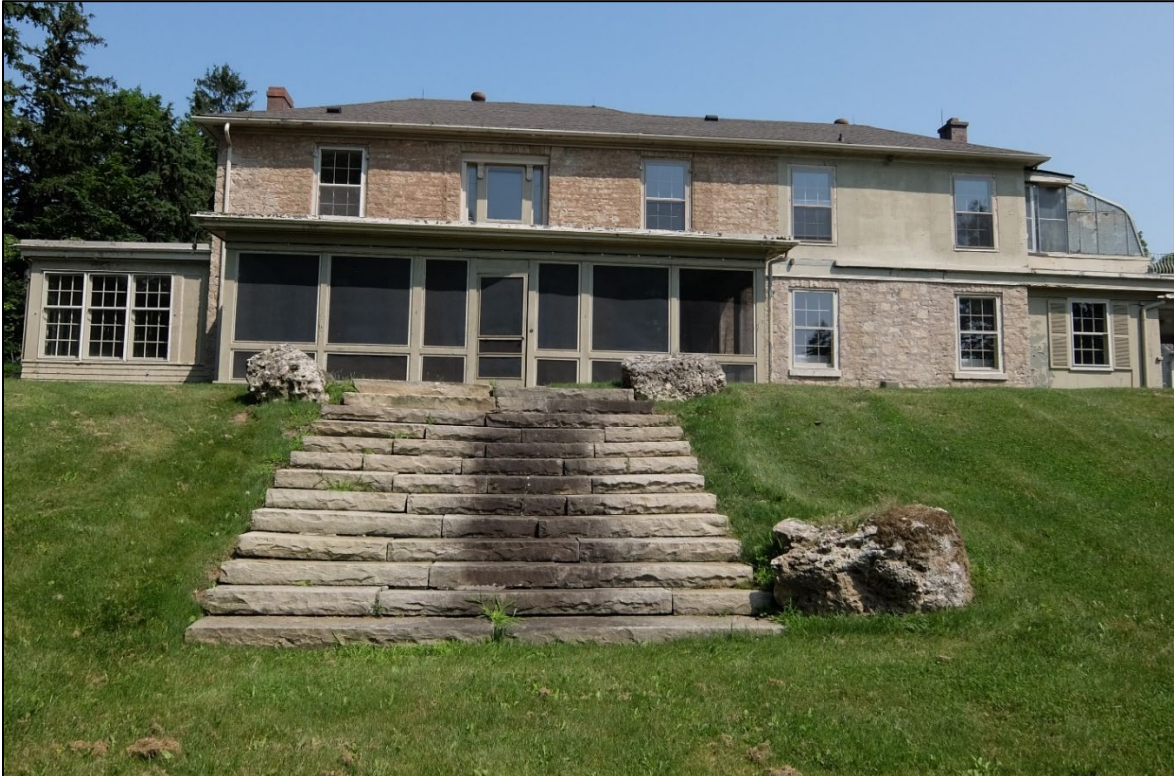
Figure 1: Front (south) elevation showing the central three-bay circa 1846 stone Neoclassical dwelling (middle), eastern stone addition (right) and one-storey western sunroom addition (left).

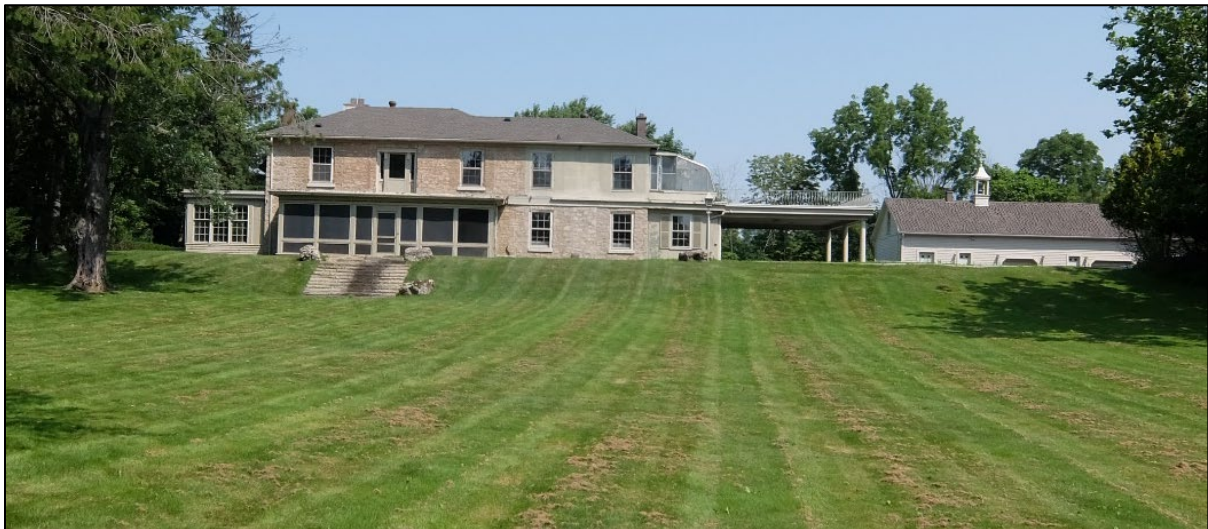
Figure 2: View of south (front) elevation of the building, showing the original circa 1846 Neoclassical residential building to the left, side additions with covered drive and detached accessory building.

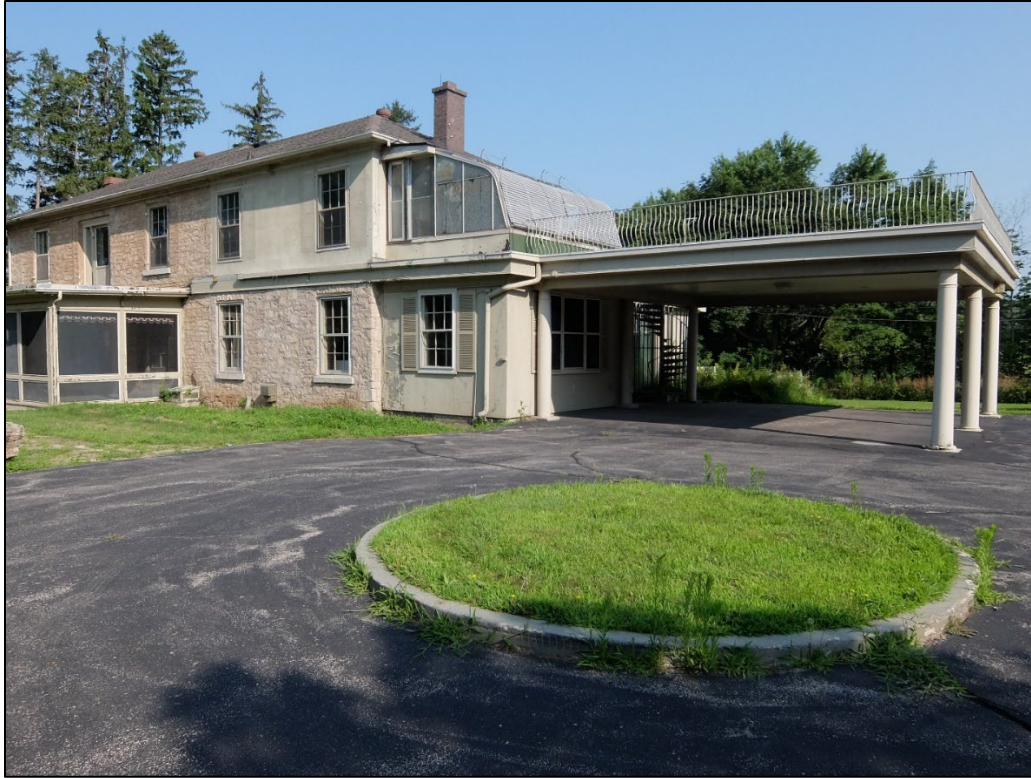
Figure 7: View of southwestern elevation showing side additions.

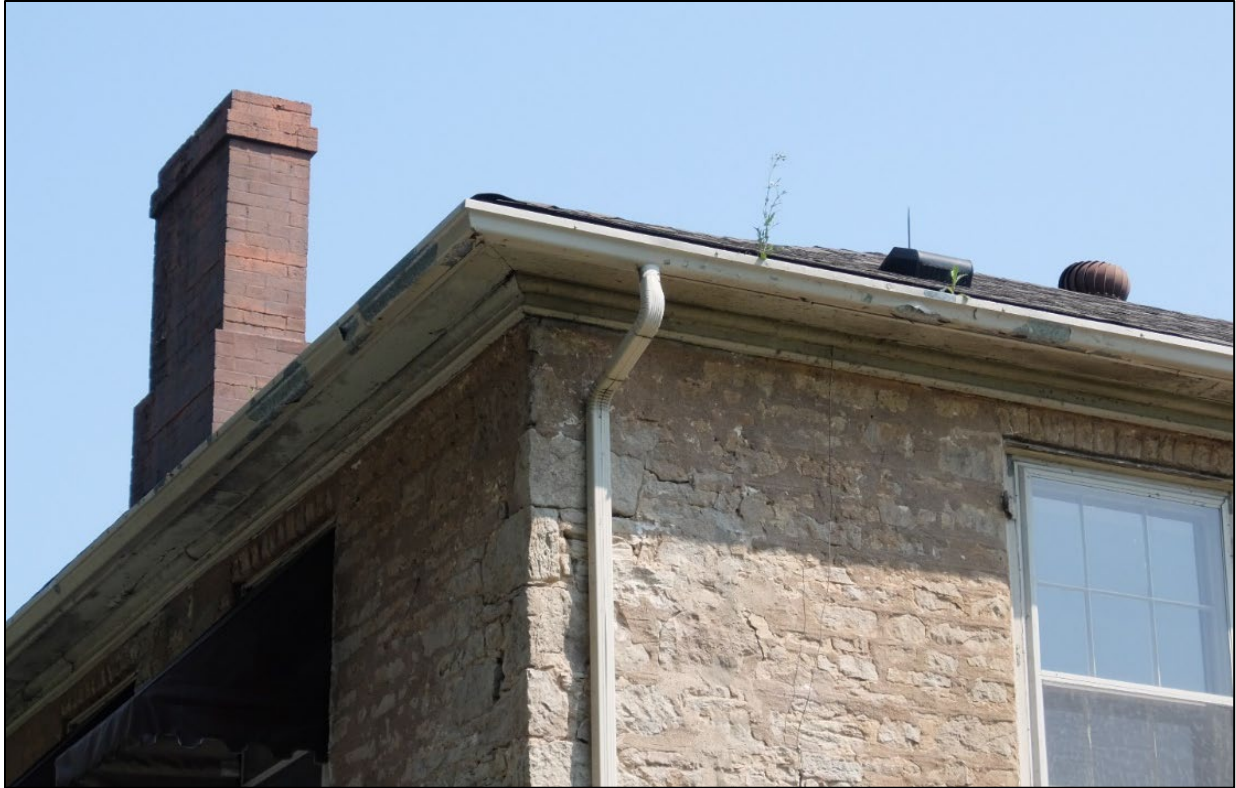
Figure 9: Detail view of eaves showing cornice.

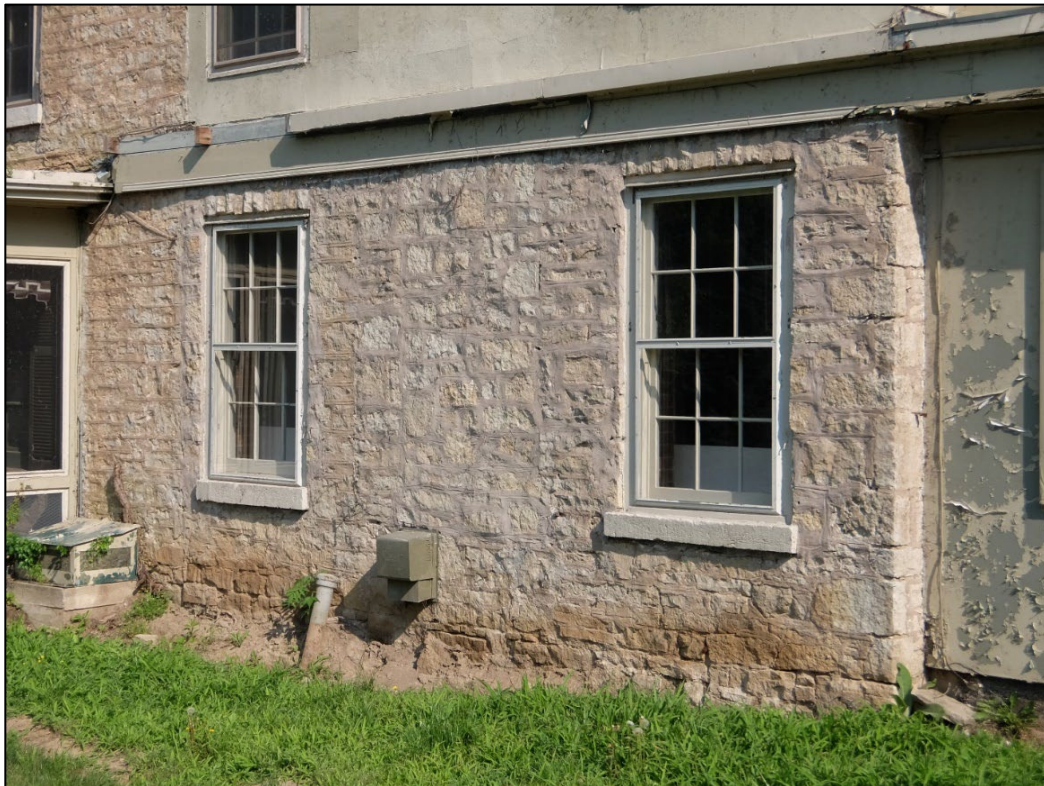
Figure 10: Detail view of the first storey of the circa 1860 eastern side addition.

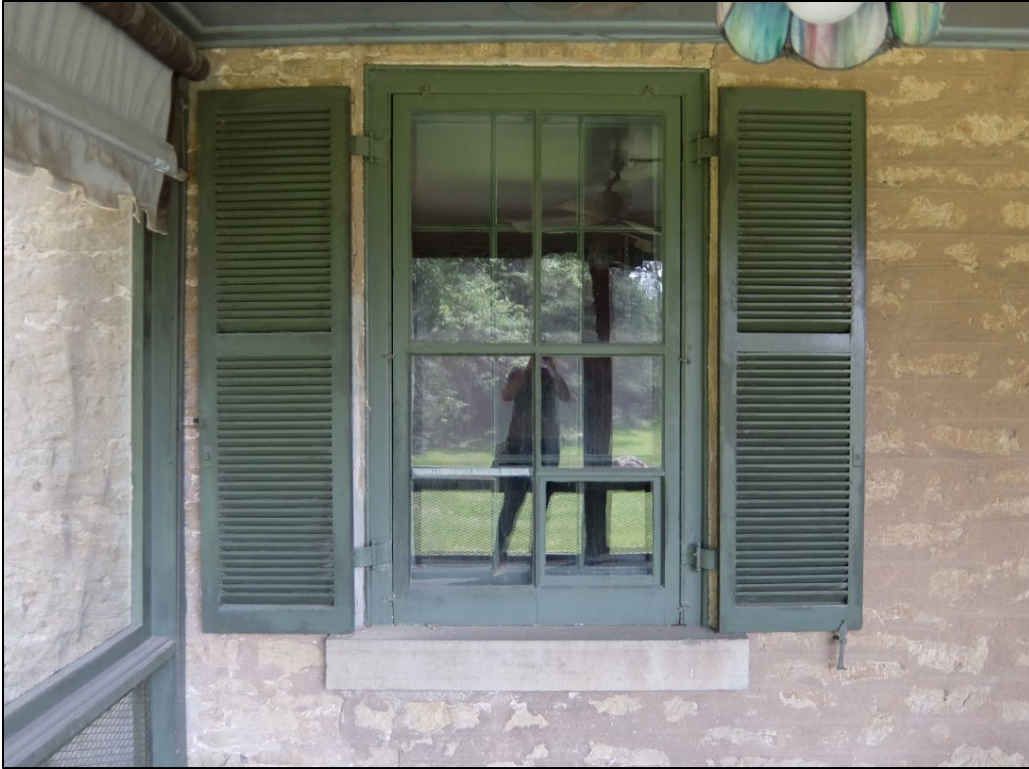
Figure 11: Detail view of window on south elevation showing wooden storms and shutters and stone sill.

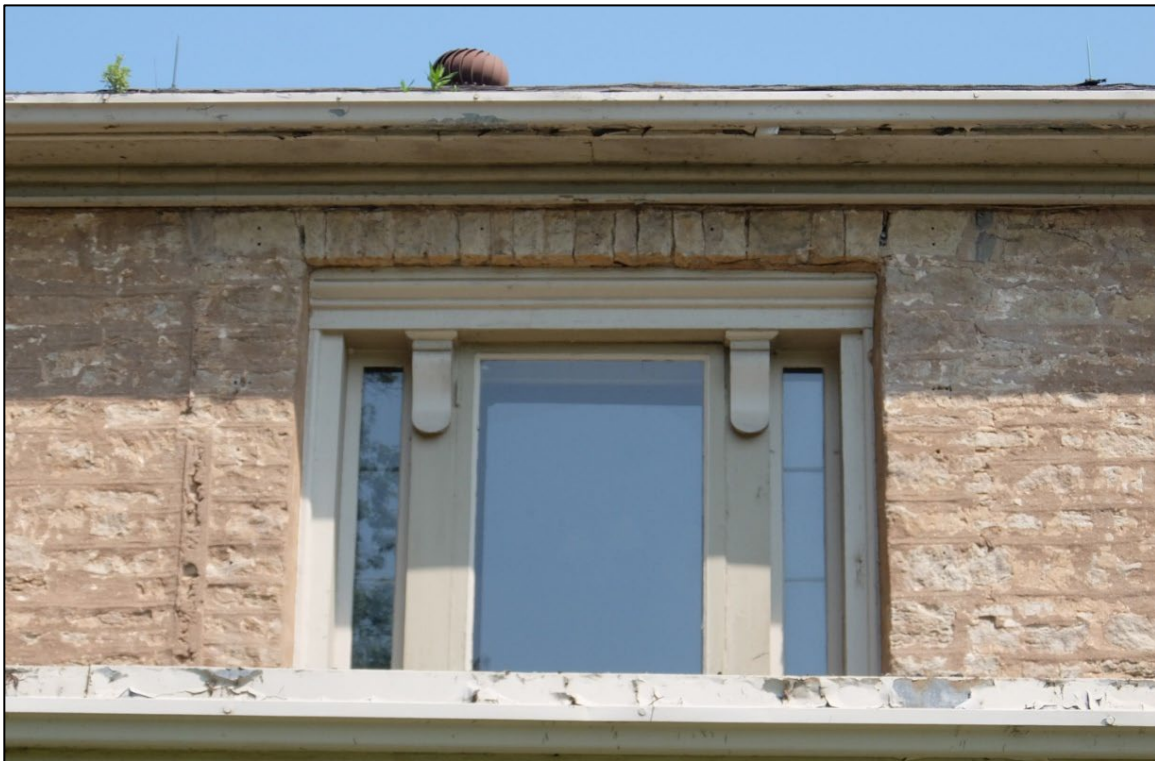
Figure 12: Detail view of Venetian window in the second storey of the south (front) elevation.

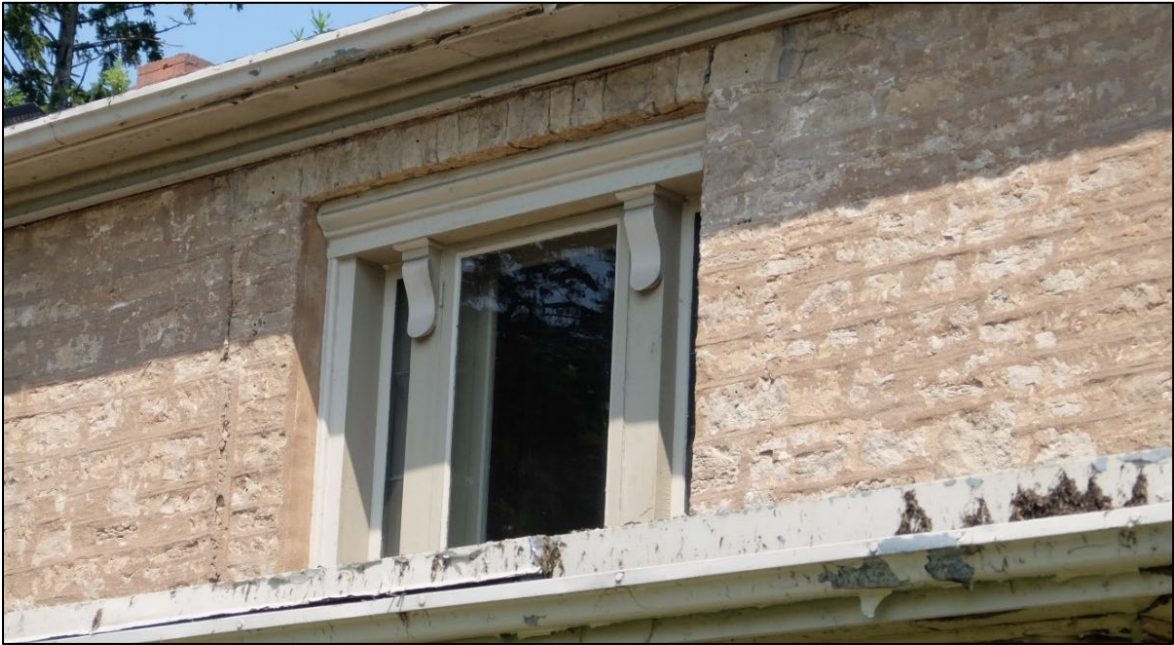
Figure 13: Detail view of Venetian window on south (front) elevation.

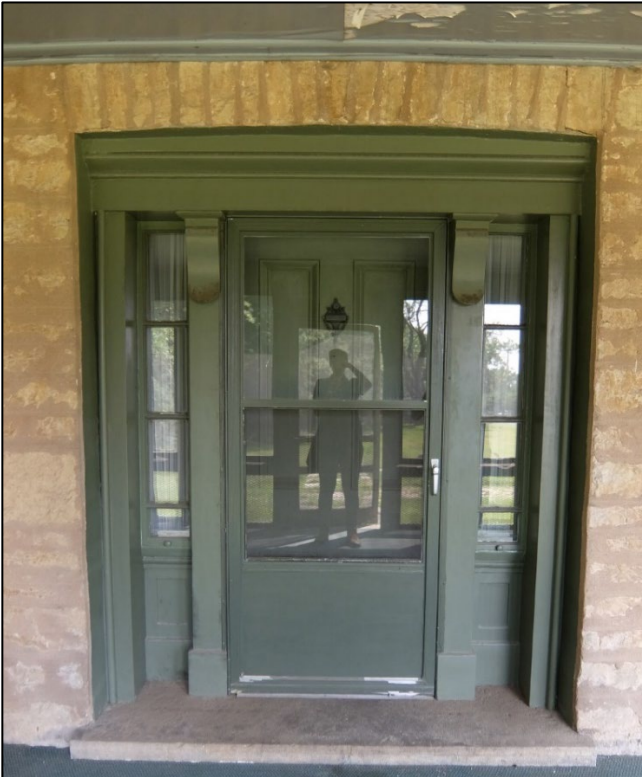
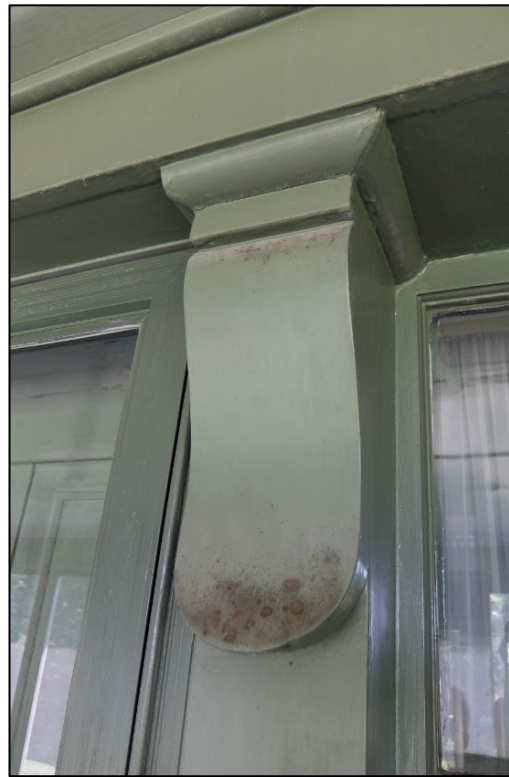
Figures 14 and 15: Detail view of the front entrance on south elevation, including sidelights and decorative wood detailing (left); Detail view of door surround on south elevation entrance (right).

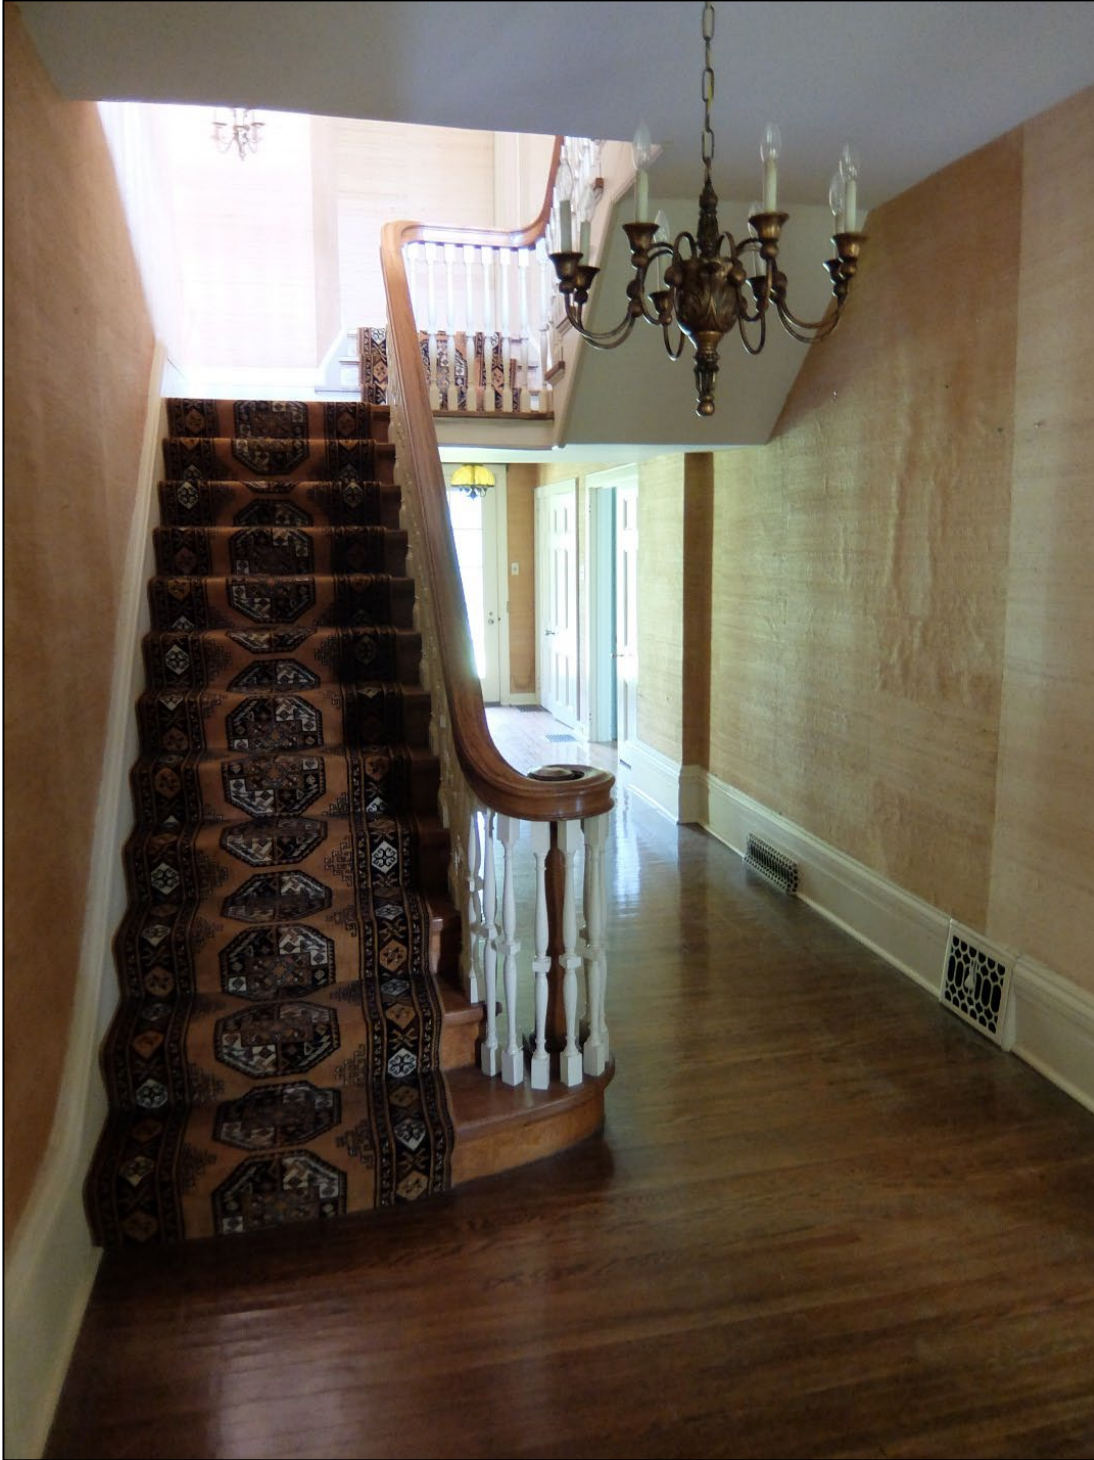
Figure 16: Interior view of property, showing central quarter-sawn American white oak staircase.
