BI-ANNUAL WQ TRENDING REVIEW

JANUARY 2023

PUBLIC WORKS
HAMILTON WATER

City of Hamilton's Surface Water Quality Program

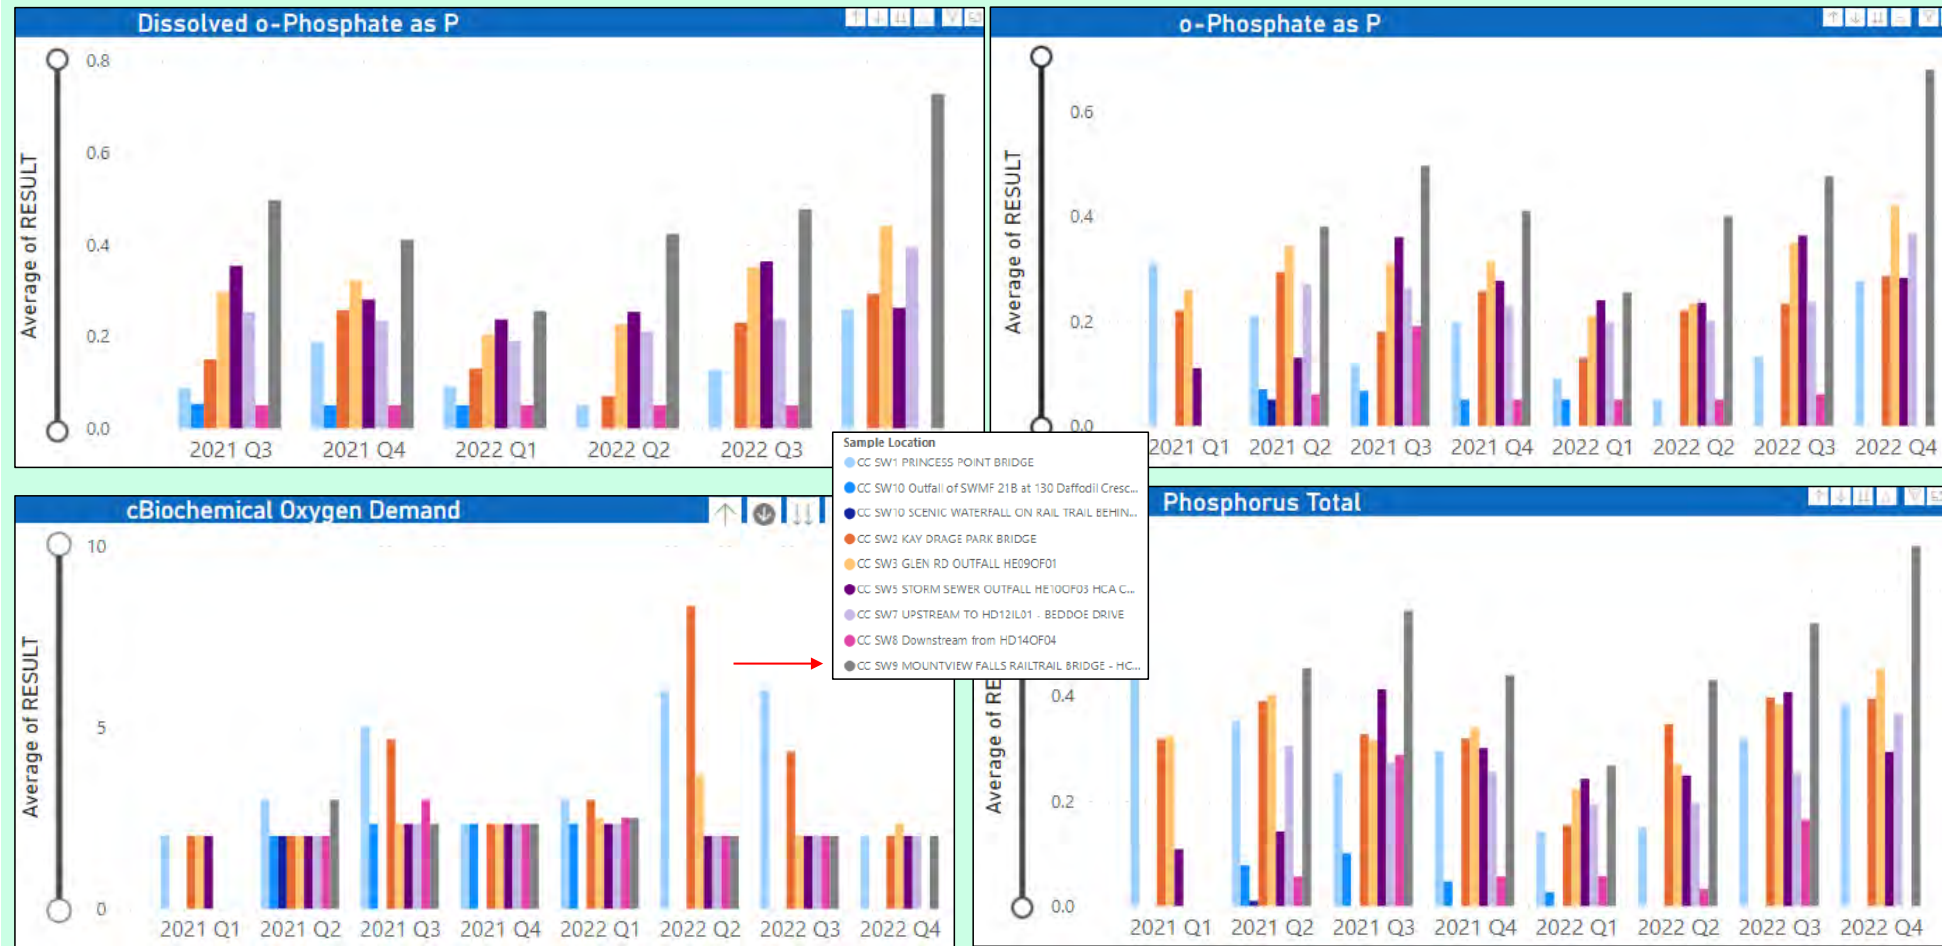
Chedoke Creek – Average Nutrient Results – Cont'd

WD dosing of ortho phos. = 3.1mg/L

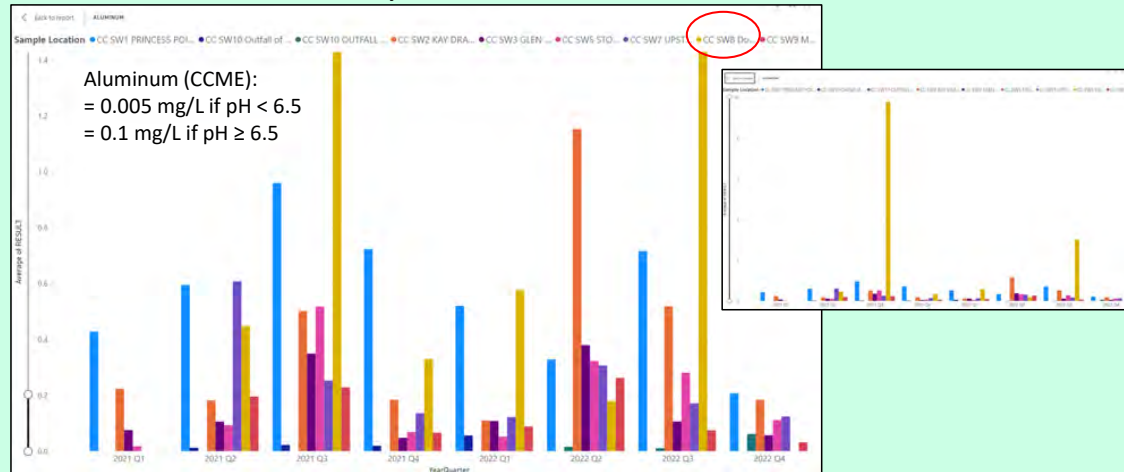
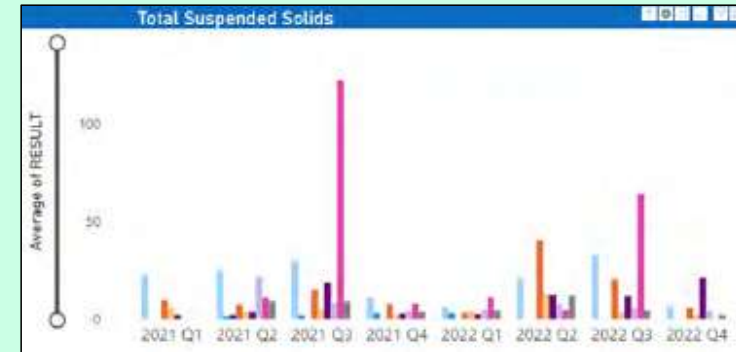
Chedoke Creek – Quarterly Results

- Sample Location
- CC SW1 PRINCESS POINT BRIDGE
 - CC SW10 Outfall of SWVF 21B at 130 Daffodil Cres...
 - CC SW10 SCENIC WATERFALL ON RAIL TRAIL BEHIN...
 - CC SW2 KAY DRAGE PARK BRIDGE
 - CC SW3 GLEN RD OUTFALL HE090F01
 - CC SWS STORM SEWER OUTFALL HE100F03 HCA C...
 - CC SW7 UPSTREAM TO HD12IL01 - BEDDIE DRIVE
 - CC SW8 Downstream from HD140F04
 - CC SW9 MCUNTVIEW FALLS RAILTRAIL BRIDGE - HC...

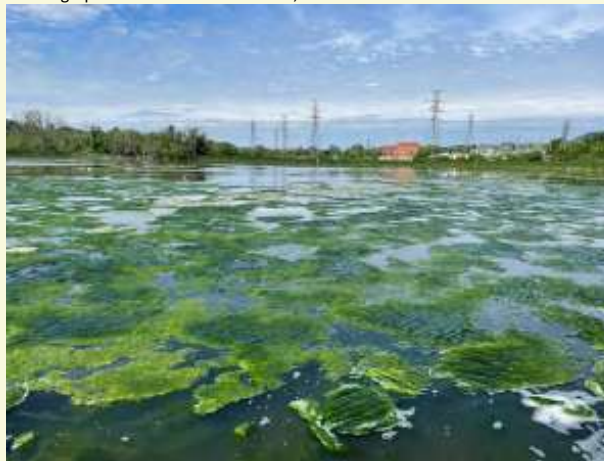
Photograph of West Pond on June 20, 2022

- West Pond area is a 1.5 km long inlet of West Cootes Paradise Marsh; acting as the **mixing zone for the DWWTP** before it joins with Spencer Creek.

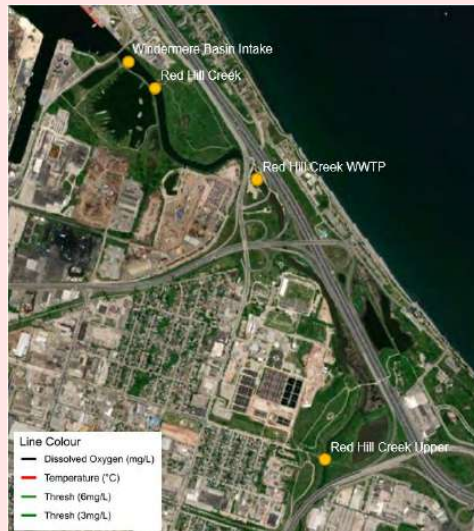
Analysis Suggests:
 HWWTP discharge disrupts the natural dissolved oxygen signal in Red Hill Creek

Variation in temperature and dissolved oxygen in 2020

LOCATION	PARAMETER OF CONCERN	OTHER INFORMATION
City's RHV SW1 & SW2 (downstream to WWTP)	Lower DO & higher temperatures, Phosphorus (including Ortho), Ammonia (including Unionized), Nutrients	Additional time and samples needed to determine how new outfall location and effluent is influencing WQ in lower RHC.
WUP Locations – long term WWTP outfall study	NA	WQT reviewed WUP's 2022 Report. No updates to provide – similar trends noted from previous years.
DFO's DOT Program	DO & Temperature	As water flows downstream from Upper Red Hill Creek (City's SWQP RVH SW3 – Rennie Brampton), you can see that the natural cycle of dissolved oxygen disappears downstream of the HWWTP.

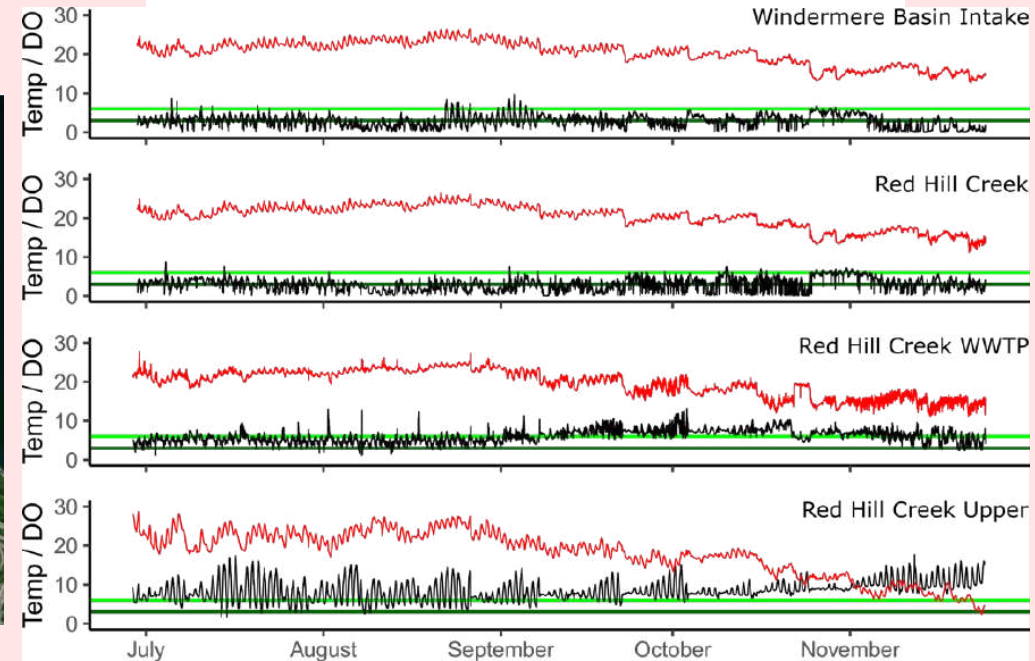
To understand how Red Hill Creek is influenced by human activity, **4 loggers were placed** moving from the less impacted upstream site (Red Hill Creek Upstream) to more impacted (most downstream site being Windermere Basin Intake).

As **water flows downstream** (move from bottom to top in the graphs) you can see that the **natural cycle in dissolved oxygen disappears**. In addition, the amount of time that the dissolved oxygen falls below the two DO thresholds depicted increases, reducing the quality of nearby fish habitat.

These **changes in DO are likely the result of WWTP effluent disrupting the natural dynamics** (changes in temperature and DO, as well as changes to water chemistry that affect stream biota, i.e. phytoplankton and bacterial communities that contribute to DO). As this creek water is being directly pumped into Windermere Basin, Red Hill Creek water quality will have a direct effect on the water quality within the basin.

As water flows downstream from Red Hill Creek Upper (City SWQP RVH SW3), you can see that the natural cycle in dissolved oxygen disappears downstream of the HWWTP.

Changes in DO are likely the result of WWTP effluent disrupting the natural dynamics (changes in temperature and DO, as well as changes to water chemistry that affect stream biota, i.e. phytoplankton and bacterial communities that contribute to DO).

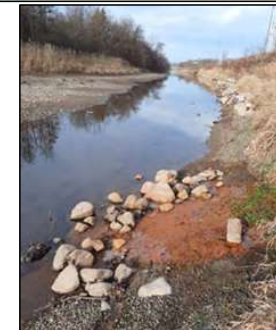
Note 1: Kay Dredge Park Storm Pipe

LOCATION	PARAMETER OF CONCERN	OTHER INFORMATION
Multiple along lower Chedoke Creek Locations	Multiple Parameters	Dredging on-going.
Kay Dredge Park	NA	Recycling & Waste Department working with contractors to CCTV drainage pipes within closed landfill and along lower CC.
