SEMI- ANNUAL DATA REVIEW: City of Hamilton's Surface Water Quality Program

April 25 2024

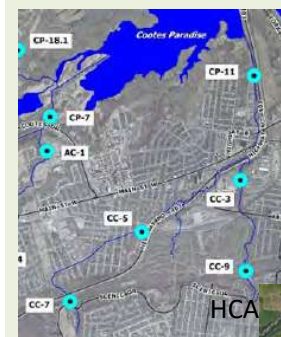
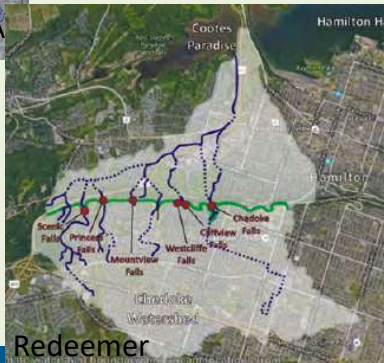
Landfill Leachate Seep @ Storm pipe between CC SW2 & CC SW3	N/A (Landfills)	CCTV inspection completed; seep was identified. Landfills have retained Dillon Consulting; pipe is beyond the limit of waste & current leachate collection system.

Leachate @ Stormwater drainage pipe: Completed CCTV inspection. Seep was identified. Pipe is partially lined; considering to line the remainder of the pipe.

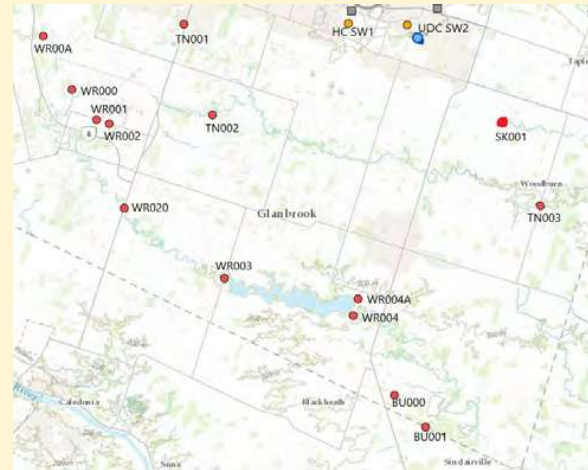
LOCATION	PARAMETERS OF INTEREST	OTHER INFORMATION
NPCA	Total Phos. = 96% of samples Chloride & Zinc = WRO02	NPCA monitors twelve (12) SW sites within the <u>CoH</u> Two of the sites were added in 2023 from the City's SWQP Phase II. Lake <u>Niapenco</u> in Binbrook Conservation Area is also monitored throughout the year. Chloride & Zinc commonly exceeds downstream to the Hamilton International Airport.

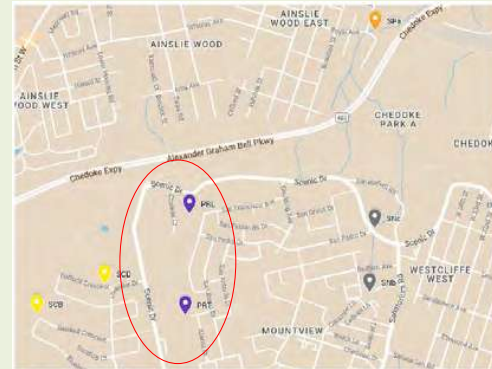
Table 2. Analysis Results of Chedoke Outflow samples.

PRL and PRT: elevated levels of all WQ parameters = indicate sewage of contamination.

Location	Nitrate (ppm)	Phosphate (ppm)	Total Phosphorus (ppm)	Chloride (ppm)	BOD ₅ (mg/L)	Total Coliform (CFU/100mL)	E. coli (CFU/100mL)
SCB	3.07	0.149	0.258	73.099	5.6	25267	200
SCD	1.80	0.058	0.050	142.938	1.4	3267	67
PRL	4.15	0.929	1.039	190.716	7.6	160667	81333
PRT	2.46	0.353	0.403	329.908	5.0	157200	34267
SNb	2.35	0.046	0.044	279.552	1.5	2533	200
SNc	1.84	0.052	0.037	369.704	1.2	16467	6600
SPa	2.63	0.121	0.113	213.796	1.3	16533	1467

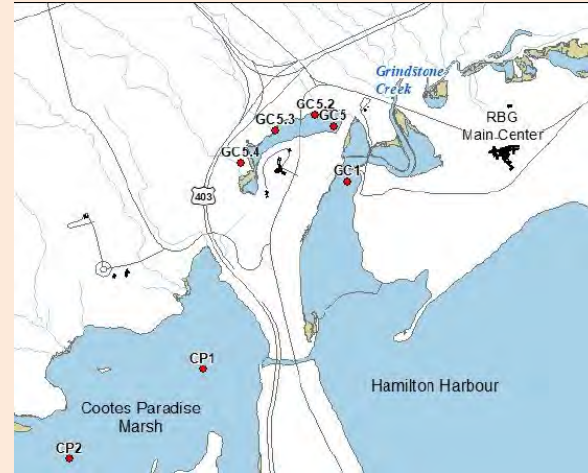
Parameters	HHRAP Targets Cootes/Grindstone		Guidelines	Grindstone Sampling Stations	
	Initial	Proposed Final		1	5
Secchi (m)	>1.5/>1			0.42**	0.35
Temperature (°C)				19.36	20.77
pH				8.32	8.06
Chl a (µg/l)	<20			8.02	-
Turbidity (NTU)		<4 / <8		16.54	21.05
DO (mg/L)	>5	>5 for 80% of samples and >3 for 95% of samples		8.35	7.00
TP (µg/L)	60 – 70		<30 ^{1,3}	97.37	133.56
Nitrate-N (mg/L)			<3.0 ¹	0.76	-
Nitrite-N (mg/L)	< 0.06			0.03	-
Un-ionized Ammonia (mg/L)	<0.02	<0.02	<0.02 ³	0.004	0.0003
TSS (mg/L)	<25	<10 / <14		25.40	24.62
ISS (mg/L)				6.31	16.11
E. coli (#/100 mL)			<1000 ²	97	16

Water quality parameters (mean values) measured during the entire 2023 field season (May 3rd to September 27th); initial and proposed final HHRAP targets associated delisting stations in Cootes Paradise Marsh (CP2) and Grindstone Marsh (GC1) are also listed.

Values highlighted in bold exceed targets/guidelines.

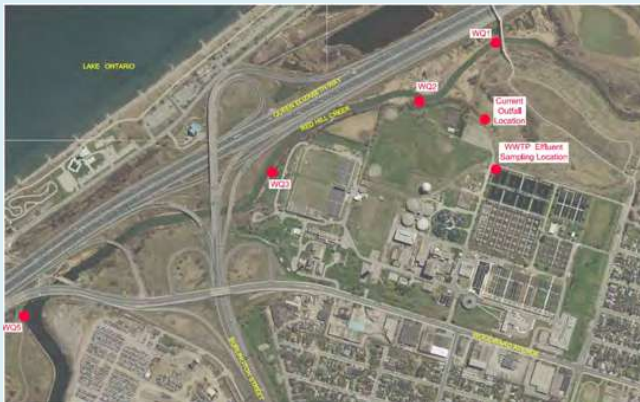
WUP Data

- Metal concentrations such as Copper, Lead, Iron, Zinc are consistently high; **Boron and Cobalt concentrations should continue to be specifically monitored for trends** in future years;
- Nutrient based parameters (**Nitrate/Nitrite, TKN, Total Phosphorous, Ammonia**) generally do show a consistent **upward trend downstream** for the sample locations;
- PWQO exceedances at the upstream monitoring locations (**WQ1, WWTP effluent**) were **consistently lower** than those further downstream (WQ2, WQ3, WQ5); and
- A **consistent number of PWQO exceedances** was noted for the majority of the samples collected in 2023, these exceedances were **for parameters which typically exceed PWQO limits for urban watercourses** (metals, E. Coli).

WUP WQ Locations	Nutrients Metals	Metal concentrations such as Copper, Lead, Iron, Zinc are consistently high; Boron and Cobalt concentrations should continue to be specifically monitored for trends in future years; Nutrient based parameters (Nitrate/Nitrite, TKN, Total Phosphorous, Ammonia) generally do show a consistent upward trend downstream for the sample locations; and PWQO exceedances at the upstream monitoring locations (WQ1, WWTP effluent) were consistently lower than those further downstream (WQ2, WQ3, WQ5);

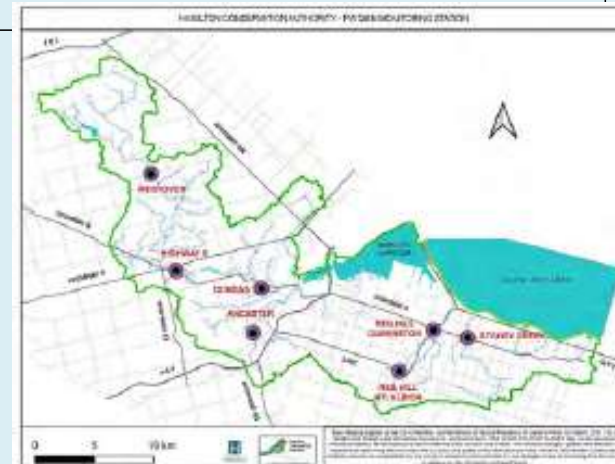
- Red Hill Creek at Mt. Albion exceeded every sample event in 2023
- Red Hill Creek at Queenston Road exceeded on 5/7 samples in 2023
- Since sampling began in 2003 E.coli in Red Hill are experiencing an increasing trend in concentration
- HCA's analysis suggests that a steady source of E.coli within this creek could potentially be located near the Mt. Albion location
- Downstream at Queenston, E.coli concentrations suggest there is a dilution effect taking place within Red Hill Creek

UO SW1 & HCA's Mt. Albion (<u>Ecoli</u>)	Chloride, <u>Ec. coli</u> , Zinc	HCA's analysis suggests that a steady source of <u>Ec. coli</u> within this creek could potentially be located near the Mt. Albion location
