CULTURAL HERITAGE IMPACT ASSESSMENT ADDENDUM

46-48 Ferguson Avenue South
Hamilton, ON

FINAL REPORT

Project #: LHC0463

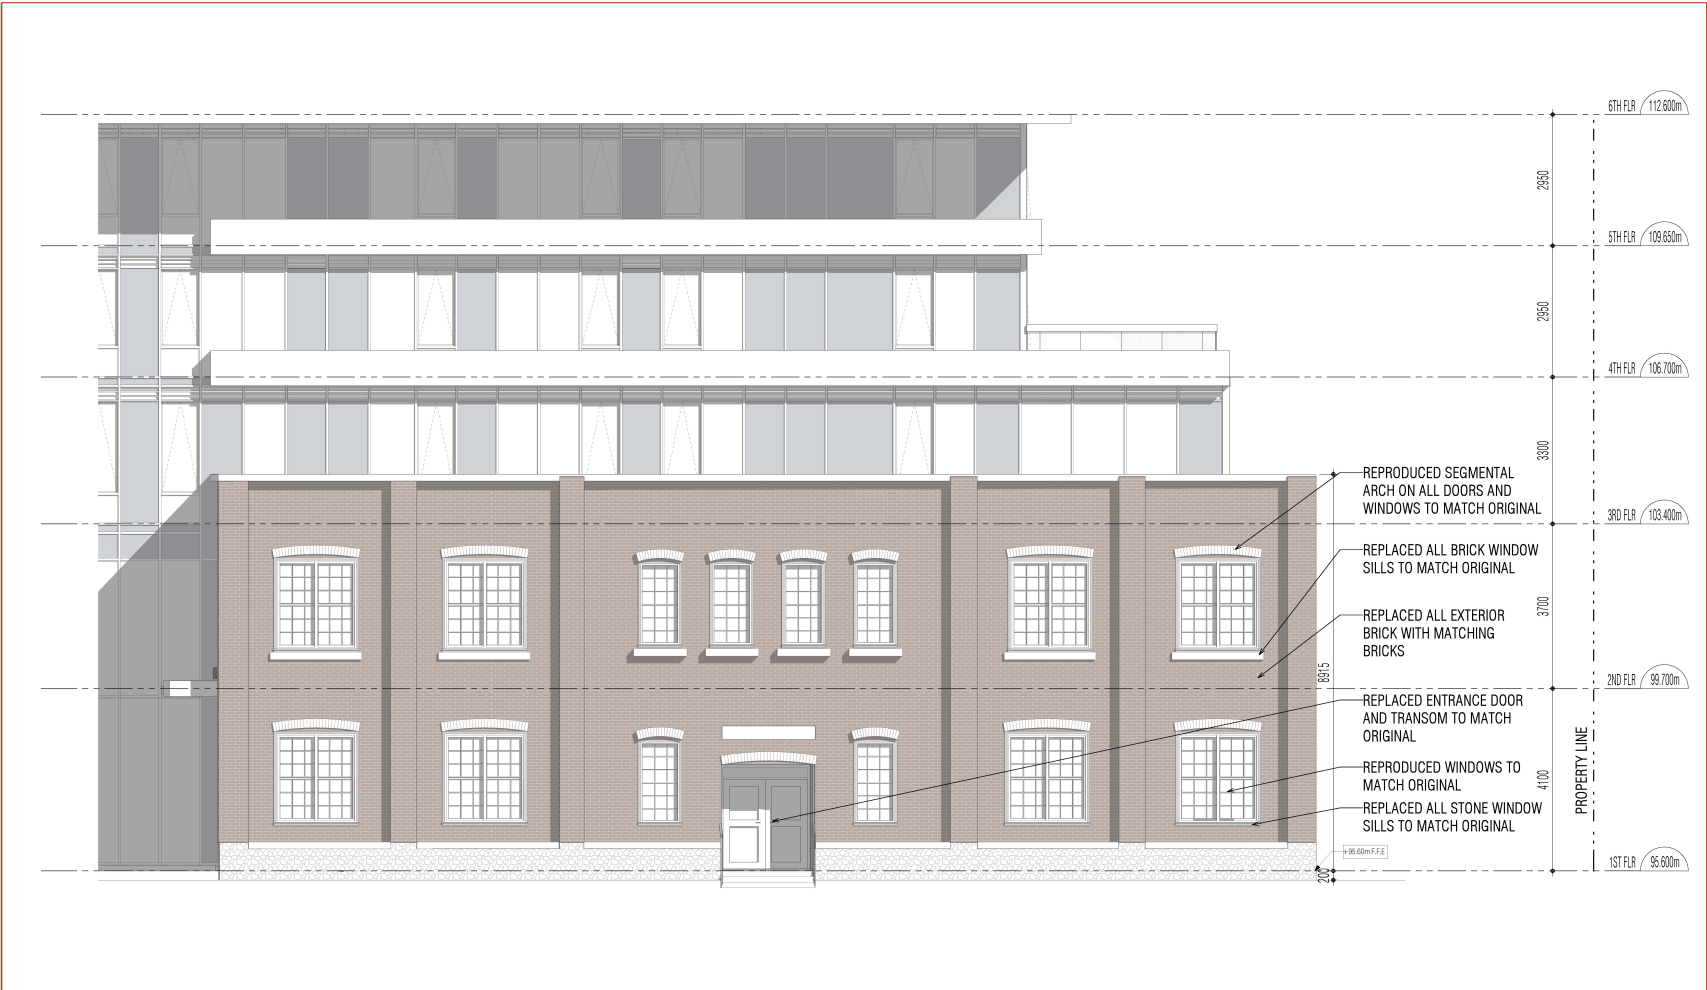
Figure 5. Detailed East Elevation of the Recreated Podium (Graziani + Corazza Architects)

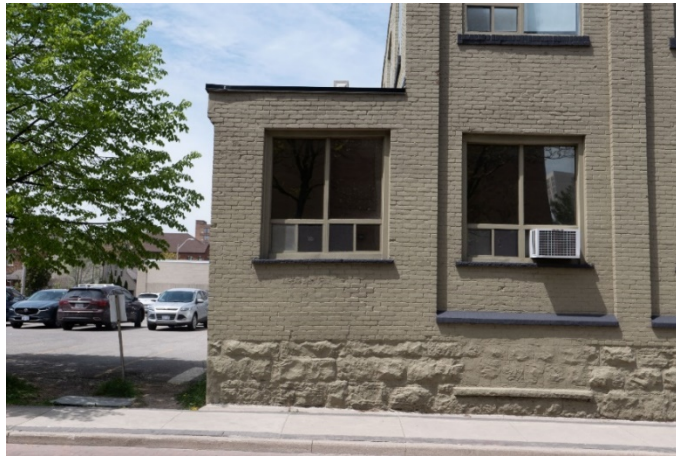
Figure 6: Non-original flat window openings seen on south end of the main elevation and south addition.

The building has been enlarged and modified numerous times. Original window and door openings feature segmental arches, while modified openings have flat lintels (Figure 6). The windows are not original, being double aluminium types with small sliding sashes. A number of window or loading door openings have been infilled on the rear and side elevations, likely to accommodate new elevator technology (Figure 7). Previous window openings to the basement in the raised foundation have since been infilled with masonry block and struck with false masonry joints. Several seams are evident in the brickwork of the north, west and south elevations, suggesting which portions of the building preceded others. A three bay one-storey addition has also been added to the south elevation.

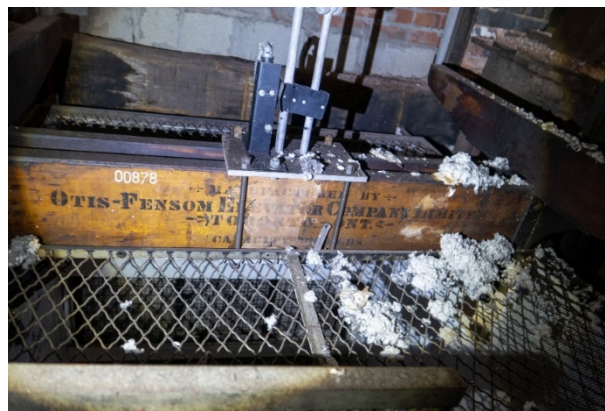
Figure 19: Otis-Fensom top beam of the elevator car.

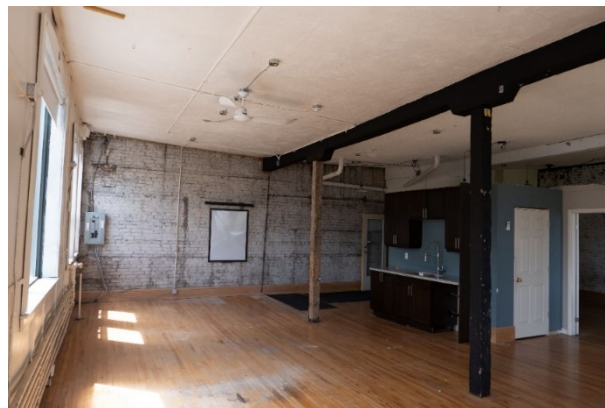
Figure 20: View of party wall and wooden posts at the second floor level.

The second storey contains four spaces to be independently occupied, accessed via central corridor with washrooms. These spaces contain full and partial partitions to suit various uses. Exposed wooden posts, beams and brick walls are found throughout the spaces (Figure 20).

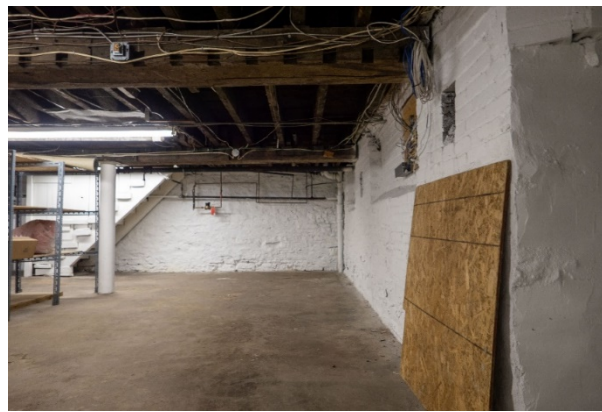
Figure 21: Looking south from the northeast quadrant of the basement at the party wall separating 46 and 48 Ferguson. The former rear foundation wall is at right, with previous window openings visible.

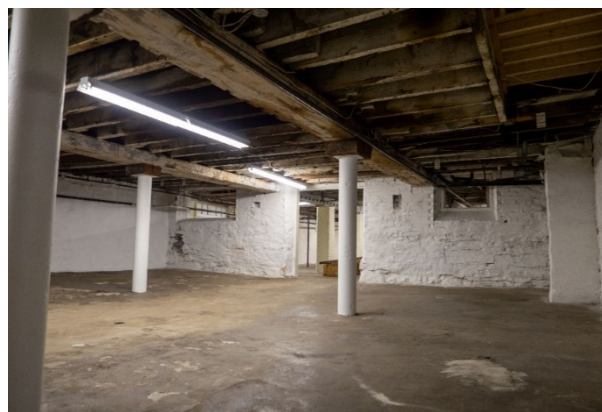
Figure 22: Looking southwest from the southeast quadrant, past the original rear foundation wall and window openings.

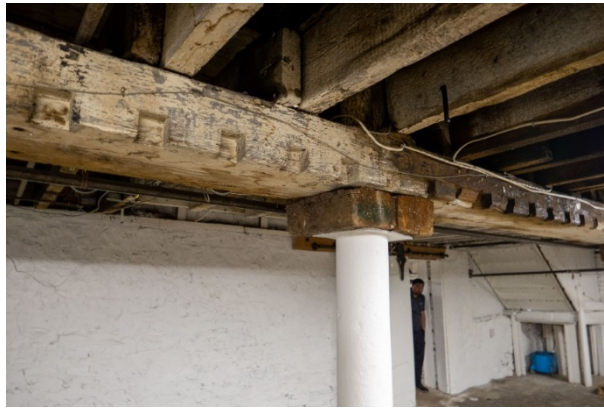
Figure 23: Salvaged wood beams and round posts under the original portion of 48 Ferguson.

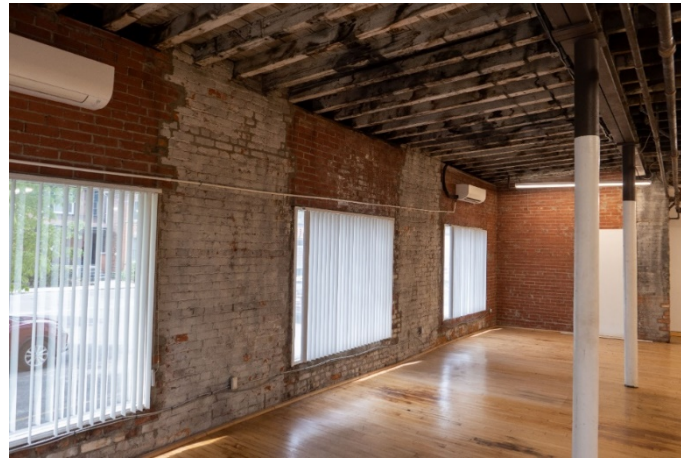
Figure 37: View of Section Z addition interior space, with steel beam and different ceiling structure.

The relative chronology of Section Z is less certain, being a smaller addition, although exposed interior brickwork suggests it was built subsequent to Section A. There is no excavated basement beneath Section Z, although it has a raised foundation with similar masonry to Section A. A steel beam supported by posts carries the upper portion of Section A's original south wall (Figure 37).

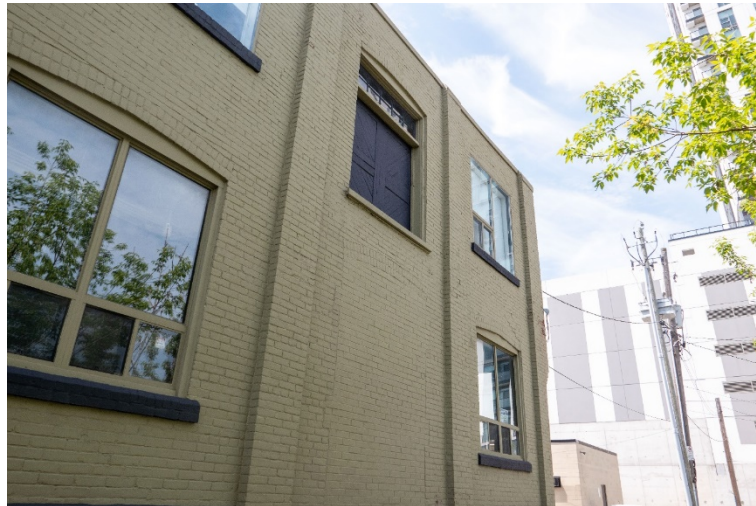
Figure 49: Former openings taller than windows at grade, and the remnant door above suggest loading functions related to the elevator .

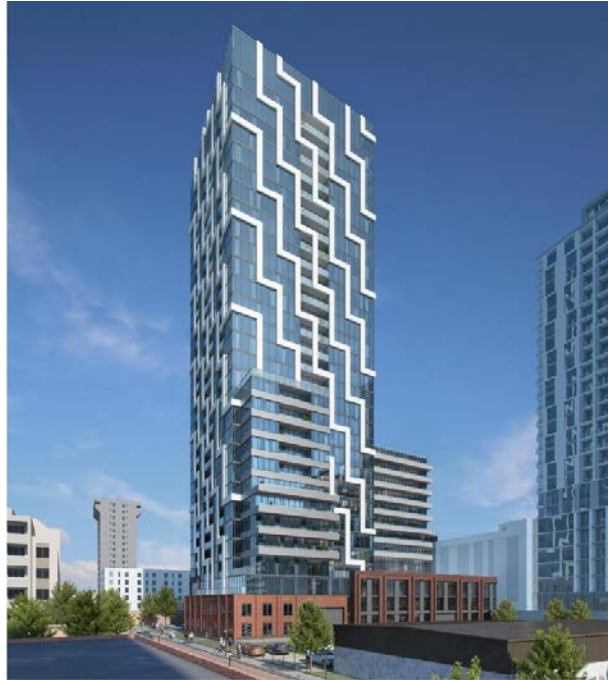
Figure 74: Perspective southwest view, conceptual, of the reconstructed heritage facades in the proposed new development (G+C Architects, November 2023)

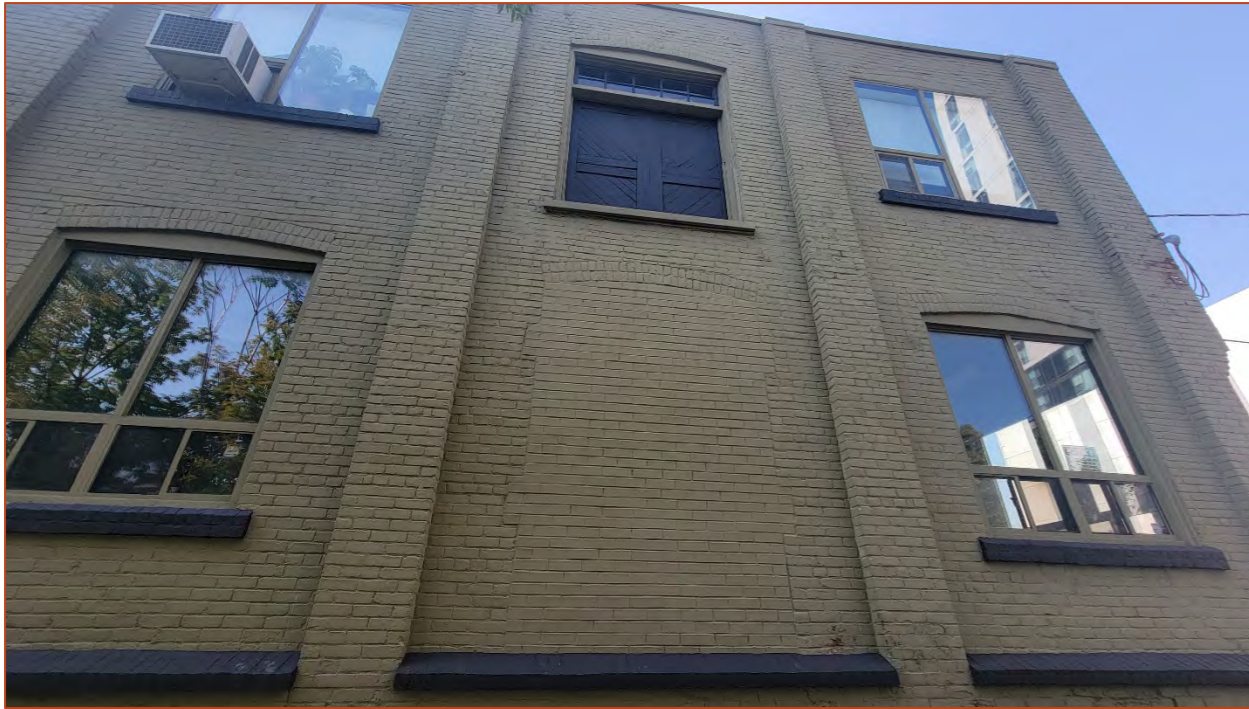
Photo 9. View of the second-storey freight elevator opening and the infilled opening on the first storey of the north elevation of the Radigan Building.

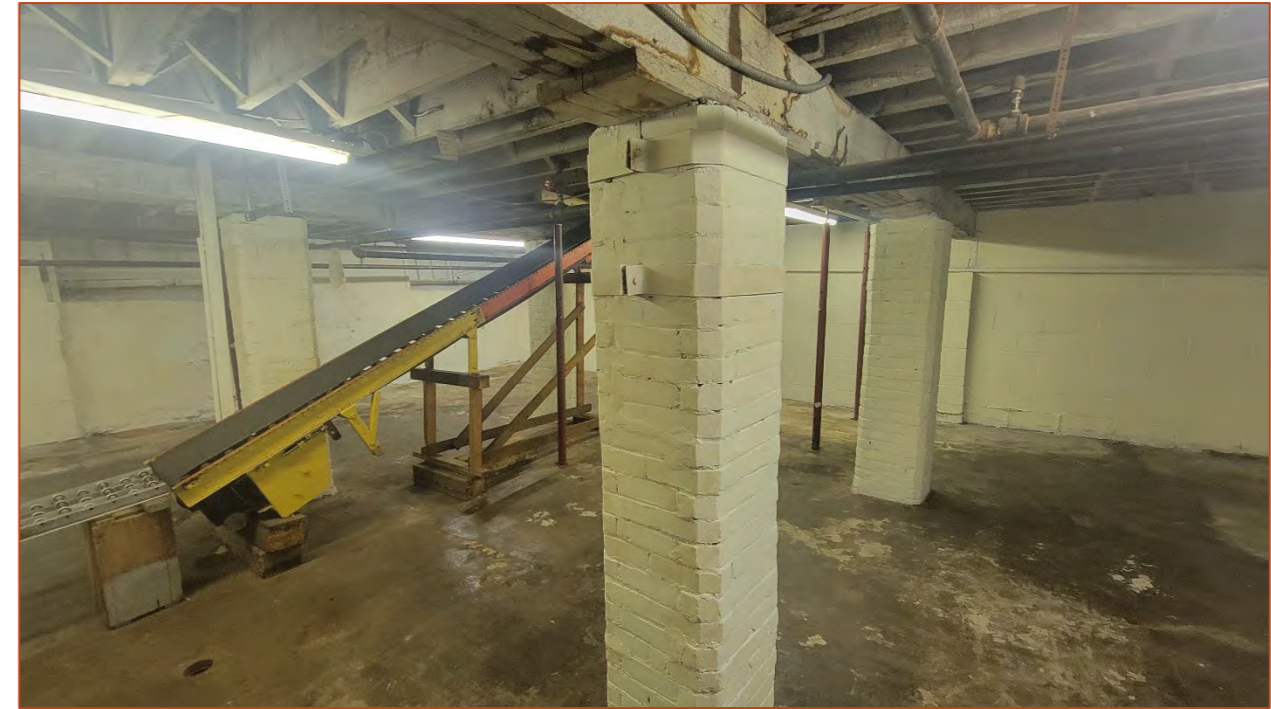
Photo 15. View of a partitioned room with a conveyor belt and wooden beams supported by chamfered brick pillars.

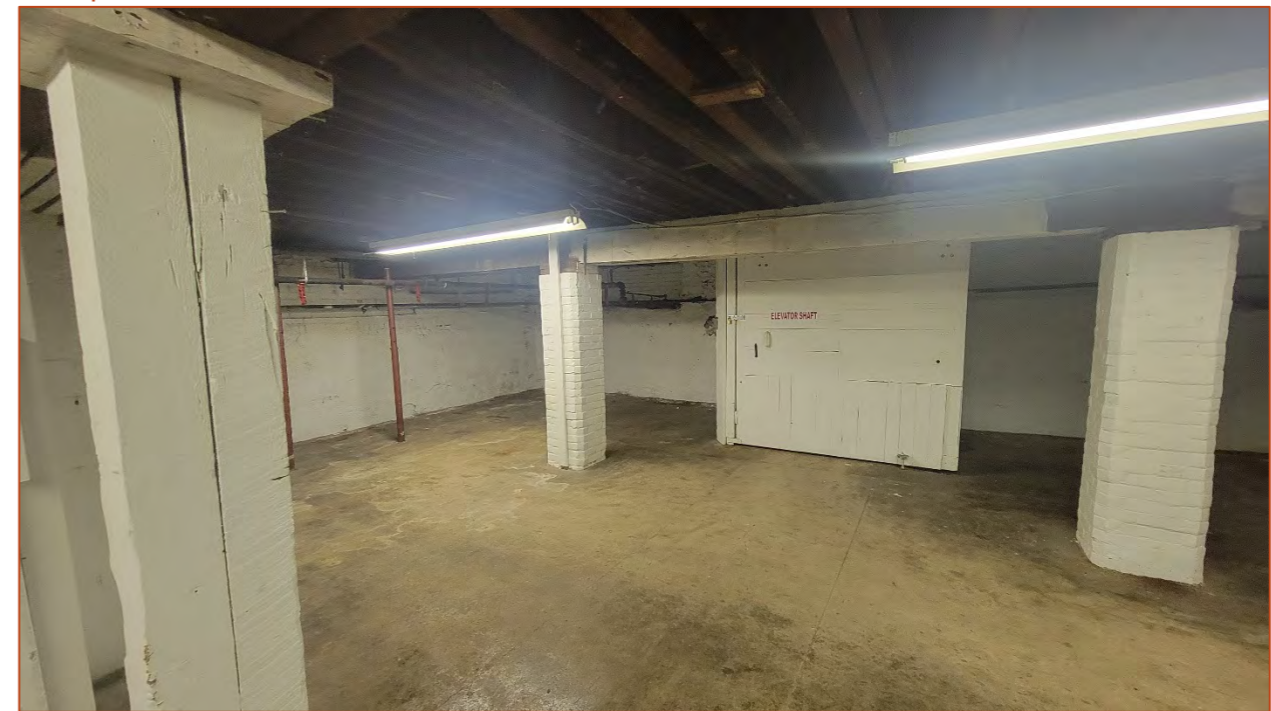
Photo 16. View of the 1909 freight elevator shaft and painted timber beams supported by brick pillars and painted timber posts.

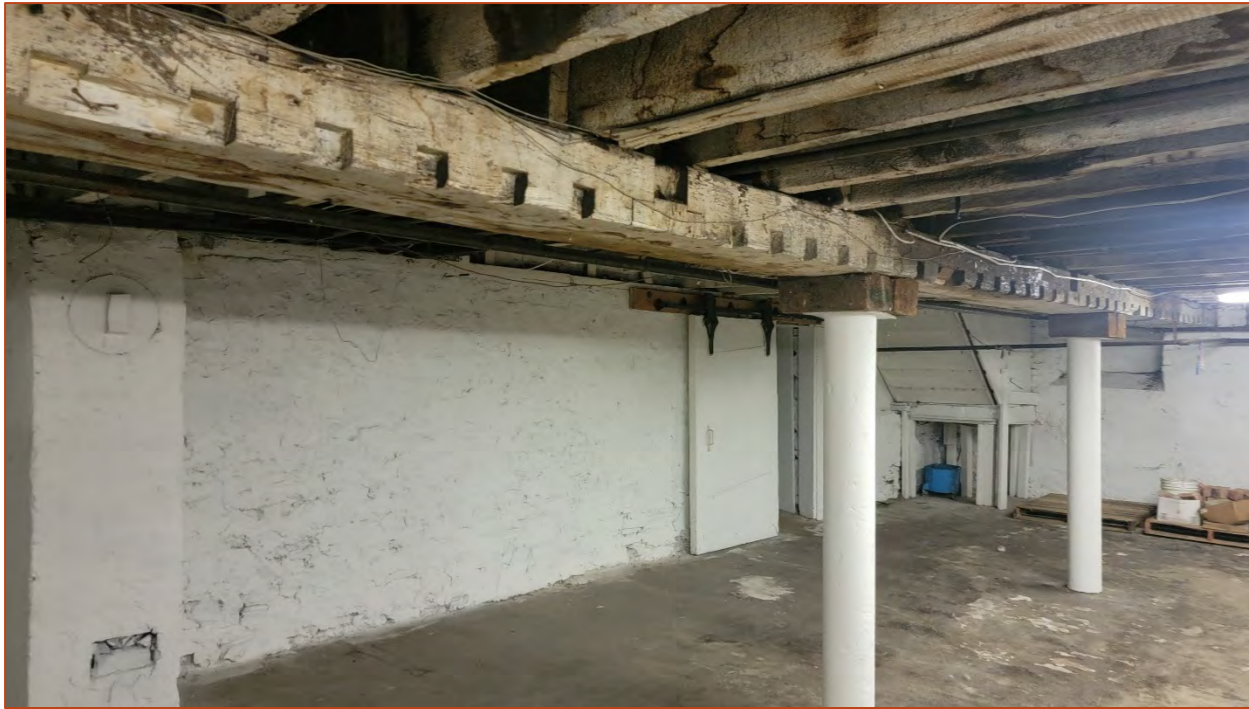
Photo 17. View of the brick foundation walls and timber beams with mortises and timber joists supported by cylindrical metal pillars.

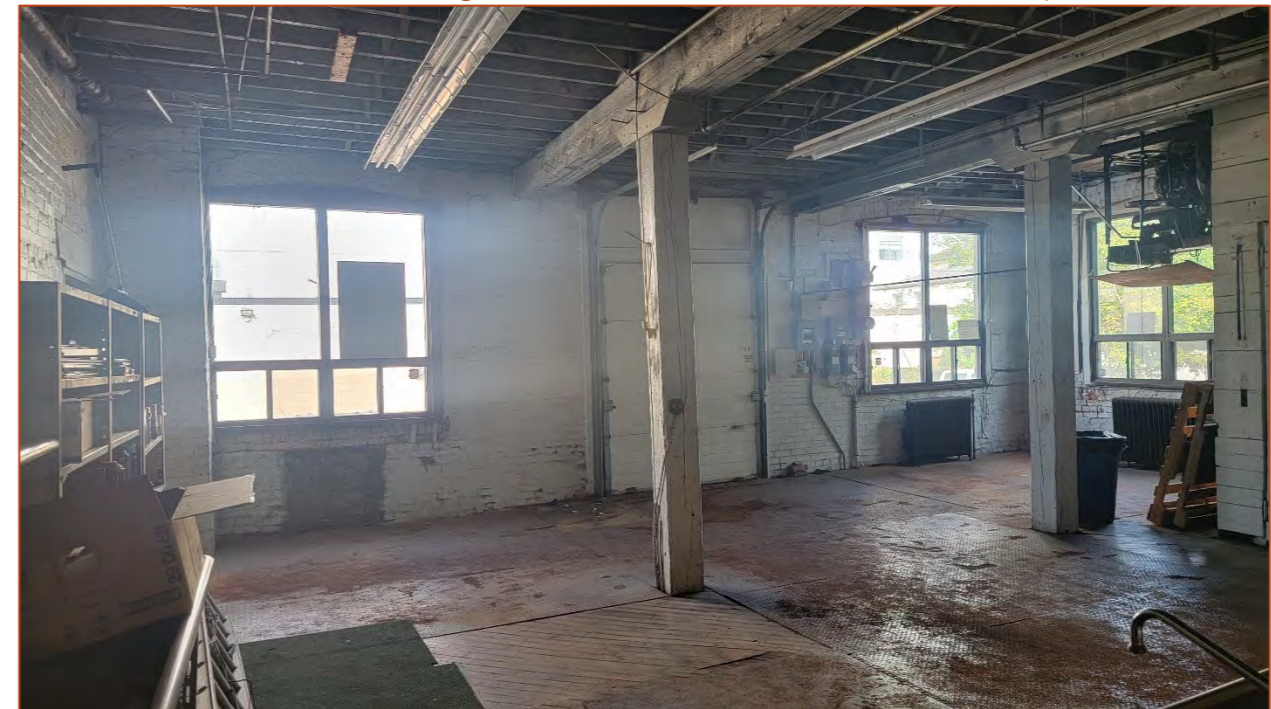
Photo 24. View of the rear workshop area showing wooden timber posts and beams, casement windows, metal grate flooring, and a loading door at centre.

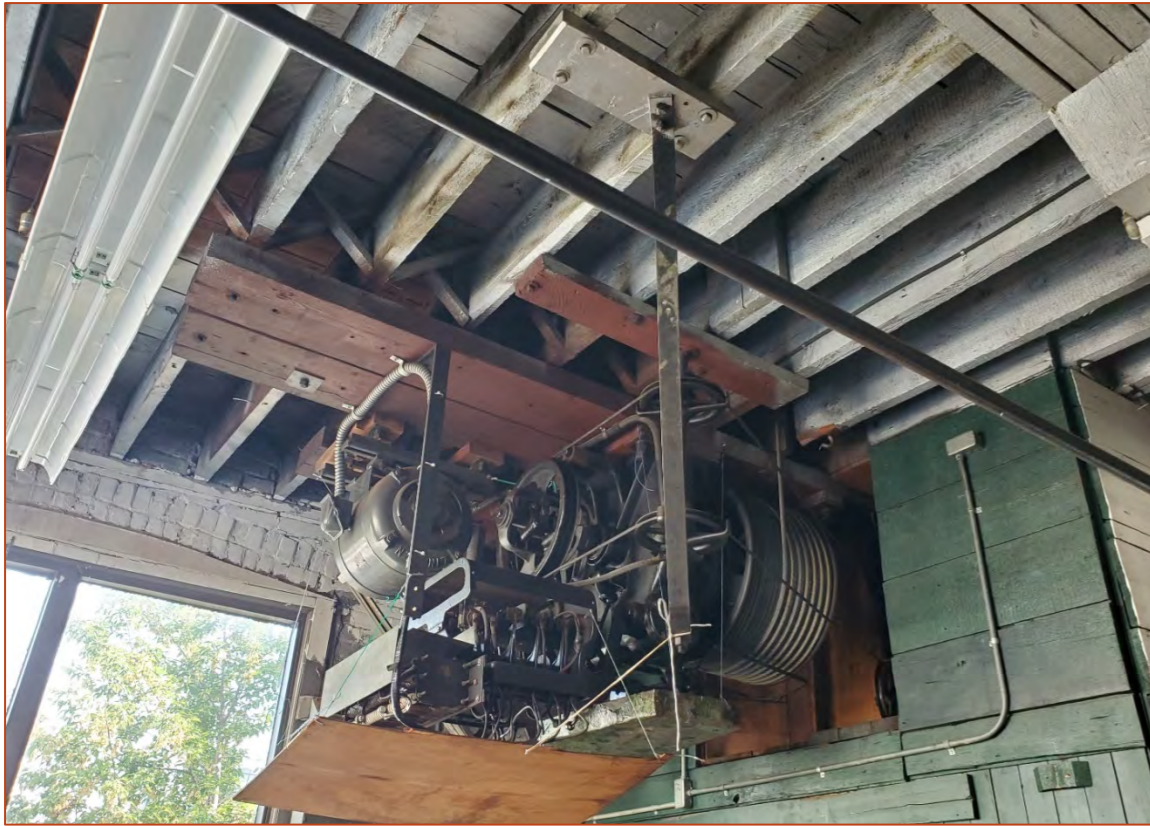
Photo 29. View of the freight elevator motor.

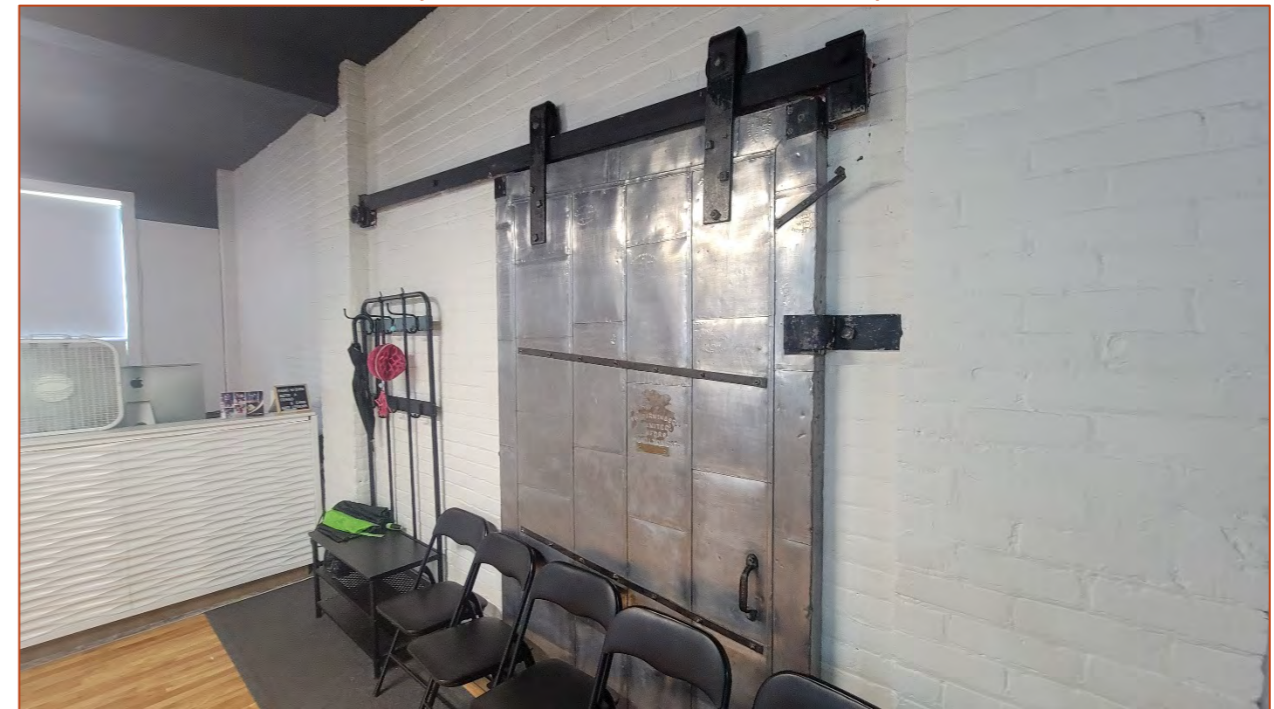
Photo 44. View of a brick wall and a copper steel-plated fire door.

A copper steel-clad fire door is recommended to be salvaged and incorporated into the proposed building’s lobby interior. The rails of the fire door will be cleaned of dirt and debris; however, the copper steel-clad door and its rails will otherwise remain unchanged.

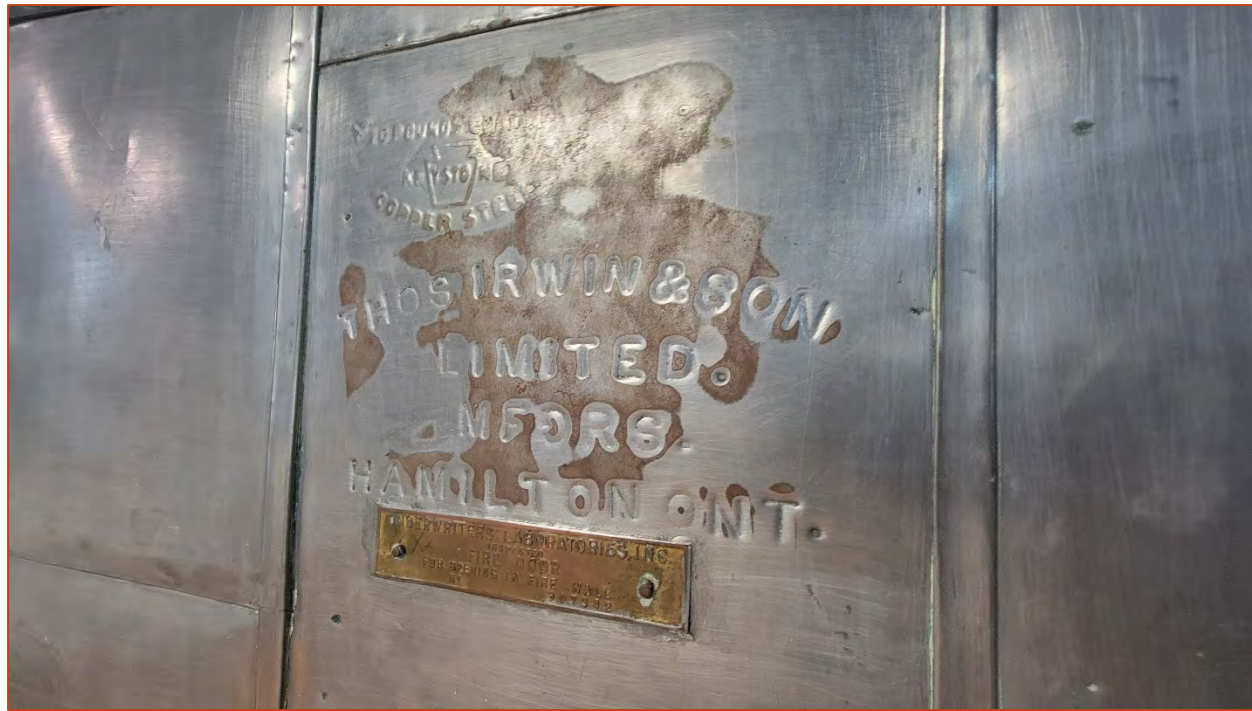
Photo 45. Enlarged view of a manufacturing stamp on the fire door.
